Days Bay Incident August 2024

Hutt Valley Services Committee 20 Sept 2024

Days Bay pump station - background

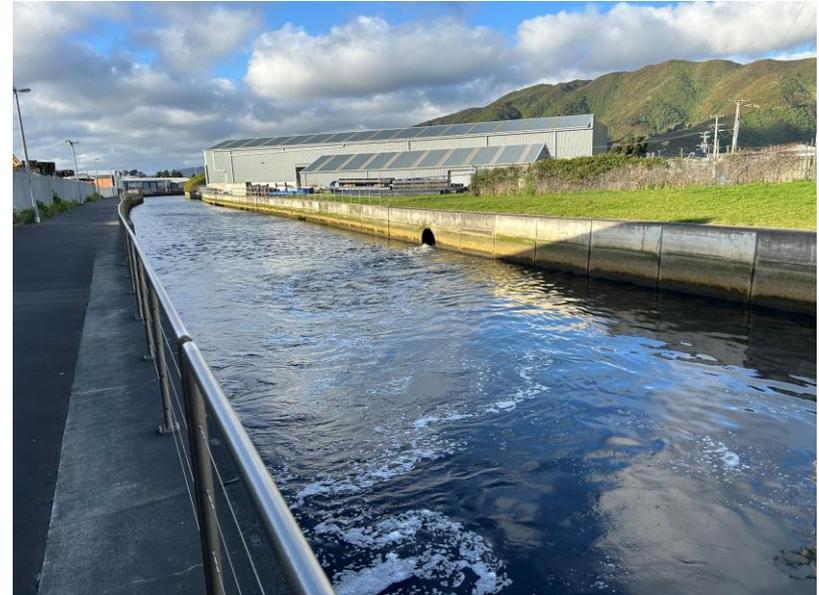
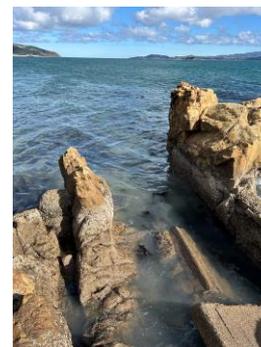
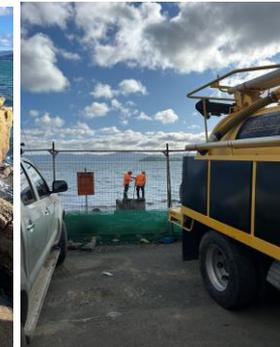
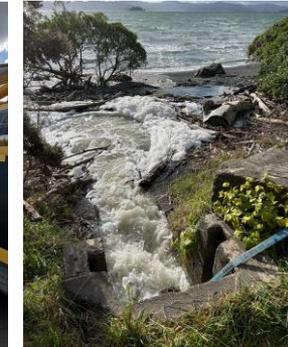
- COG responded to leak outside pump station
- Turning off Days Bay pumps didn't stop the leak
- Incident escalated to EMT
- Old connection from outfall (two valves) couldn't be closed
- Diverted WWTP to Waiwhetū Stream on Sunday 11 August
- Outfall required draining
- Eastbourne pipeline isolated

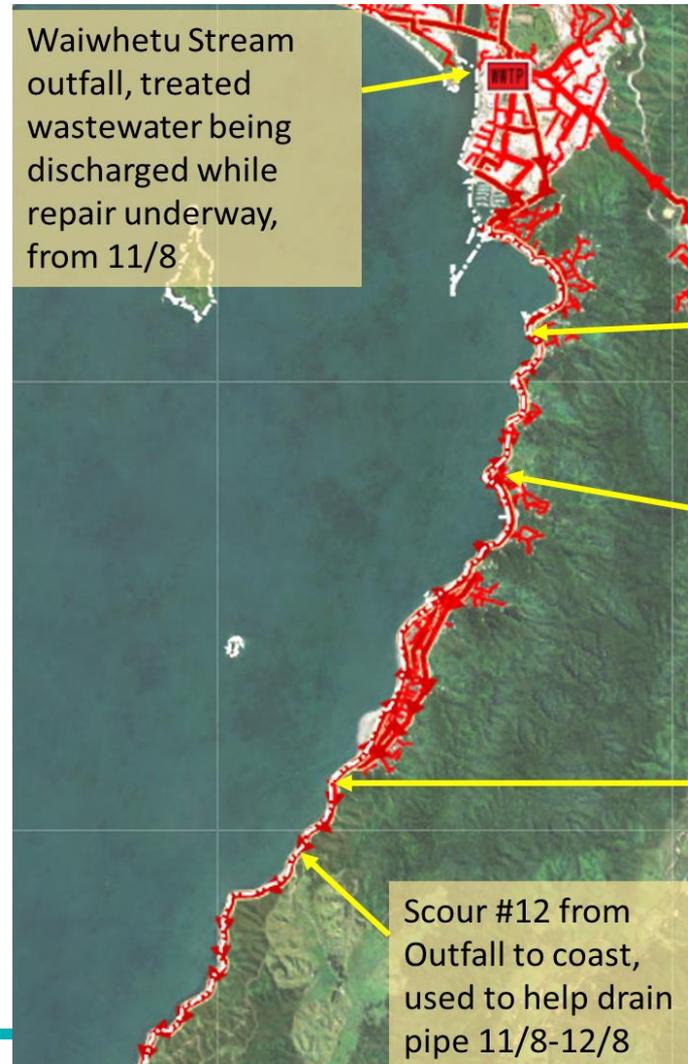
York Bay pump station, initial overflow to harbour, back on line Tues 13/8 PM

Days Bay pump station, site of failed valves/pipes, overflowing to harbour from 11/8, sucker trucks operating from Tues 13/8 PM

Point Arthur pump station, initial overflow to harbour, back on line Tues 13/8 PM

Scour #12 from Outfall to coast, used to help drain pipe 11/8-12/8

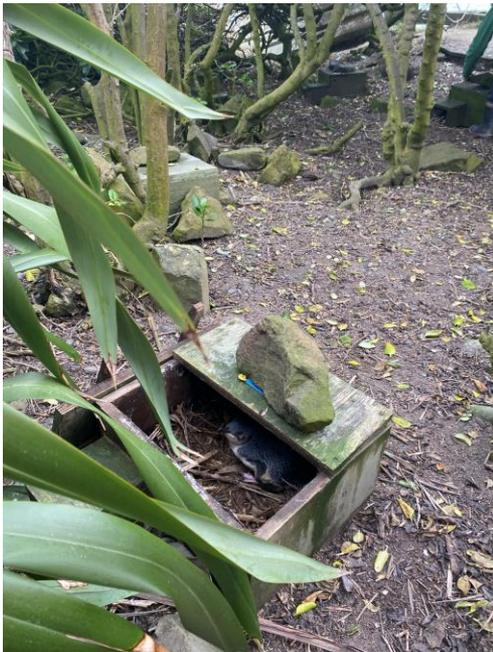
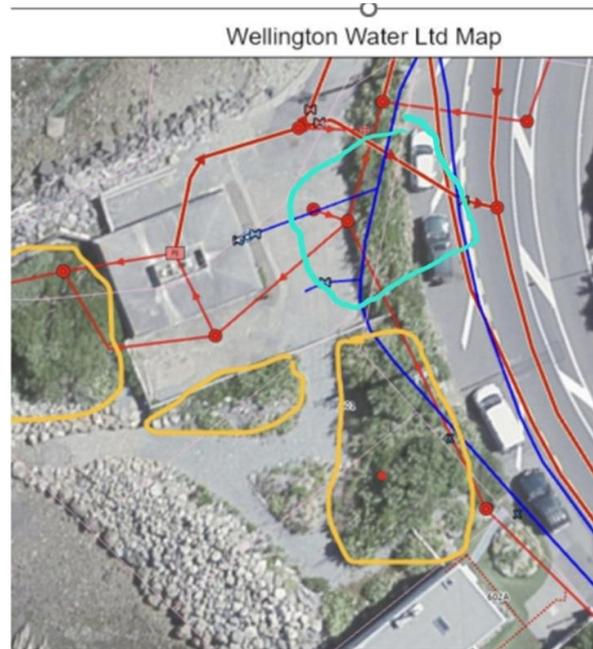
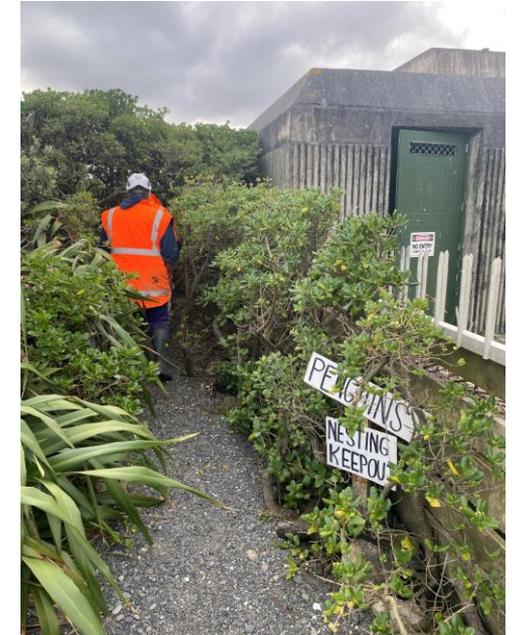
- Iwi and DoC involvement
- Detector dog checked area
- Sensitive time of year for nesting
