SEAVIEW WASTEWATER TREATMENT PLANT MAIN OUTFALL PIPELINE CONDITION REPORT

Prepared for Hutt City Council

August 2016

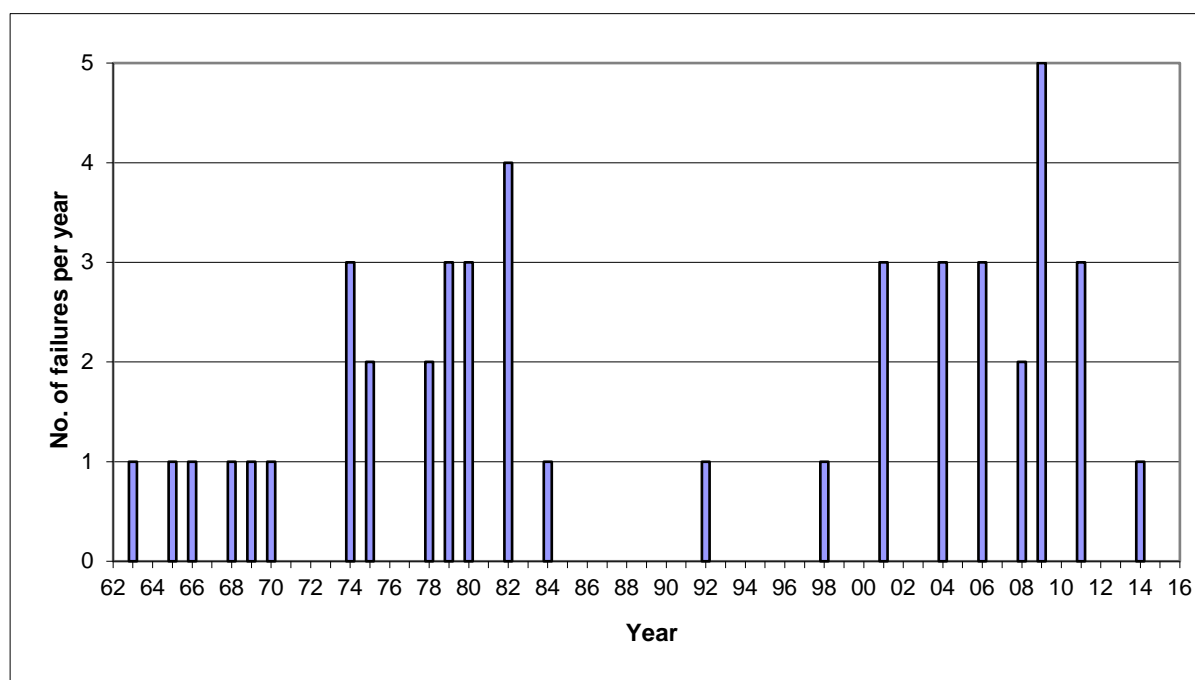
The pipeline has experienced 50 rubber ring joint leaks since it came into service (refer Figure 1) and in the 54 years of operation several condition inspections have been undertaken. The most recent was completed in 2013 and inspected the condition of the pre-stressed reinforcing wires that provide structural integrity to the pipeline. As a result of this investigation two pipe sections were replaced.

Figure 1 Rubber ring joint failures per year on the Main Outfall Pipeline
