Executive summary

We have now completed an Initial Seismic Assessment (ISA) of Dowse Art Museum at 45 Laings Road, Lower Hutt using the Initial Evaluation Procedure (IEP). The assessment was carried out after completing a site visit and inspection of building consent documentation.

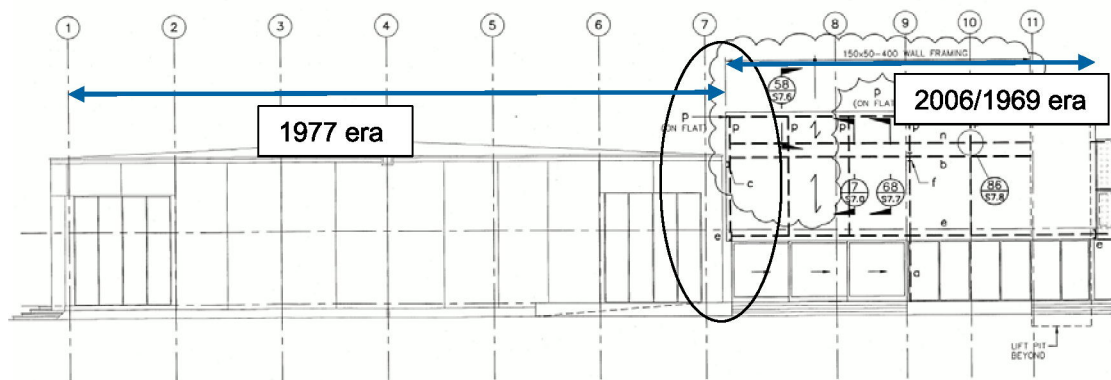
This resulting 2006 amalgamated portion of the Dowse Art Museum is mostly structurally separate from the 1977 gallery to the north and therefore is treated as a separate building in this ISA. An example of structural separation is shown in Figure 2.

Figure 2 Example of structural separation between 1977 gallery building and the rest of the Dowse

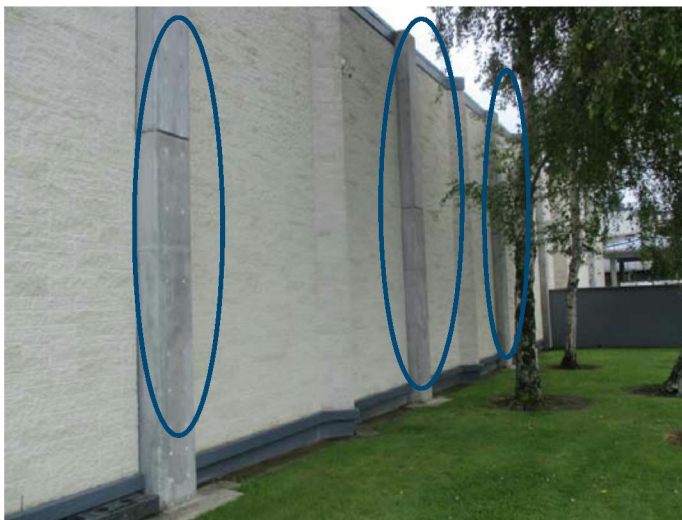
The 2006 extension consists of steel portals, diagonal steel bracing, and block walls to the new area. Reinforced concrete columns were built at the south and east elevations to strengthen the out-of-plane capacity of the building, as shown in Figure 3.

Figure 3 External reinforced concrete columns

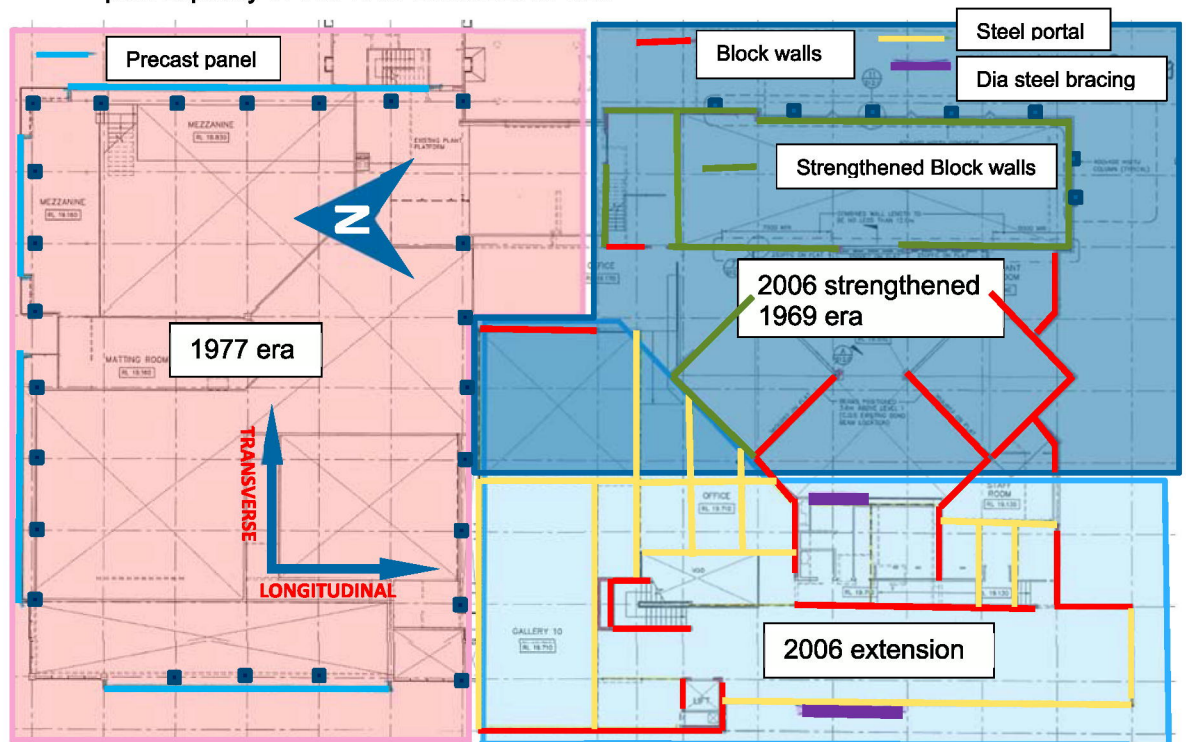
Figure 4 Plan view of the Dowse Art Museum

The block walls are not evenly distributed in both the longitudinal and the transverse directions, as shown in Figure 4 above. Therefore, the centre of mass is not located at the stiffness centre of the building. When the building is subjected to the lateral load, the load will not be evenly attracted through the building, which could induce excessive torsion within the building.

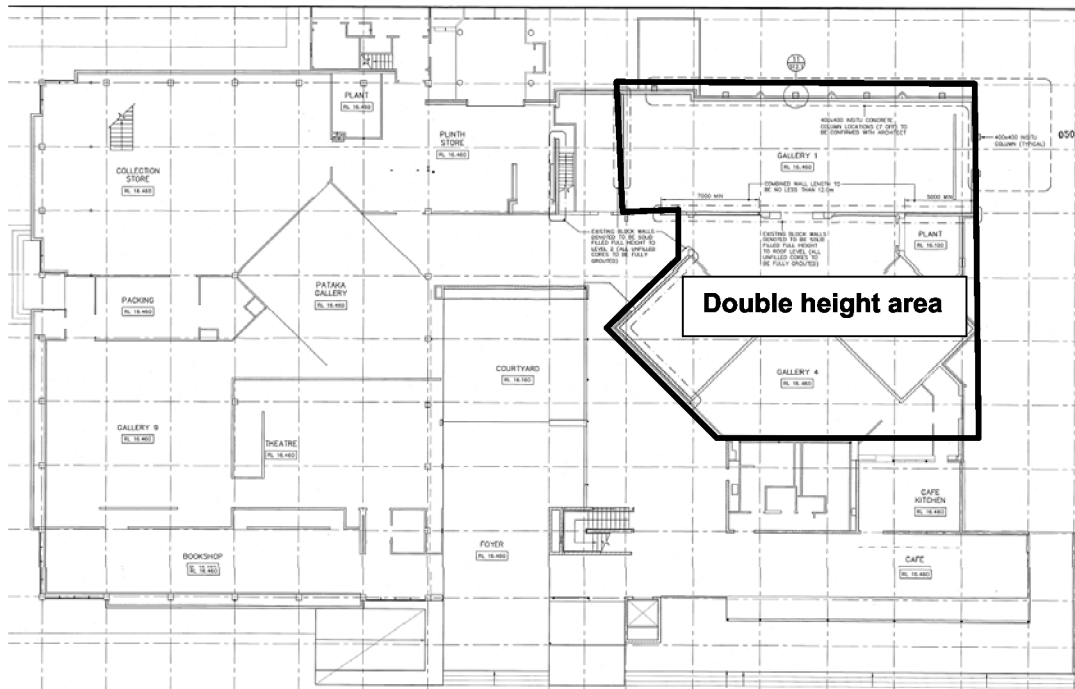
Most of the 1969 portion of the building is double the height of the two-storey components adjacent, as shown in the Figure 5 below. When the building is subjected to the lateral load, differing floor heights will alter the load distribution over the height of the building, which could induce irregular performance of the building.

Although this geometric configuration exists in the Dowse, the effect we expect is not significantly detrimental compared to other irregular aspects of the building.

Figure 5 Double height area at the ground floor

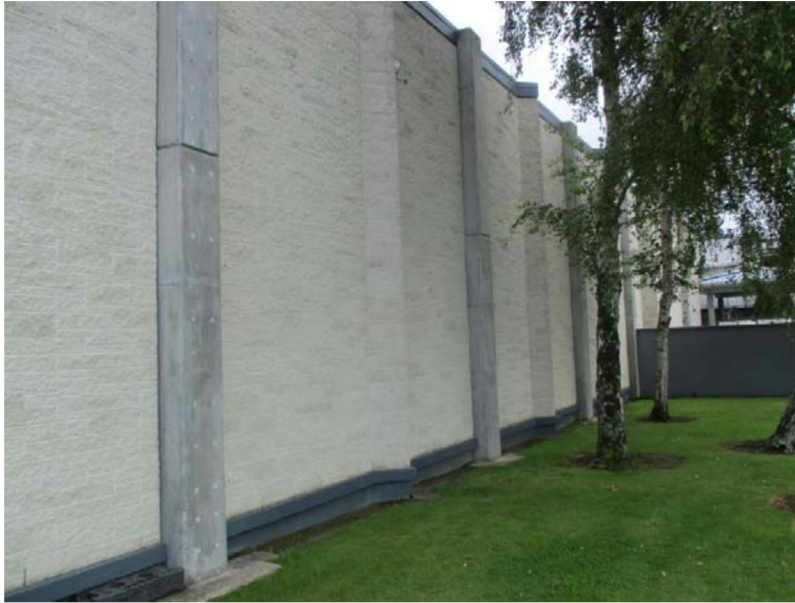
The brick veneer wall cladding appears to be in good condition, with no obvious signs of cracks or damage. However, there were no drawings available to confirm the brick tie system. It is recommended to carry out further invasive investigation to confirm the types and locations of the brick ties as part of a DSA.

Figure 6 Brick veneer URM wall cladding at south and east elevations

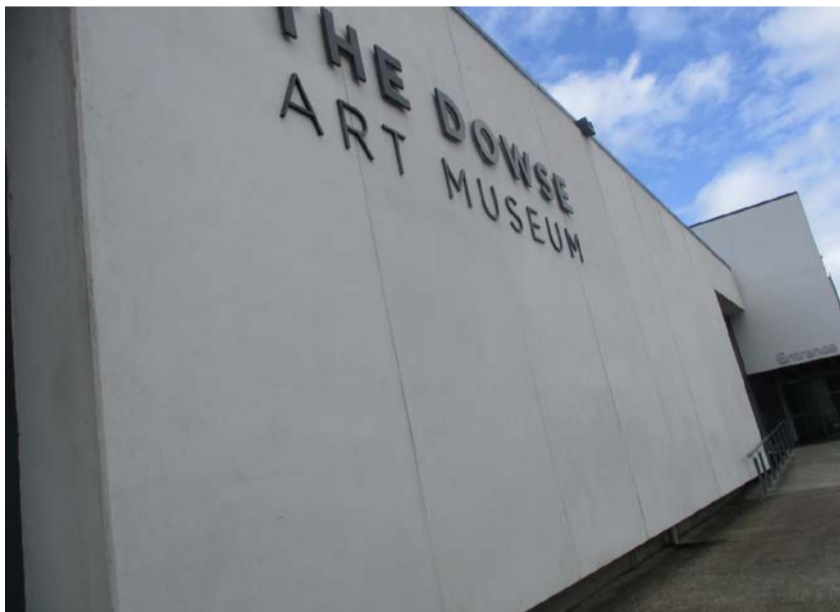
Precast panels

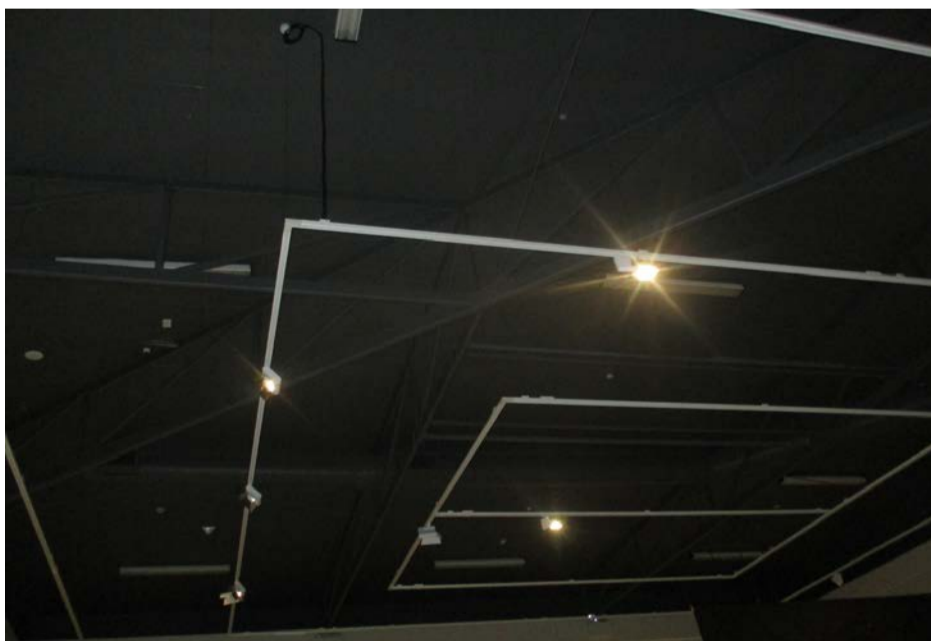
Steel roof truss

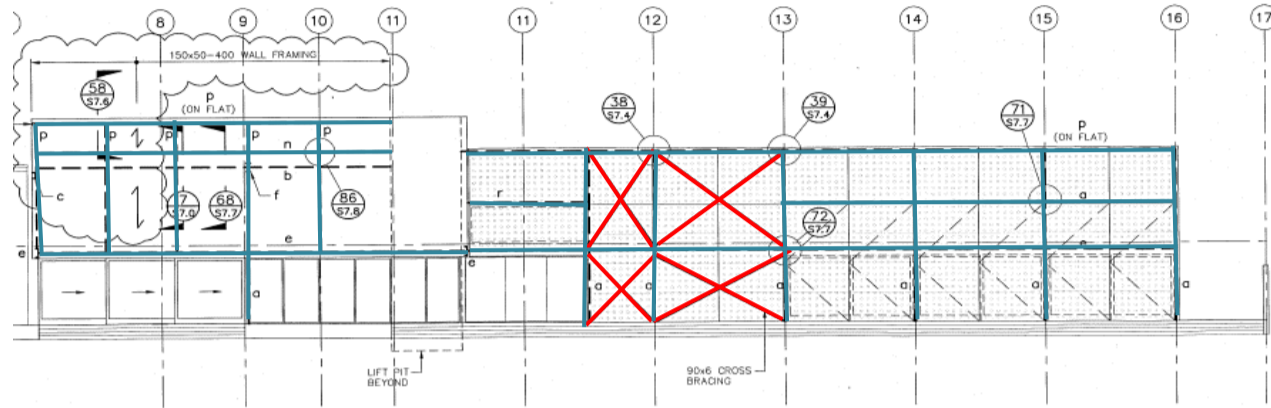
WEST ELEVATION
1:100 (A1)

Structural system - diagonal steel bracing and steel portals

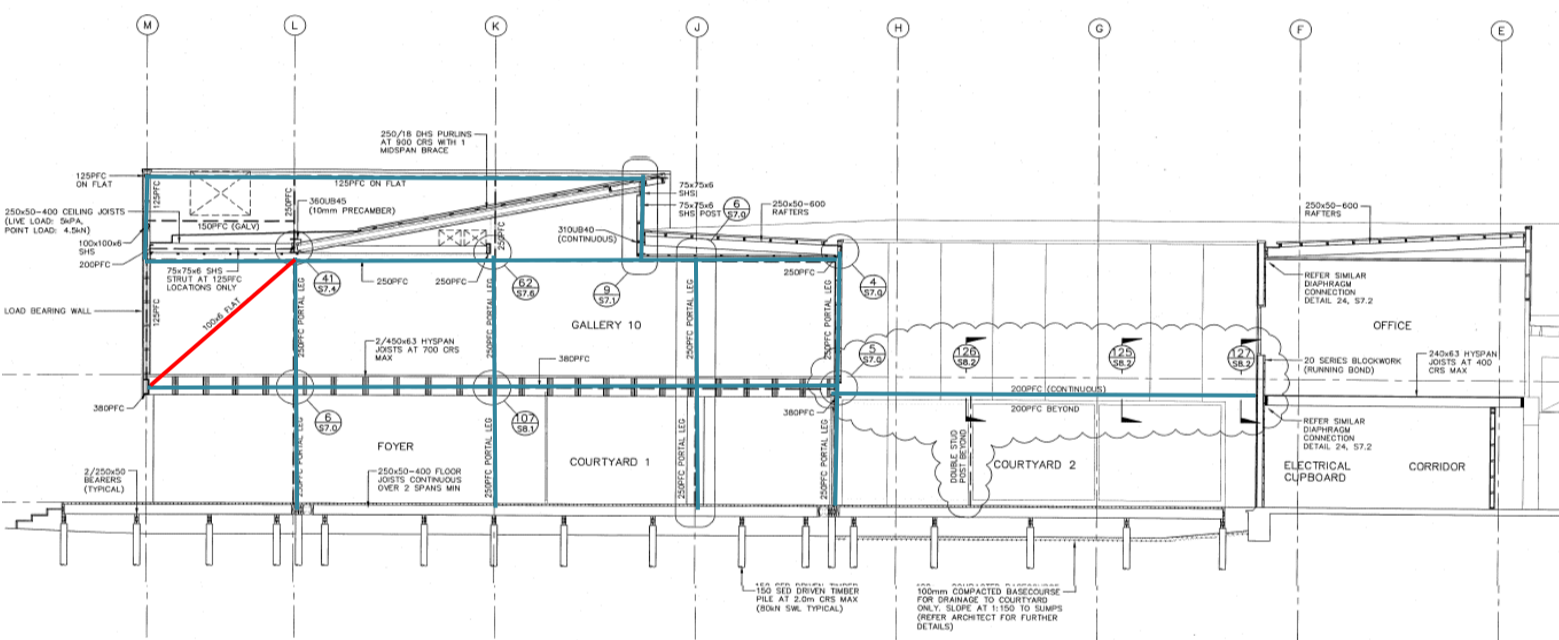
Structural system - steel bracing and steel portals
