Initial Seismic Assessment Report - Naenae Library Building, 341 Cambridge Tce, Naenae

Initial Evaluation Procedure (IEP) Assessment - Completed for Hutt City Council

Street Number & Name:	341 Cambridge Terrace	Job No.:	5270911
AKA:		By:	TP
Name of building:	Naenae Library	Date:	21/03/2018
City:	Lower Hutt	Revision No.:	1

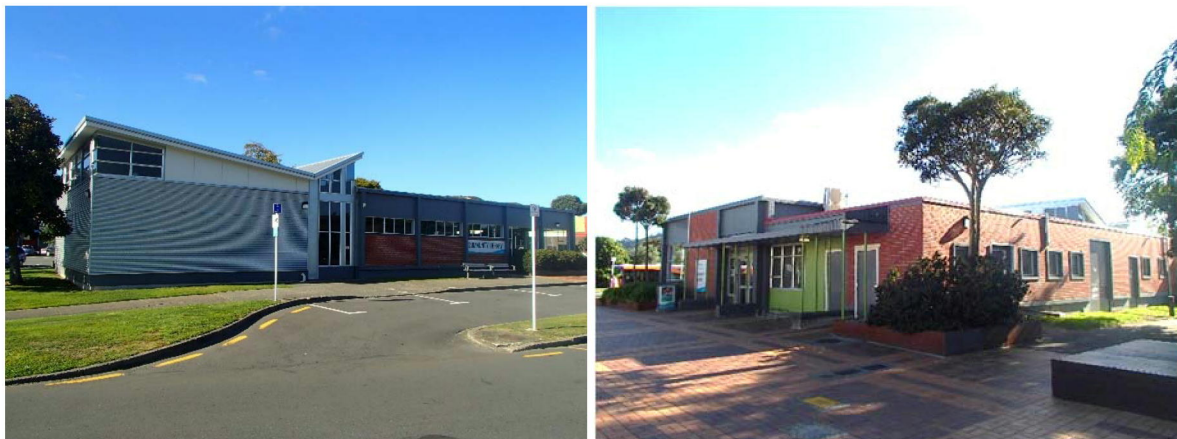
Figure 2: External photographs (NE view and SW view)

- A site visual inspection conducted on 20 March 2018 of the building exterior which confirmed the nature of the building, its relationship to surrounding buildings, and the exterior cladding details.

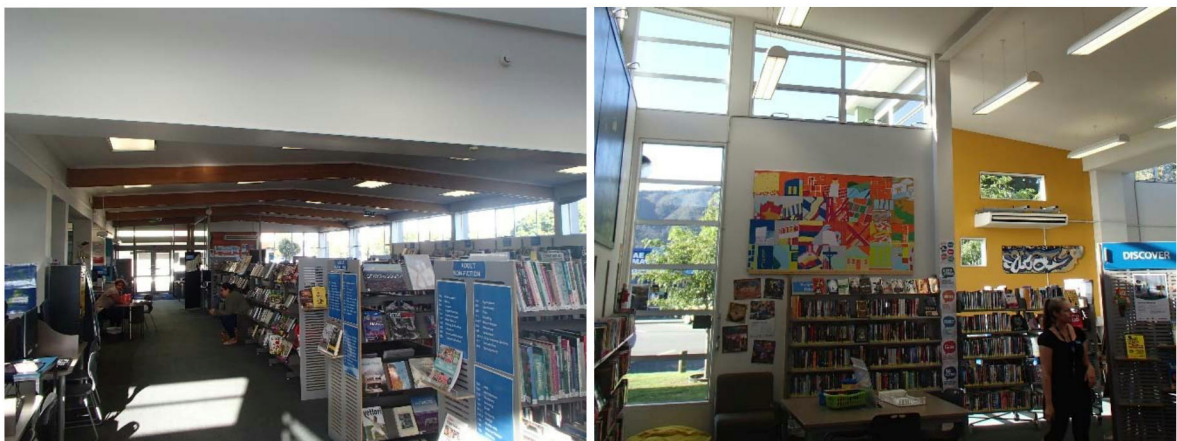
Figure 3: Internal photographs

- A structural visual inspection of the building interior on 20 March 2018, which confirmed the structural form of the building. The inspection was limited to areas where safe, ready access was available to:

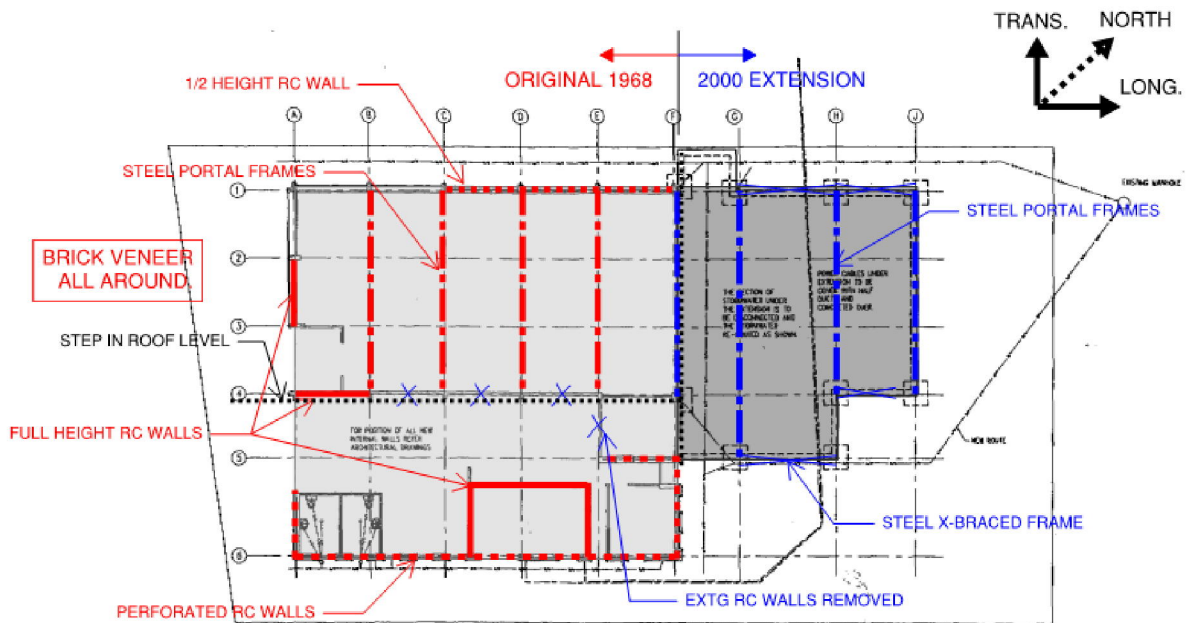
Figure 4: Structural arrangement

The structural drawings for both portions were reviewed prior to the site inspections. During the site visit we compared the drawings to what we could readily observe to note any differences. The structure generally appeared in accordance with the drawings, although there were some discrepancies noted, in particular:

- The 2000 retrofit drawings indicate that all the internal RC walls along Grid 4 were removed from the 1968 portion, however the section of wall between Grid A and B remains in place.
- The openings along the southeast elevation differ to what is shown on the drawings.

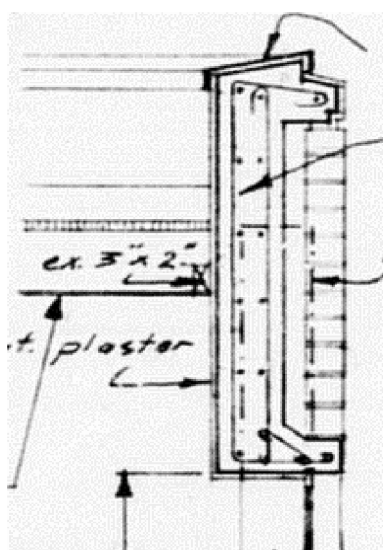
Figure 5: Typical brick veneer detail

The cladding around the 1968 portion consists of a cavity brick veneer in front of the RC walls. The original specification for this brick veneer required galvanised wall ties at regular centres tied to the RC panel behind. It also required mortar bed reinforcement at regular centres up the veneer. When we were on site we scanned the brick veneer in a couple areas to determine if the ties and mortar reinforcing was in place. While the results of the scanning were not entirely conclusive, there was some indication of ties and mortar reinforcing being present.

In considering the brick veneer, we assumed that the brick ties and mortar reinforcement are in place based on the specification requirements and some positive indications from site scanning. We have also assumed the ties are in a reasonable condition due to the building being located away from a coastal environment. Another positive feature when considering the brick veneer is that it appears to be confined by flanges on the RC wall behind, see Figure 5 below.
