Sawrey Consulting Engineers
Document No: 43405_1
Project: 9755

McKenzie Baths 79 Udy Street Petone, Lower Hutt Initial Seismic Assessment (ISA) of facility building

Hutt City Council

Date: 18 December 2019

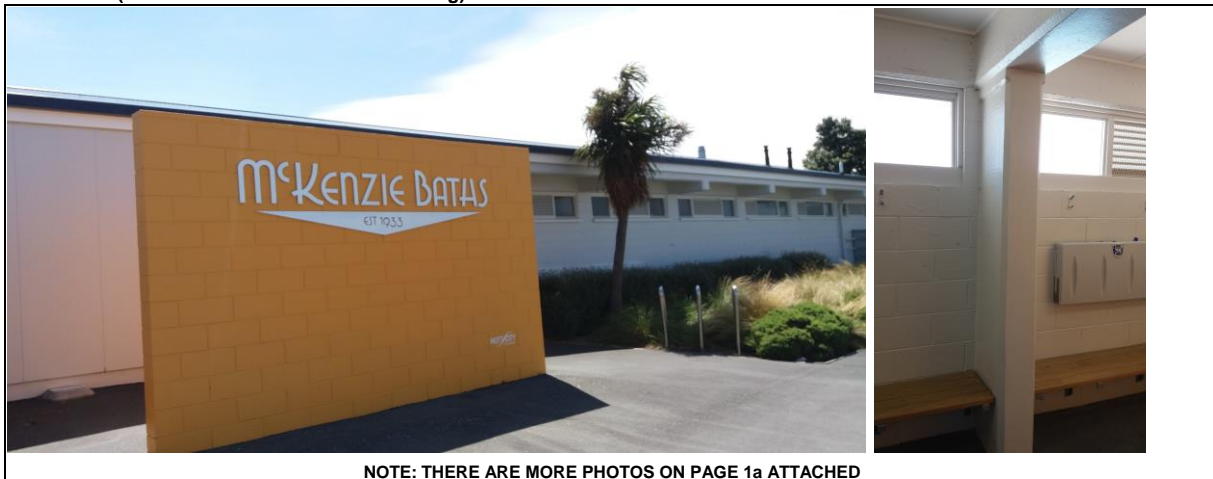
1.1 Photos (attach sufficient to describe building)

- Single storey public building, built Circa 1964.
- Multiple smaller rooms; office, female and male changing rooms, plant rooms and storage rooms.
- The building had a refurbishment in 2012.
- Reinforced concrete 2-way frame construction with reinforced concrete masonry block infill walls.
- Light weight gable roof with timber trusses.
- Concrete slab on grade and concrete foundations.
- The building appears to be designed for very high loadings based on the size of the reinforced concrete 2-way frame members.
