Sawrey Consulting Engineers  
Document No: 43189\_1  
Project: 9754

# **Eastbourne Pool 2 Marine Parade Eastbourne, Lower Hutt Initial Seismic Assessment (ISA) of changing room and plant room building.**

Hutt City Council

Date: 18 December 2019

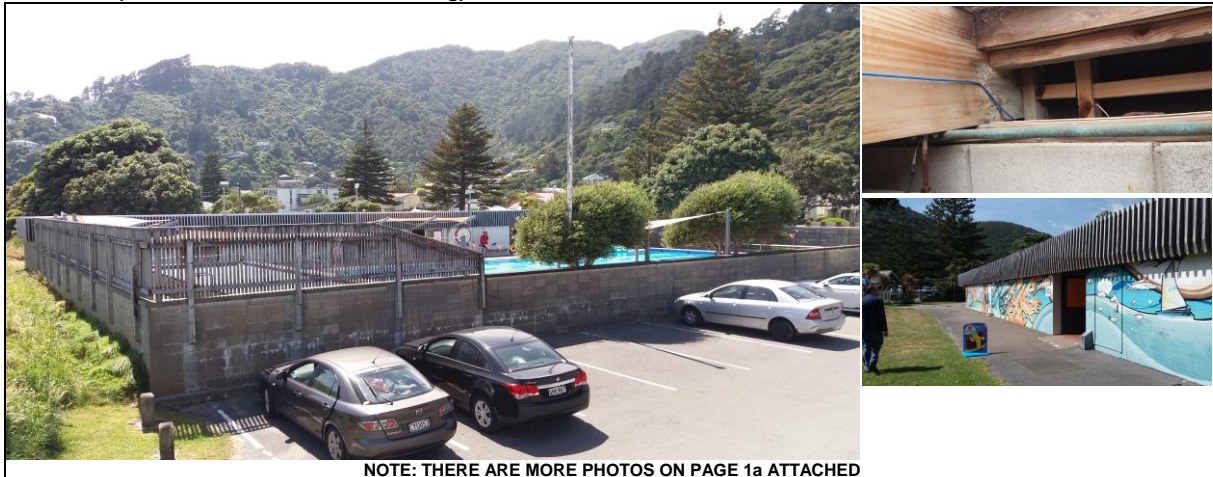
**1.1 Photos (attach sufficient to describe building)**

- Single storey public building, built Circa 1978.
- Multiple smaller rooms; kitchen, office, storage and bathrooms
- The changing rooms had a refurbishment in 2011.
- Reinforced concrete masonry block construction.
- Light weight monopitch roof with timber rafters.
- Concrete slab on grade and concrete perimeter foundation
- Appears to be no roof bracing.
