# Healthy Homes Mould and Bacteria Inspection Report

Hardwick Smith Lounge

Hutt City Council

19 Jul 2021

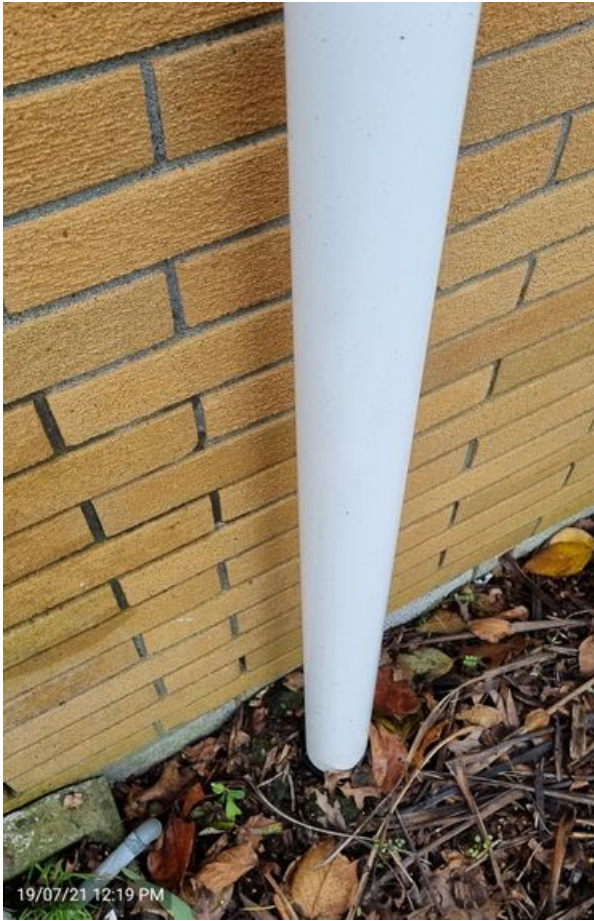
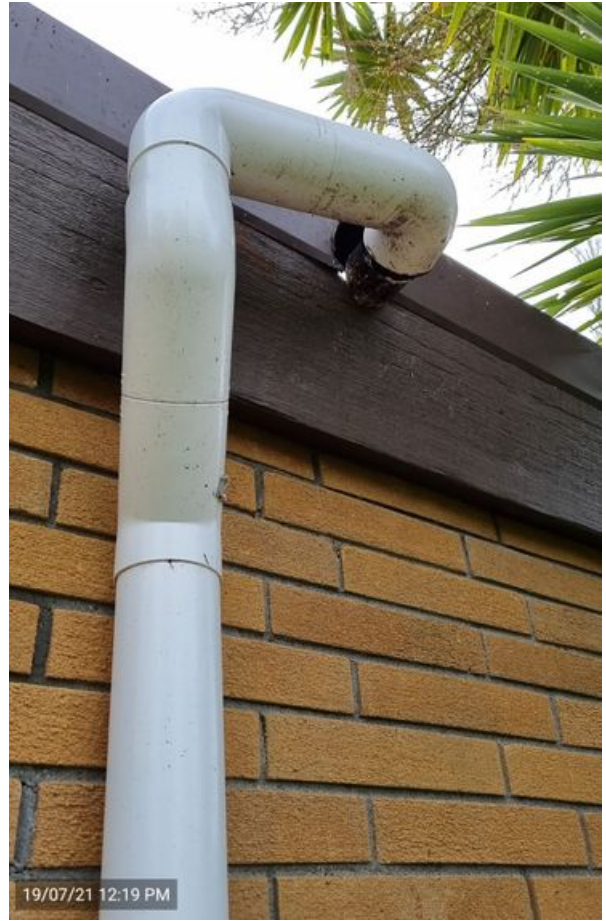
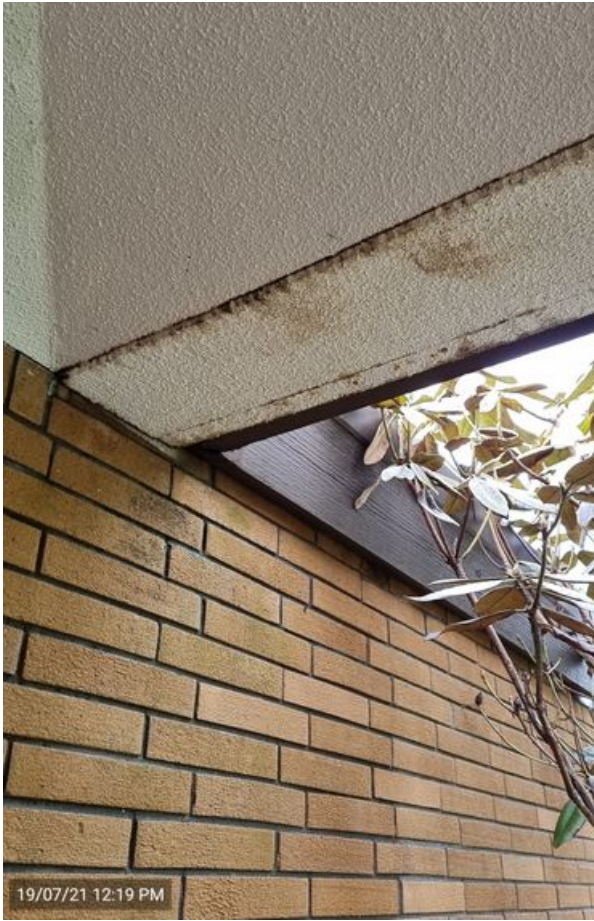
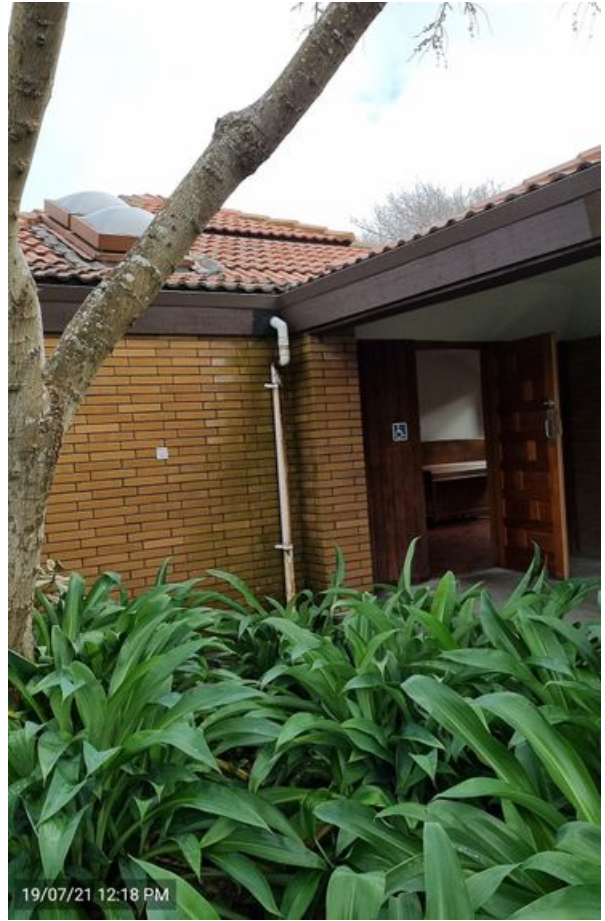
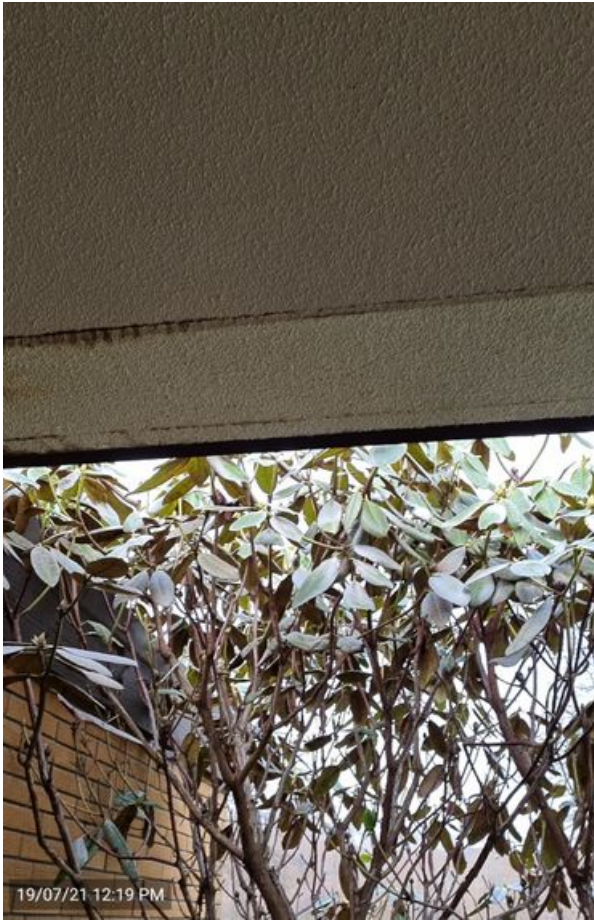
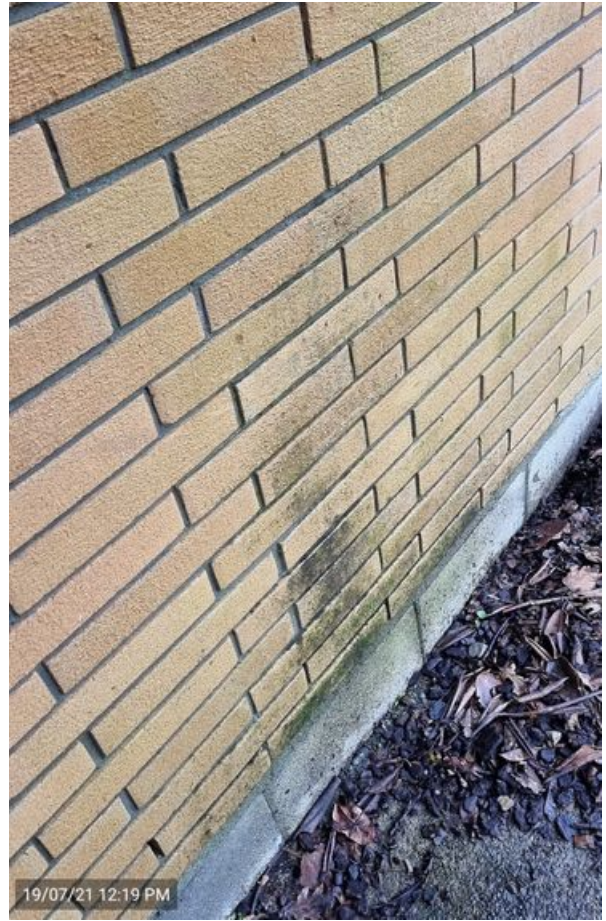
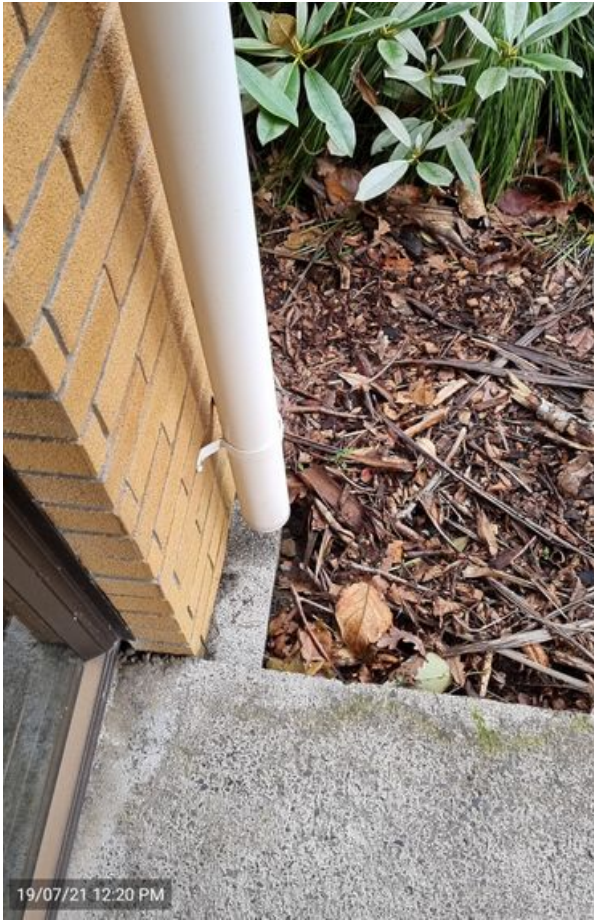
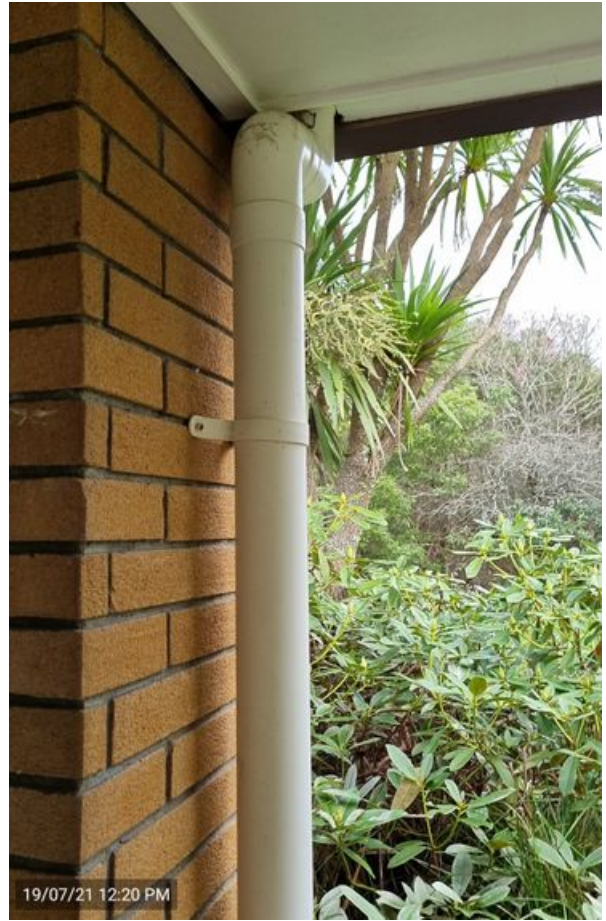
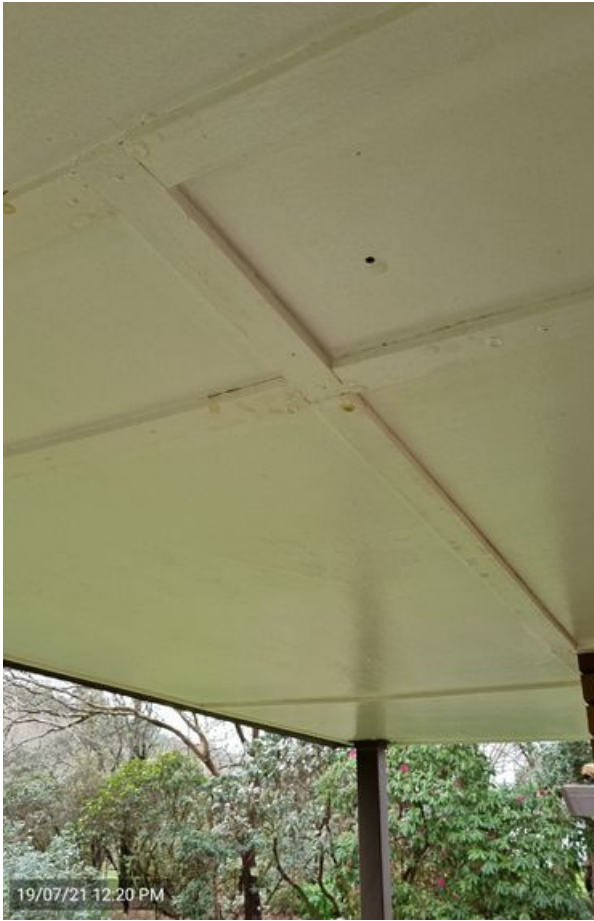
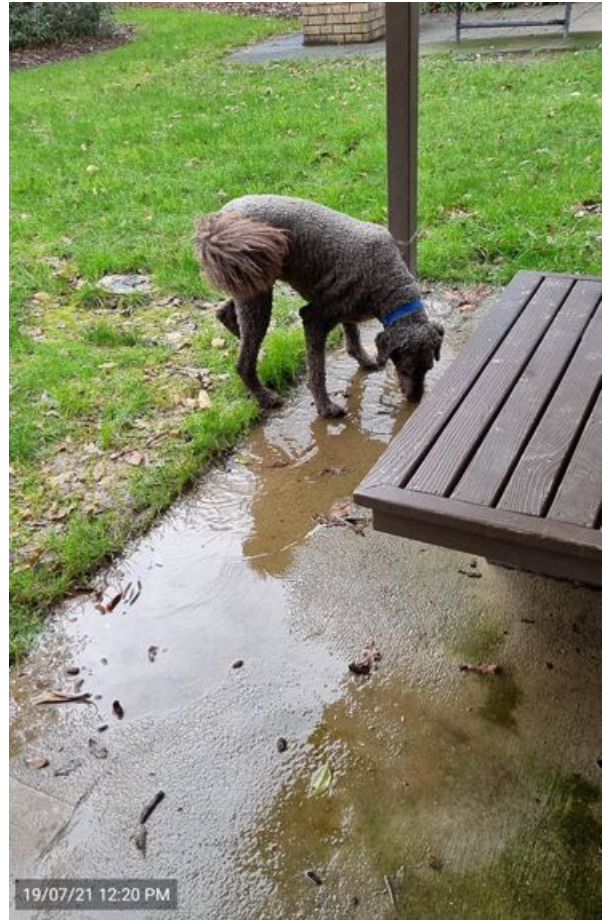
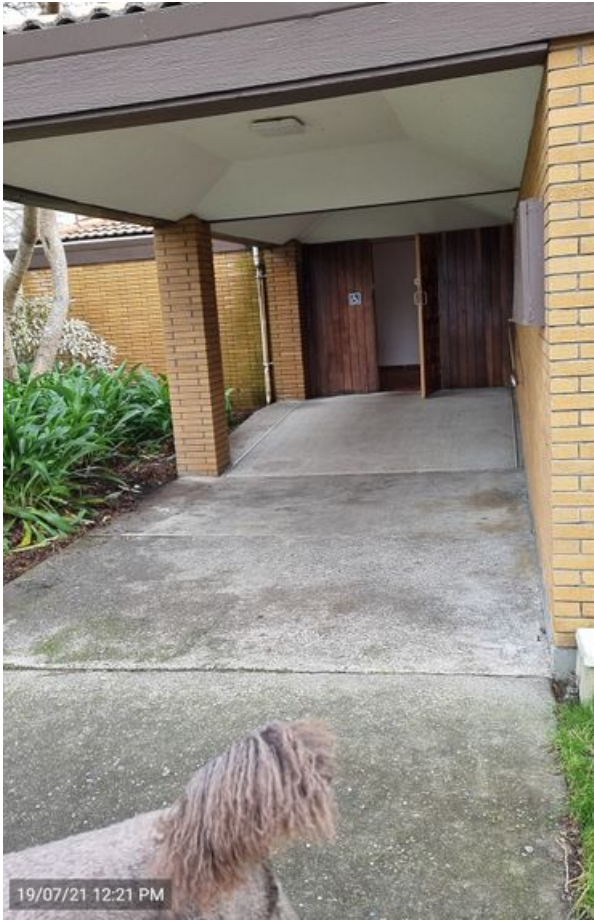
**Standing Water, Water Staining, Water Damage, Wood Rot/Structural Damage or Visible Mold on Exterior of Building**

1 Down Pipe not connected.  
Cladding is leaking on the outside Via the roof and also into the interior Walls  
1Down pipe at front leaking  
1Down pipe at rear discharging onto ground, should be connected to drain system

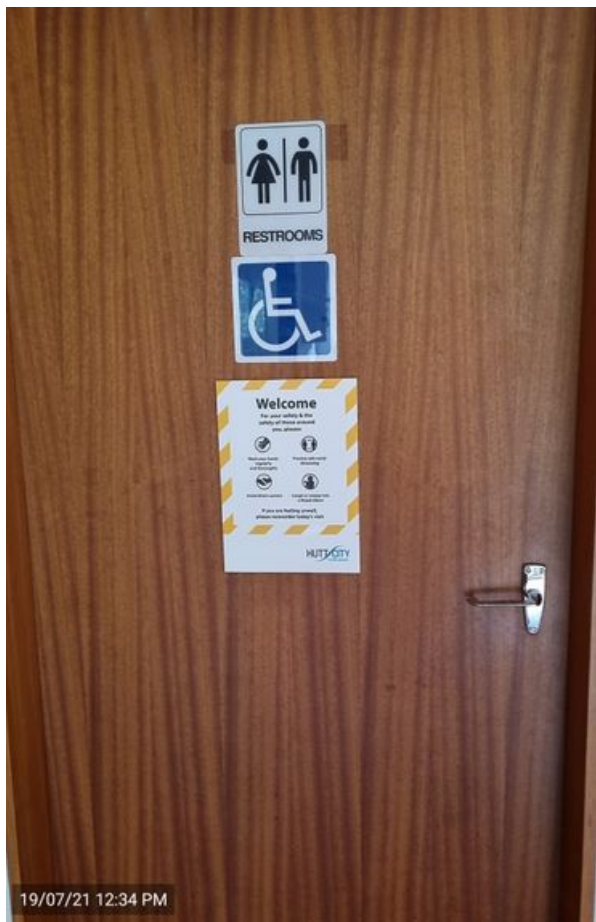
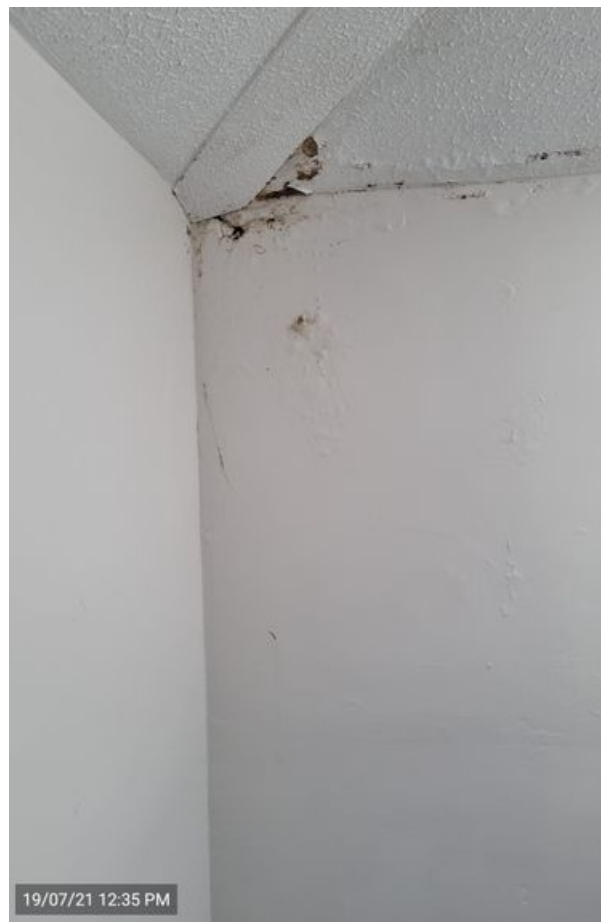
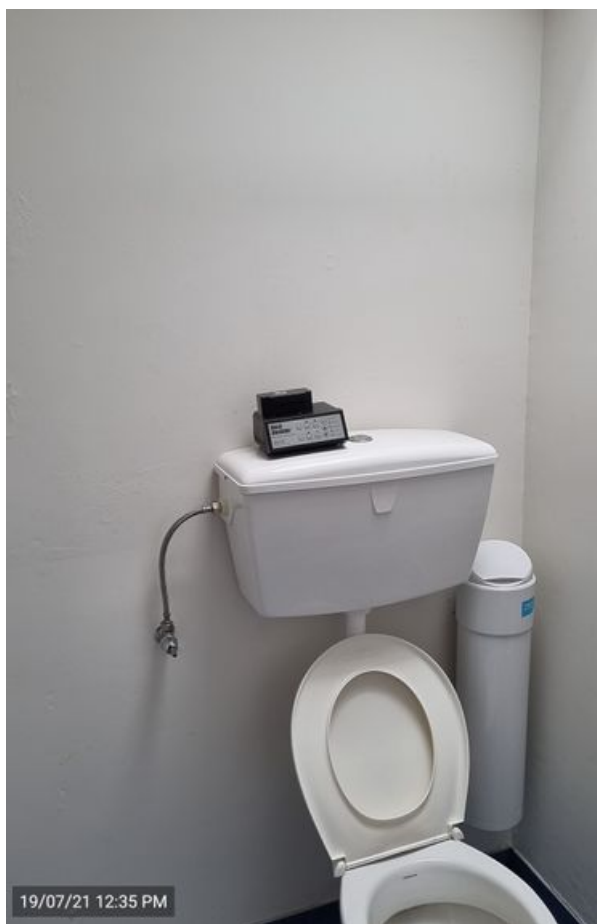
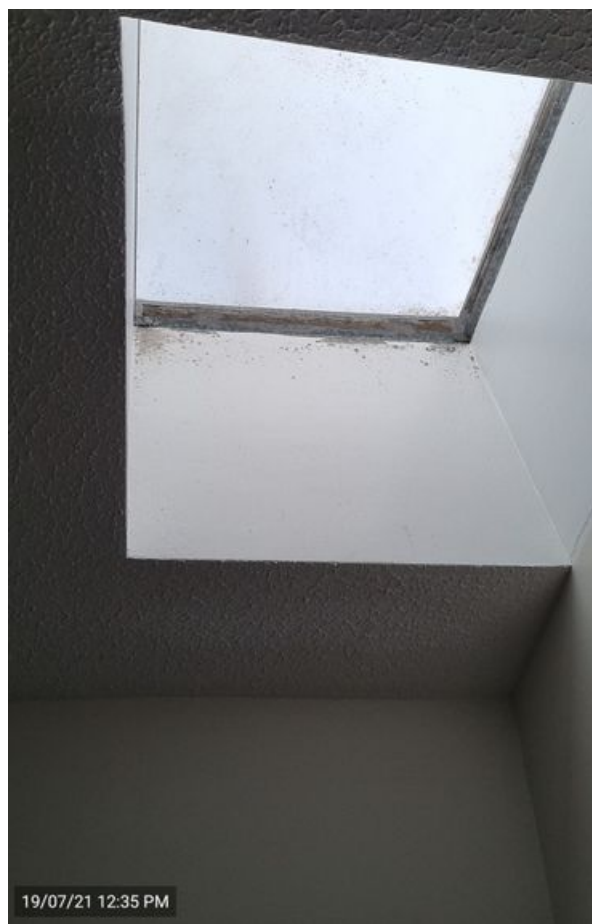
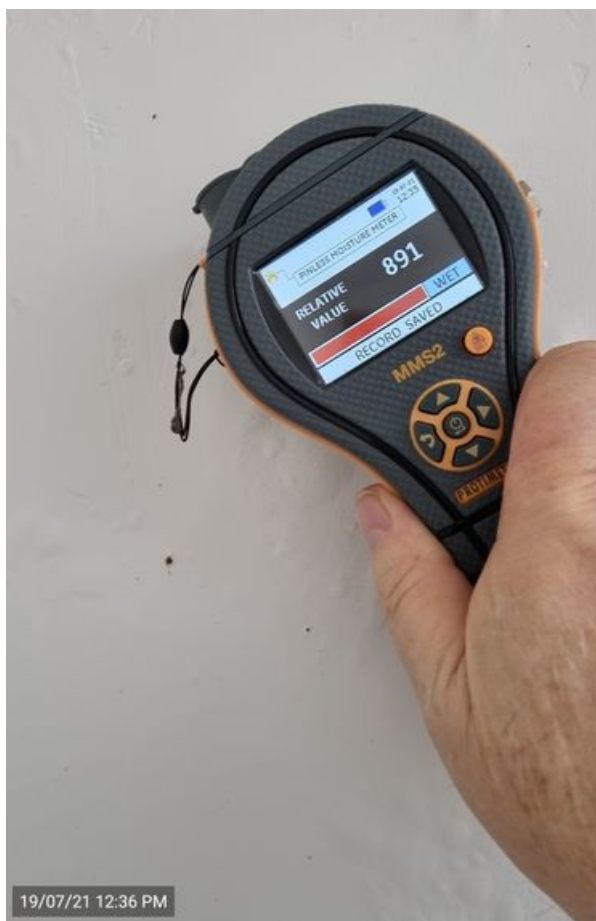
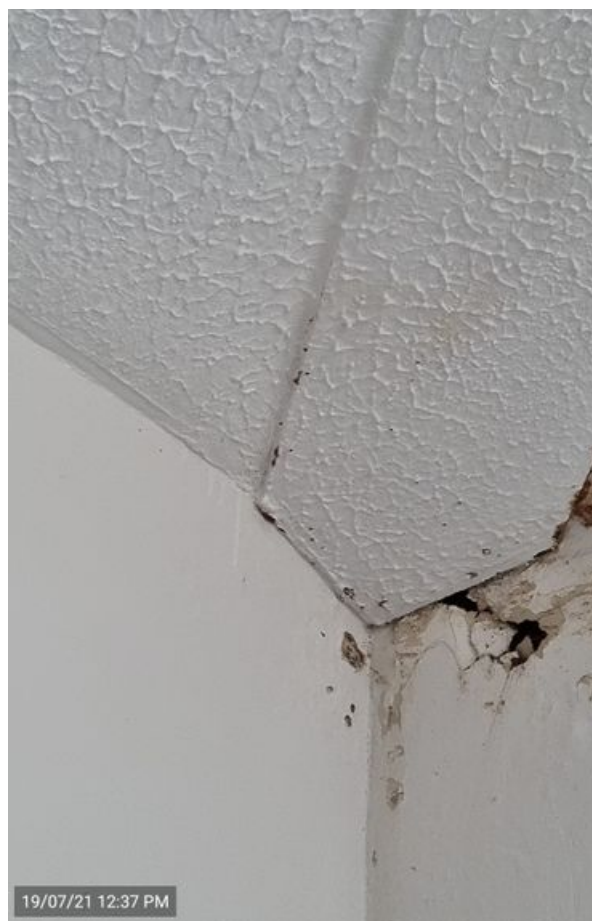
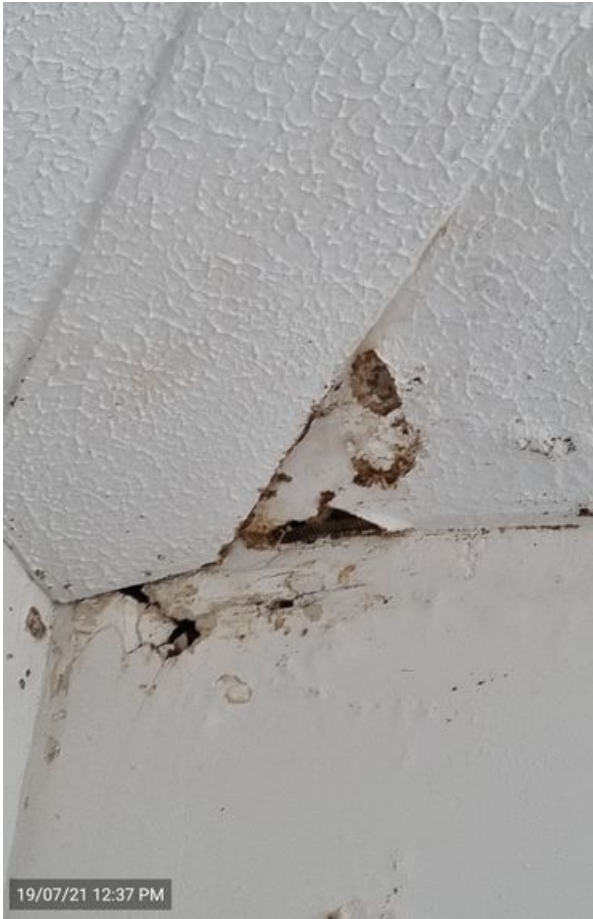
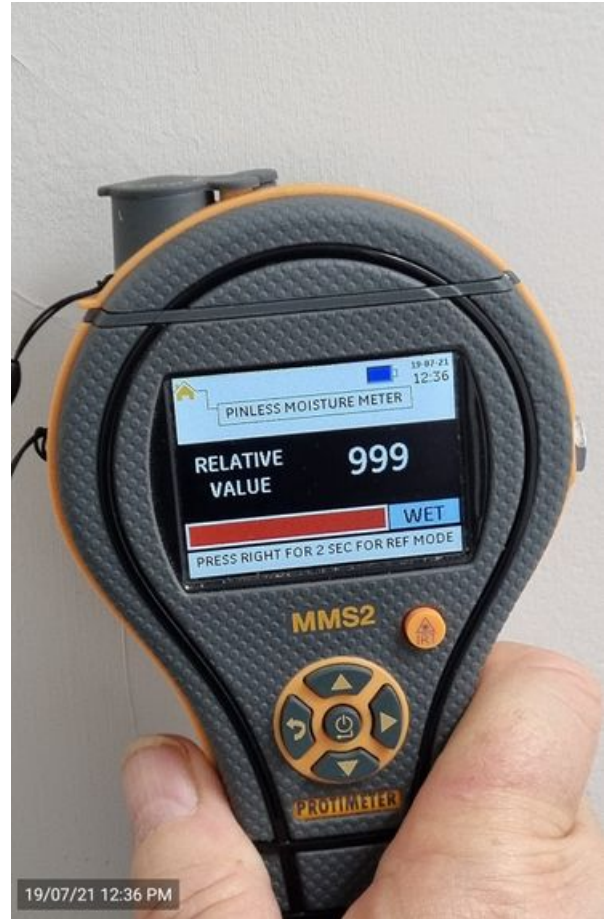
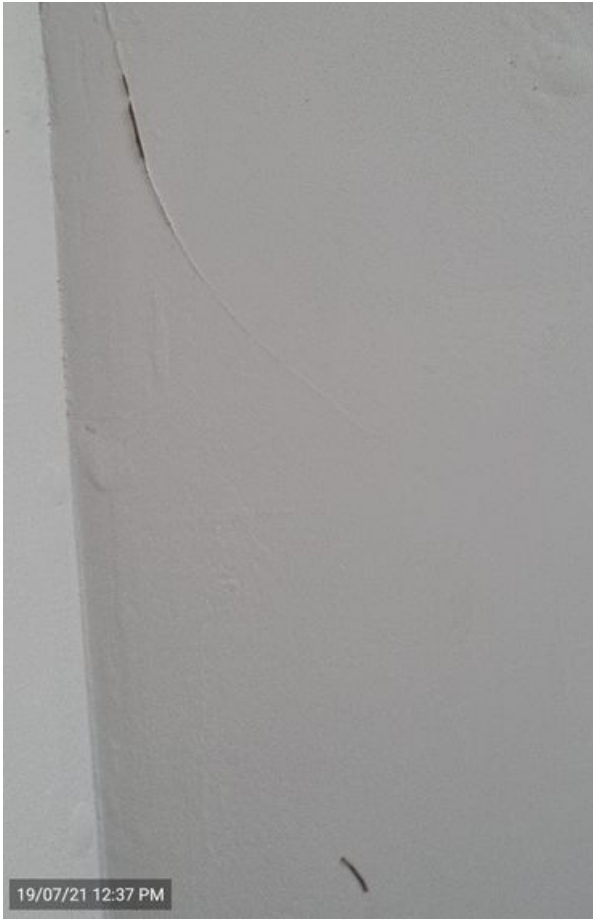
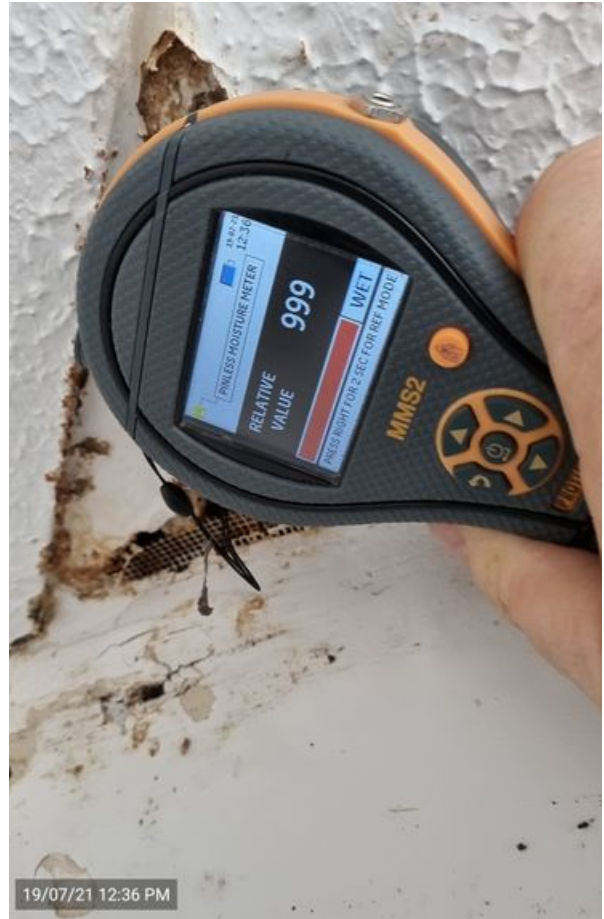
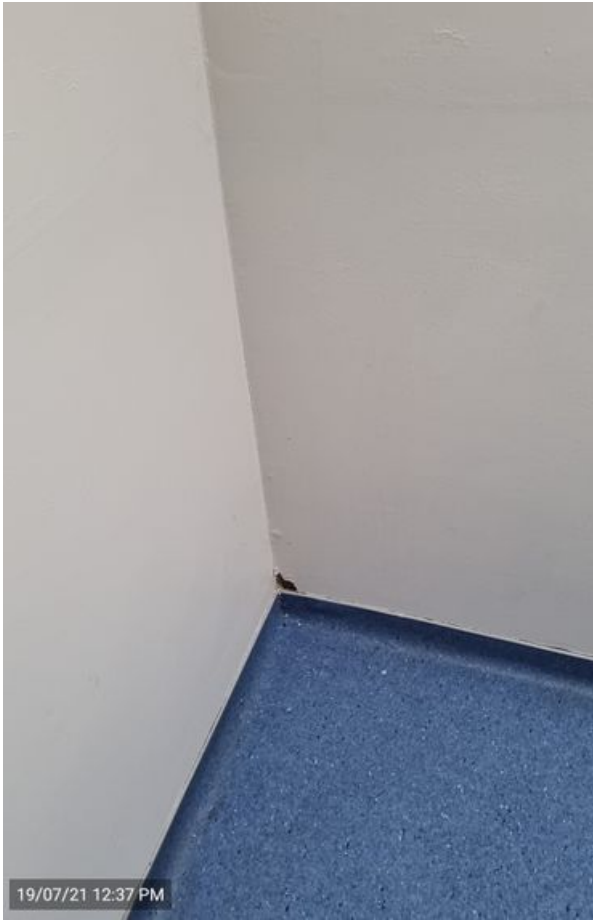
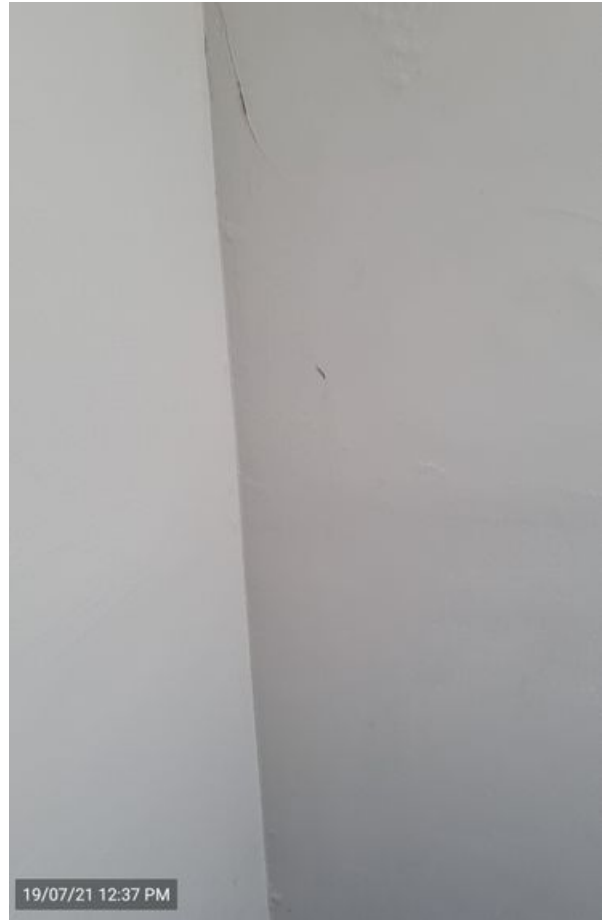
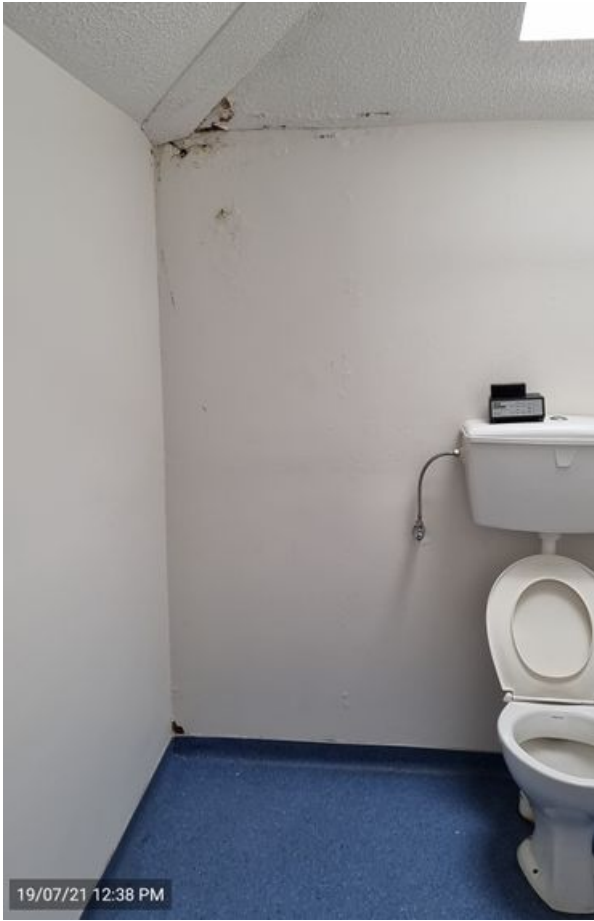
Toilet near Entrance

Mouldy wall

Whole of back wall is wet. Issue with water penetrating rear wall.

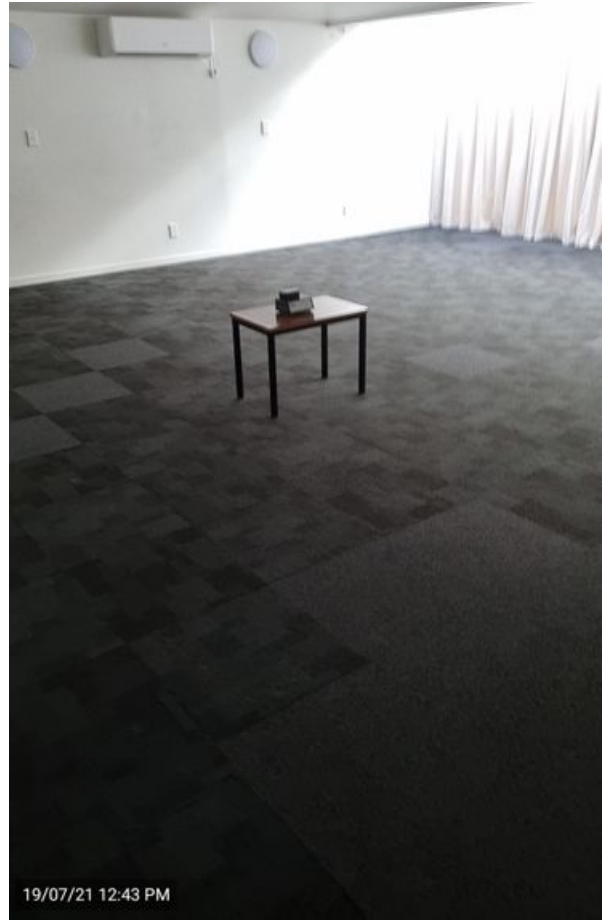
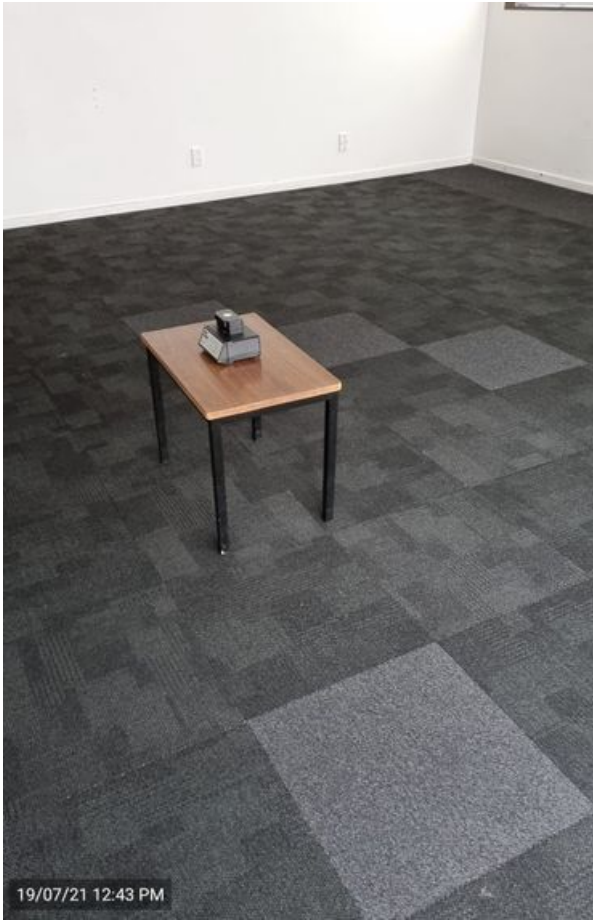
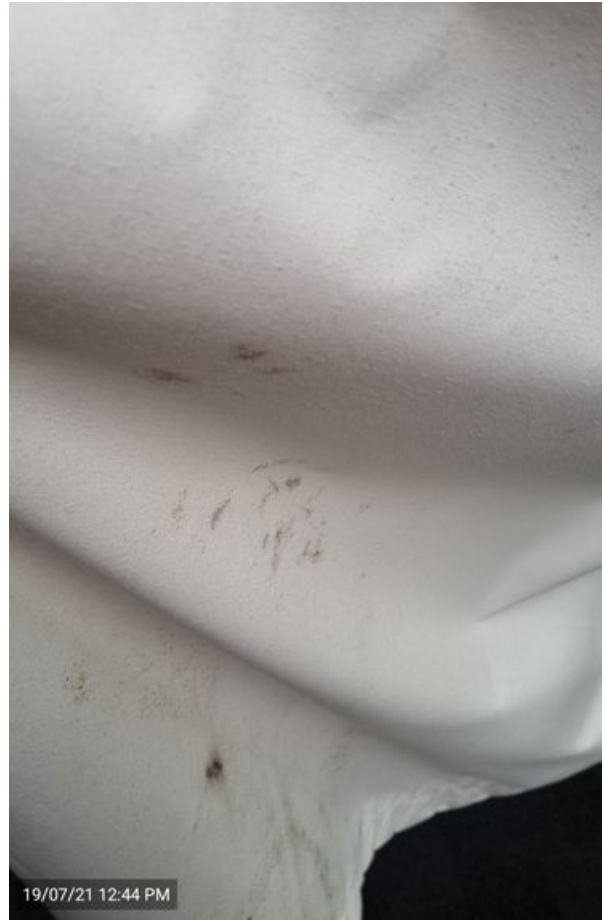
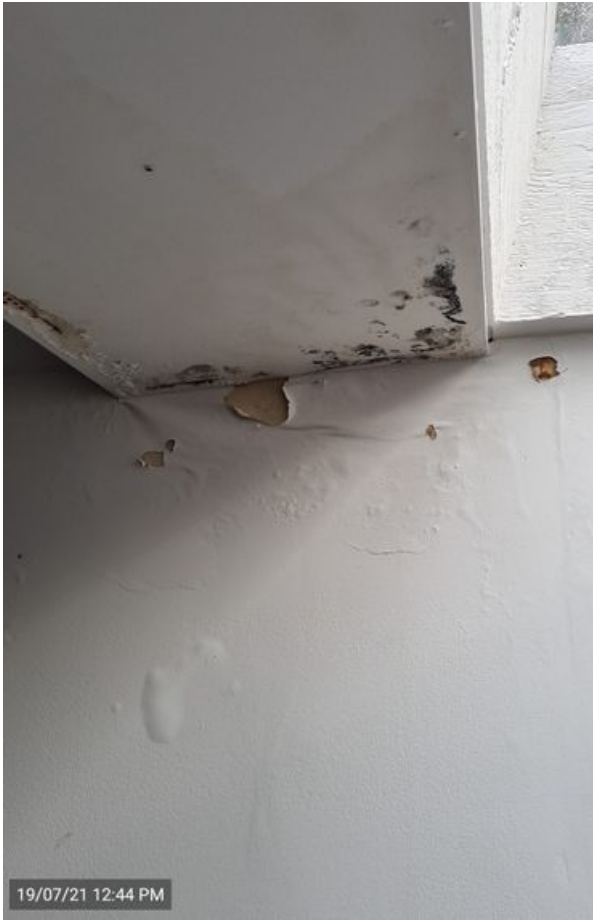
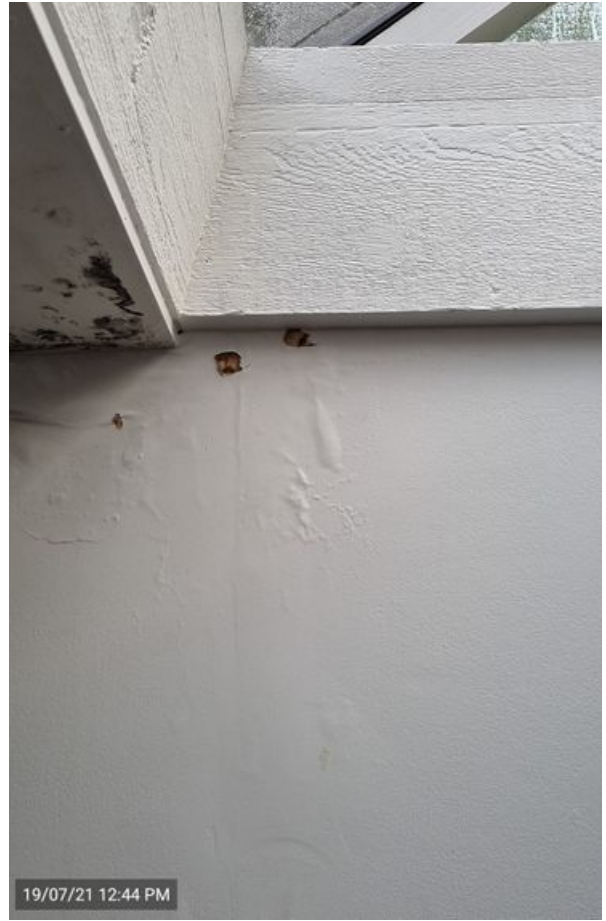
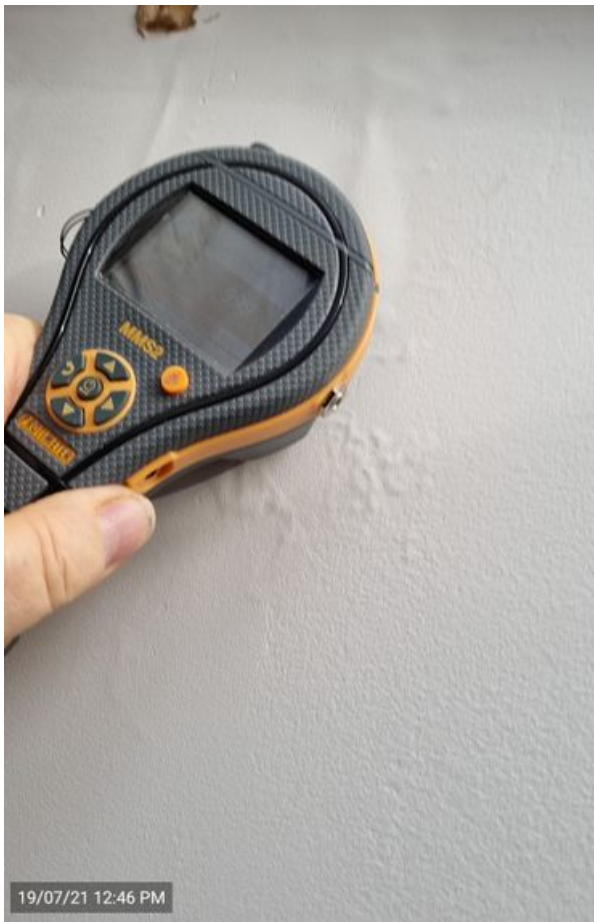
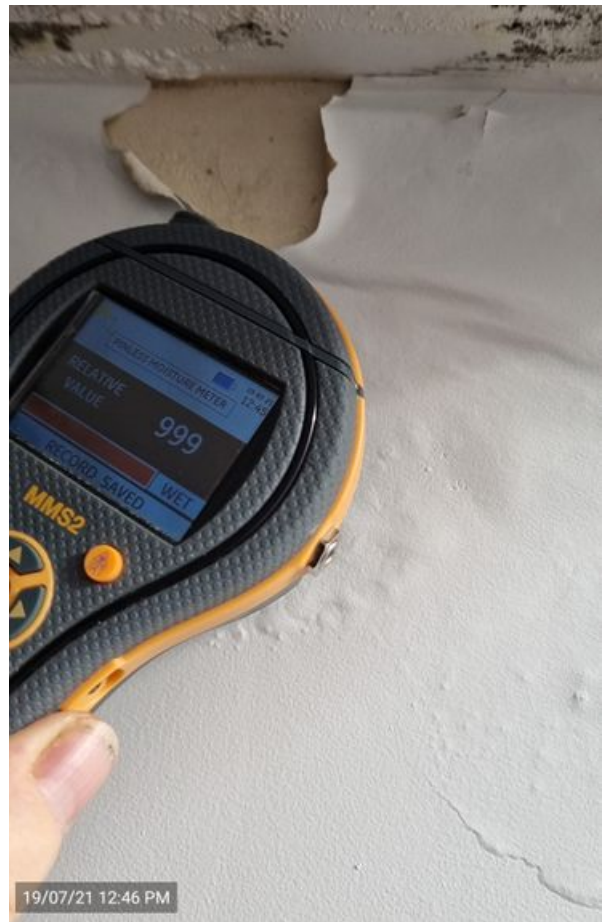
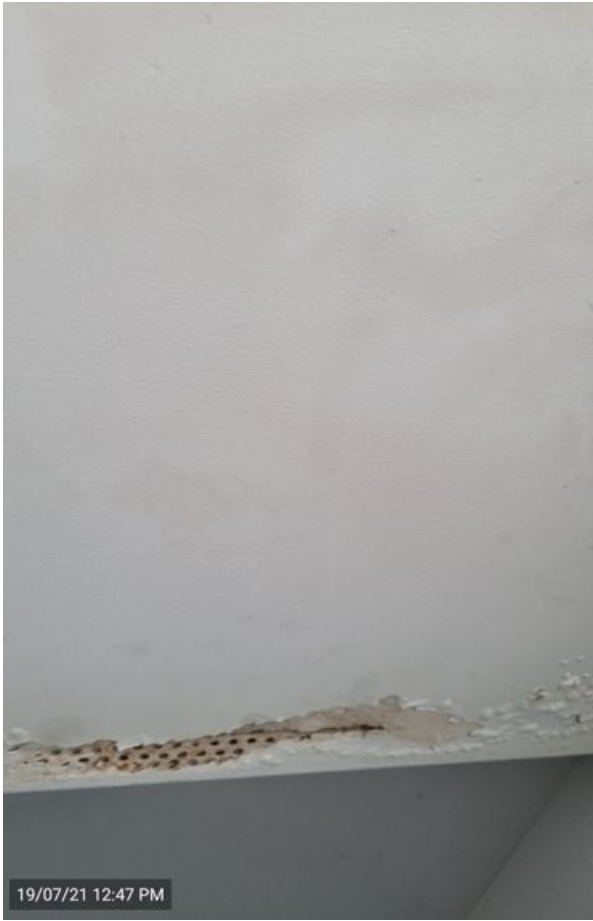
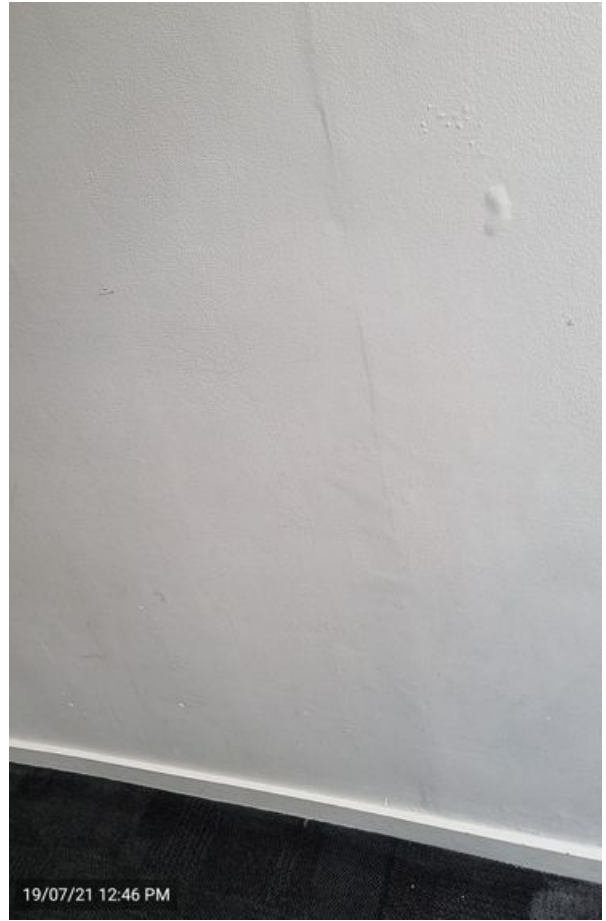
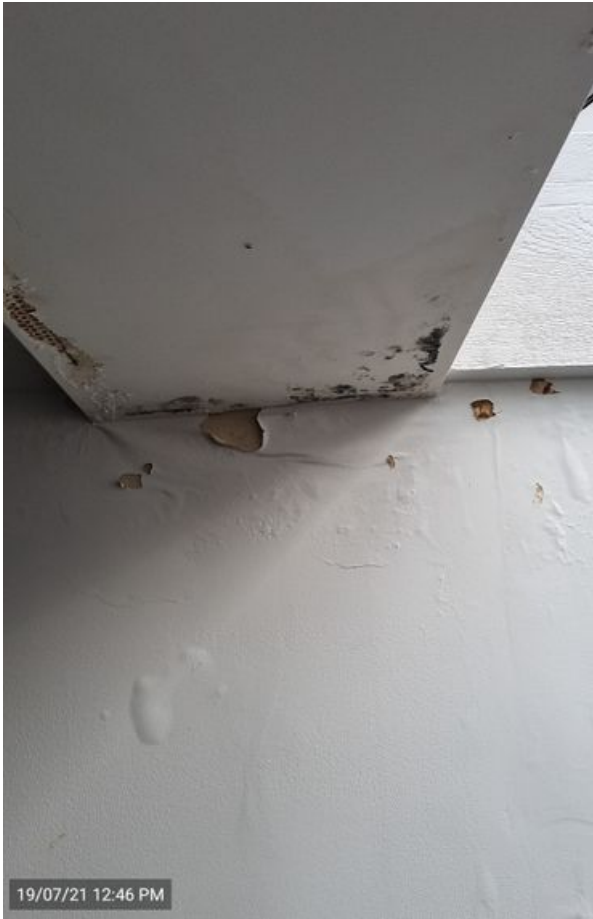
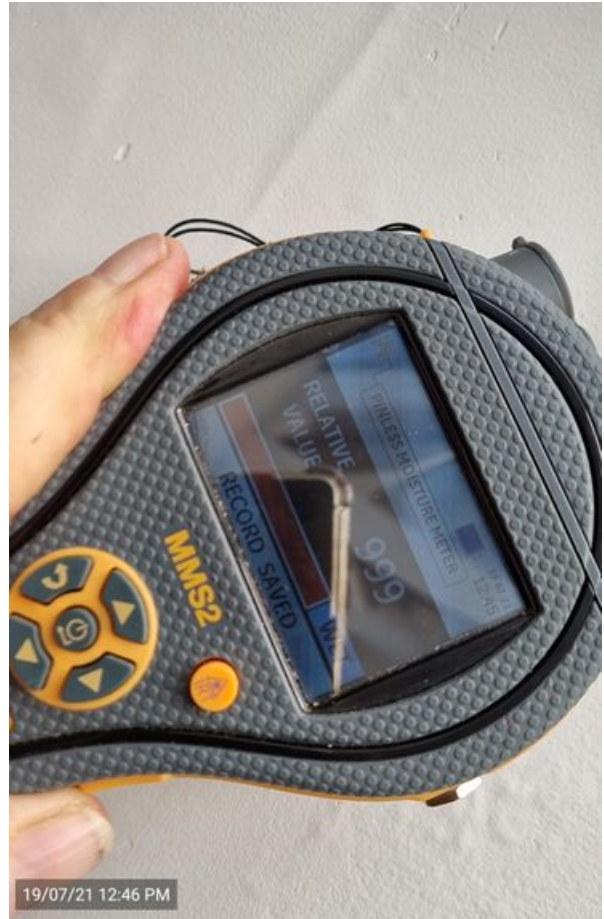
Centre of lounge

Mould on Curtains. Left hand rear wall very is wet.
