# Healthy Homes Mould and Bacteria Inspection Report

Hardwick Smith Lounge

Hutt City Council

19 Jul 2021

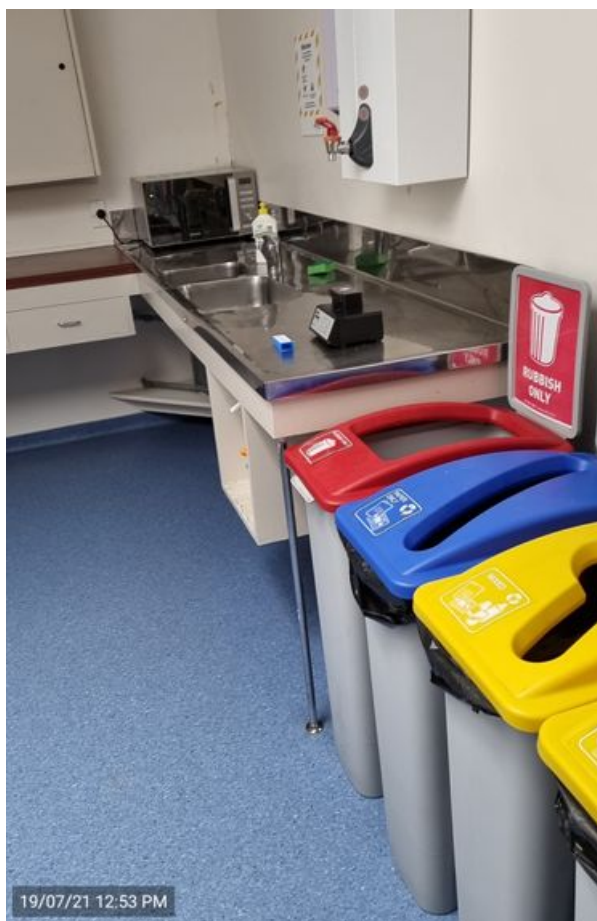
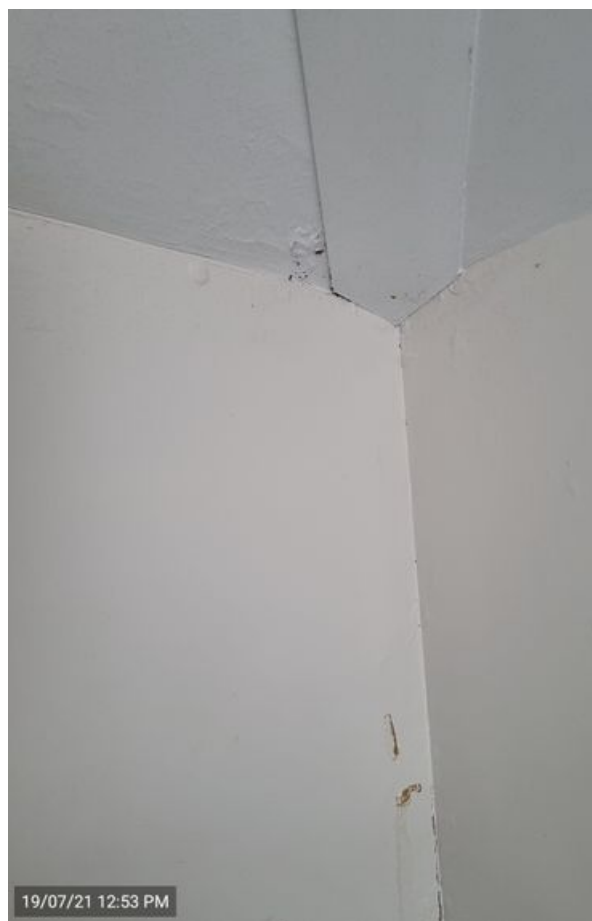
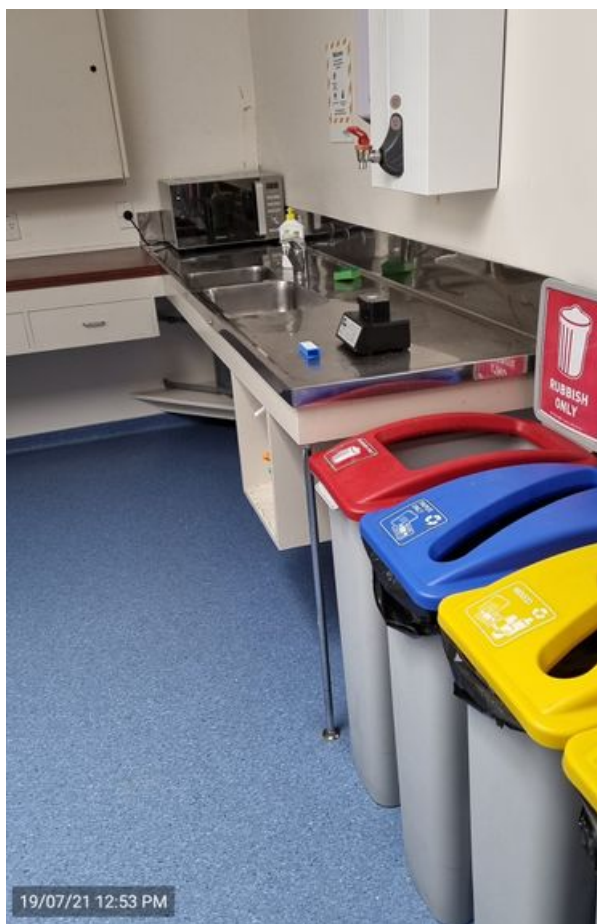
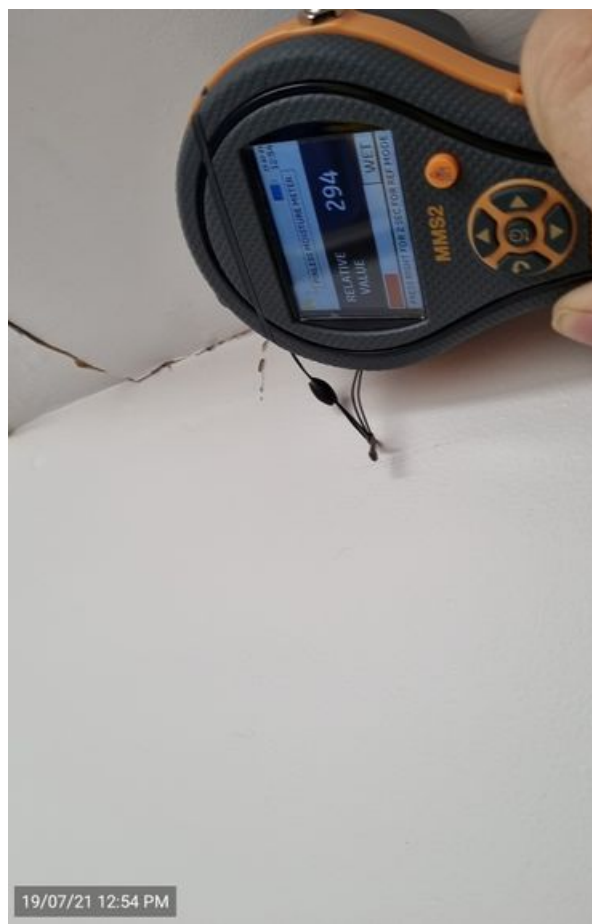
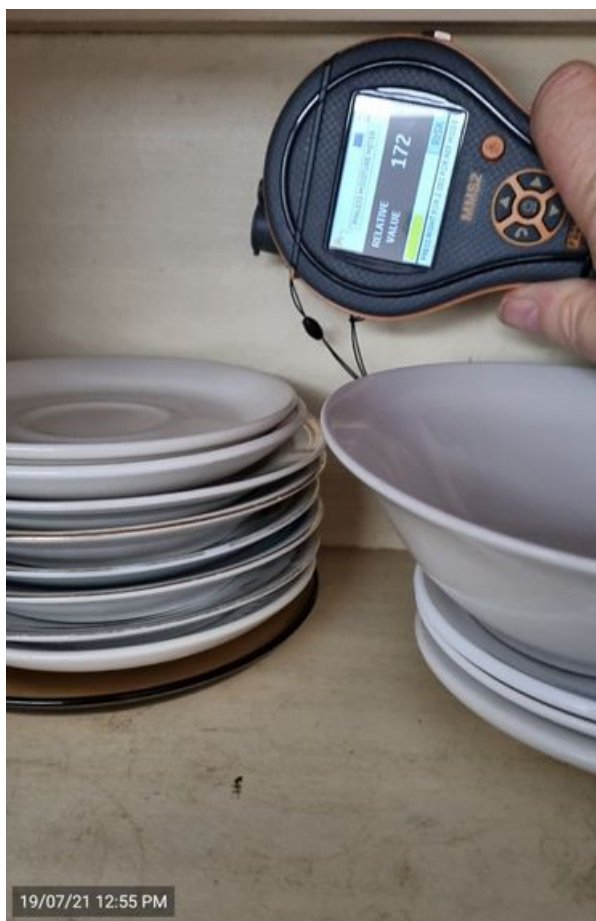
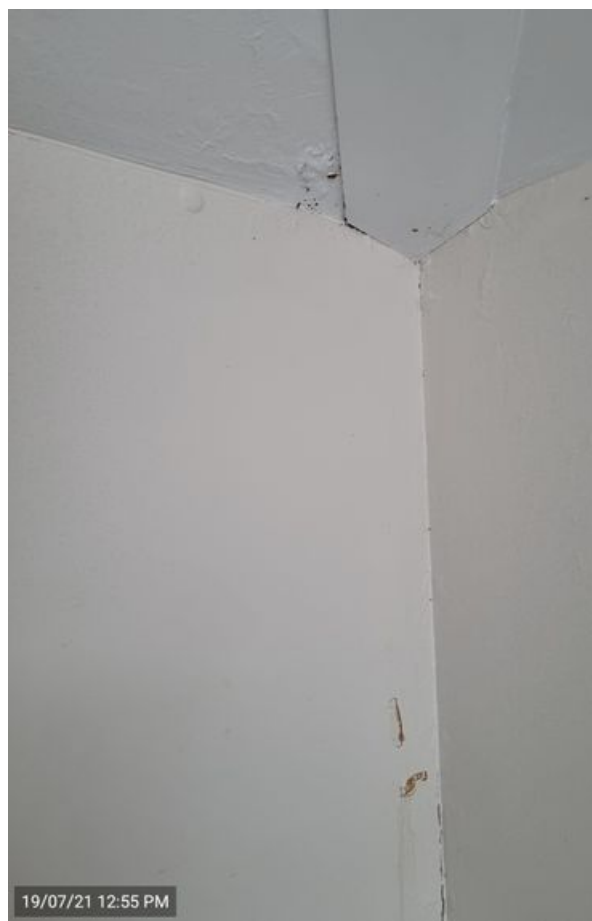
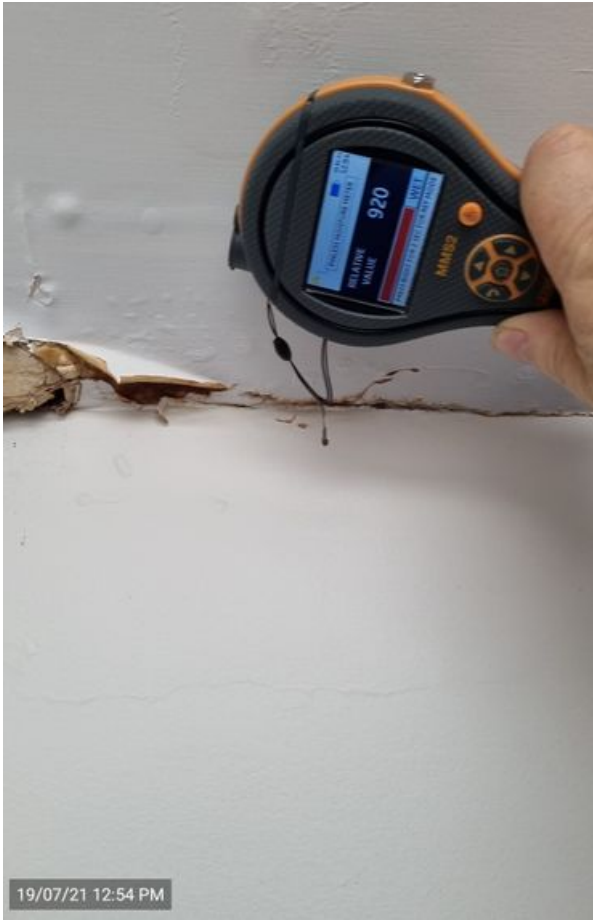
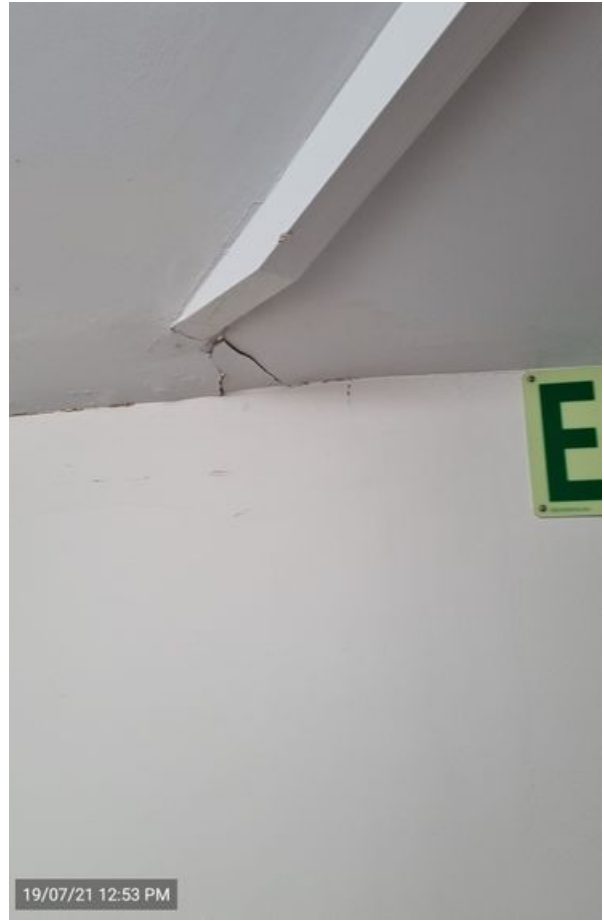
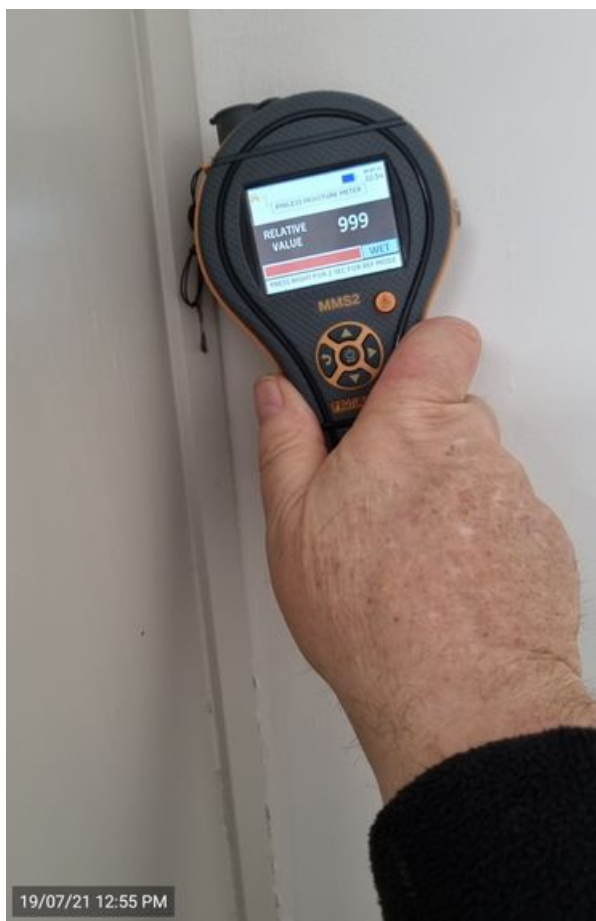
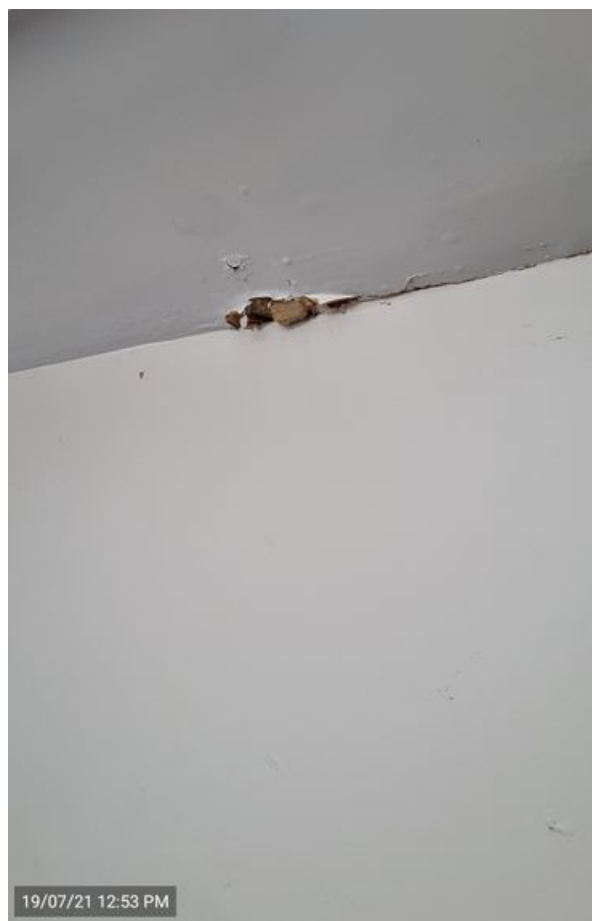
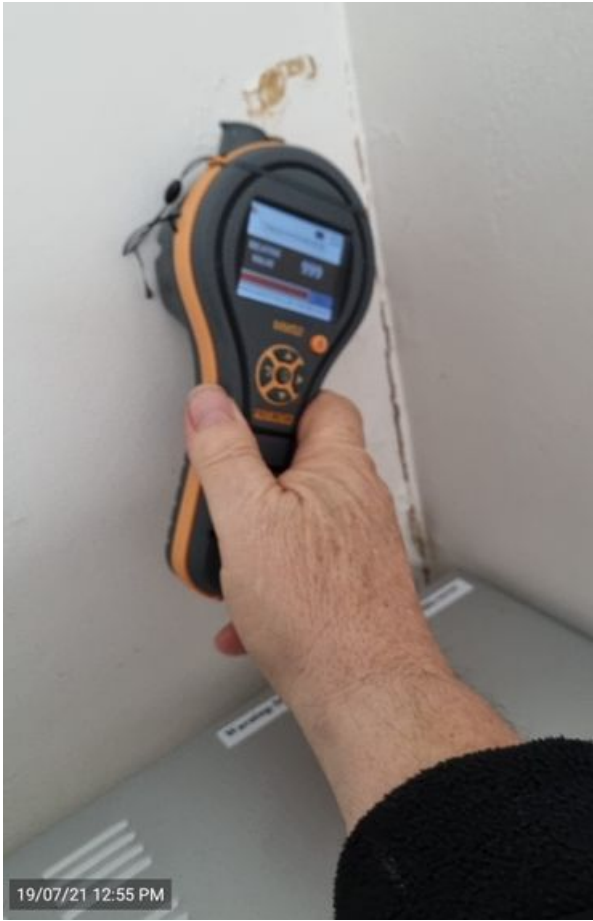
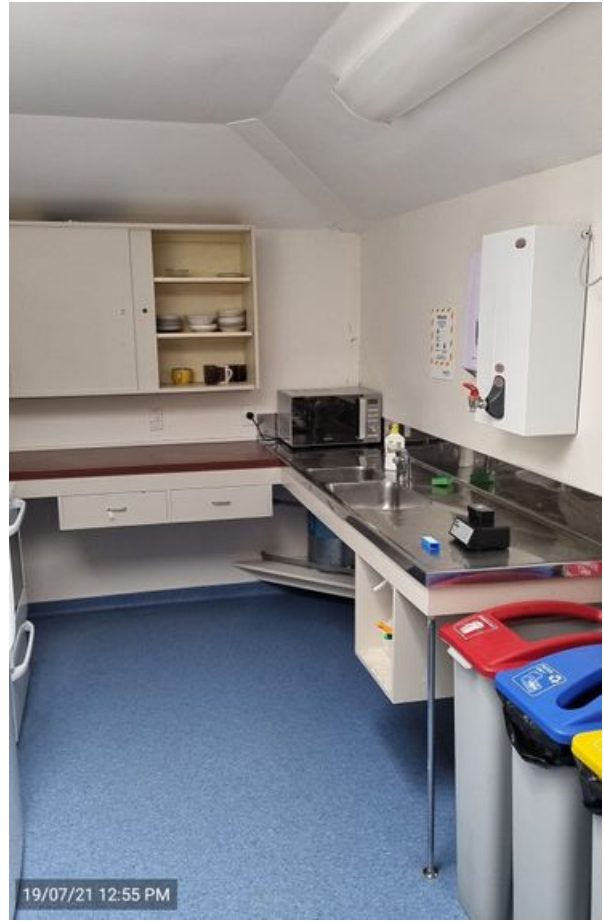
Kitchen

Kitchen mould and disintegrating gib Outside wall is very wet
