9683

29 July 2019

**Initial Seismic Assessment Report  
 Stokes Valley Swimming Pool, 187 George Street**

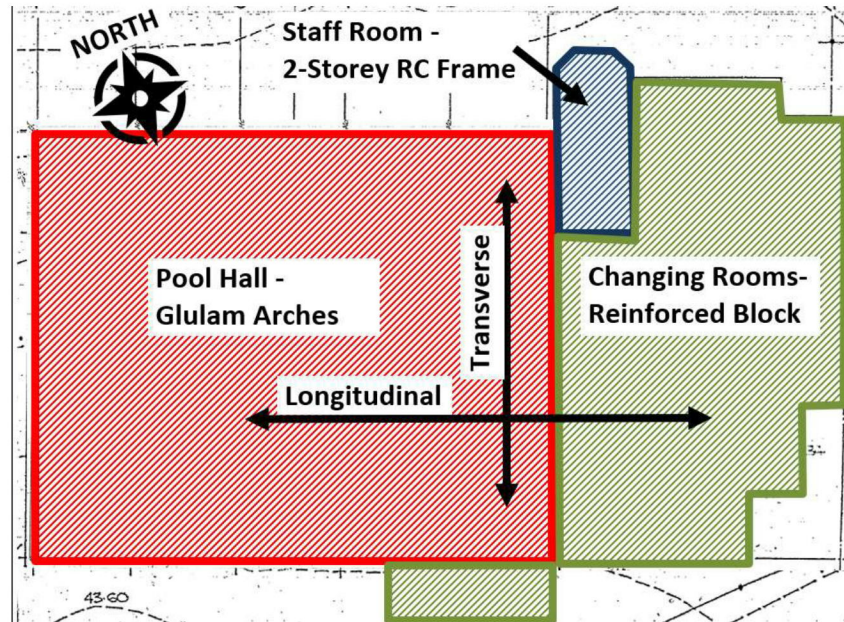
Plate 2. Structural Systems for the Building

- Plan irregularity has been observed to be insignificant based on the building layout and mass distribution being close to symmetric and the lack of a rigid diaphragm. For longitudinal actions there are a series of struts and a pop-top roof in the pool hall which are off centre. Furthermore, the two storey area is positioned on one side of the building. For transverse actions almost one third of the building is significantly stiffer than the flexible glulam arches of the pool hall.

A more reliable assessment might include a detailed seismic assessment of the glulam arches, reinforced concrete columns supporting the upstairs slab, connection between the timber arch structure and the block wall structure, torsion and accidental eccentricity, foundations etc.

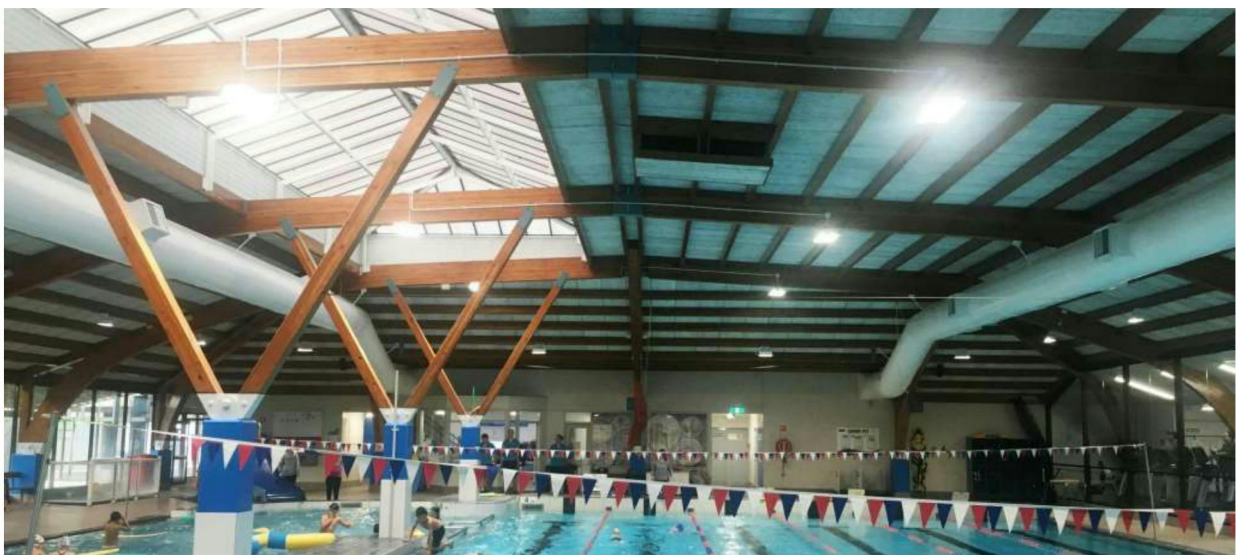
- Vertical irregularity has been observed to be insignificant based on the building being mostly single storey.
- Short columns have been analysed through shadow calculations and demonstrated to be insignificant. Calculations have been carried out on the column supporting the 'v' brace which demonstrate an assessment of >100%NBS (IL3) in bending and shear. By observation other pedestals to the glulam arches also appear to be >100%NBS (IL3).

*Plate 3. Glulam Arches on Reinforced Concrete Pedistals*
