# Executive summary

We have now completed an Initial Seismic Assessment (ISA) of the Wainuiomata Community Centre at Queen Street, Wainuiomata using the Initial Evaluation Procedure (IEP). The assessment was carried out after completing a site visit and inspection of the building consent documentation.

Street Number & Name:	1C Queens Street	Job No.:	5137964
AKA:		By:	RC
Name of building:	Wainuiomata Community Centre	Date:	6/08/2018
City:	Wainuiomata	Revision No.:	0

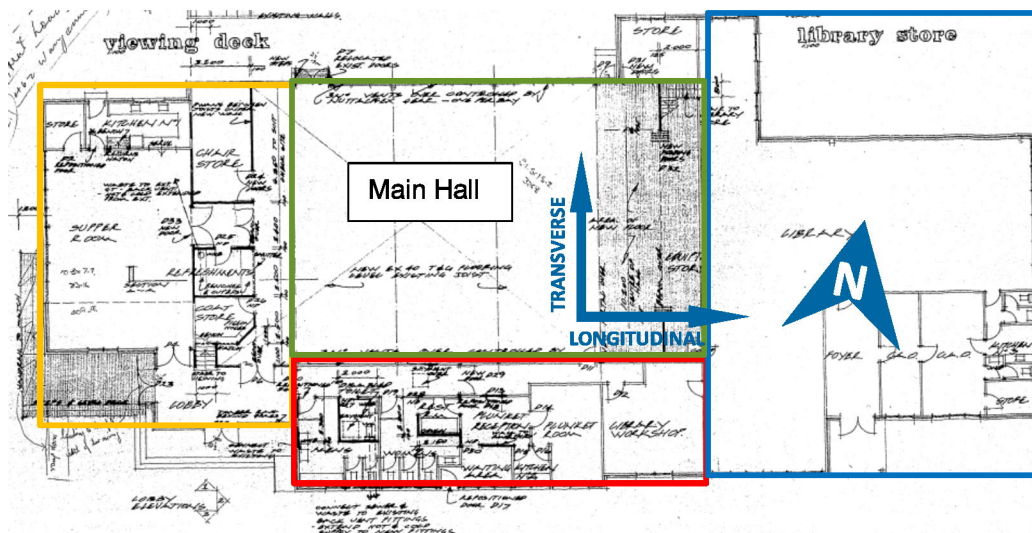
**Figure 2 Floor Plan of the Wainuiomata Community Centre**

The regularity of a building shape affects the way that a building can respond to lateral loading. As shown in Figure 2, the building is asymmetric in plan. However, according to NZSEE Guideline, the effect from plan irregularity on timber-framed building can be assumed to be insignificant.

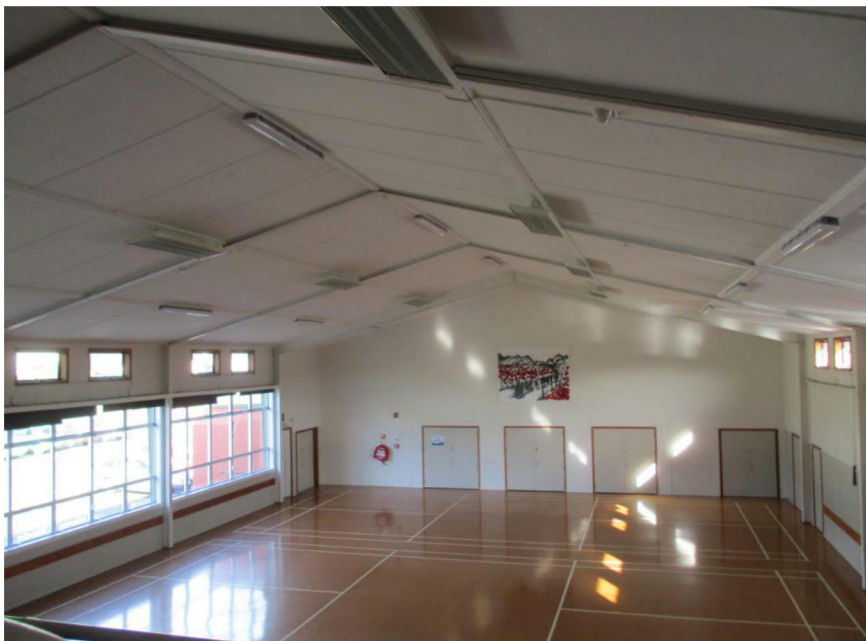
**Figure 3 View of the steel portal frames in the main hall with infill timber walls**

The steel portal frames span in the North-South direction in the main hall to provide lateral resistance in the transverse direction through bending of the beams and columns. The timber infill walls span in the East-West direction in the main hall to provide lateral resistance in the longitudinal direction through bending and yielding of the nail fixings around the perimeter of the wall.

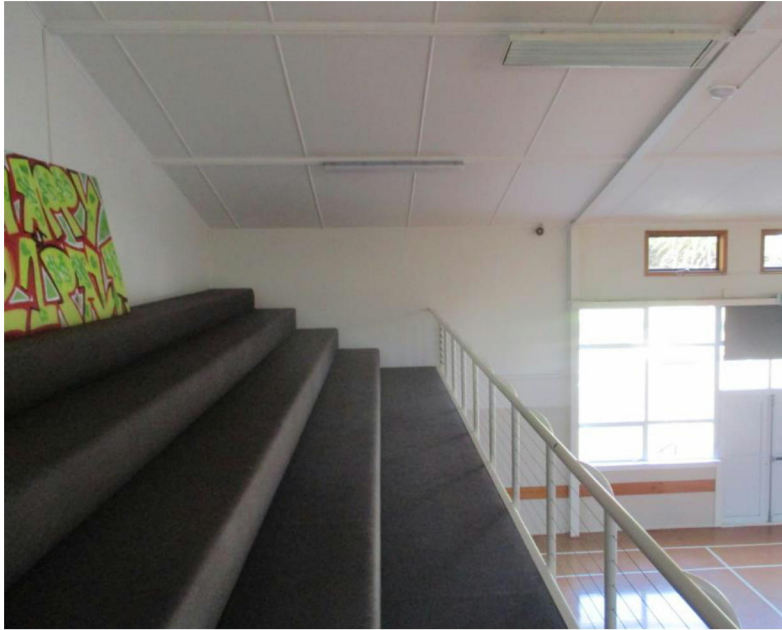
There are extensive openings and glazing along the northern elevation of the main hall, which will induce weakness under seismic loading. However, there are two large braced walls connected to the glazing at the northern elevation, as shown in Figure 4. The braced walls will provide lateral strength to the main hall under the seismic loading.

**Figure 4 View of braced wall located beside the glazing**

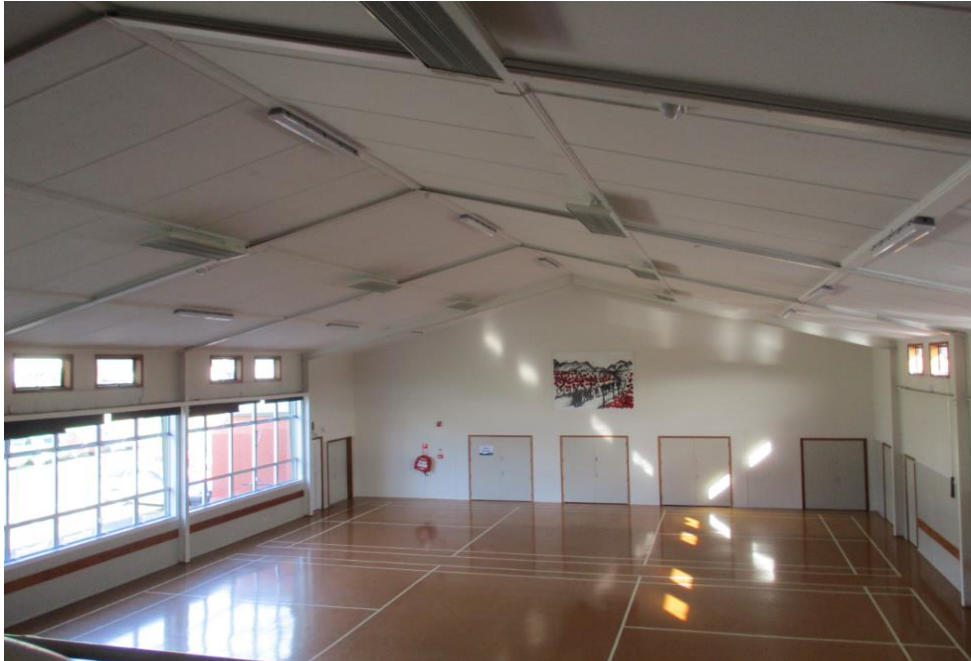
Steel portal frames span in the transverse direction

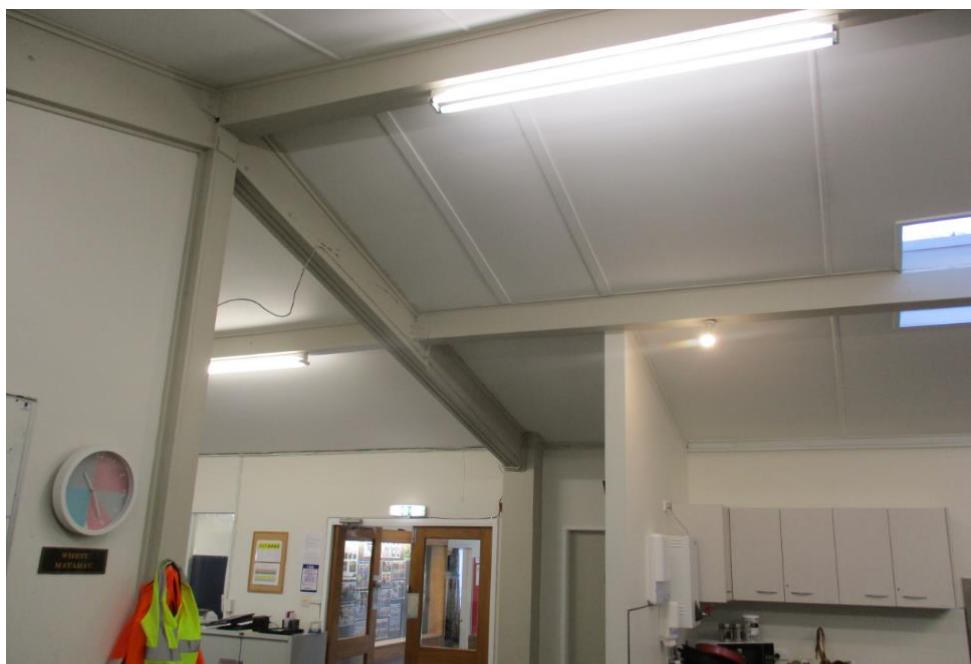
Timber-framed ancillary building
