**Mary Crowther Park Changing Rooms and Toilets
101N Wise Street, Wainuiomata**

Initial Seismic Assessment

**for
Hutt City Council**

Project 9793

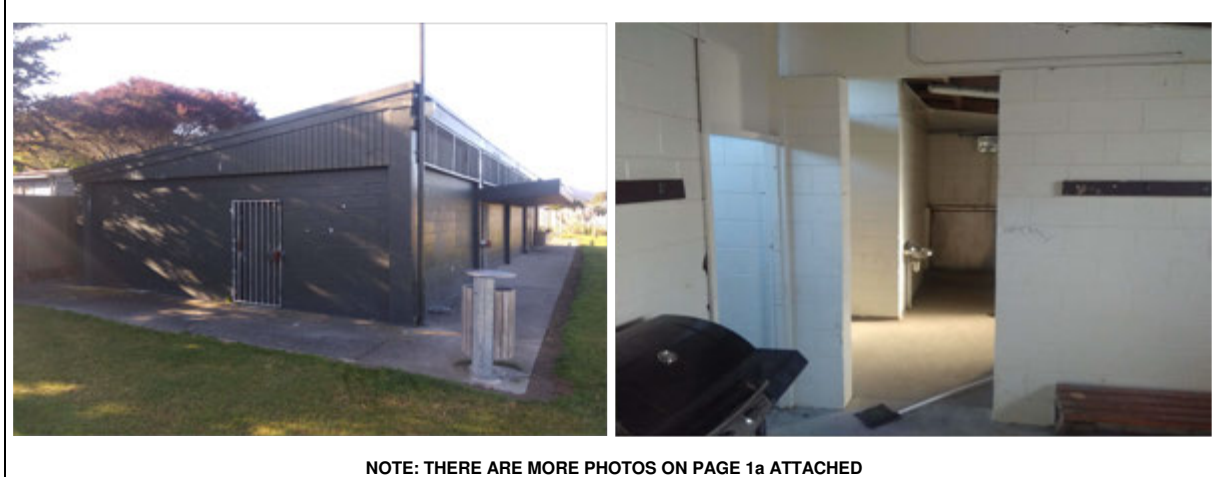
1.1 Photos (attach sufficient to describe building)

The building is single storey and appears to have been constructed in 1969.

The roof is monoslope, with corrugated iron supported on timber purlins, which in turn are supported by steel I-beams. The steel I-beams span the width of the building and are supported by 300mm x 300mm concrete columns. There are eight columns in total - four on each side of the building. At the high side of the building, the columns cantilever approximately 800mm above the top of the block walls and there are clerestory windows above the block walls between the columns.

The external walls are 190mm thick blockwork between the concrete columns. The internal walls are a mix of 190mm and 140mm thick blockwork. Some of the block walls have returns, but others do not and are vertical cantilevers.

There is a concrete floor slab. It is assumed the foundations consist of shallow footings.
