Petone Settlers Museum

136 The Esplanade Petone
Detailed Seismic Assessment
November 2019

Date: 20 November 2019
Reference: RP001-5-C3987.00
Status: Final

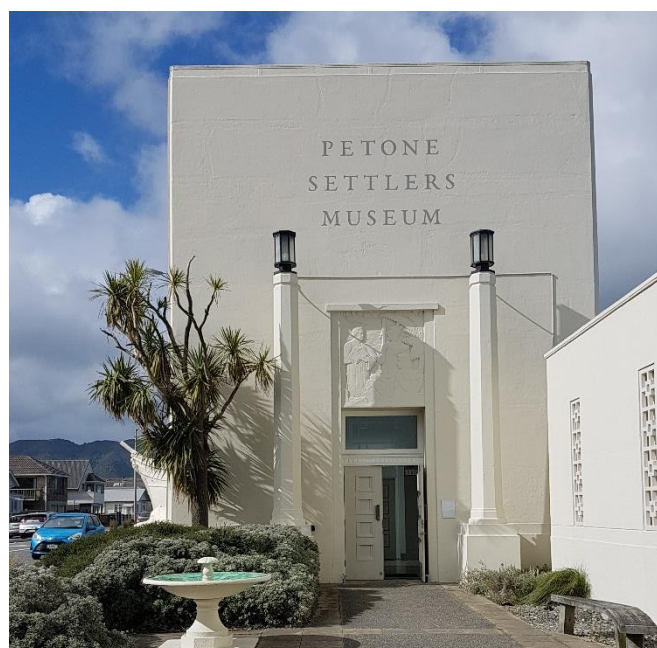
Figure 2: West elevation of Memorial Hall with lampstands in front.

On two sides of the Memorial Hall are lampstands that are 6.5m high. The lampstands are hollow precast concrete tubes which have been fitted inside a square walled reinforced concrete base. This is tied into the foundations of the Memorial Hall.

The lampstand acts separately from the main building when seismic acceleration is applied. Seismic load on the lampstand is calculated using the parts and components method assuming a ductility of 1.0. The precast concrete tube bends about the base concrete walls which provide resistance through its connection into the foundations of the Memorial Hall.

Both the precast concrete tube that makes up the lampstand and its concrete base are rated as 100%NBS. The lampstand relies on its connection to the foundations of the Memorial Hall to prevent overturning.

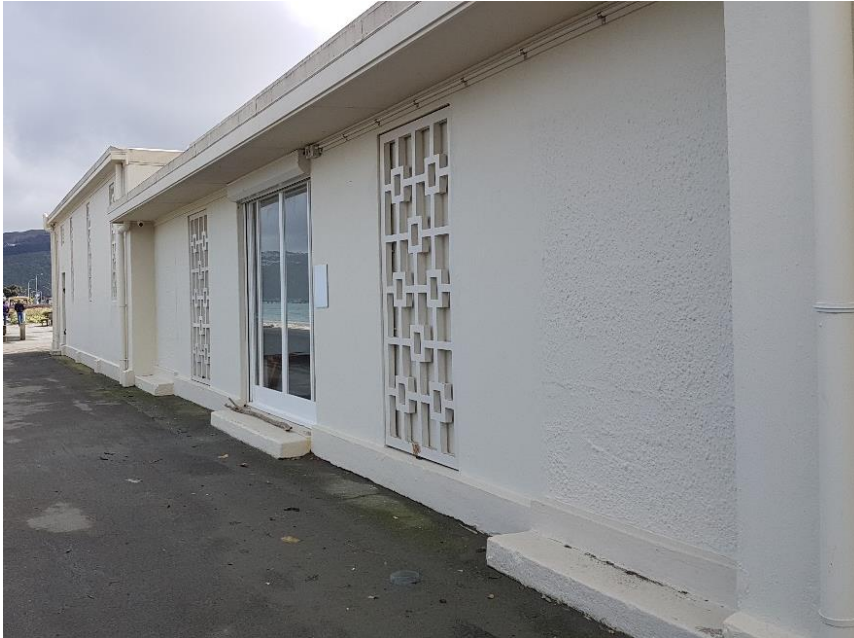
Figure 3: South elevation of Vestibule and Gallery Wing.

The vestibule and gallery wings consist of perimeter 150mm thick reinforced concrete walls that are 3.5m to 4.5m high. Internal walls are 100mm thick reinforced concrete. The roof over these areas consists of timber rafters supporting timber sarking and metal roofing, like the Memorial Hall. Drawings from proposed alterations in 2005 suggest that there are existing steel beams that support the roof over the gallery wings, however such beams have not been mentioned in the original 1939 drawings.

The perimeter concrete walls at the end of the Gallery Wings comply with 75%NBS for in-plane seismic loads applied in the east-west direction. This rating is based on the walls acting independently from the roof structure. All other walls in the Vestibule and Gallery Wings meet 100%NBS.

Further investigation could be made to determine the connection between the roof over the Gallery Wings and the concrete walls. The existing connection may be strong enough to allow the roof to act as a diaphragm and transfer seismic loads to the end walls. This would reduce the seismic demand on the concrete nib walls and so improve the %NBS rating. If the existing connection is not adequate two options to strengthen the Gallery Wings could be considered: (1) construct additional reinforced concrete columns with a new footing along the north and south walls, or (2) improve the connection between the timber roof and concrete walls by adding metal fixings.

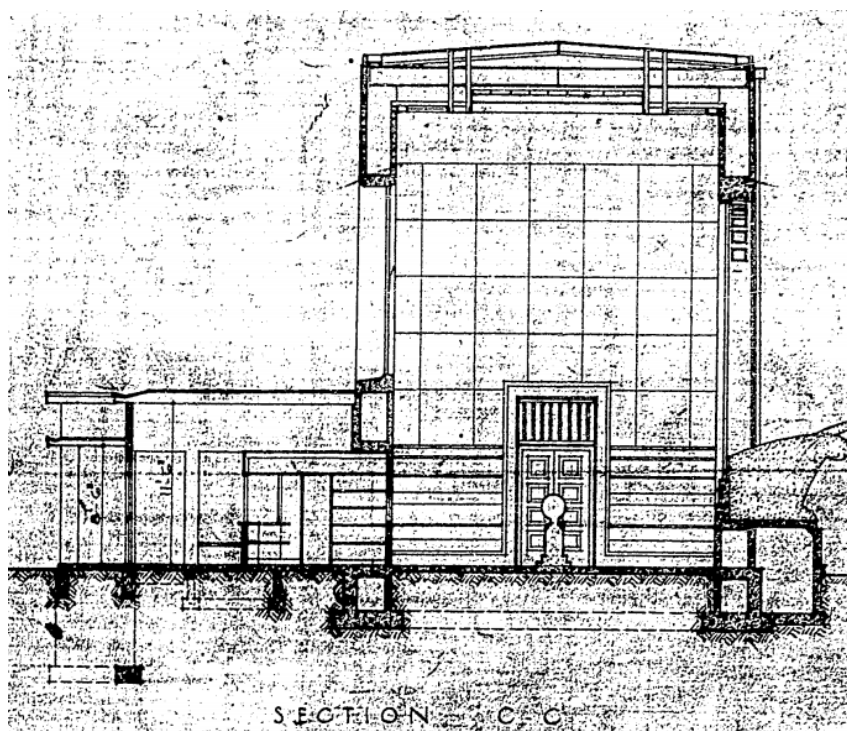
Figure 4: North-South cross-section of Memorial Hall and Vestibule

The concrete perimeter walls for the Memorial Hall meet 100%NBS when the walls bend out-of-plane. The concrete beams and columns transfer the seismic loading from these walls into the adjacent walls which provide in-plane resistance. The in-plane flexural capacity of these concrete walls is rated at 70%NBS.

The building's critical structural weakness is the in-plane strength of the concrete walls to the Memorial Hall. The concrete walls are specified with a reasonably high level of reinforcing for a building of its age, however the yield strength of the bars is not enough to accommodate the amount of seismic load applied at an Ultimate Limit State event. The reinforcing is also round bars, instead of deformed bars, which means that the wall has only limited ductility. When the strength of the walls is exceeded a large amount of cracking is expected. The building is not expected to be a life safety risk however it is unlikely to be able withstand another seismic event of similar magnitude.

To strengthen the Memorial Hall would require improving the flexural strength of the walls. This could be achieved by applying a thin layer of Fibrewrap to the ends of the walls.
