**Initial Seismic Assessment Report
Original Walter Nash Stadium
14 Tocker Street, Taita**

**For
Hutt City Community Facilities Trust**

**Project 9581
February 2019**

**Initial Seismic Assessment Report
Original Walter Nash Stadium, 14 Tocker Street, Taita**

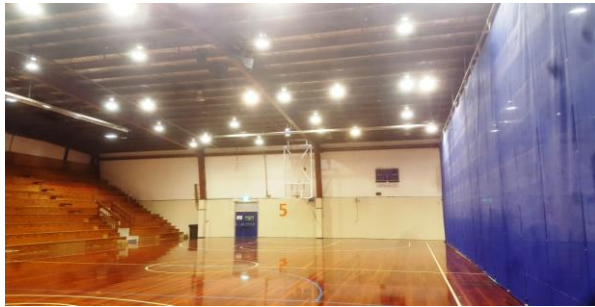
fig 1a.1 inside gymnasium (portal frames & tiered seating)

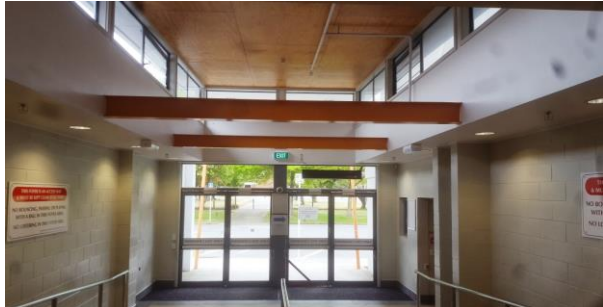
fig 1a.2 inside the north-west entry (2002 addition)

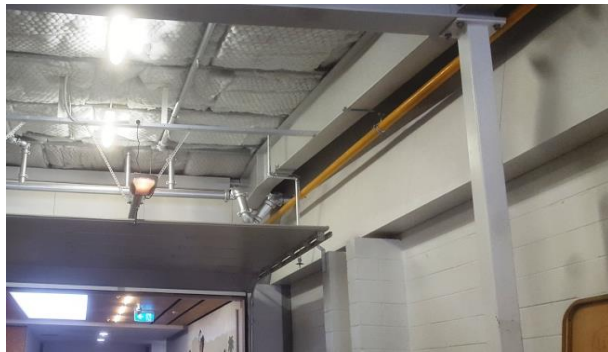
fig 1a.3 outside the south wall (inside the adjacent 2013 building)

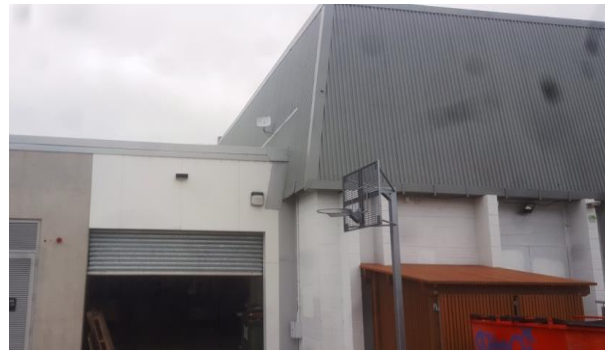
fig 1a.4 outside the south-east wall (seismic gap to the 2013 building to the south)

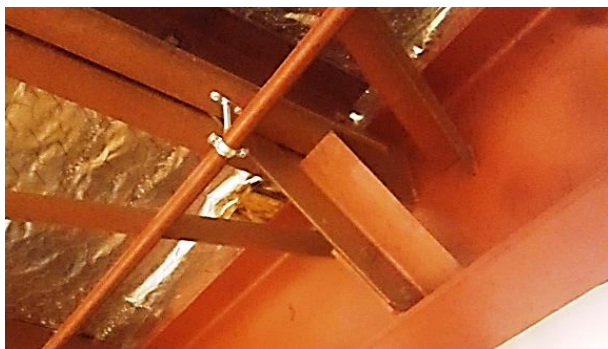
The roof of the tall building is sheet metal on steel purlins bolted to welded cleats. There is steel equal angle cross bracing in each end bay. The ends of the roof bracing are fully welded.

fig 1a.5 welded connection at roof bracing, fly bracing and purlin cleat

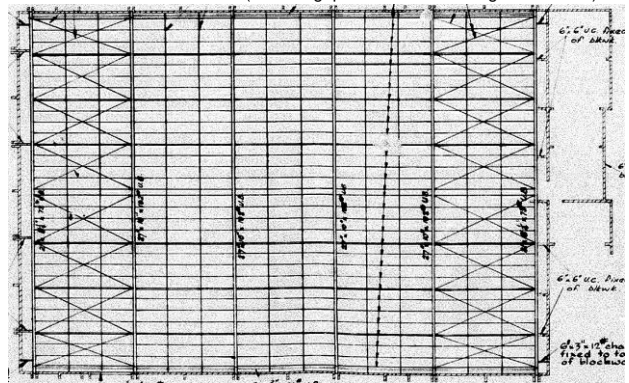
fig 1a.6 original structural roof bracing plan
