**Avalon Park Pavilion  
61 Taita Drive, Avalon**

**Initial Seismic Assessment**

**for  
Hutt City Council**

**Project 9741**

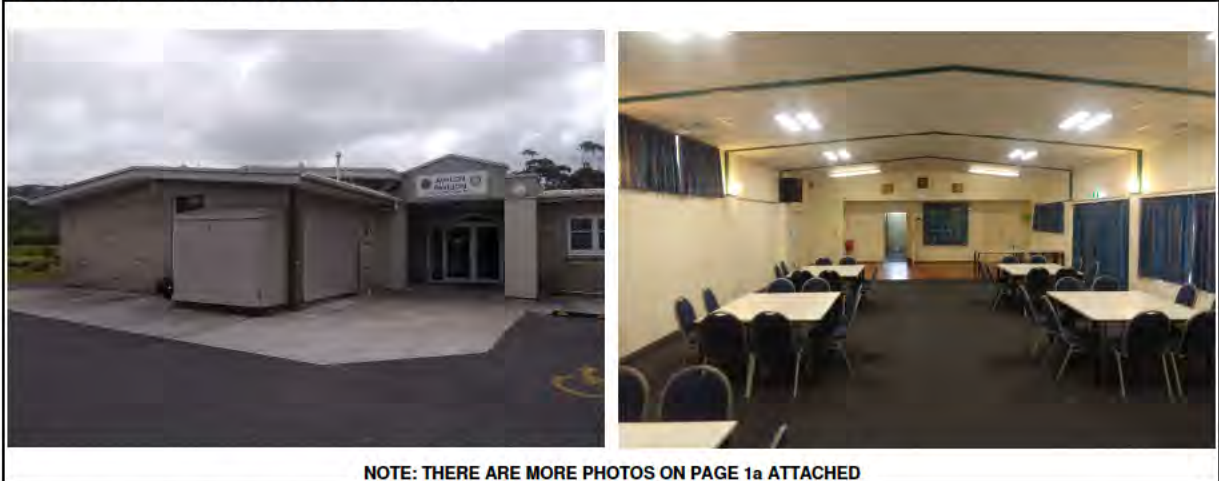
**1.1 Photos (attach sufficient to describe building)**

The building was constructed in 1967.  
 The building is single storey with a light metal clad roof and brick veneer cladding. The hall has steel portal frames across it. The remainder of the building has reinforced masonry shear walls.  
 The foundations consist of shallow footings.  
 There is a large verandah attached to the building on two sides.
