# Executive summary

We have now completed an Initial Seismic Assessment (ISA) of Treadwell Street Hall at Treadwell Street, Naenae using the Initial Evaluation Procedure (IEP). The assessment was carried out after completing a site visit and inspection of building consent documentation.

Treadwell Street Hall was designed and built in 1968. Alterations to the building were carried out in 1973 and 2010 including an addition to the north end of the building, and an upgrade to the kitchen. This building is a single-storey steel portal frame structure with blockwork and timber-framed infill walls. The building is currently used as a community hall. This building has been subjected to an Initial Seismic Assessment (ISA).

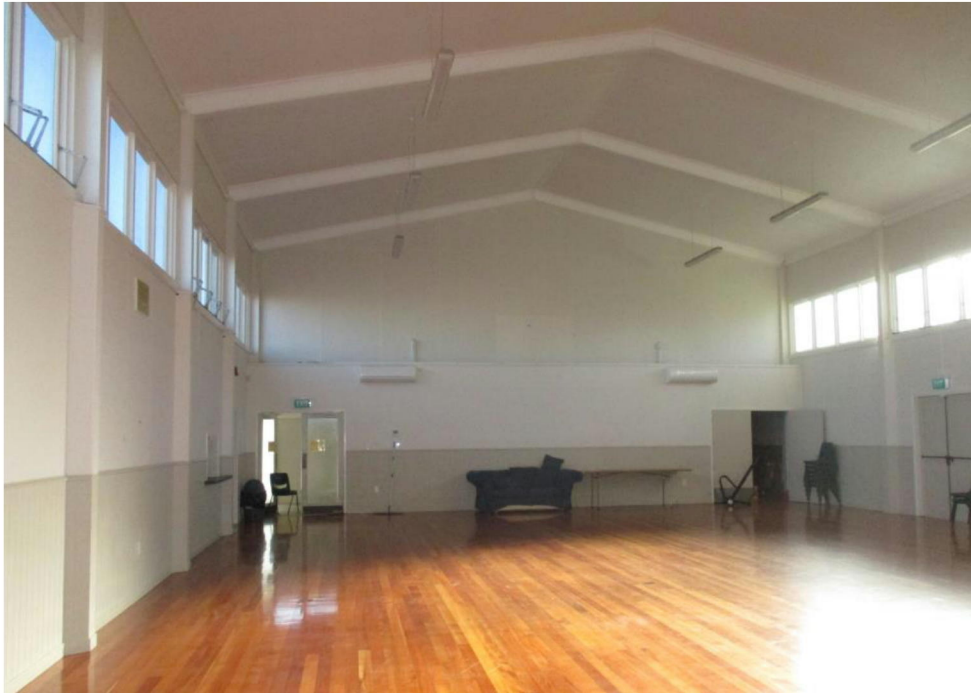
Six concrete encased steel portal frames span in the transverse direction to provide lateral resistance in the transverse direction. The steel portal columns can bend in the weak axis to provide lateral resistance in the longitudinal direction above the clerestory windows. Timber and blockwork infill walls provide lateral resistance below the clerestory windows.

**Figure 2 Steel portal frames in Treadwell Street Hall with infill timber and blockwork walls below clerestory windows**

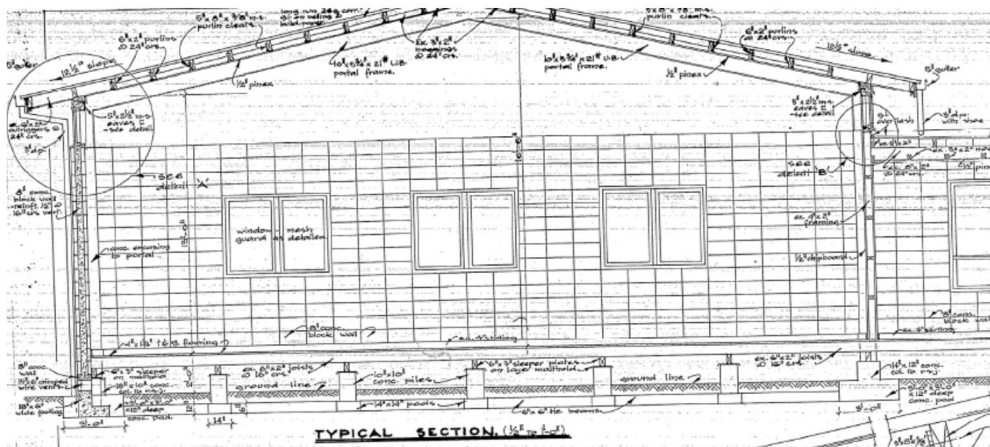
**Figure 3 Typical view of the steel portal frames**

Generally the interior of the Treadwell Street Hall appears to be in good condition. There were no obvious cracks observed during the inspection.

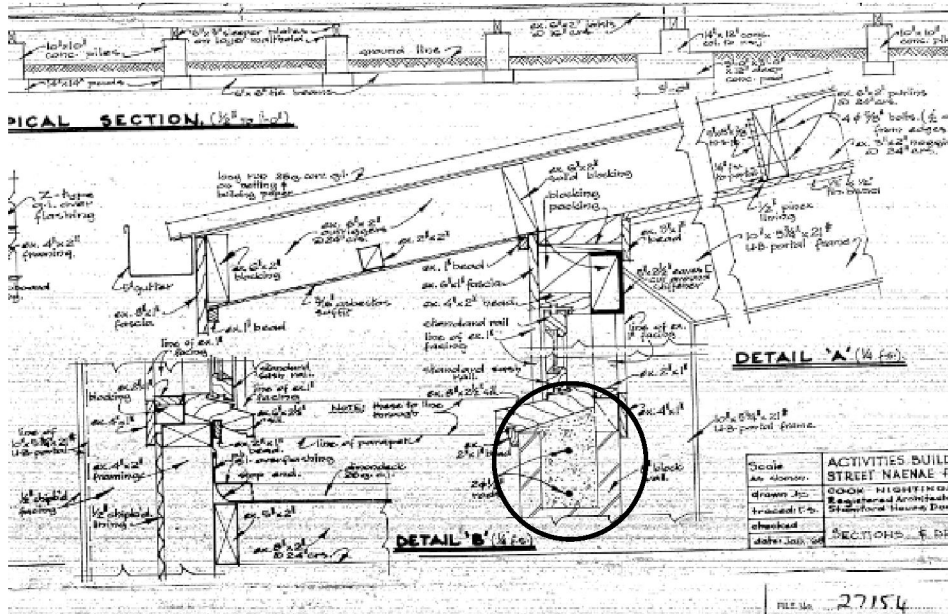
There is a reinforced concrete bond beam at the top of the infill blockwork wall spanning between the portal columns, refer to Figure 4 below.

**Figure 4 Details of bond beam**

The reinforced concrete bond beam currently provides support to the infill blockwork wall panels against out-of-plane seismic loads. The top of the wall appears to be well detailed and is reinforced with 2-D12 bars. The walls appear to be in good condition with no obvious signs of cracks or damage.

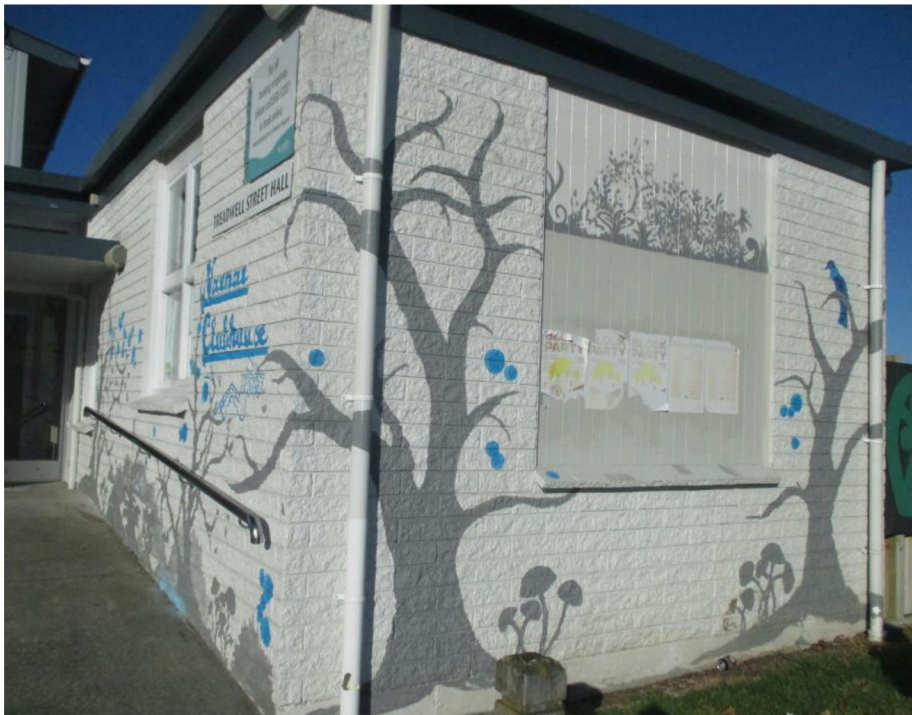
**Figure 5 Brick veneer cladding to the north end of the building**

A timber frame box with brick veneer cladding was added at the north end of the building to form two offices in 1973.

The brick veneer wall cladding appears to be in good condition, with no obvious signs of cracks or damage. However, there were no drawings available to confirm the brick tie system. It is recommended to carry out further invasive investigation to confirm the types and locations of the brick ties if a DSA is required.

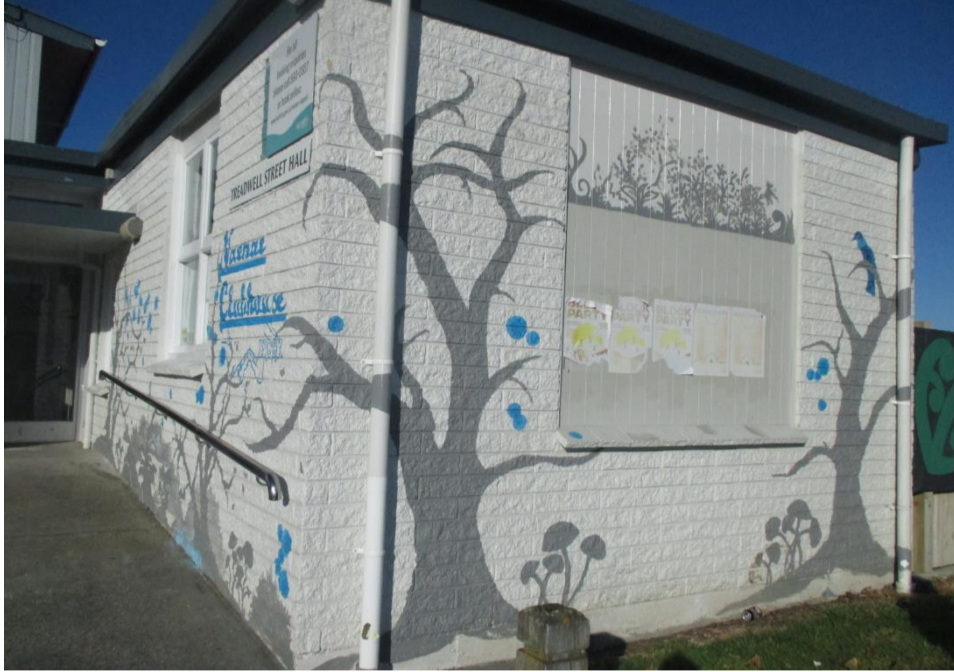
Addition to north end in 1973

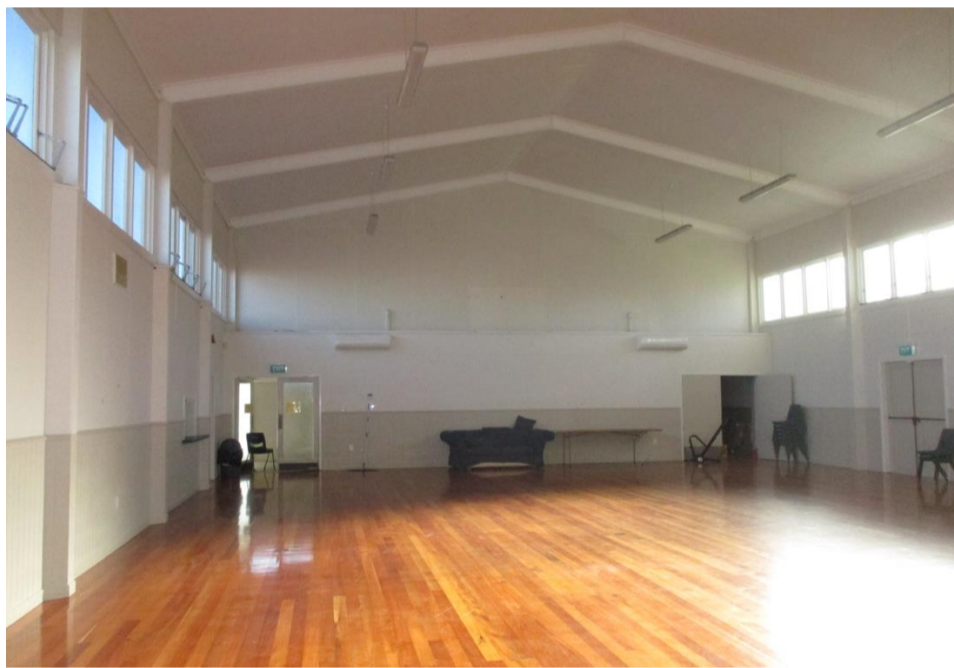
Steel portal frames in the building

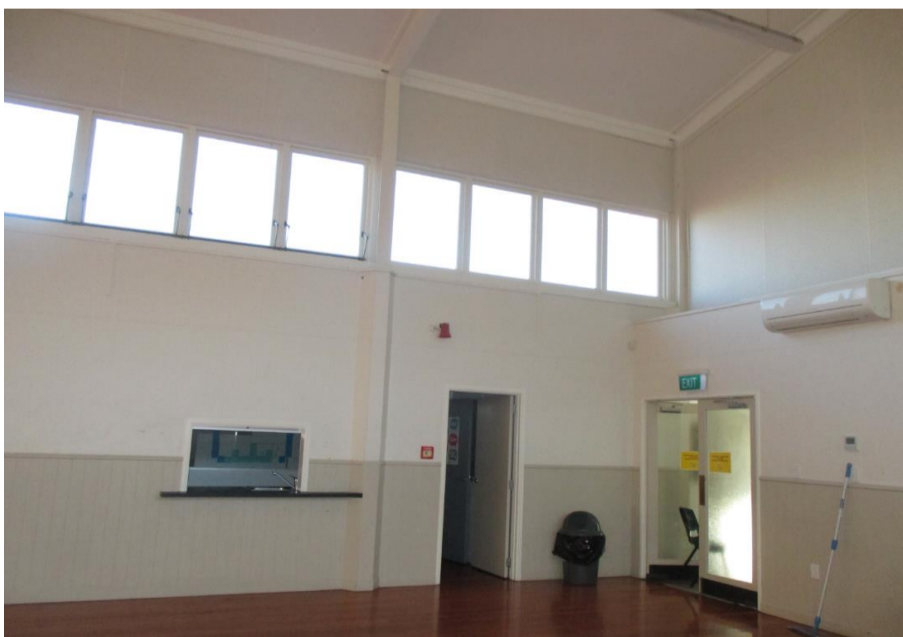
North and west timber walls

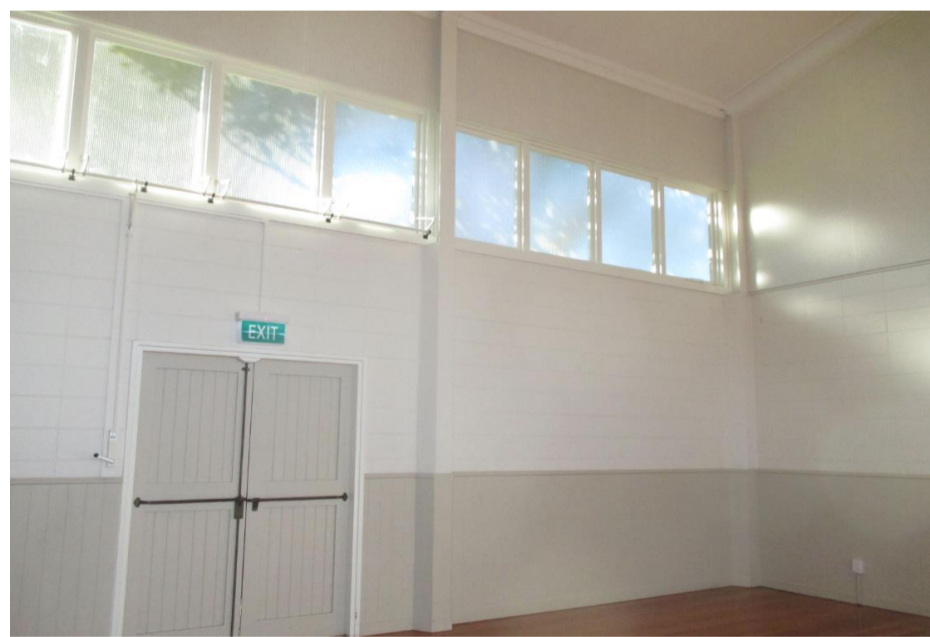
South and east masonry walls
