# Executive summary

We have now completed an Initial Seismic Assessment (ISA) of the building at 6 Britannia Street, Petone using the Initial Evaluation Procedure (IEP). The assessment was carried out after completing a site visit and inspection of building consent documentation.

**Initial Evaluation Procedure (IEP) Assessment - Completed for Hutt City Council**

Street Number & Name:	<b>6 Britannia St</b>	Job No.:	<b>5137964</b>
AKA:		By:	<b>MF</b>
Name of building:	<b>Petone Community House</b>	Date:	<b>28/05/2019</b>
City:	<b>Lower Hutt</b>	Revision No.:

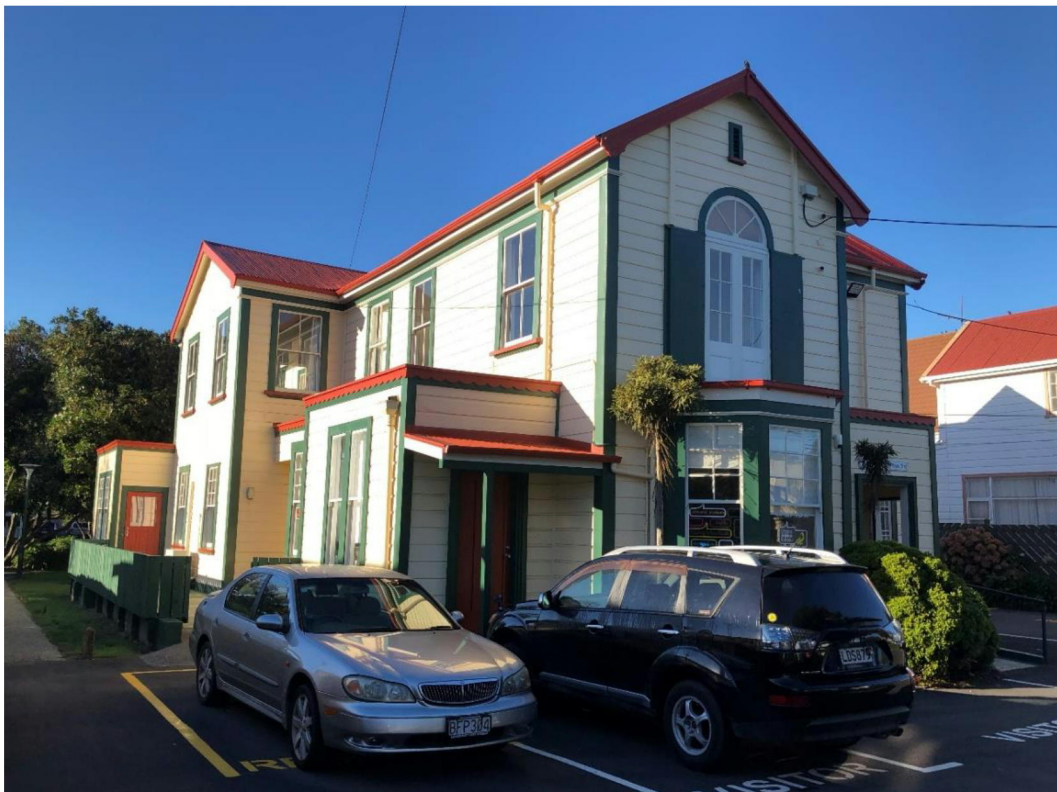
**Figure 3: Front view of Petone Community House**

Generally, both the interior and exterior of the Petone Community House appears to be in relatively good condition for its age (Figure 3 & 5). The roof is clad in corrugated iron with timber sarking and a series of ridges in place in the roof cavity (Figure 4). The building has been well maintained with refurbished plaster ceilings of varying ages and walls relined with plasterboard. The walls are timber framed with the original board lining in places and plasterboard lining over top (Figure 6). The floor is timber framed with tongue and groove floorboards (Figure 7). The exterior paintwork had been refurbished on numerous occasions. The structure was releveled and re-piled in 1993 and shows some undulation. All chimneys have been removed from all spaces inspected.

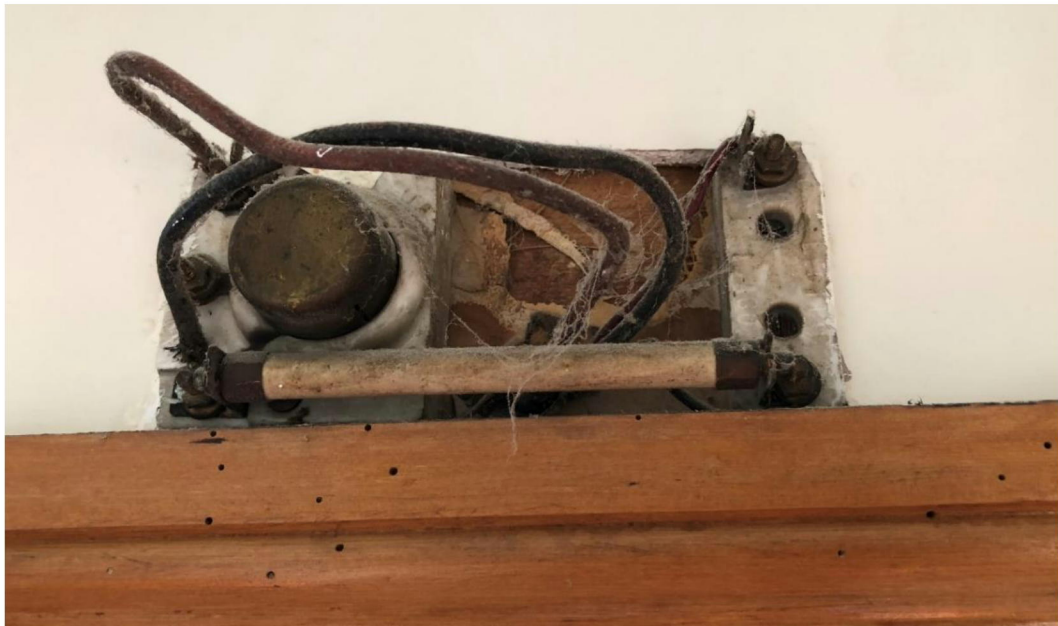
**Figure 6: View of layers of wall**

This building carries the horizontal loads through the timber-framed walls and into the foundation piles. The timber frame is lined with timber board that is in turn lined with plasterboard, which creates a brace to resist the horizontal forces of an earthquake.

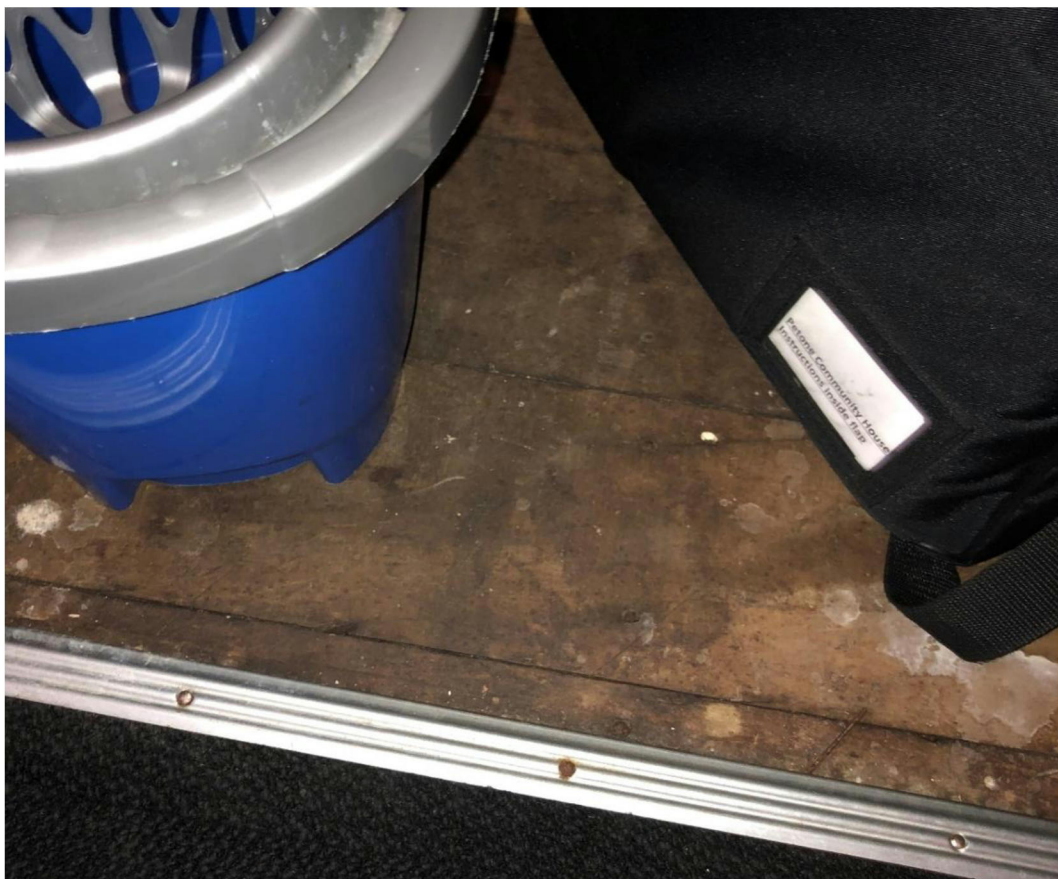
**Figure 7: Original floorboards**

- New ceilings throughout (except bathroom)
- Walls relined with plaster board
- Some sign of sagging of floors
