# Executive Summary

The War Memorial Library, located at 2 Queens Drive, Lower Hutt, is a two-storey reinforced concrete moment frame structure with masonry infill panels. The building was originally designed and constructed circa 1953. The building is currently used as a library.

This building has been subjected to a Detailed Seismic Assessment (DSA), using the procedures recommended in the NZSEE Guidelines in particularly Section C5 [Concrete Buildings] and C7 [Moment Resisting Frame with Infill panels].

The limiting feature is the in-plane bending capacity of the reinforced concrete walls on the South end of the building. This detailed assessment found that the building's compliance to be in the order of 40%-45% of a New Building built to the current Standards (%NBS), based on a building importance level of 2 (**40%-45% NBS IL2**).

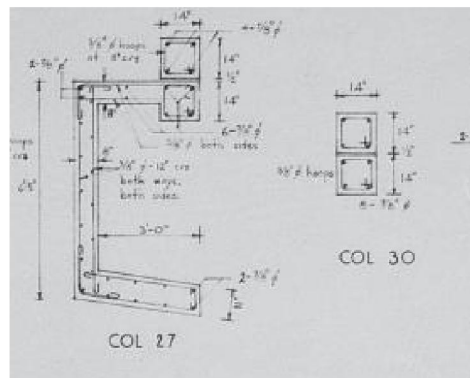
**Figure.7: Close up view of columns 27 and 30 at the interface of the Little Theatre and the War Memorial Library building showing no connections between the two structures.**

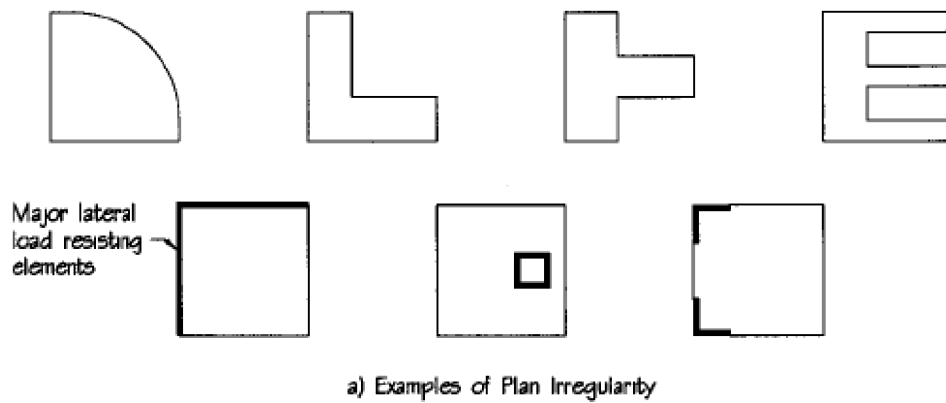
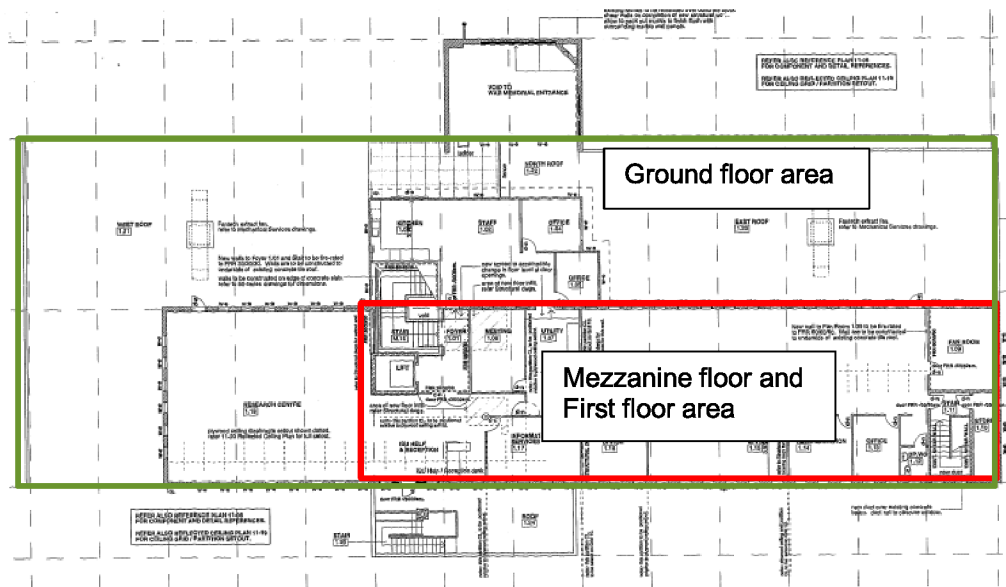
Figure.14: Floor plan showing the extent of the mezzanine Floor relative to the Ground Floor.

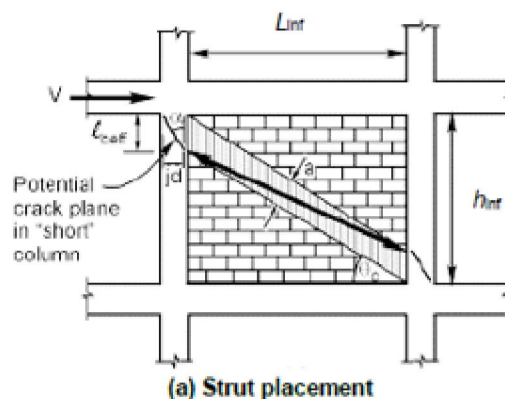
In addition, the presence of the infill brick panels at height represents a life safety hazard, as the connection around the panels are not designed based on the current design standard so may become distorted and fall from height onto the occupants.

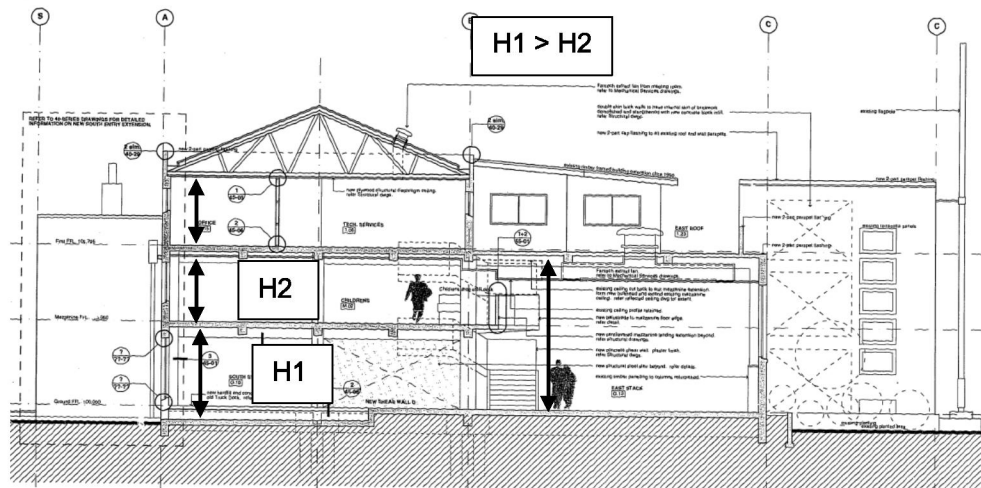
Heights of the storeys are different. The ground floor has a double height area, as shown in Figure 15 below. When the building is subjected to the lateral load, differing floor heights alter the loading distribution over the height of the building, which could induce torsional moment in the building.

Figure.15: Cross section through the building showing the different storey heights.

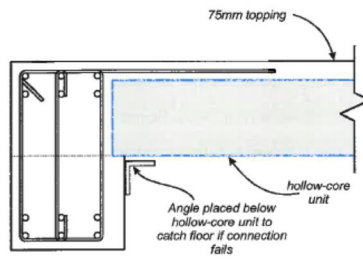
**Figure. 17: Proposed additional steel angle bracket to be installed underneath the Hollowcore floor units above the South entrance way.**

- The in-plane bending capacity of the concrete shear walls were found to be 40% NBS.
- The in-plane shear capacity of the concrete shear walls were found to be 54% NBS
- The presence of the infill brick panels at height represents a life safety hazard, as the connection around the panels are not designed based on the current design standard so may become distorted and fall from height onto the occupants. The out-of-plane [face-load] bending capacity of the infill brick panels were found to be 44% NBS
- The roof above the new South entrance is comprised of 'hollowcore' precast floor units. As highlighted in recent events, there is a potential for these precast units to lose their seatings and collapse during strong earthquake accelerations. These were found to have limited seating only and would require to be increased.

It is recommended to provide additional seatings [by installing a steel angle bracket] as shown above in Figure 17 to increase the available seating for the precast floor units to be supported on, and also to catch the units in the event that the connection fails.

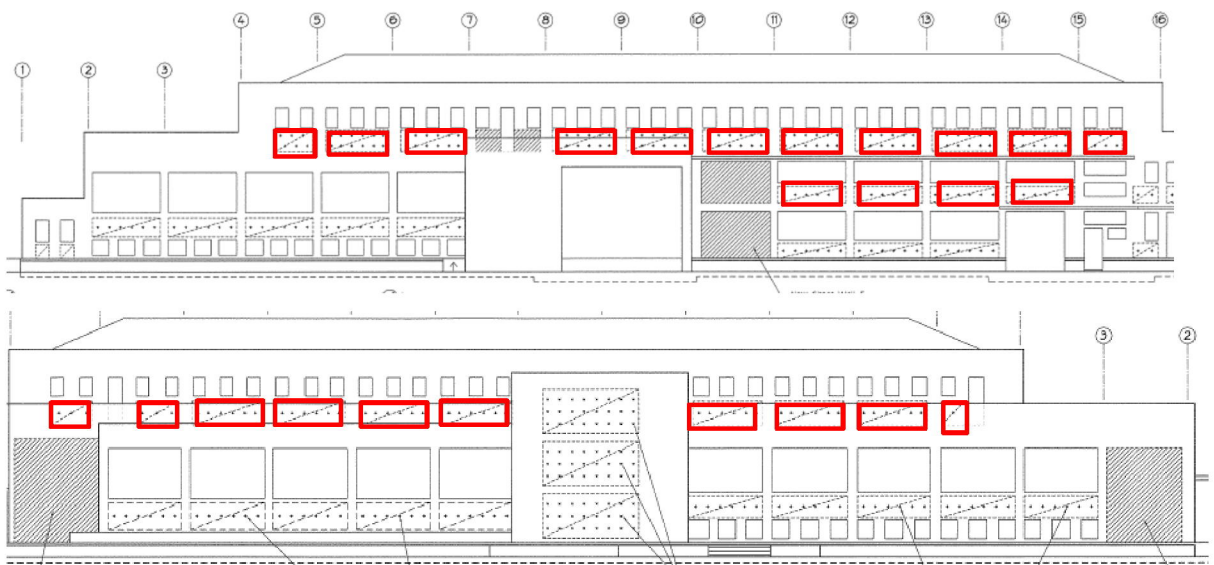
Our assessment has found that the out-of-plane moment demand expected in the infill brick panels is likely to exceed the capacity. This issue may be effectively addressed by replacing the infill brick panels at the First floor and the mezzanine floor levels with reinforced concrete in fill panels (connected to the concrete frames).

**Figure. 18: In-fill brick panels at height that can be replaced with in-fill concrete panels**
