Executive summary

We have now completed an Initial Seismic Assessment (ISA) of Moera Library at Randwick Crescent, Moera using the Initial Evaluation Procedure (IEP). The assessment was carried out after completing a site visit and an inspection of the building consent documentation.

Initial Evaluation Procedure (IEP) Assessment - Completed for Hutt City Council

Street Number & Name:	175 Randwick Road, Moera	Job No.:	5137964
AKA:		By:	RC
Name of building:	Moera Library	Date:	12/07/2018
City:	Moera	Revision No.:	0

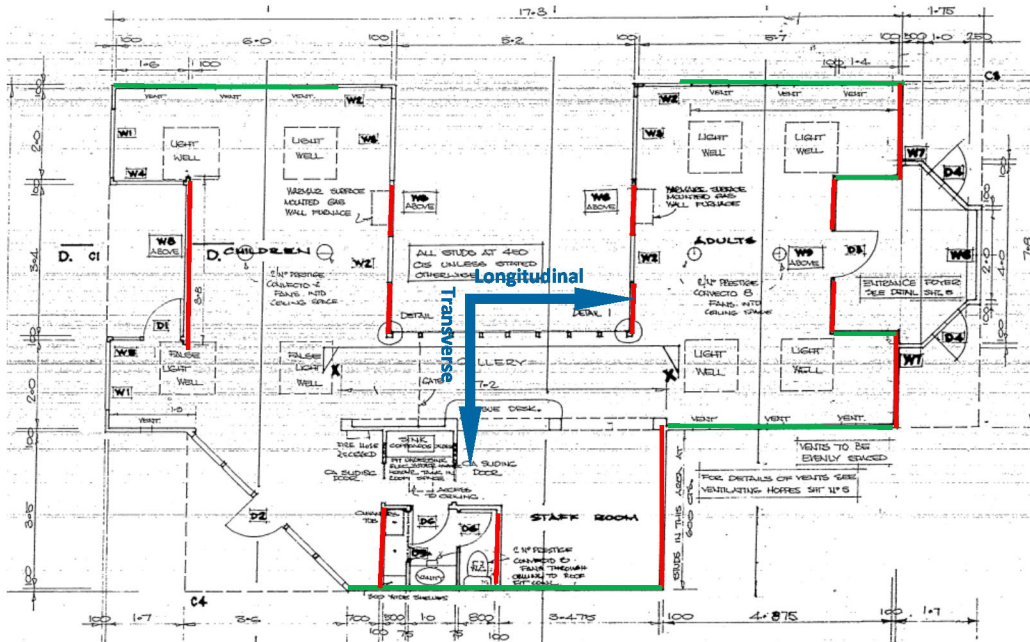
Figure 3 Location of the braced walls in the longitudinal and transverse directions

Generally the interior of the Moera Library appeared to be in good condition. There were no obvious cracks observed during the inspection.

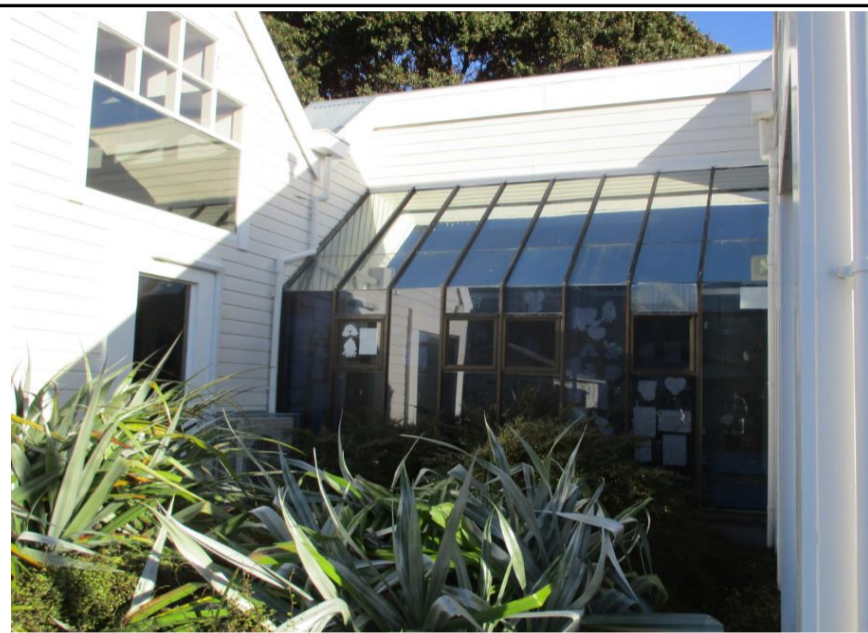
There are high-level glazing panels located at the top of the timber-framed walls. The glazing panels are supported by surrounding timber framing. The presence of these panels represents a potentially significant life safety hazard, as the timber mullions are not designed to allow for seismic movement of the building so the glazing may become distorted and fall onto people.

Glazing to the building

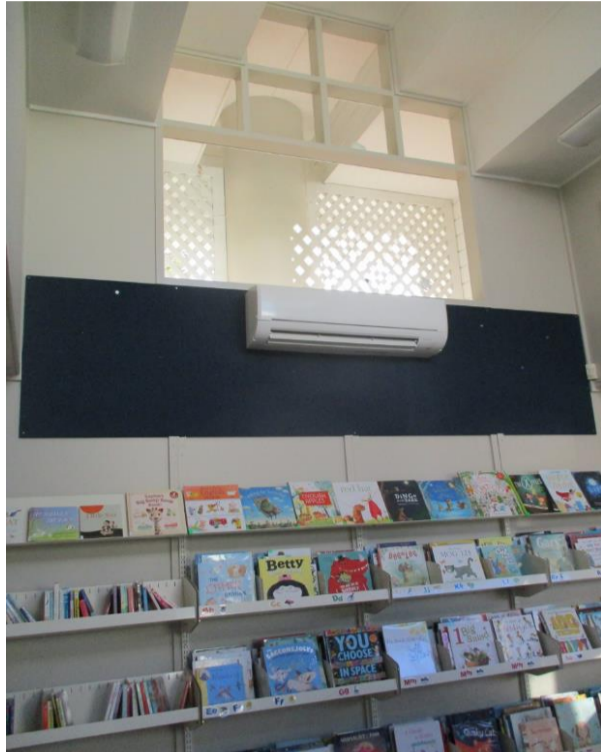
Glazing at height on wall

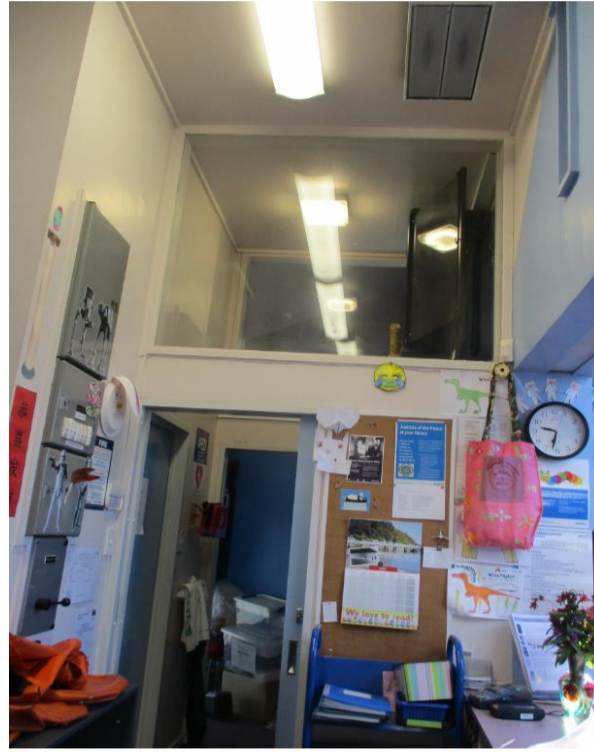
- Extremely high level windows throughout the building
- Glazing panels directly above the office area / front counter

Glazing above the reception area
