9735

**Initial Seismic Assessment Report
Huia Pool Buildings - Huia Street, Lower Hutt**

**Initial Seismic Assessment
Appendix 1 – Technical Summary
Appendix 2 – IEPs [Initial Evaluation Procedures]
Huia Pool
6 Huia Street**

Initial Evaluation Procedure (IEP) Assessment - Completed for Hutt City Council

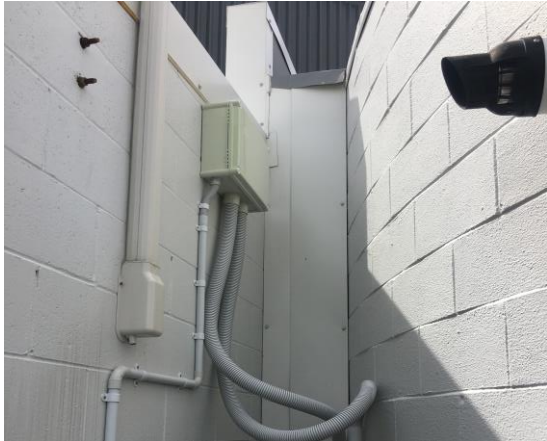
fig 1 - Seismic gap (left: new building; right: old building).

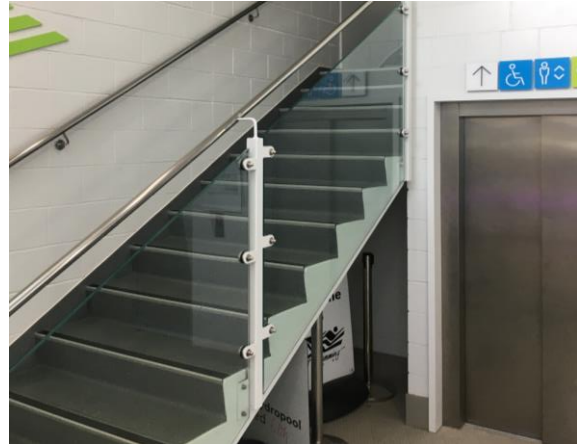
fig 2 - Pre-cast stairs and reinforced concrete lift core.

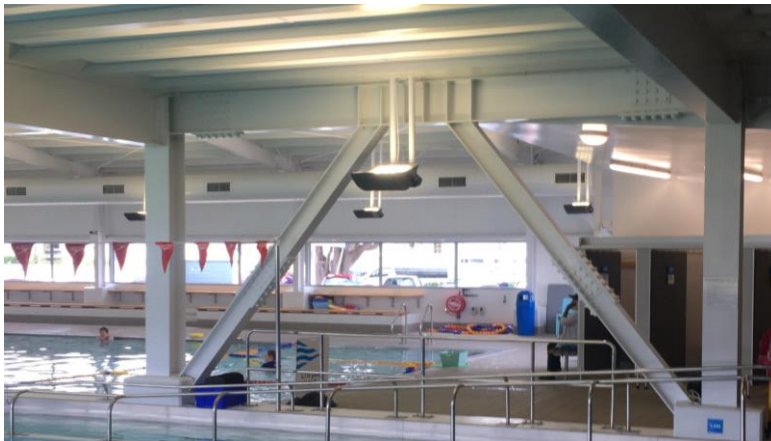
fig 3 - Eccentrically braced frame and interspan floor above.

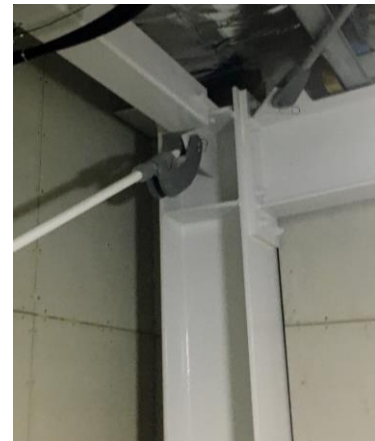
fig 4 - Tension only brace fixings.

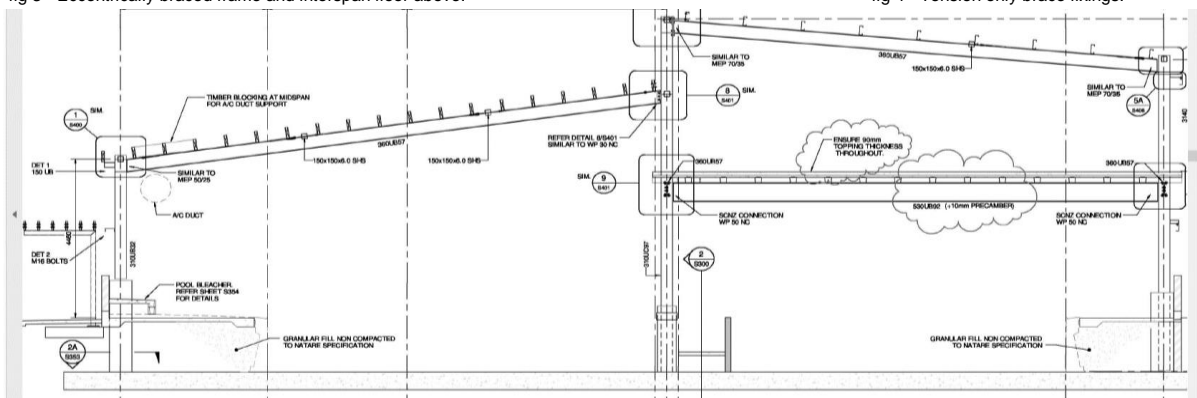
fig 5 - Typical transverse steel moment frame.
