Petone Recreation Ground Grandstand

Detailed Seismic Assessment

For Hutt City Council

Volume 2: Appendices

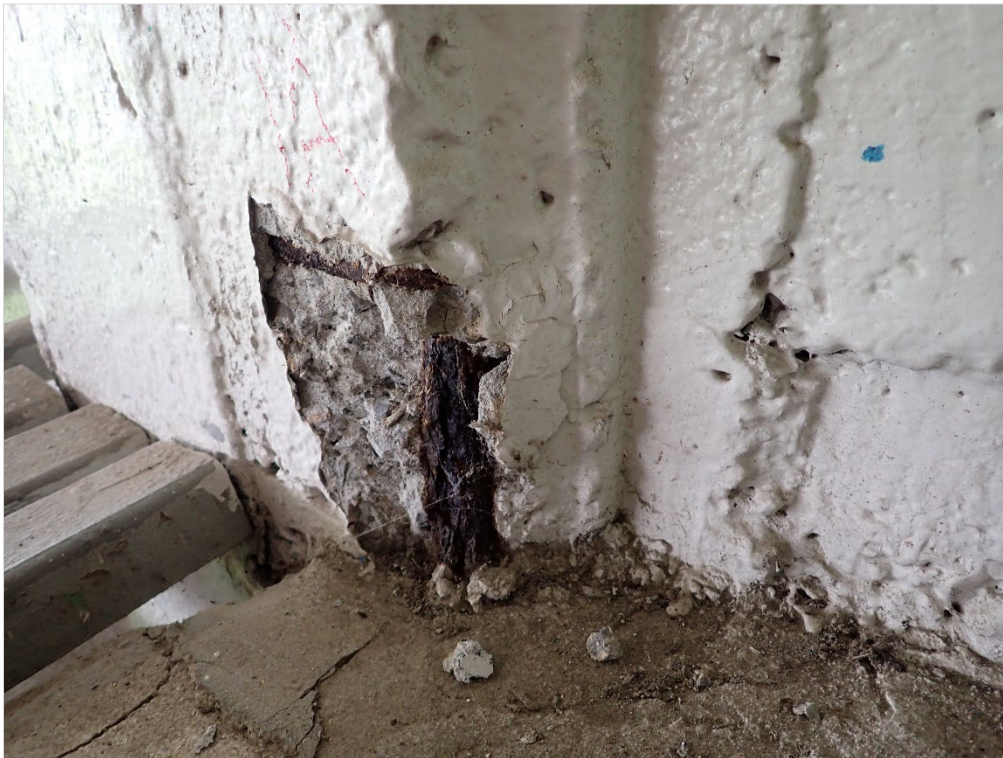
Figure 2: Location 1a - as-is

Figure 2, Figure 3 and Figure 4 display the condition of the structure at location 1a. Exposed and heavily corroded reinforcing was present. The expansion of the reinforcing bar inferred by corrosion put stress on the concrete, causing it to crack and eventually spall. Due to the progressed state of corrosion pitting and flaking on the bars has occurred.

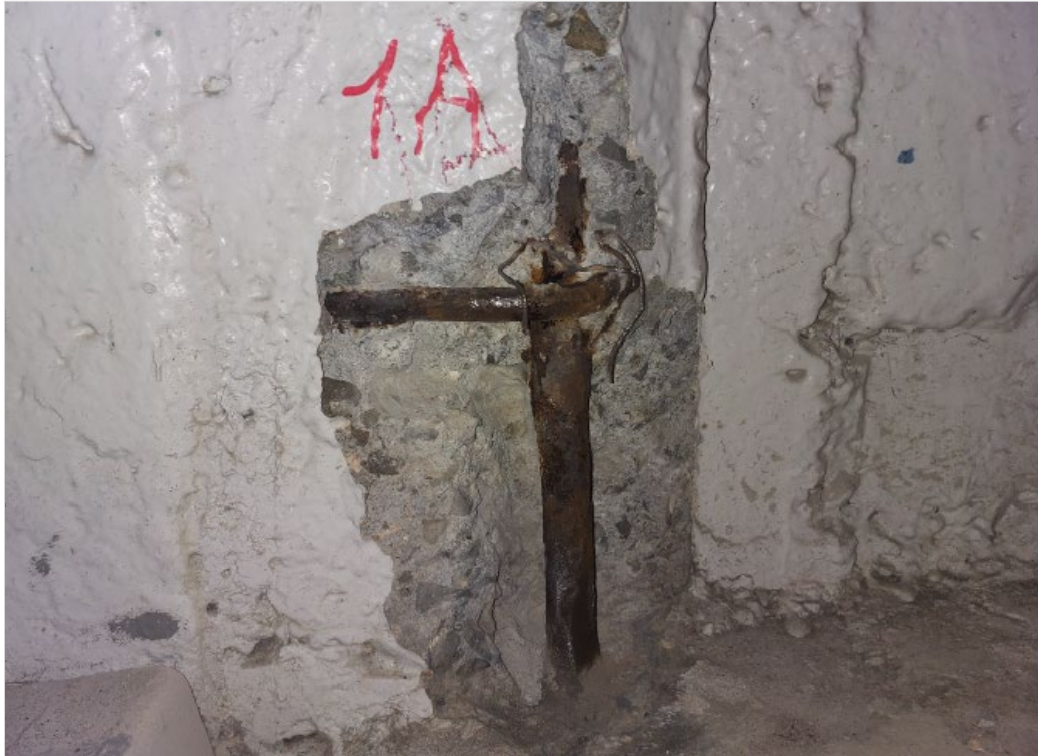
Figure 5: Polished main bar

The flaked iron-oxide was removed on the main bar and the bottom of the bar was polished.

The main bar appears to have an original bar diameter of 20mm. Due to corrosion the effective bar shape is not round anymore. Where measured, the narrowest portion of the cross section was 9mm. The cover is approximately 11mm.

Surface rust on the horizontal steel is apparent, no reduction in cross section could not be measured. The bar diameter is 12mm. There was little to no cover on the steel section facing towards the west.

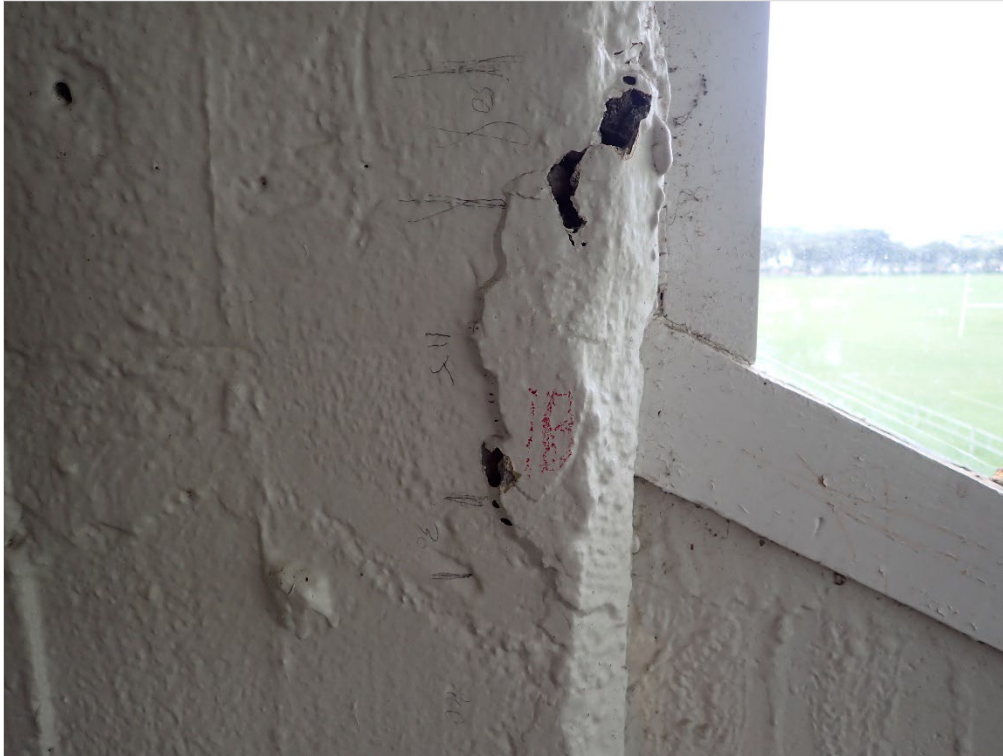
Figure 6: Location 1b - as-is

Figure 6 shows spalled concrete, caused by the effects of the expansion of corroding steel.

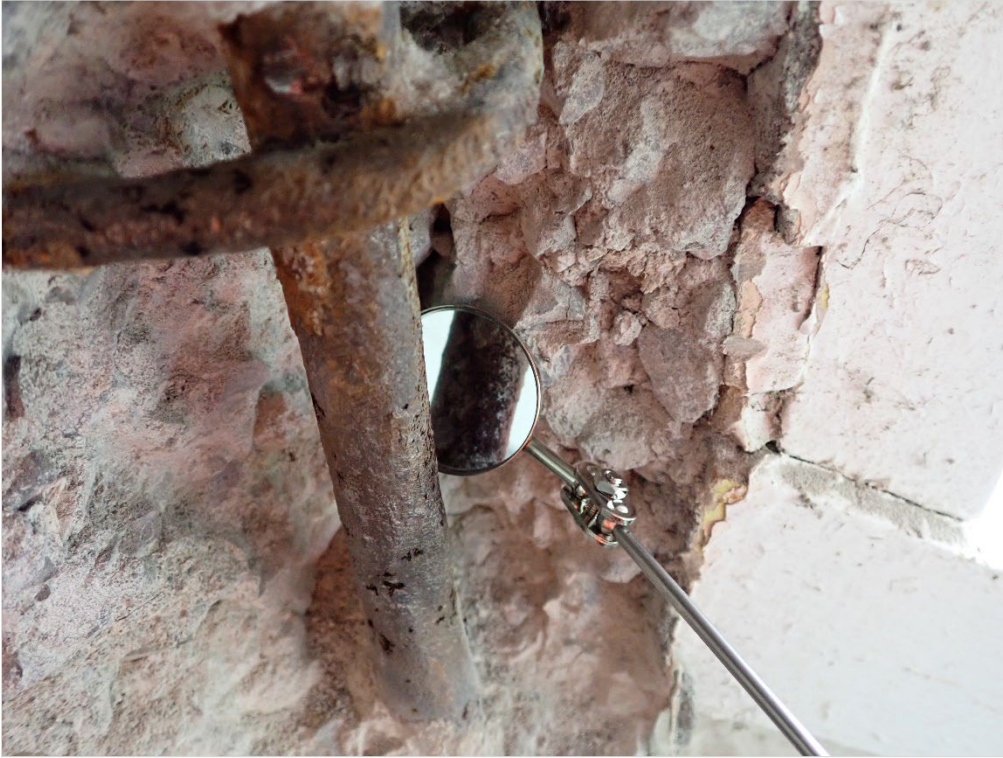
Figure 8: Location 1b - breakout

Figure 8 and Figure 9 display the location after removing the spalled concrete. Clear signs of corrosion pitting are visible.

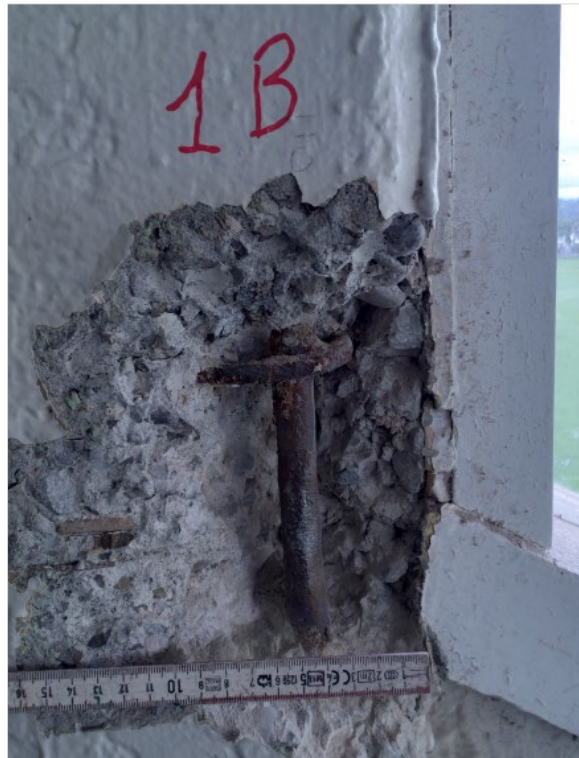
Figure 9: Polished bar

The vertical and horizontal bars (nominal diameters of 20mm and 10mm) were measured to have a remaining cross section of 16.9mm and 8.6mm, respectively.

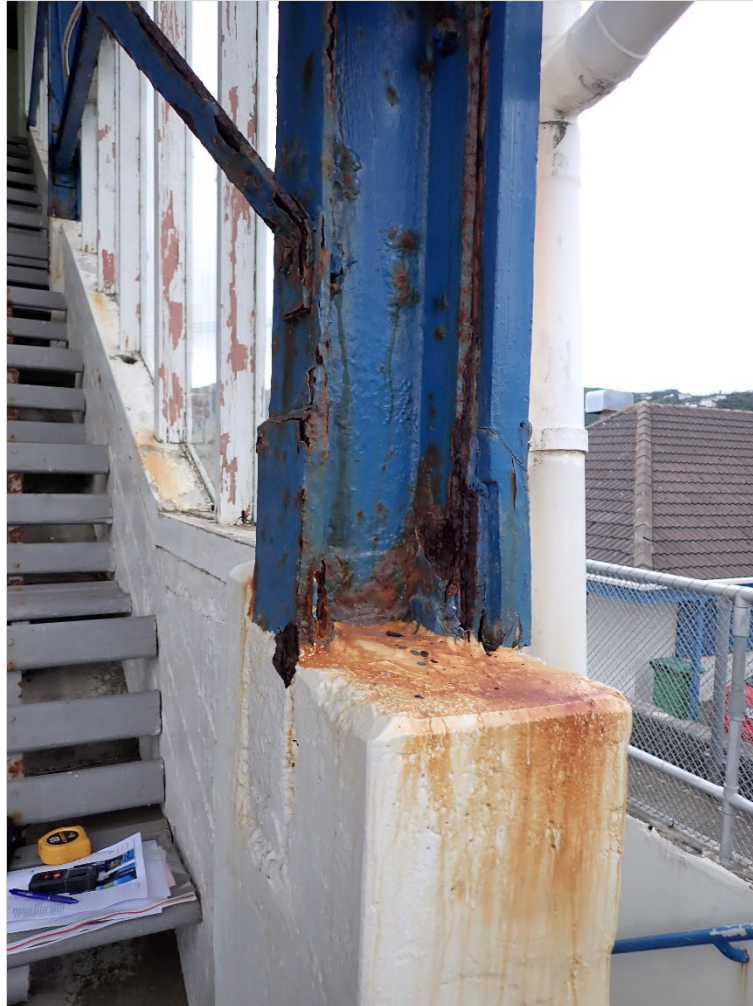
Figure 11: Location 2a - connection, sever corrosion

The steel frame is connected through welded steel plates to the structure. Sever corrosion can be seen on all connecting parts.

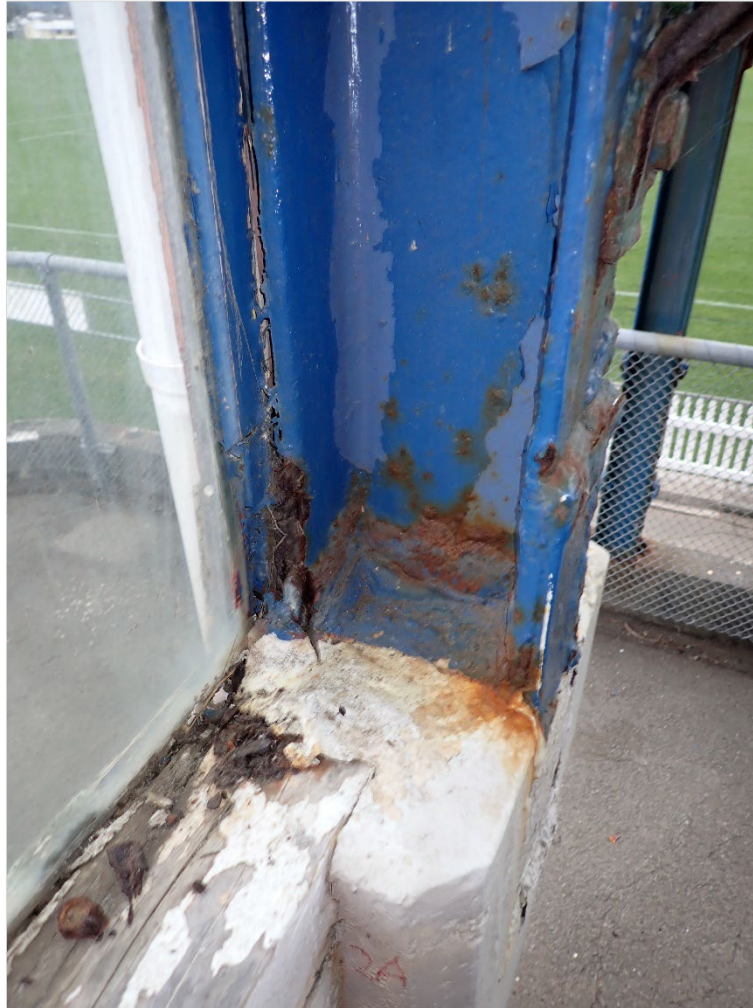
Figure 12: Location 2a - connection, sever corrosion

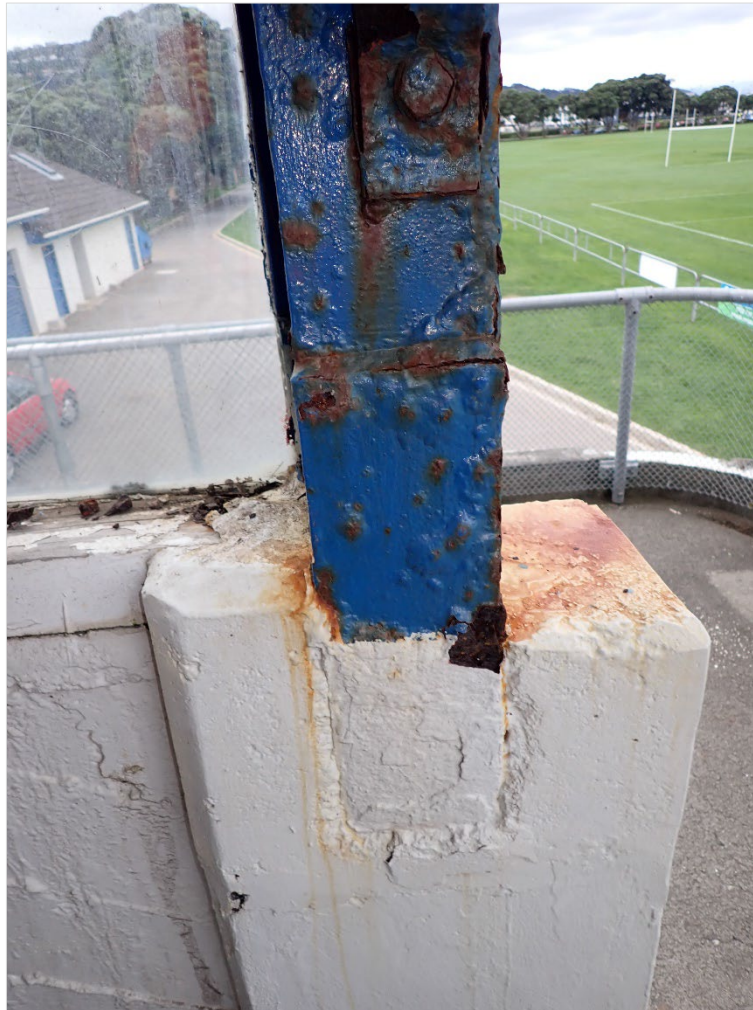
Figure 13: Location 2a - connection, sever corrosion

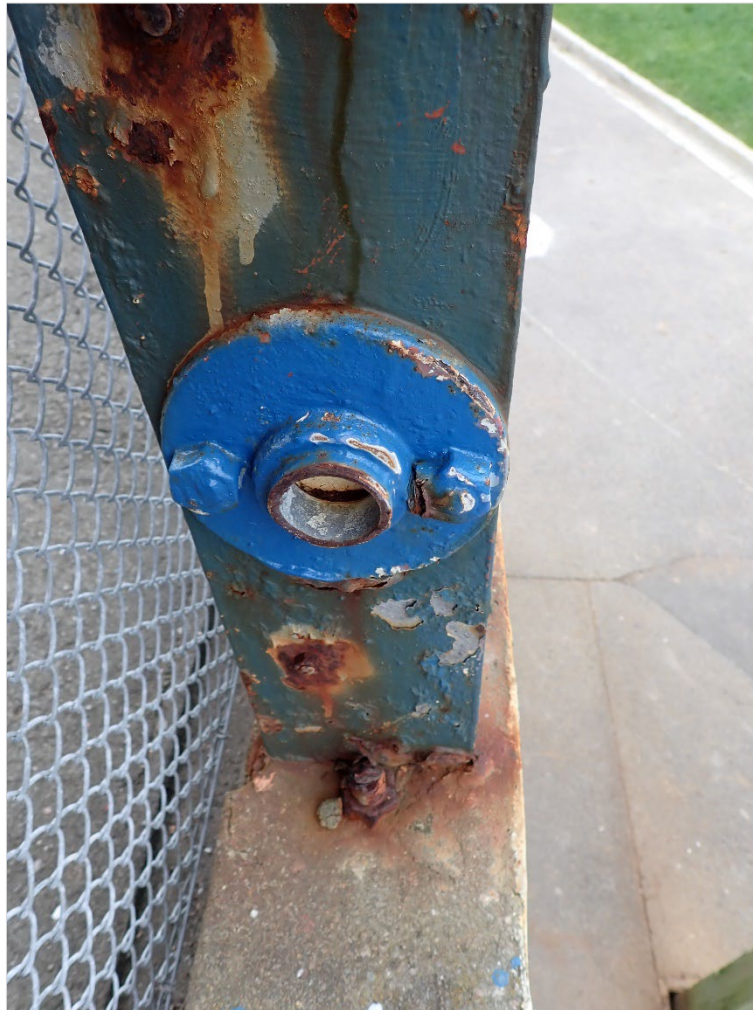
Figure 14: Grid F/X - connection, sever corrosion

Figure 14 shows sever corrosion on the base plate and the connection (fixing) to the structure is visible.

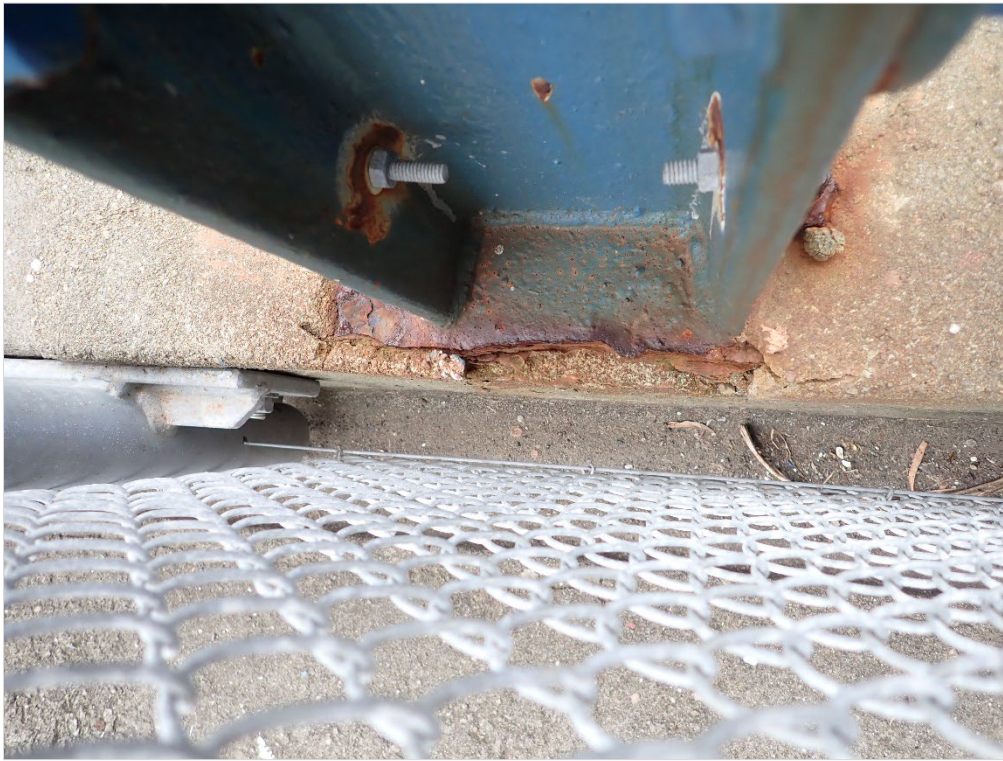
Figure 15: Grid F/X - connection, sever corrosion

Figure 15 and Figure 16 show the baseplate which appear to have lost some of its base. Corrosion caused concrete to spall.

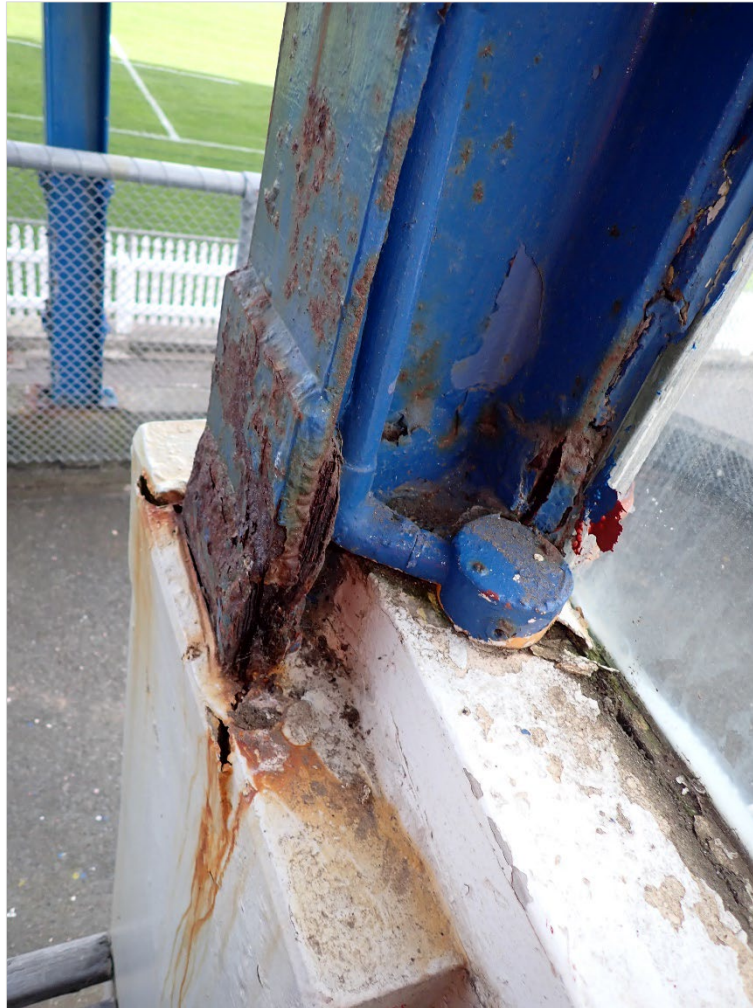
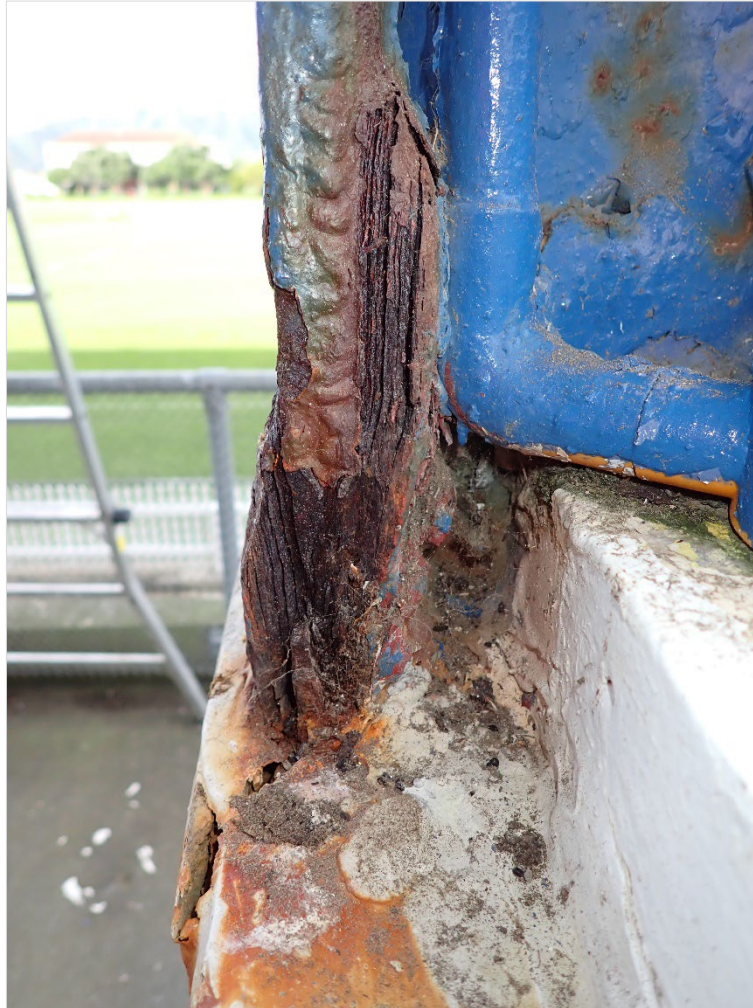
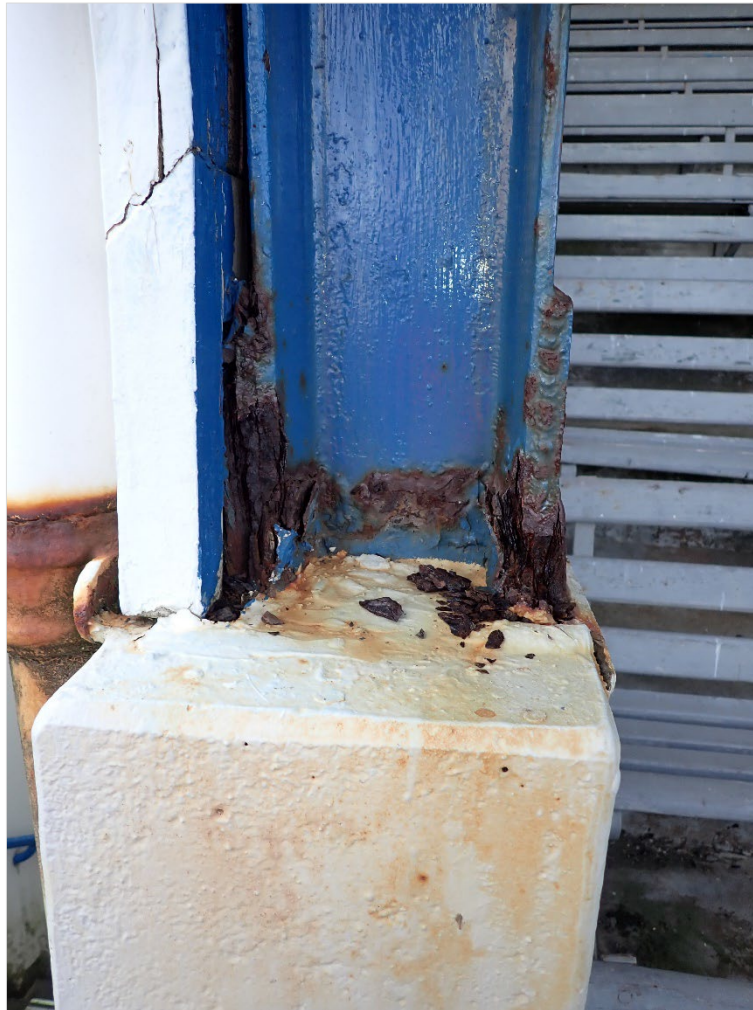
Figure 17: Location 2b - connection, sever corrosion

Figure 17, Figure 18, and Figure 19 display the steel frame connection. Sever corrosion can be seen on all connecting parts. Spalled concrete and flaking of the steel is apparent.

Figure 18: Location 2b - connection, sever corrosion

Figure 19: Location 2b - connection, sever corrosion

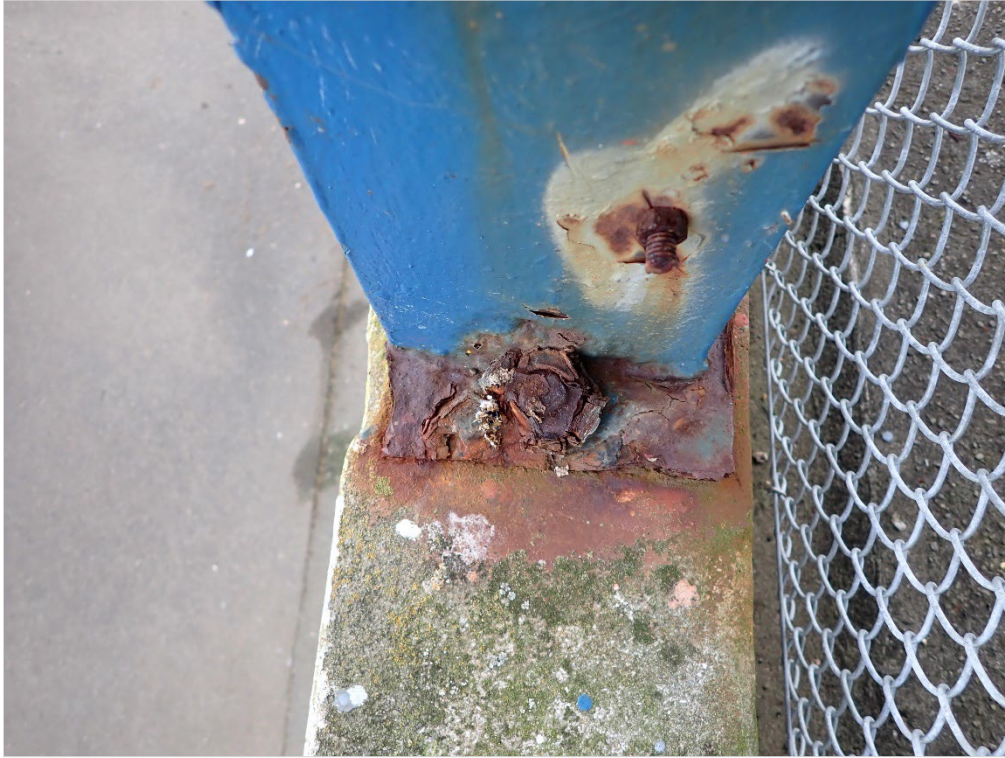
Figure 20: Grid AX - connection, sever corrosion

Figure 20 and Figure 21 display sever corrosion on the baseplate and the connection (fixing) to the structure.

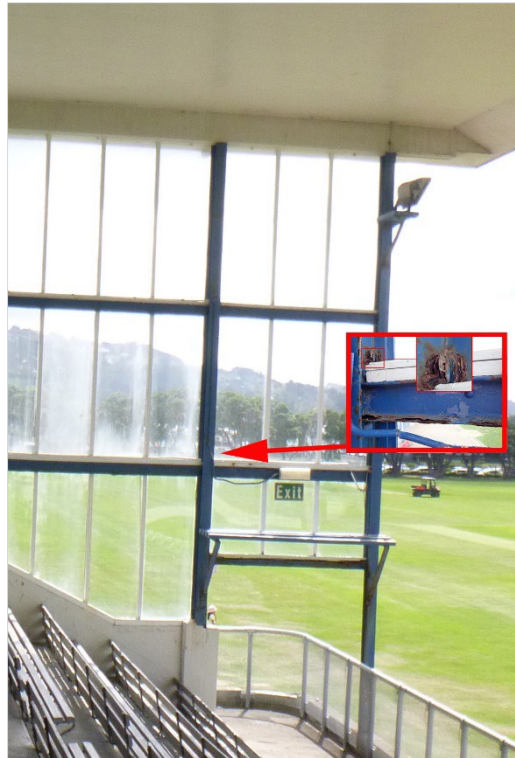
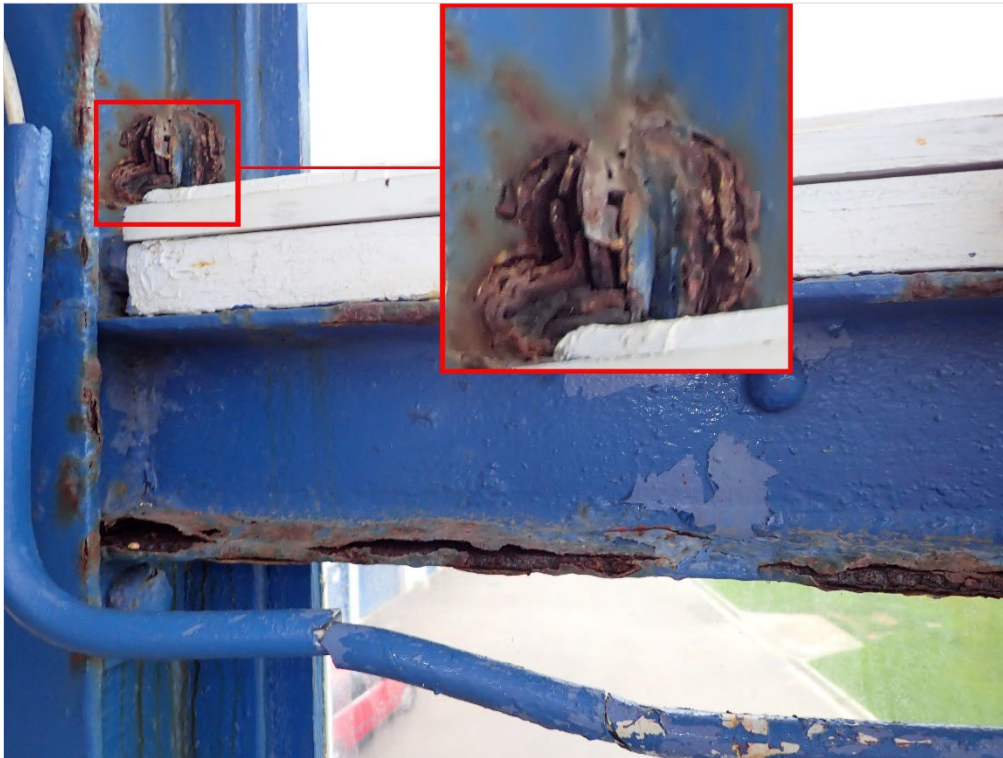
Figure 22: *Item 2a – example 1, sever corrosion*

Figure 23: Item 2a – example 1, sever corrosion

Sever corrosion on the web and the flange of the steel profile is apparent above the middle (second) horizontal profile.

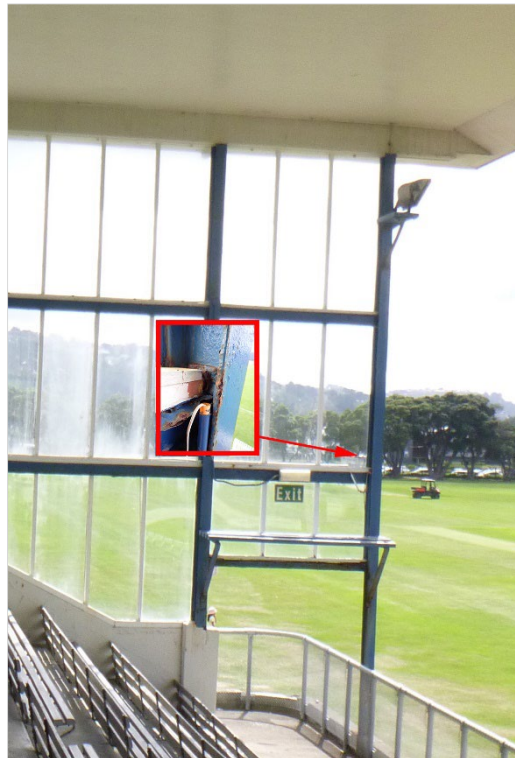
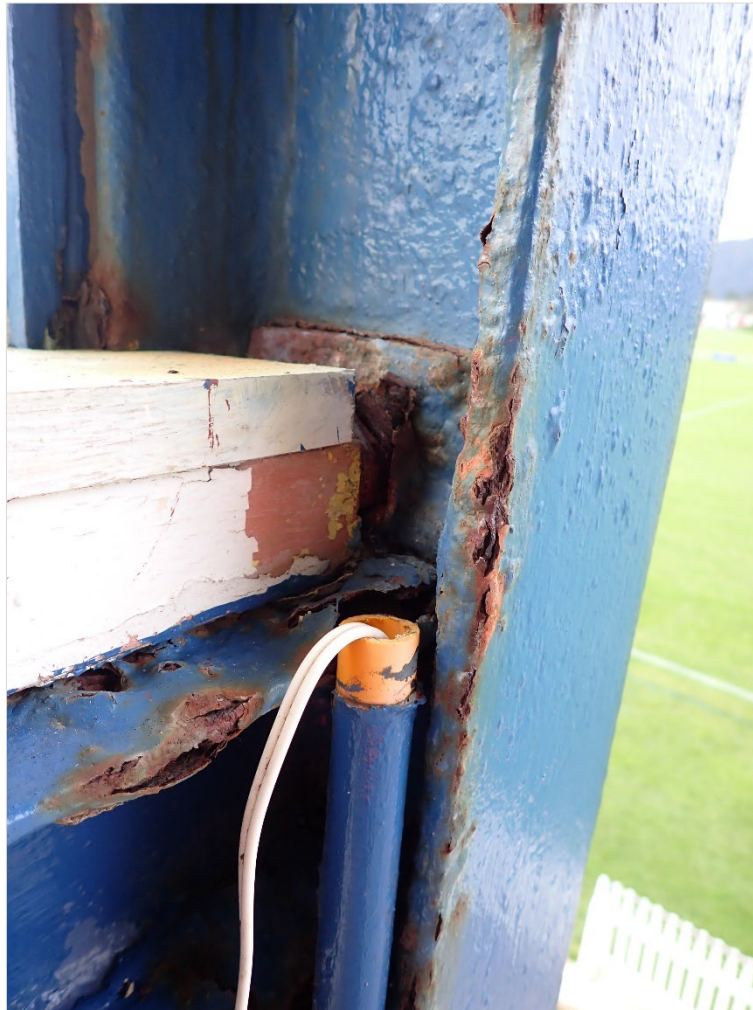
Figure 24: Item 2a – example 2, sever corrosion

Figure 25: Item 2a – example 2, sever corrosion

Figure 25 and Figure 26 show sever corrosion on various sections of the steel frame. The top flange of the horizontal member shows flaking, and the connection to the vertical profile appears to be heavily corroded. The flanges have corrosion of varying severity.

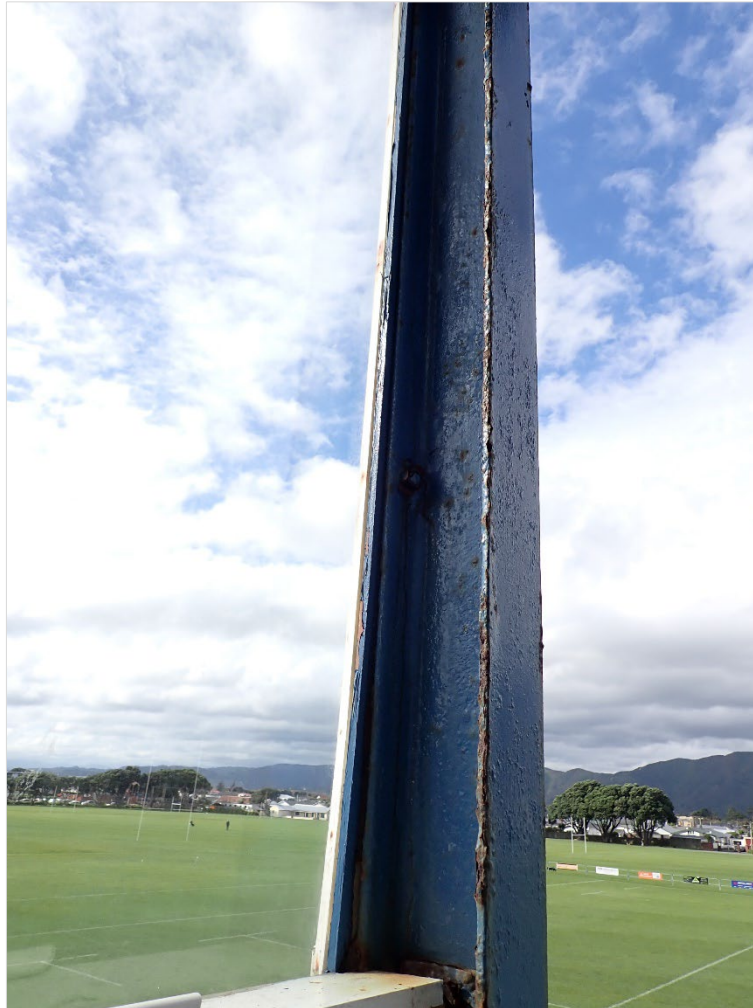
Figure 26: Item 2a – example 3, sever corrosion

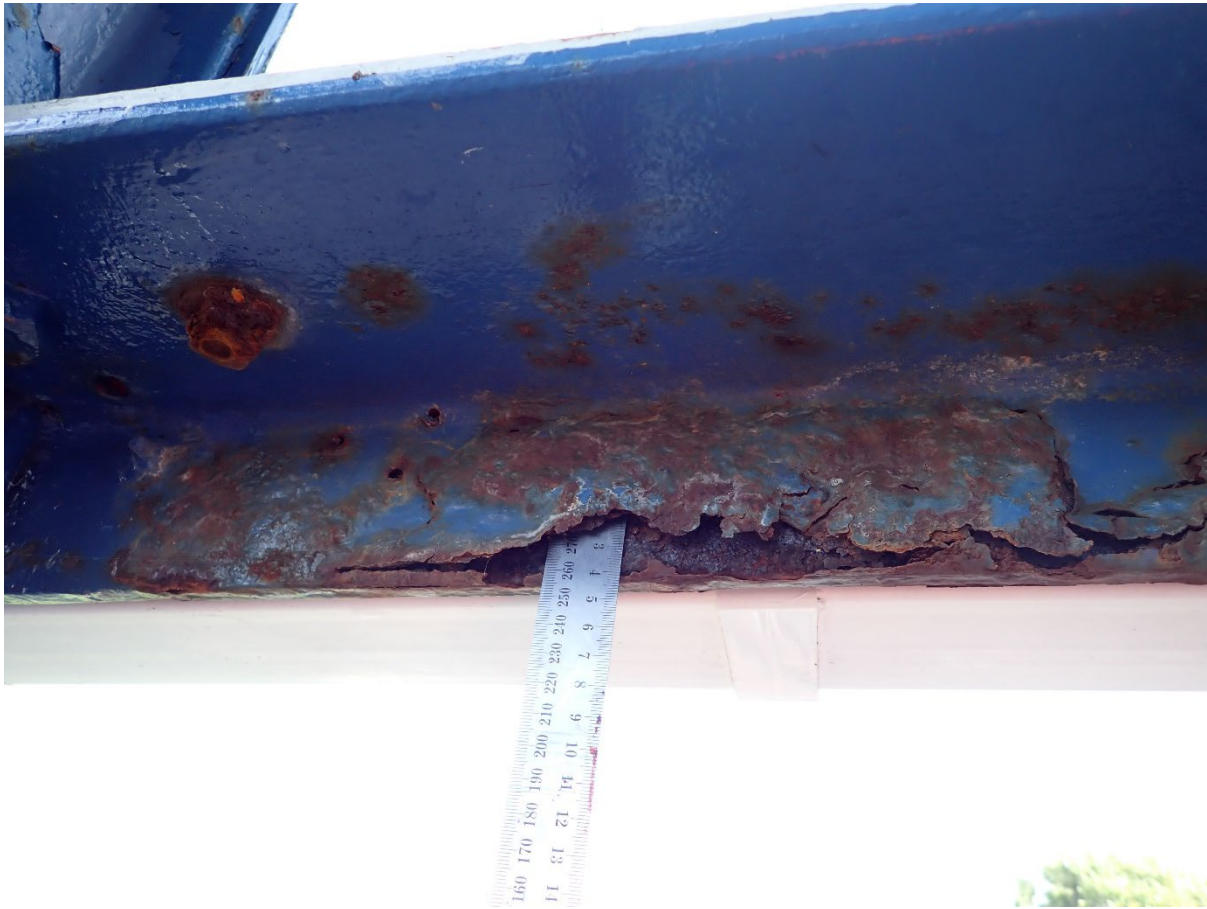
Figure 28: Item 2b – example 1, sever corrosion

Figure 28 displays a horizontal connection to the portal frame. Sever corrosion and pitting is present.

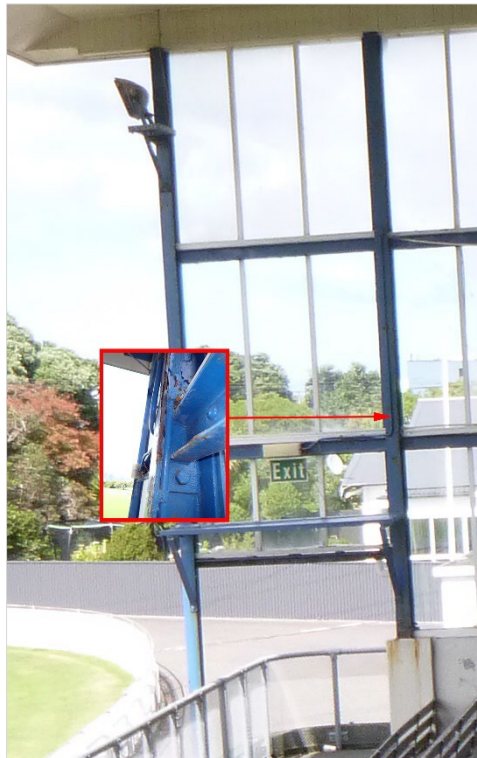
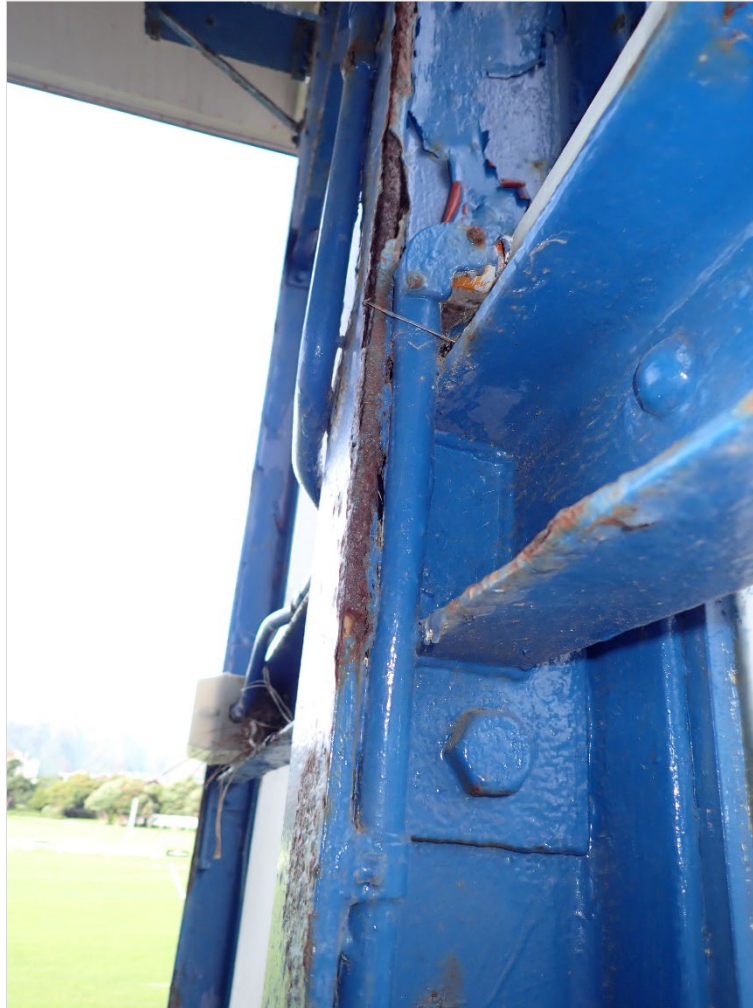
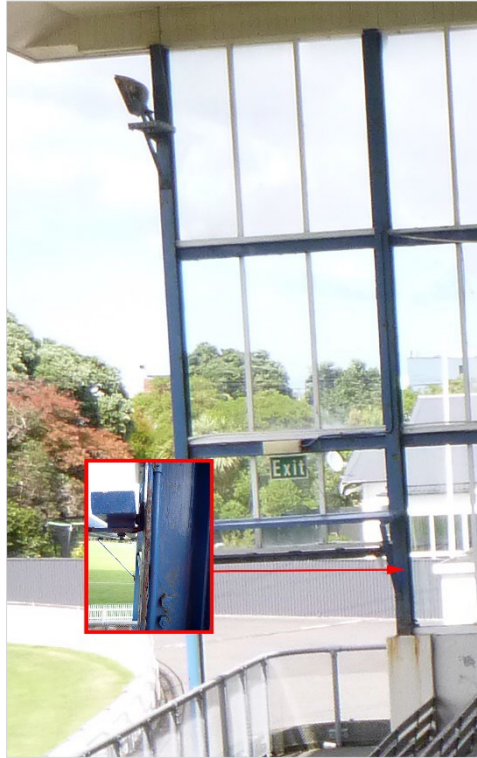
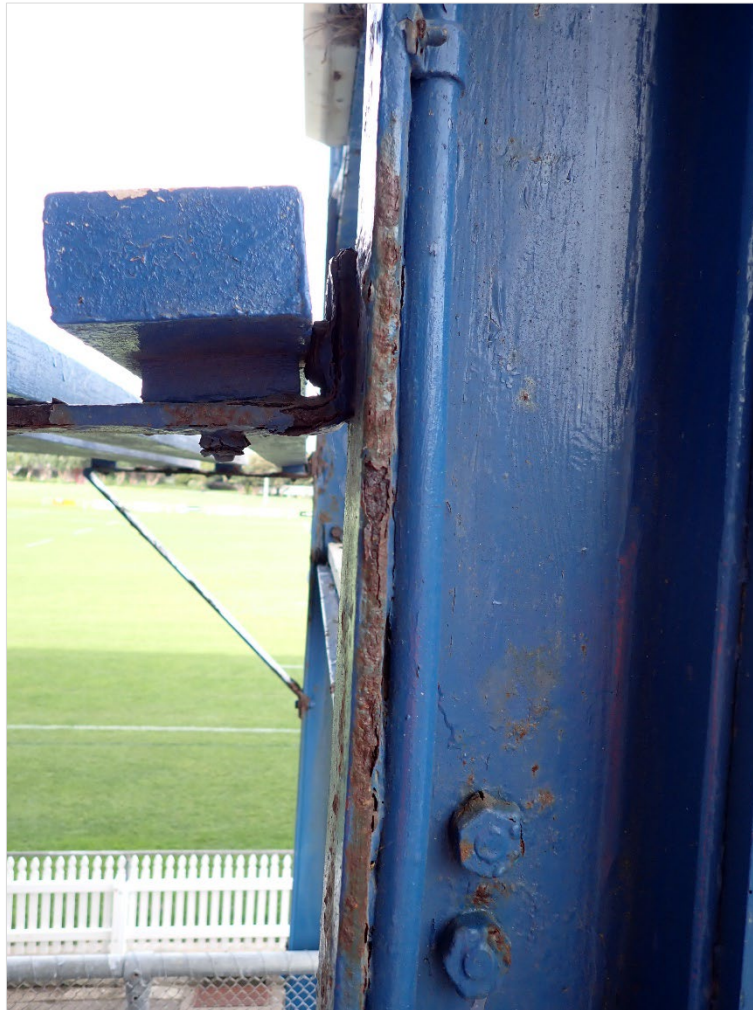
Figure 29: Item 2b – example 2, sever corrosion

Figure 30: Item 2b – example 2, sever corrosion

Figure 29, Figure 30, Figure 31, Figure 32 shows the NW face of the western portal frame. Despite this side being covered by the roof and protection from weather exposure by the windows, sever corrosion has developed.

Figure 31: Item 2b – example 3, sever corrosion

Figure 32: Item 2b – example 3, sever corrosion

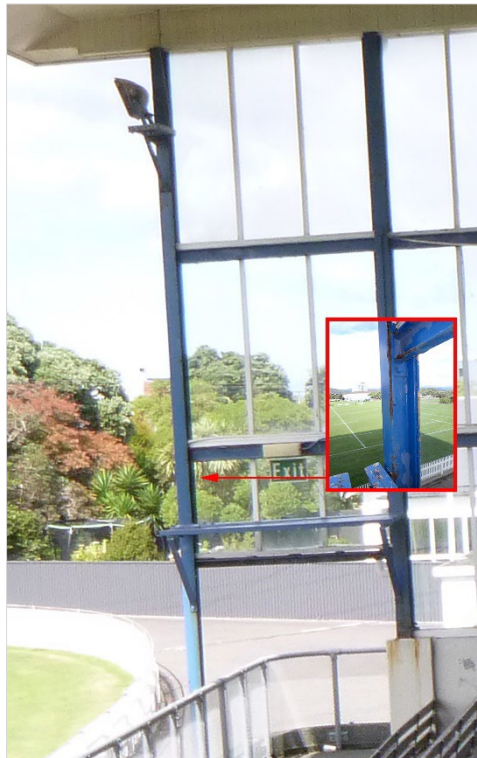
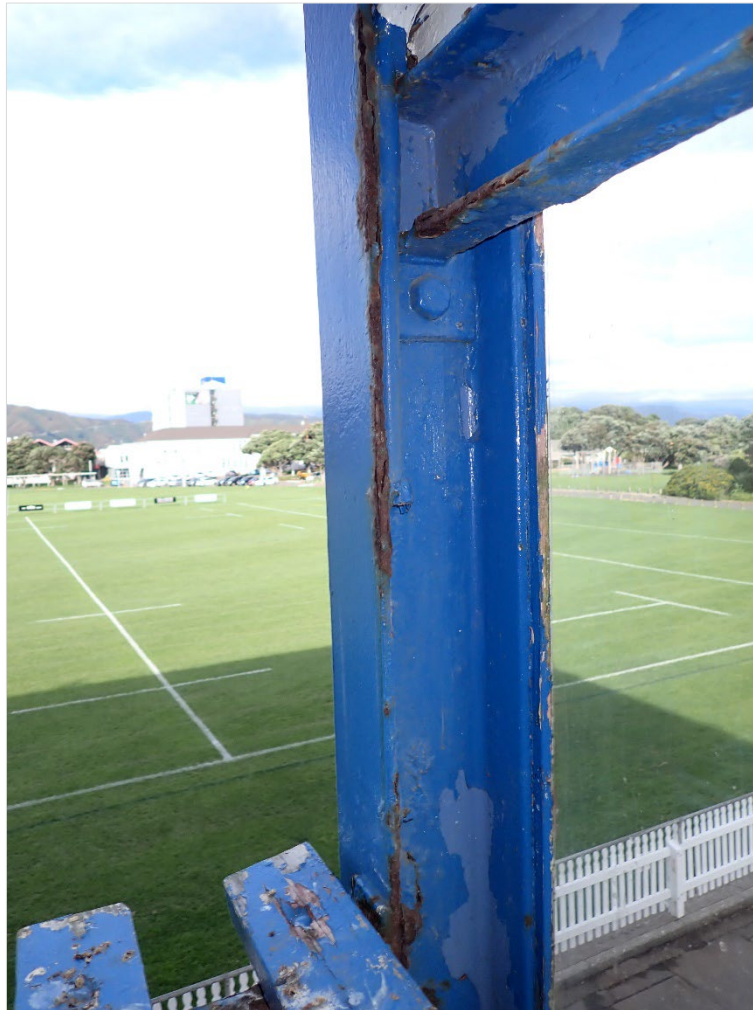
Figure 33 Item 2b – example 4, sever corrosion

Figure 34: Item 2b – example 4, sever corrosion

Figure 33 and Figure 34 show corrosion on the steel profiles.

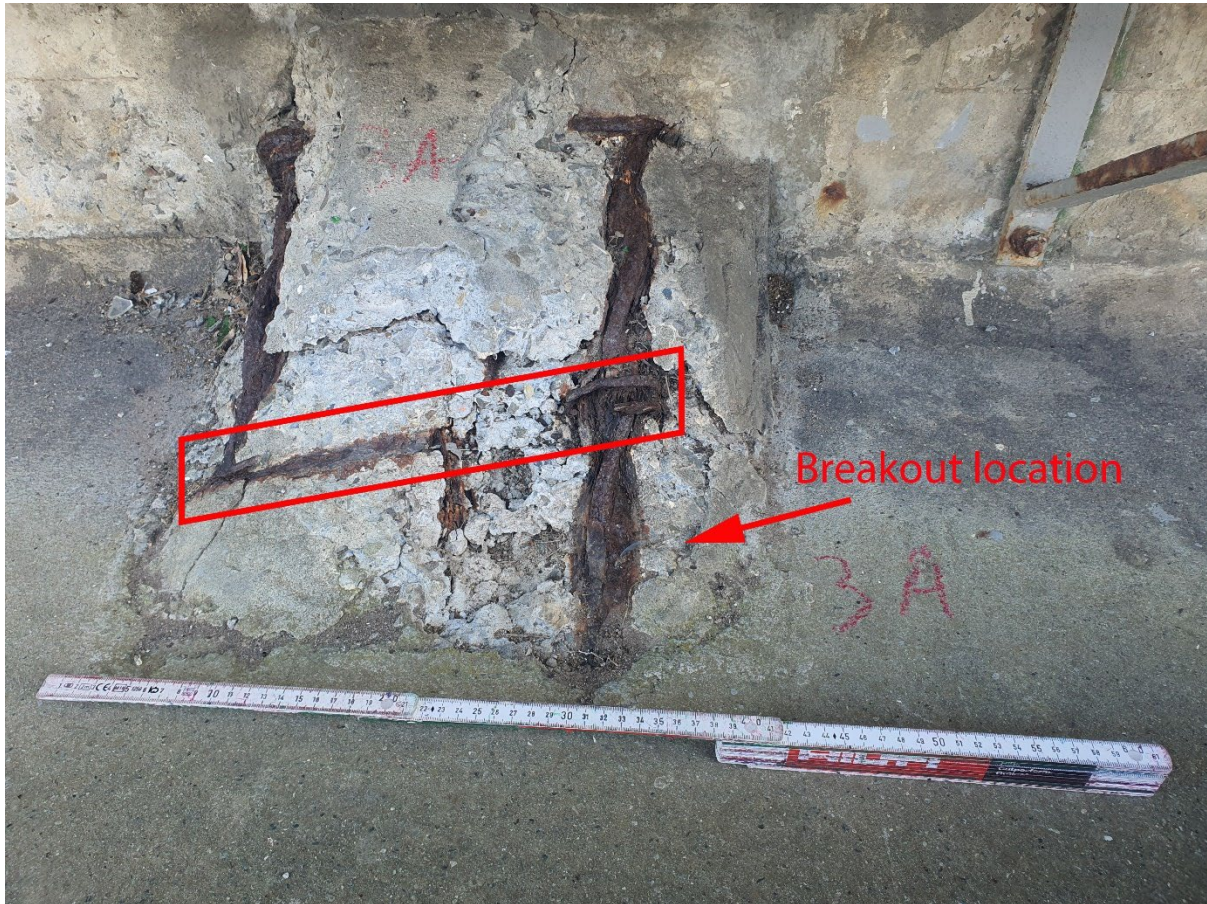
Figure 35: Location 3a - as is

Figure 35 displays the level of deterioration of the raking beam at grid C/3. Exposed and severely corroded reinforcement was present. The level of corrosion has caused the concrete to crack and spall. A stirrup appears to have fully disintegrated, highlighted by red quadrangle.

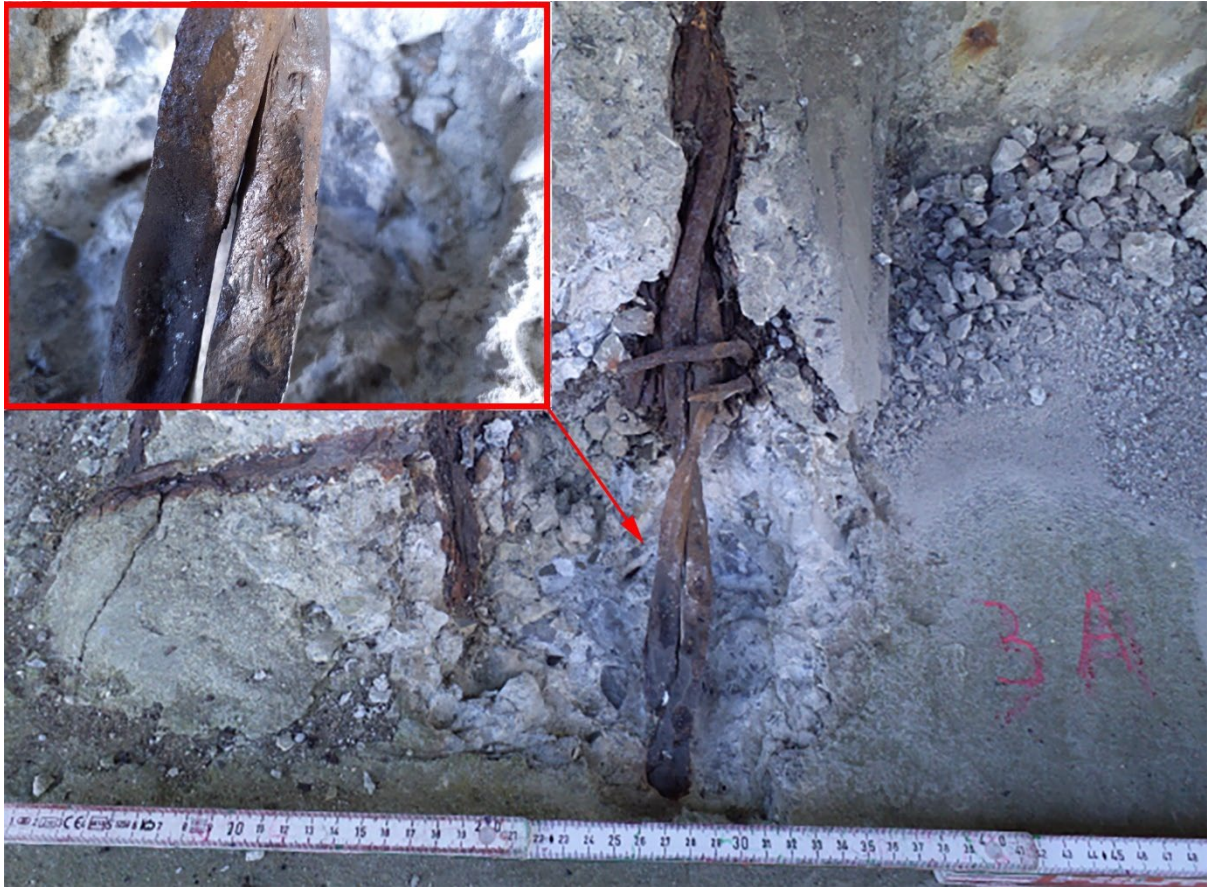
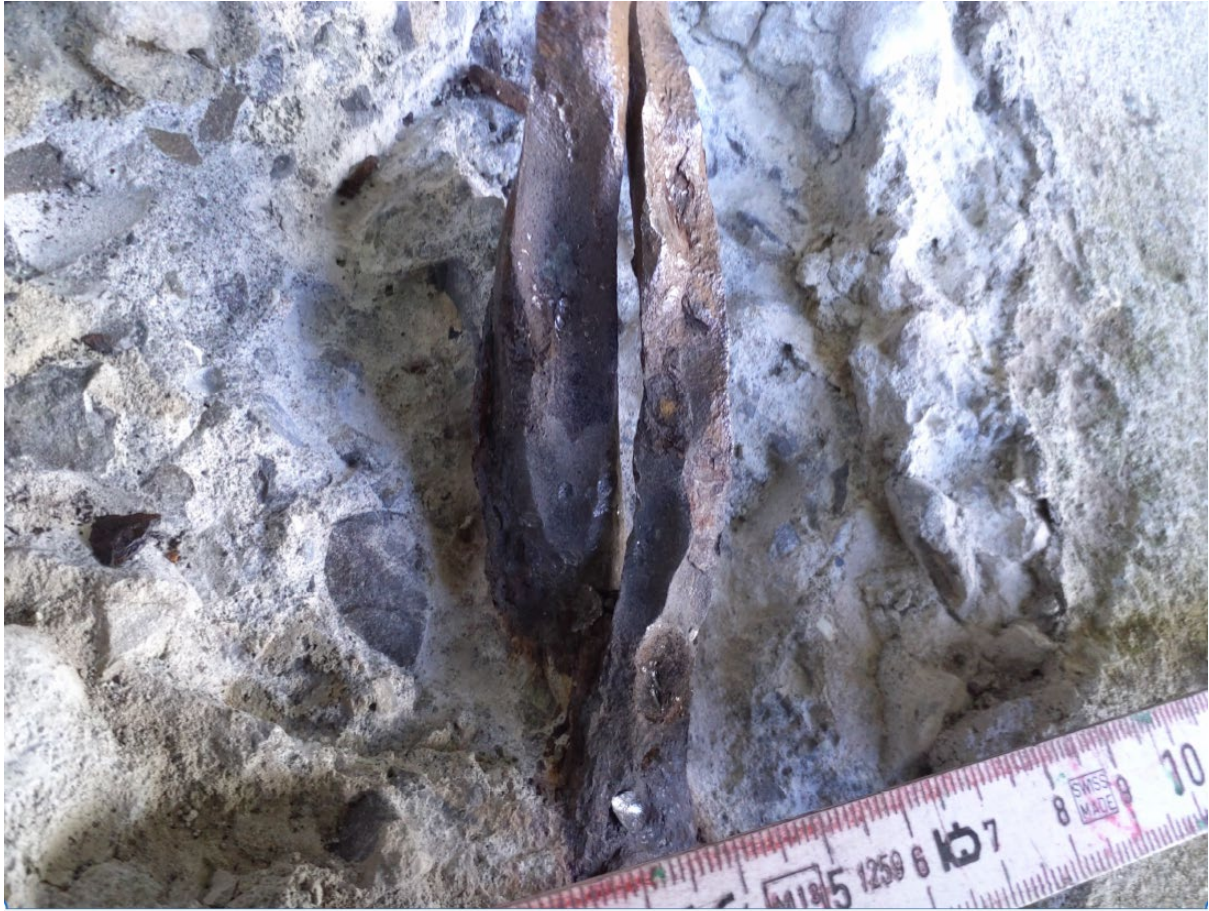
Figure 36: Item 3a – Breakout location

Figure 36 and Figure 37 show the deterioration of the raking beam.

The left bar with a nominal diameter of 20mm was found to have a reduced cross section of 5mm. One of the bars had some springing properties which is an indication for discontinuation. The bar must be assumed to be broken, although this could not be visually confirmed.

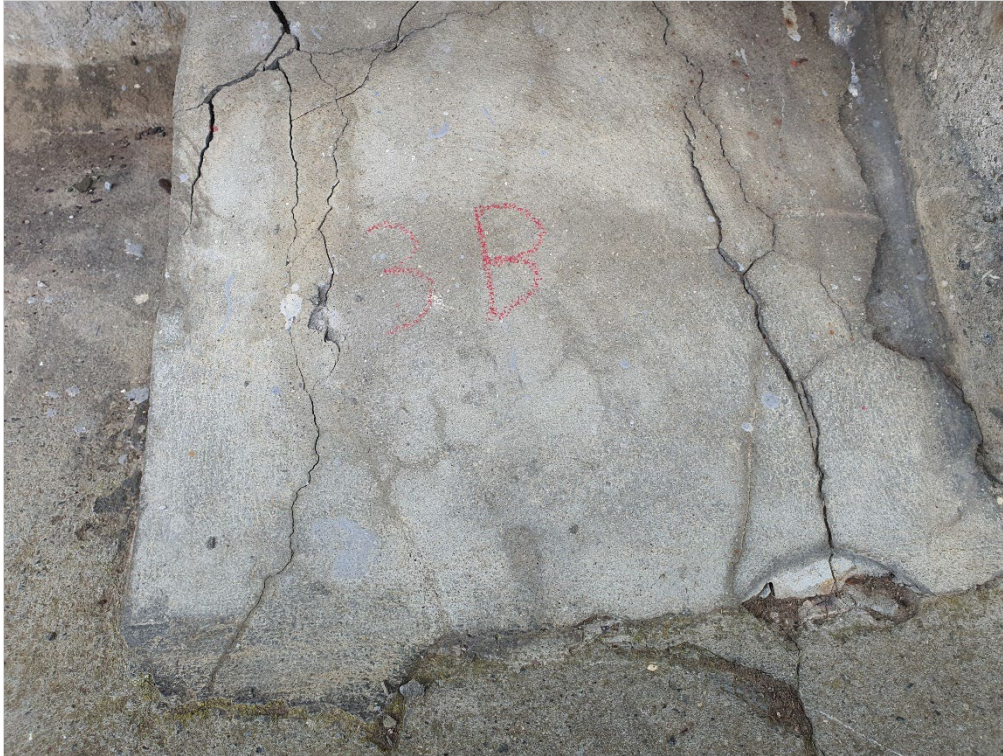
Figure 38: Location 3b - as is

Figure 38 displays location 3b before a breakout was performed. The material on the top, which shows clear signs of spalling, does not resemble the original concrete. The spalled material was easily removed by hand.
