Petone Recreation Ground Grandstand

Detailed Seismic Assessment

For Hutt City Council

Volume 2: Appendices

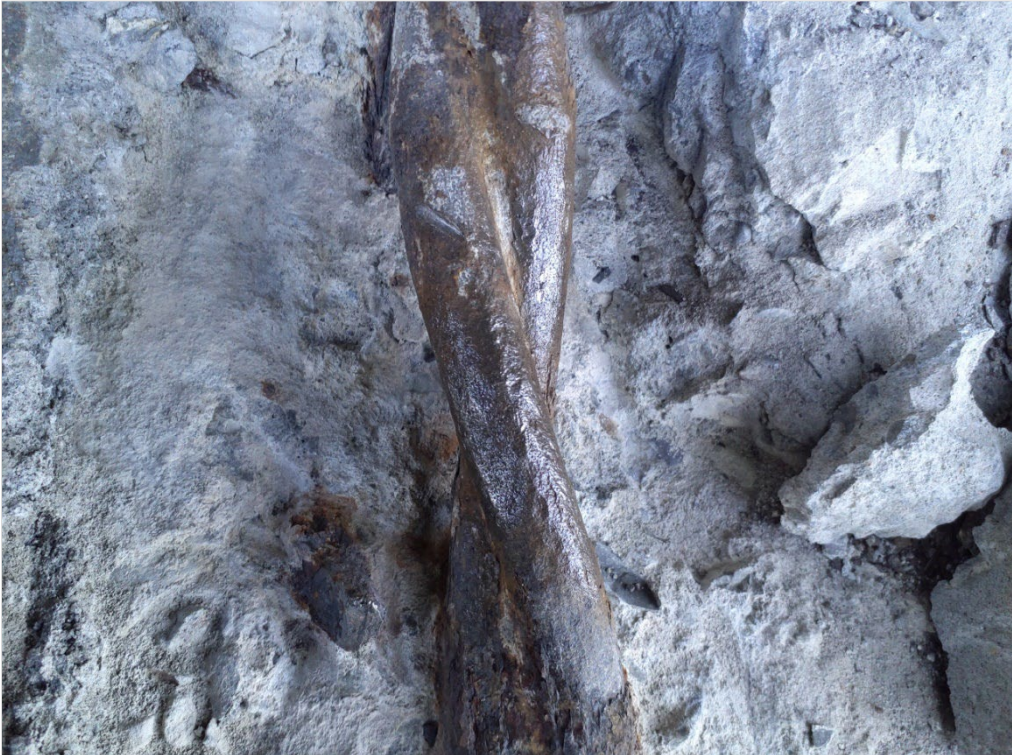
Figure 41: Location 3b - M1

The measured bar, with a nominal diameter of 20mm, was found to have a diameter of 18.93mm and 18.1mm, respectively.

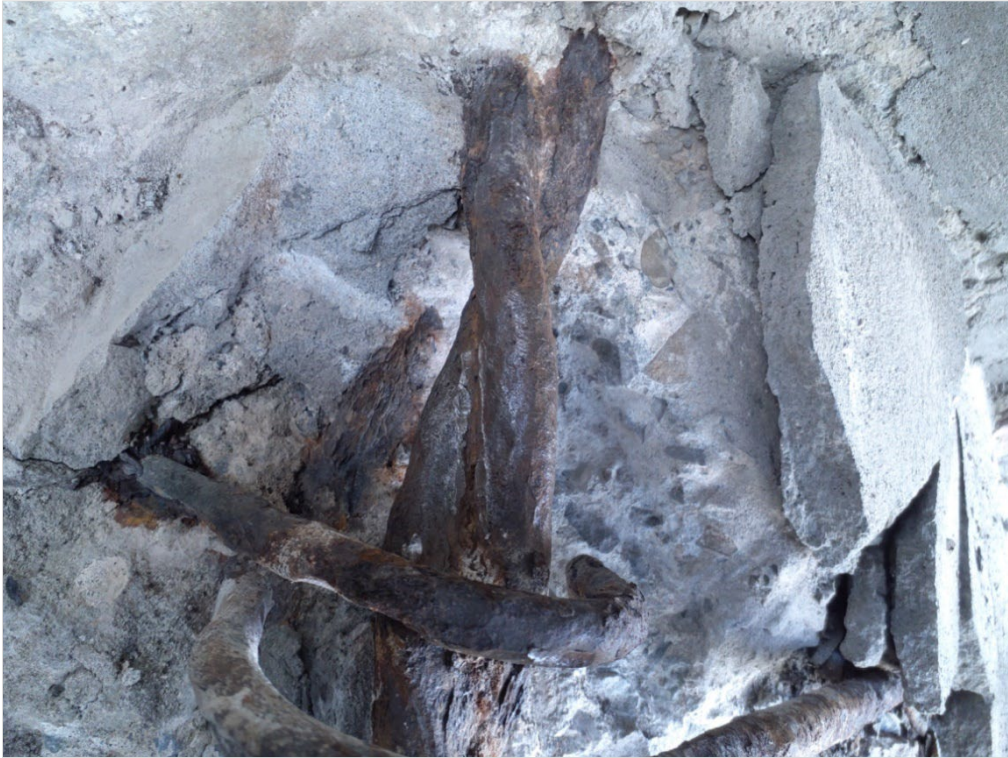
Figure 42: Location 3b - M2

The measured bar, with a nominal diameter of 20mm, was found to have a diameter of 16.7mm and 17.7mm, respectively.

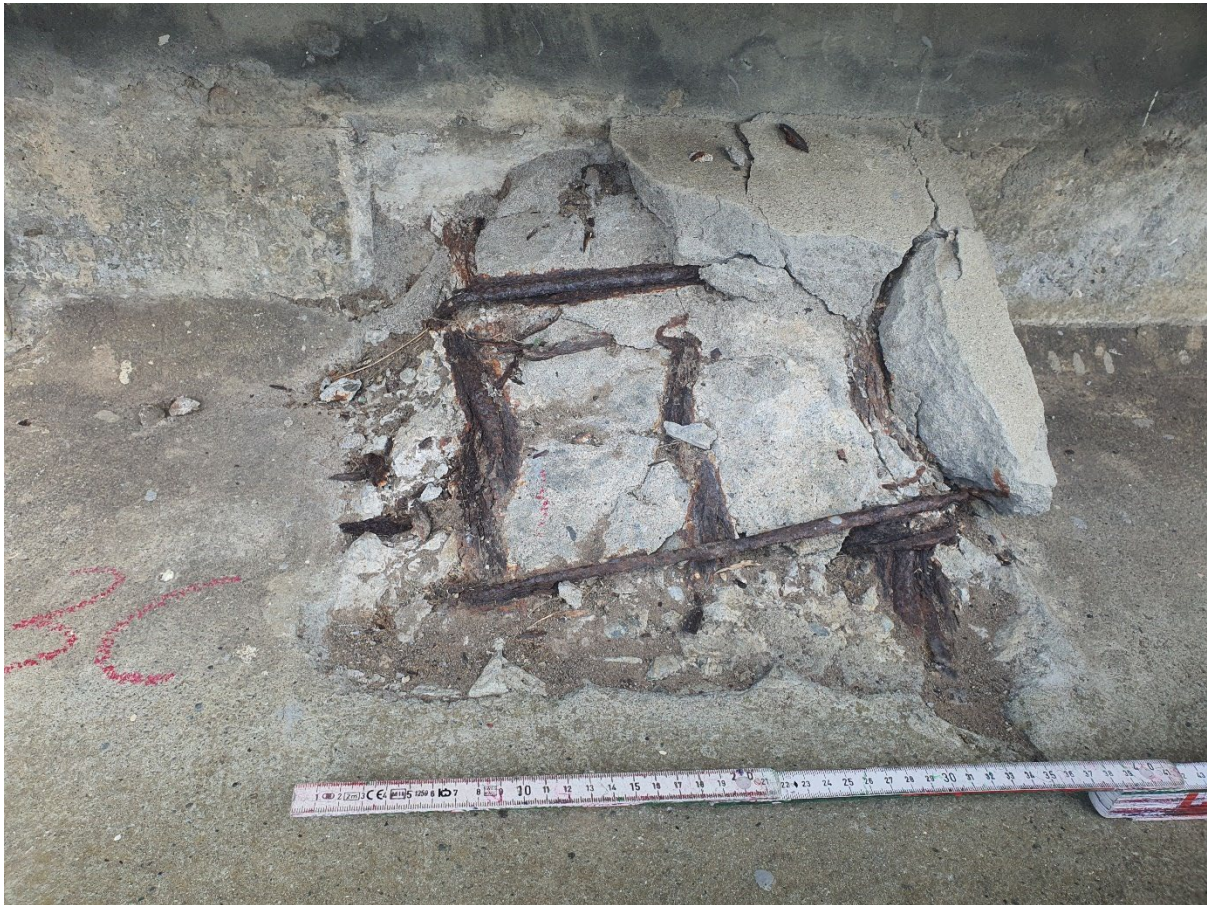
Figure 43: Location 3c - as is

Figure 43 displays location 3c in the condition before concrete was removed. It appears that some material that does not resemble the original concrete has been added at some stage. Most of the material was not present at the time of the investigations. The remaining material was easily lifted as it had segregated from the structure caused by spalling.

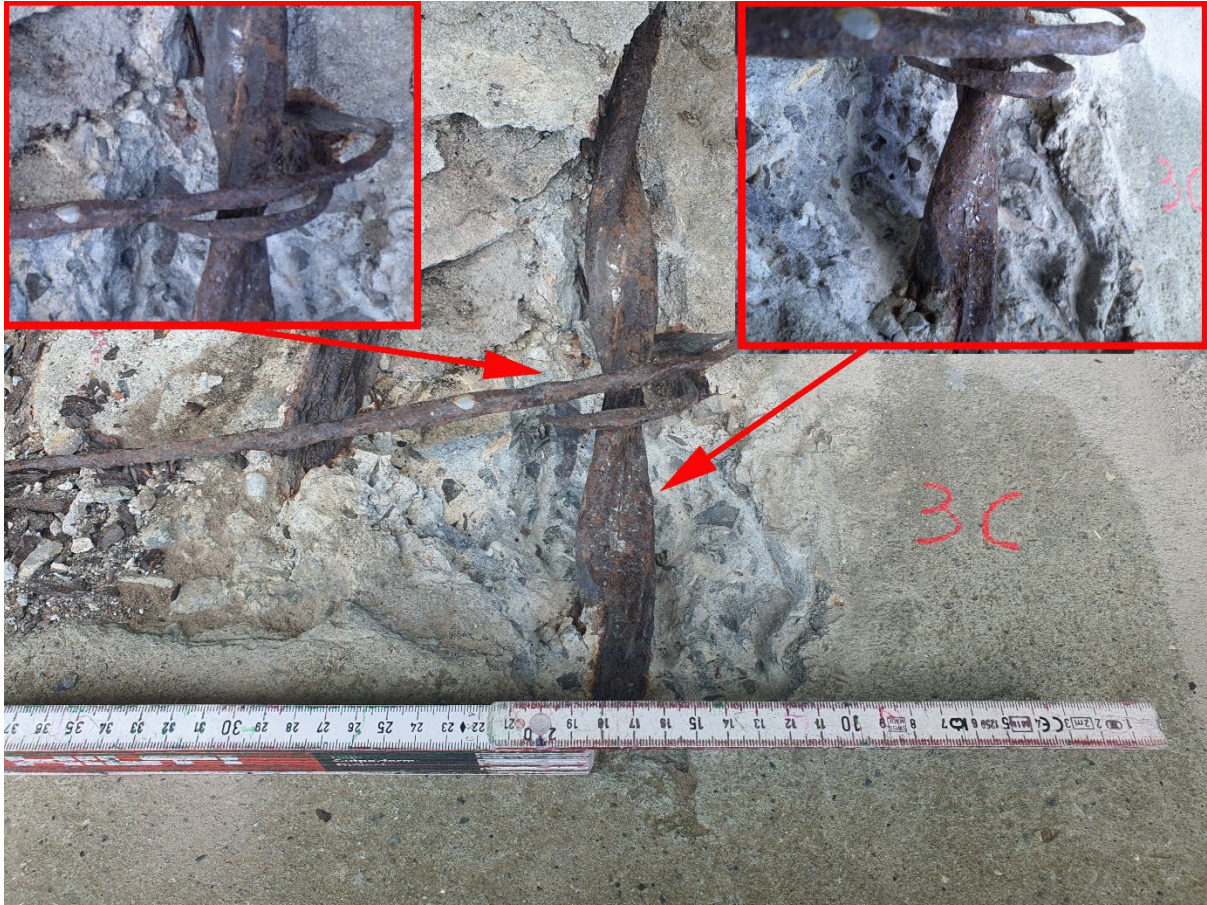
Figure 44: Item 3c – Breakout location

Figure 44 shows where remaining cross sections were measured.

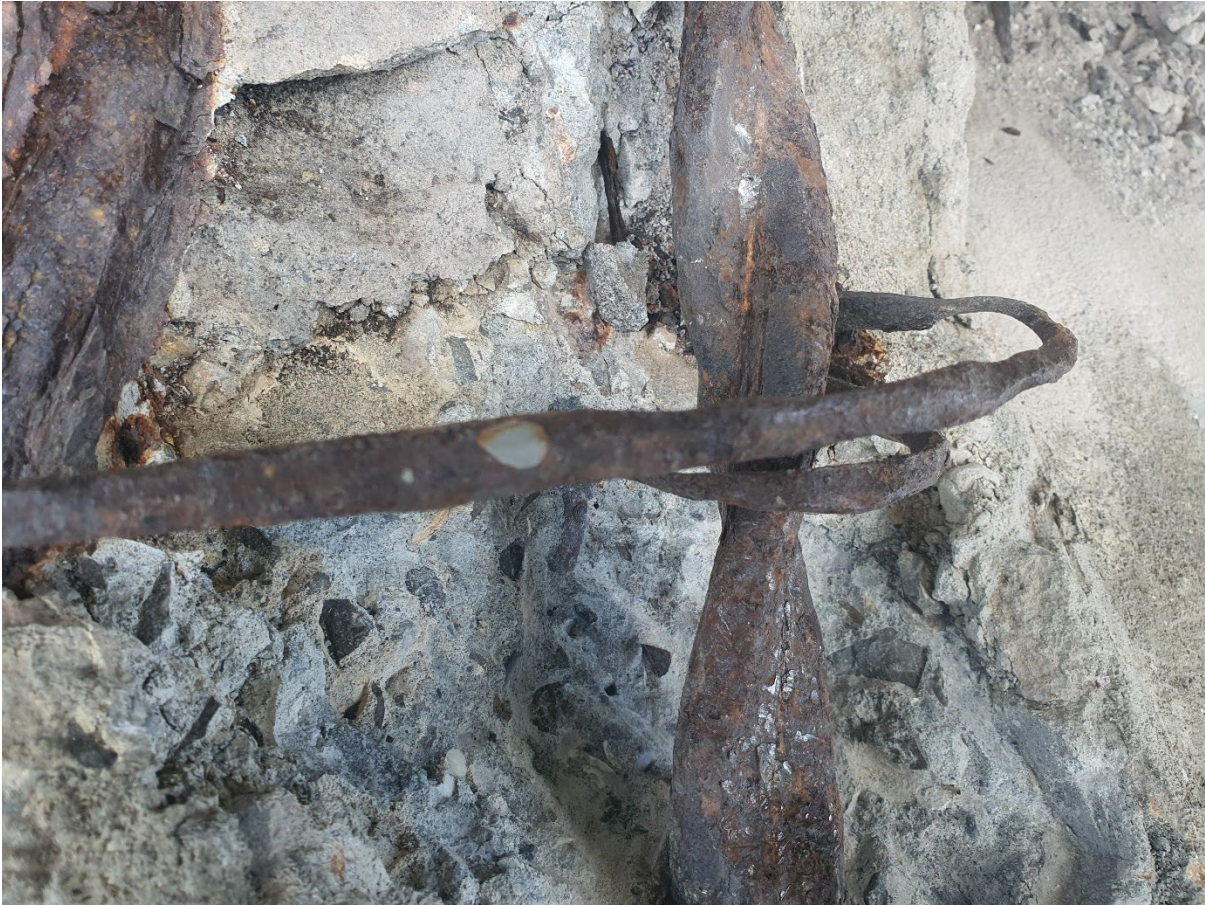
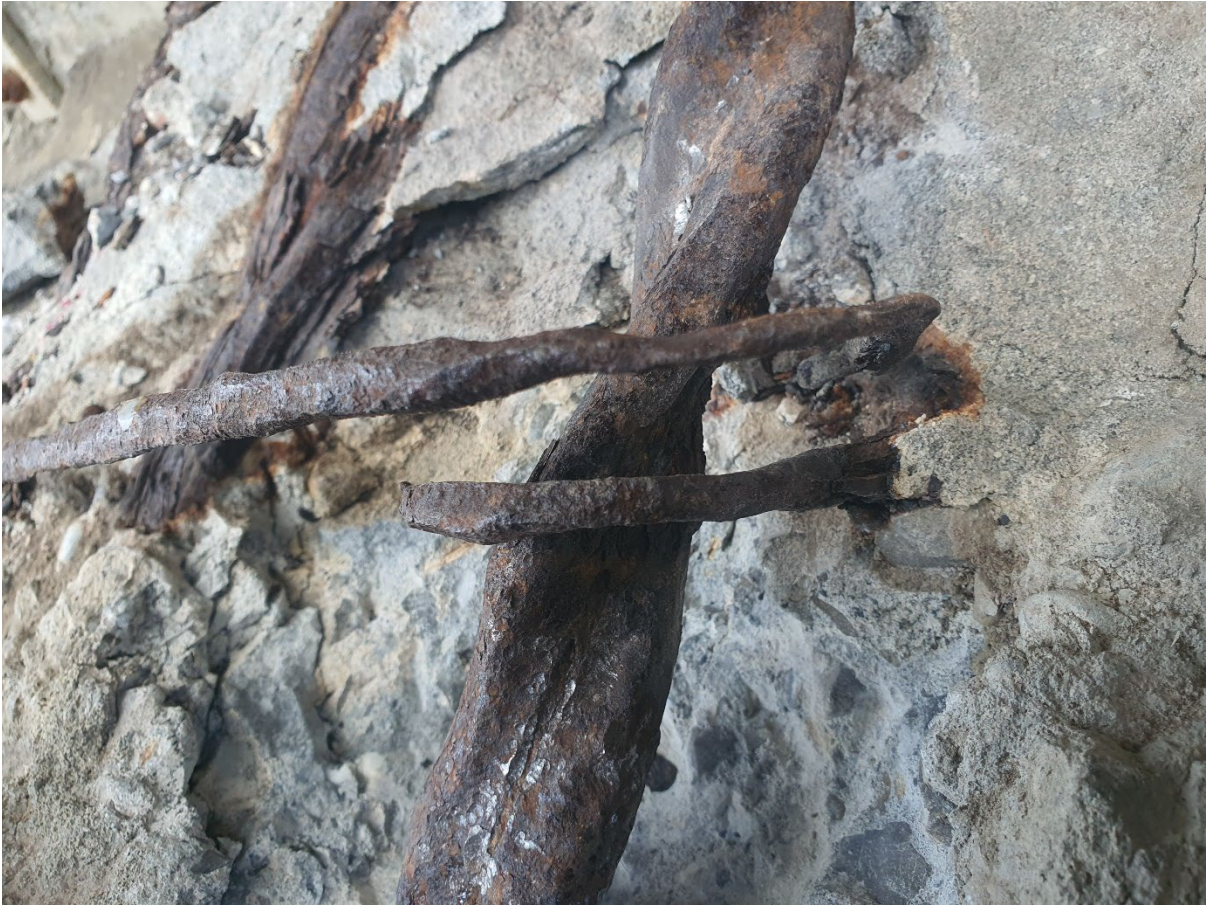
Figure 45 and Figure 46 display severe decay of the bars. The main bars, which have a nominal bar diameter of 20mm, were measured to have a remaining cross section of 12mm and 14mm, respectively. The stirrup, which has a nominal bar diameter of 12mm, was confirmed to have a remaining cross section of 3.1mm.

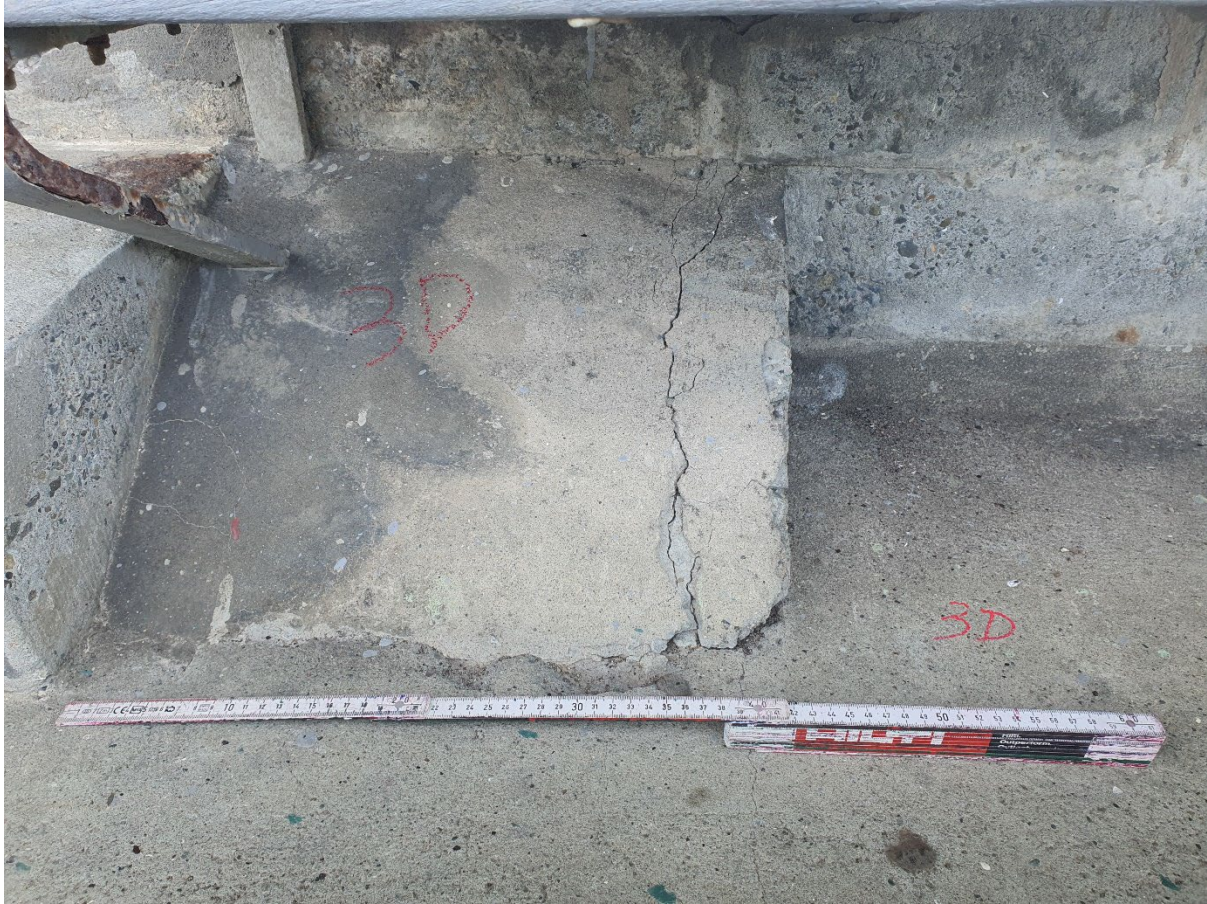
Figure 47: Location 3d - as is

Figure 47 displays the condition of location 3d before investigations took place. It appears that some of the material does not resemble original concrete. Spalling can be seen on the right side.

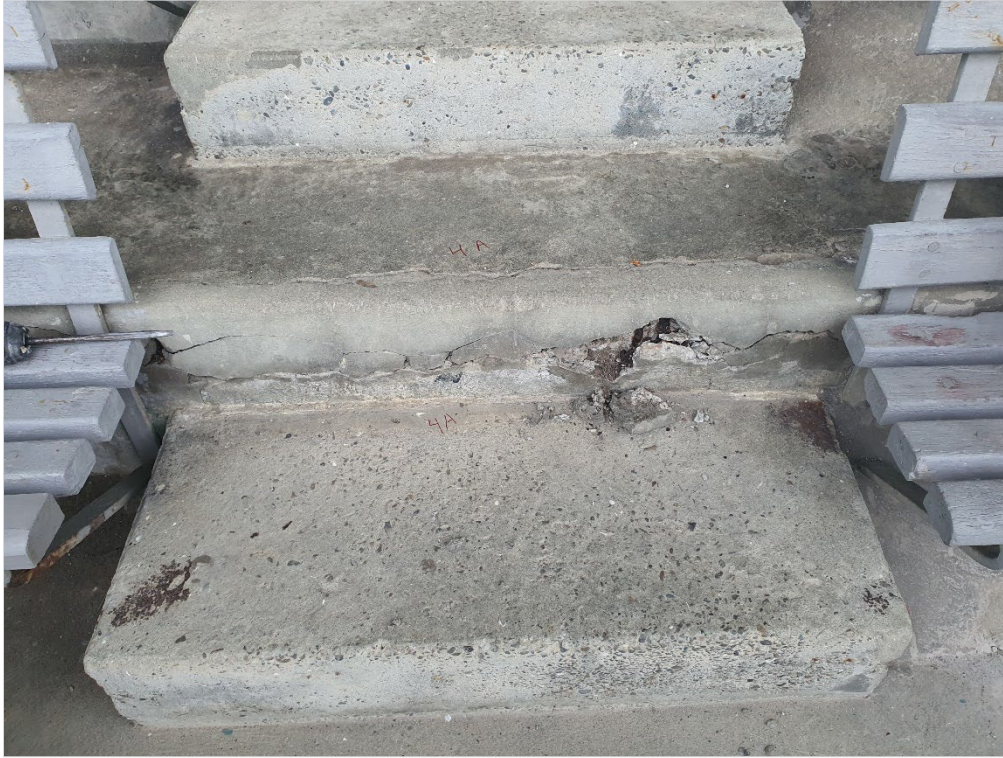
Figure 49: Location 4a - as is

Figure 49 displays the East facing edge of the beam on grid X. The location is near grid E. Material that does not resemble original concrete is apparent on the vertical face. Spalling of the patched material is noticeable.

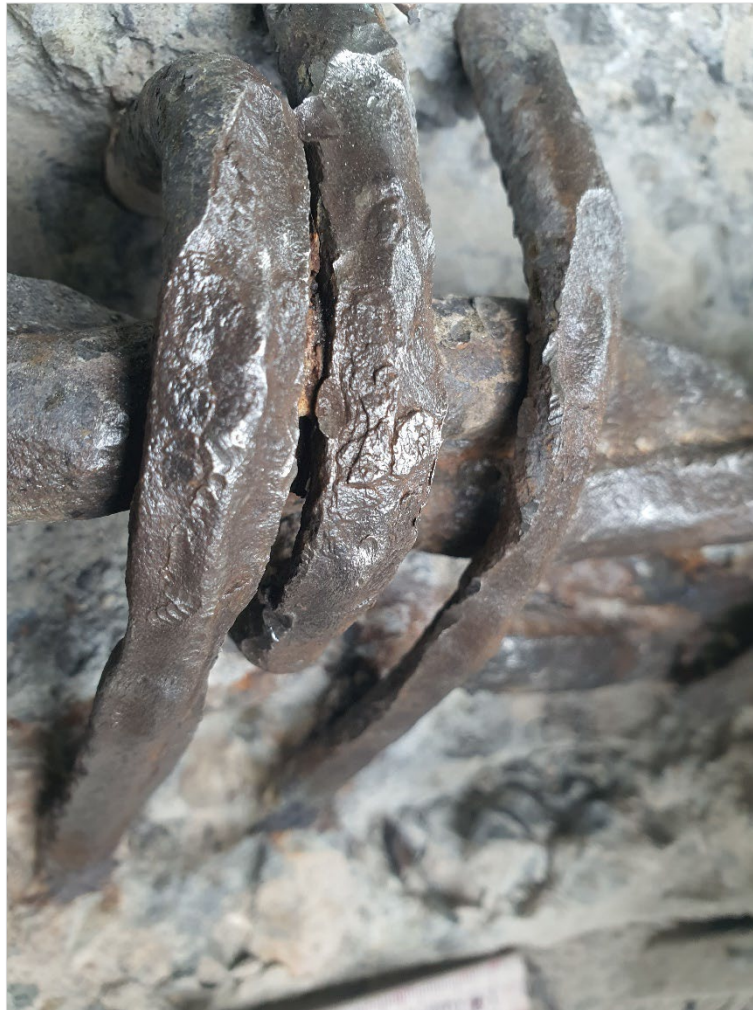
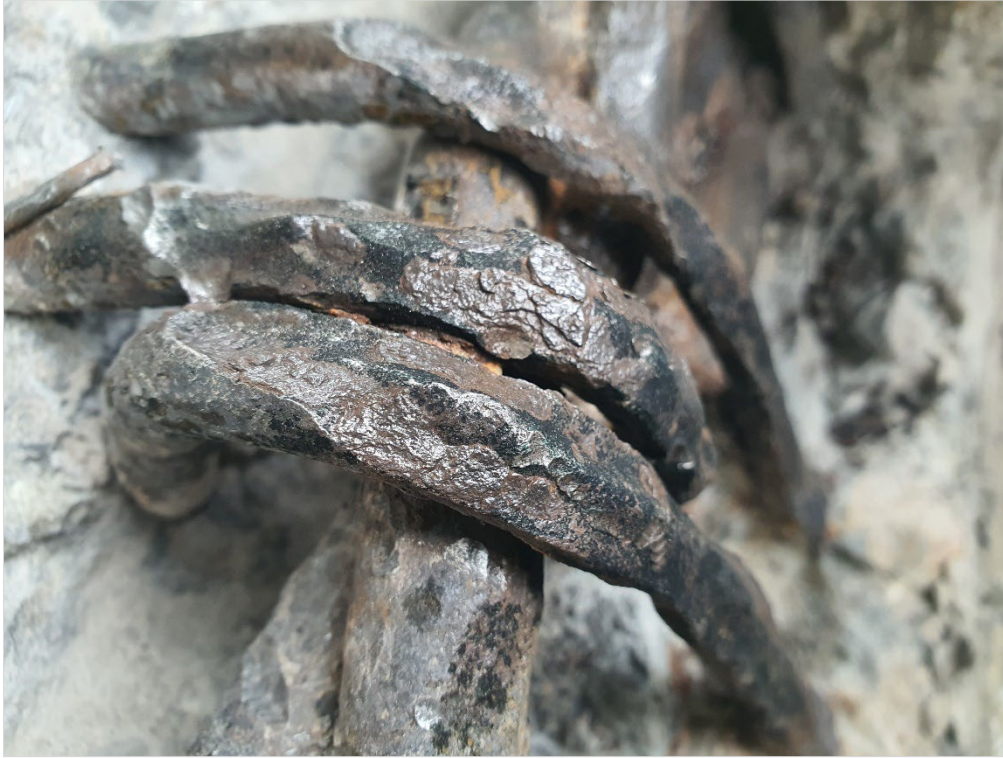
Figure 52 and Figure 53 show the decay of the steel caused by corrosion.

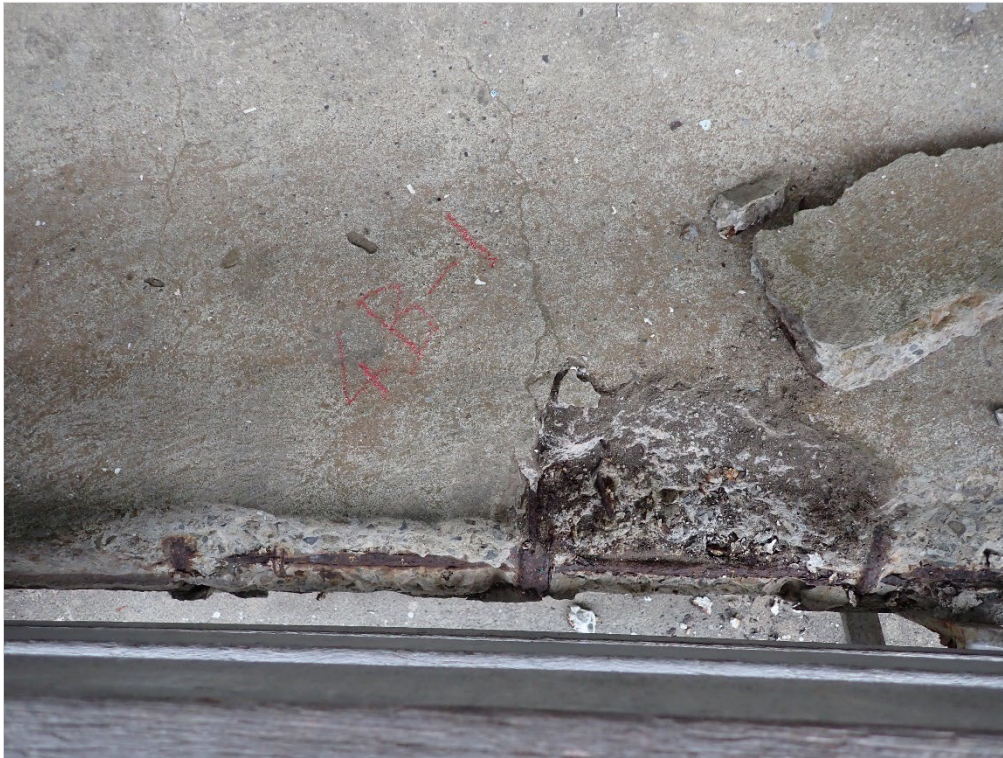
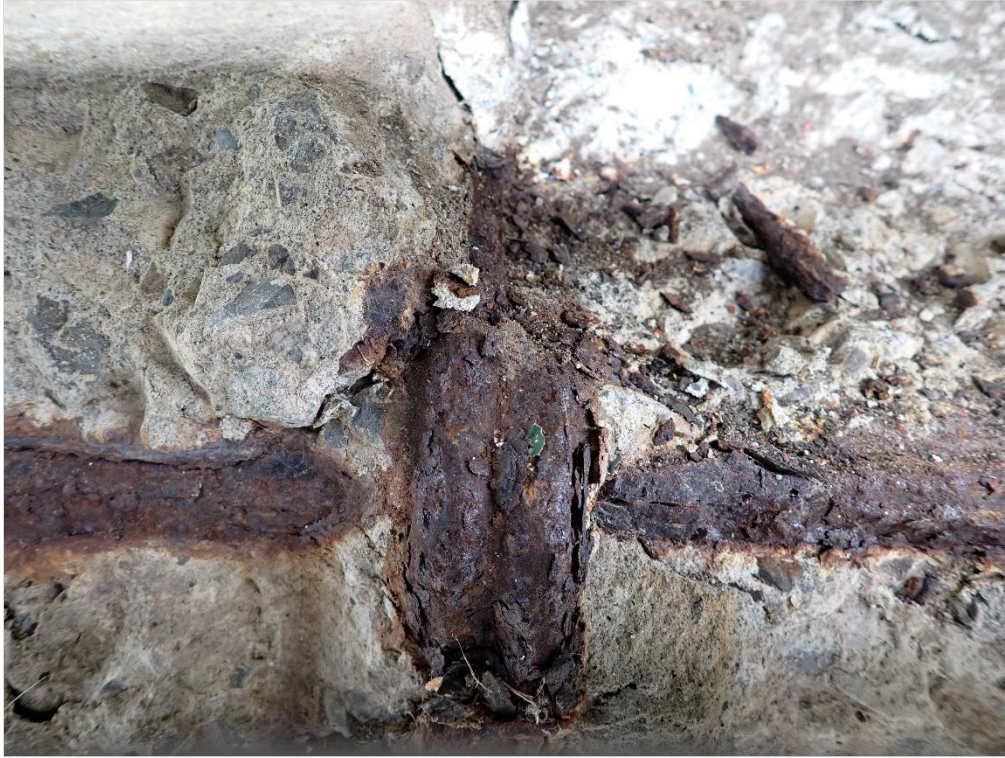
Figure 54, Figure 55, Figure 56, Figure 57, Figure 58, Figure 59, Figure 60 display the top corner and the vertical face of the beam at grid X. The location is 11.5m north of grid A. Bars can be seen exposed and heavily corroded, a portion of concrete was loose and able to be lifted off.

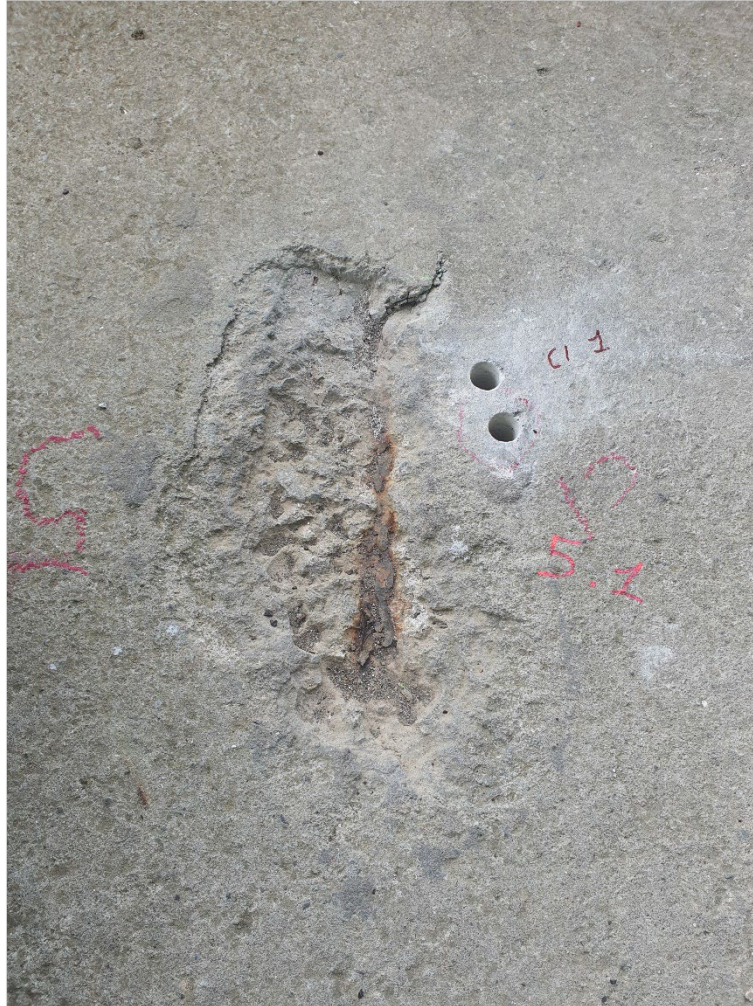
Figure 65: Location 5.1 - as-is

Figure 65 displays a spot on the slab where concrete has spalled, an exposed corroded bar is visible. The lowest cover was measured to be 27.5mm.

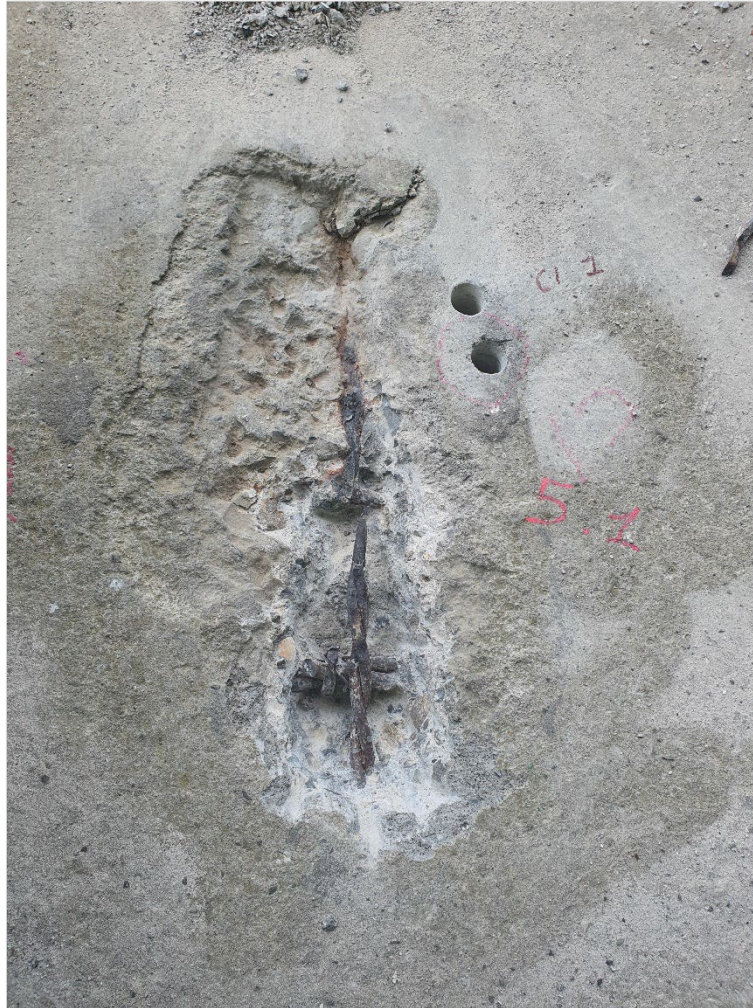
Figure 66: Location 5.1 – breakout

Figure 66 shows a double twisted bar (orientated in W-E direction) with a nominal diameter of 6.5mm which was found to be rusted completely through, refer to Figure 67 for a close-up look.

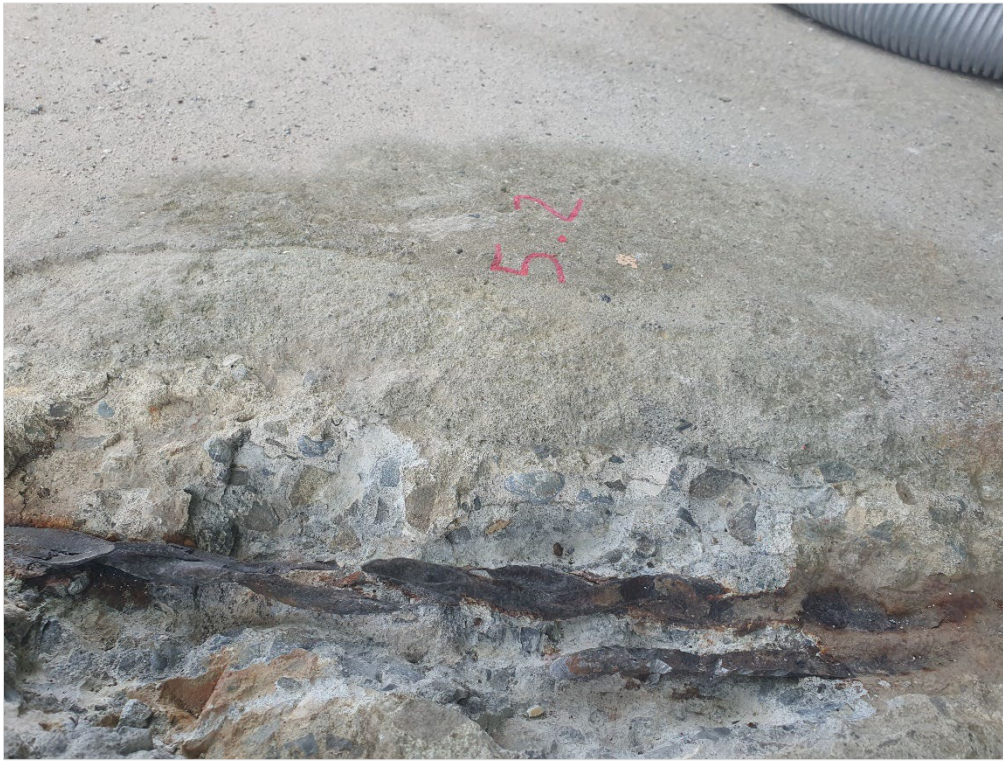
Figure 71: Location 5.2 – breakout

Figure 71 displays a spot on the slab where concrete has spalled, an exposed corroded bar is visible. The lowest cover was measured to be 20mm.

Figure 71 displays a double twisted bar (orientated in W-E direction) with a nominal diameter of 6.5mm which was found to be rusted through.
