# **Hutt City Council and Wellington Water Report – Joint review of the slip at Point Howard**

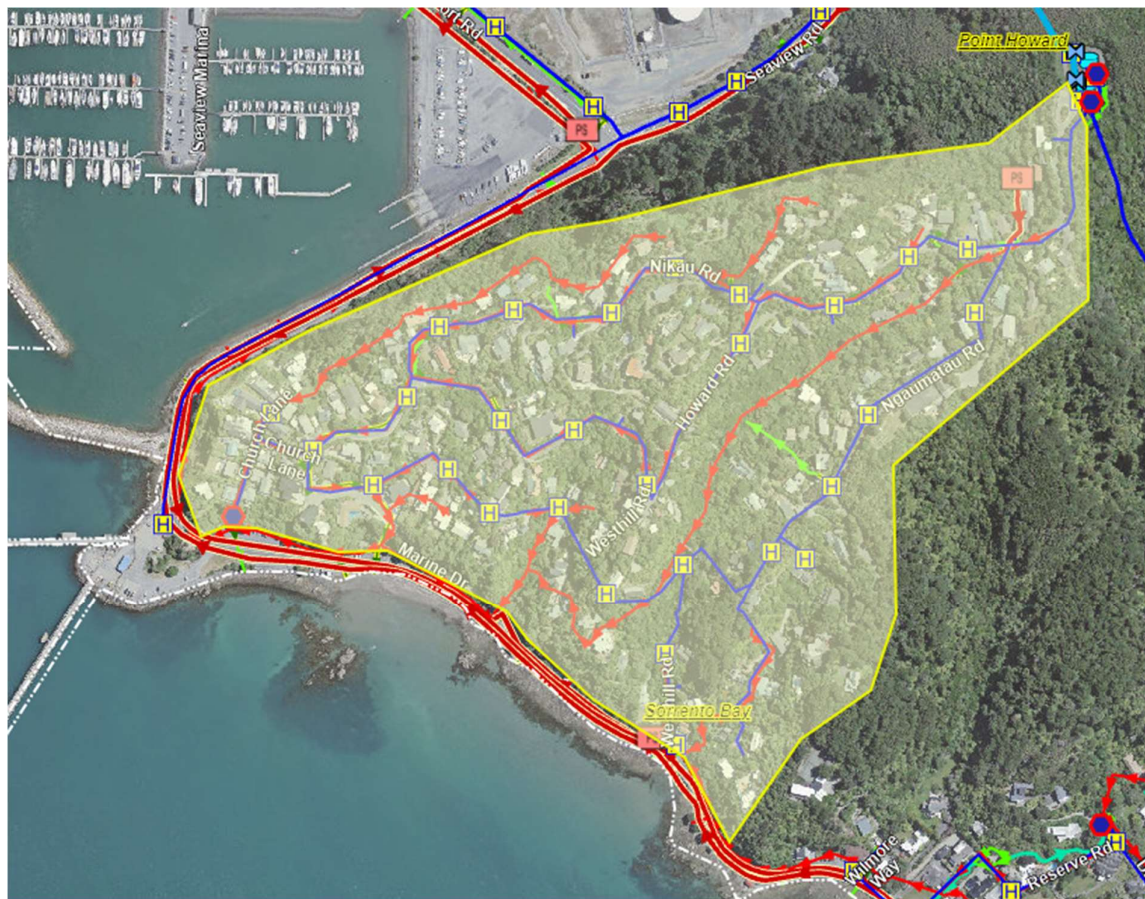
Figure 1 Point Howard, Hutt City Zone impacted.

The slip impacted approximately 165 households leading to residents being without water from approximately 10am on Tuesday the 14<sup>th</sup> March until 9am on Thursday 16<sup>th</sup> March (approx. 48 hours).

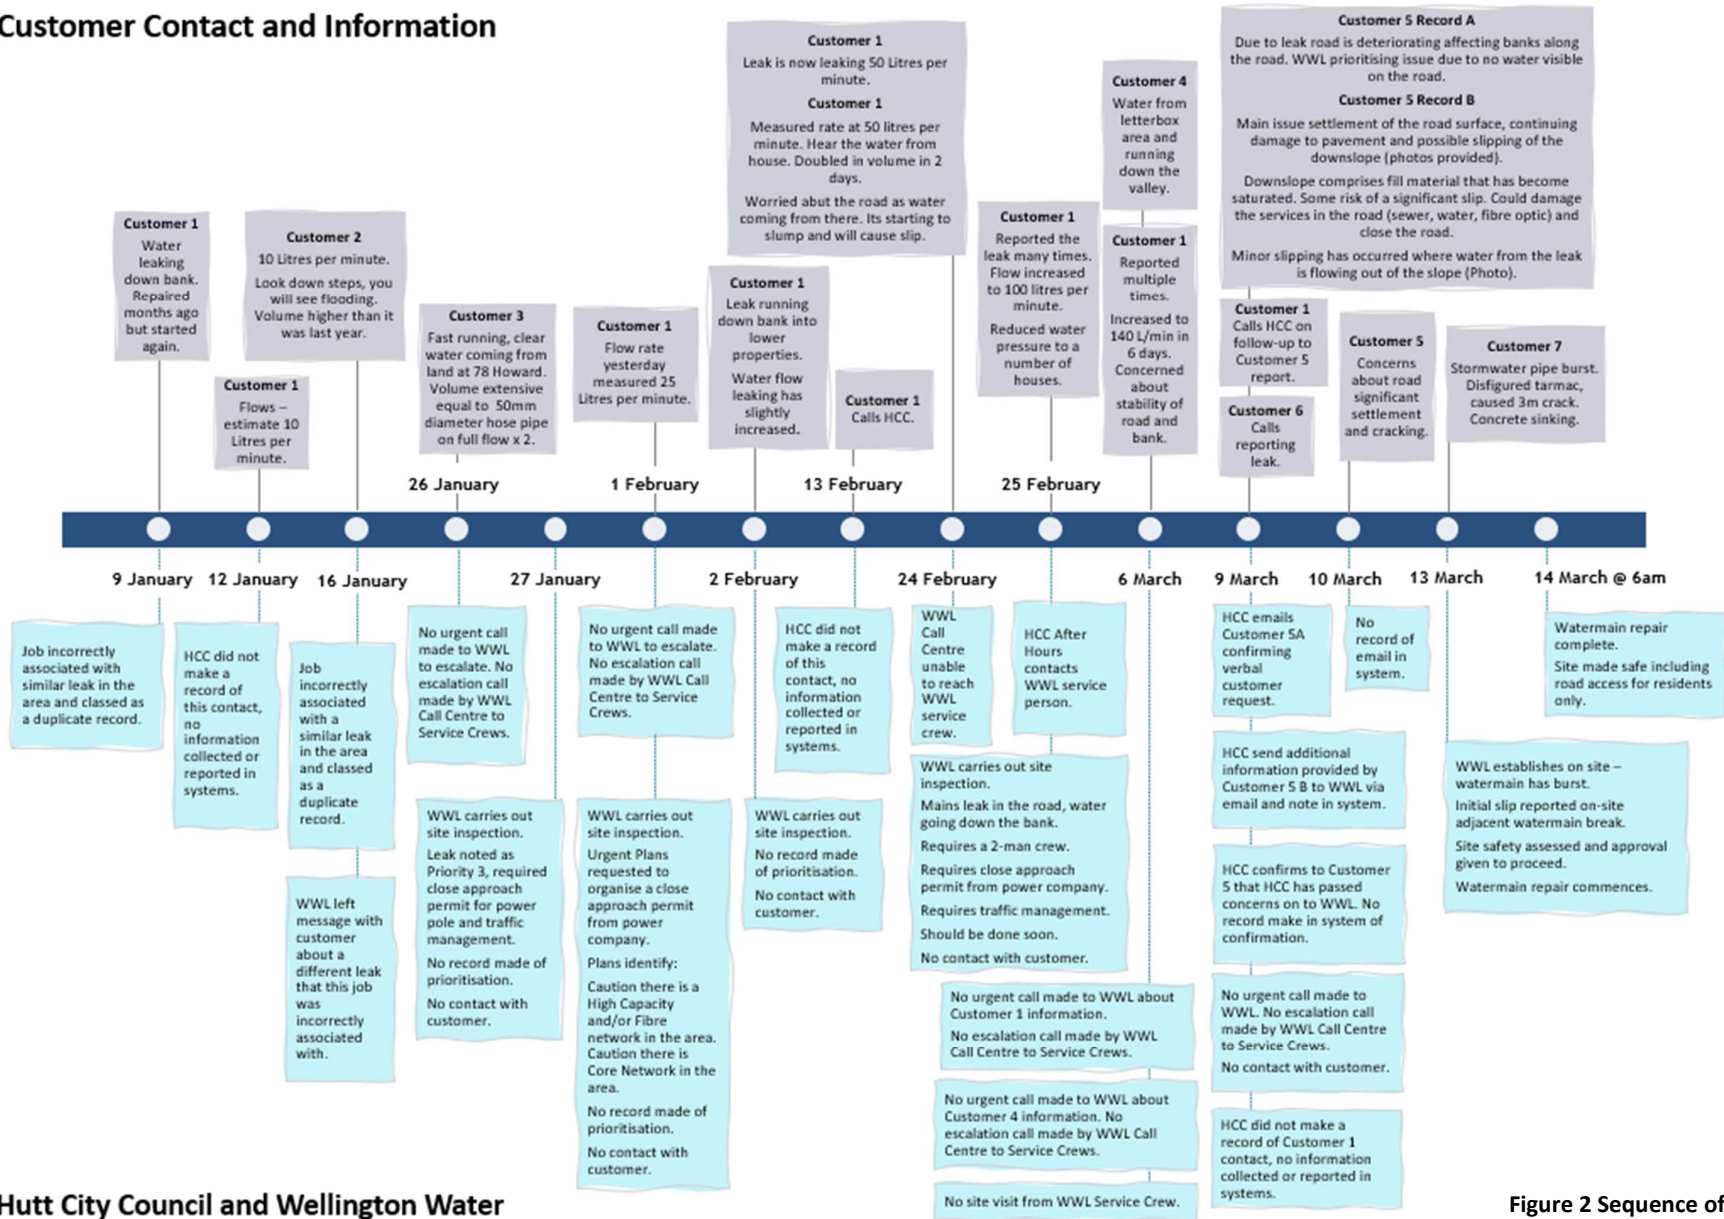
Figure 2 Sequence of Events

The diagram in Figure 2 Sequence of Events, shows there were problems with the flow of information provided by the customer which has had an impact on the prioritisation of leak and the timing of escalating its repair. There were multiple opportunities for these problems to be corrected, including by; collecting the correct information from the customers, recording it, escalating it, relaying it to service crews, reviewing the request information, contacting the customer for verification, and recording re-assessment of the leak repair priority.

**Recommendation 1**

That HCC reviews customer experience processes and training, including customer prompt resources for capturing key information to ensure:

- a. all interactions with customers are recorded and service requests created,
- b. all water service requests have sufficient information to allow WWL to create accurate records and be able to match duplicate requests to an existing record.

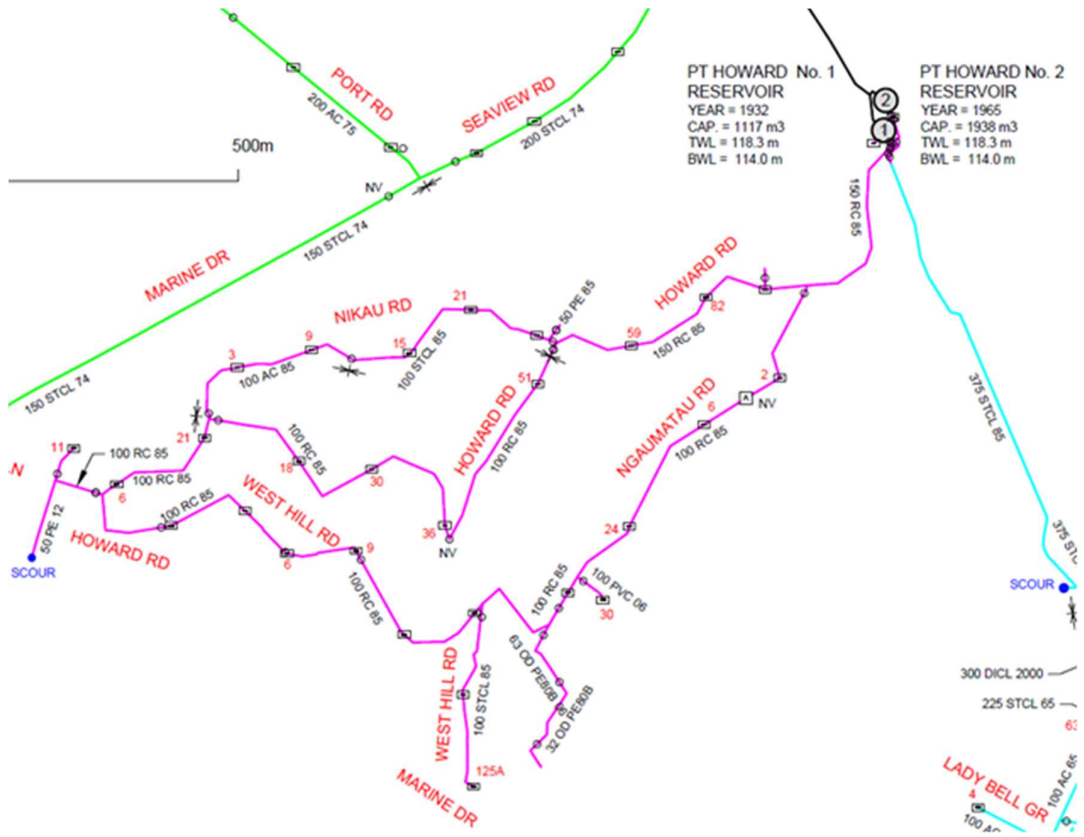
Figure 3 Diagram of watermains in the Point Howard area

The water main that has been leaking at the top of Point Howard is a 150mm Reinforced Concrete (RCON) main. There is 400m of 150mm RCON main in this section.

There are no records of what was installed for these mains. They were installed by the Eastbourne Borough Council, which had very poor records. GIS show these as having a 1985 install date. This would be wrong. They would be the original mains that were installed when the reservoir was built, which was pre-1941 and perhaps as early as the mid 1930's. So, the pipe is at least 80 years old.

- 150mm RCON - 5 failures up to the current leaks.
- 100mm RCON - 21 failures

Most of the leaks have been a failure of the rubber joint, not the pipe itself.

The RCON water mains in Howard Road and Nikau Rd, have been identified for renewal as part of the HCC water main renewals. The renewal is being progressed with delivery of this work for 2027 to 2028.

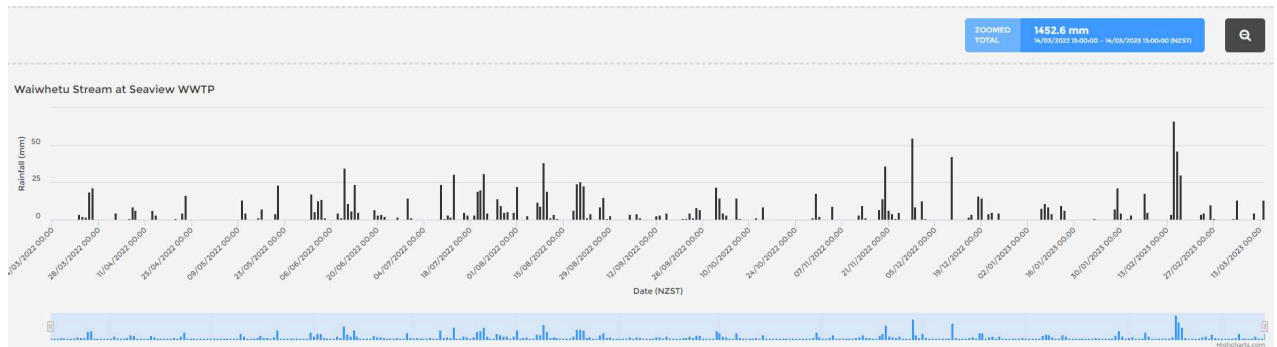
Figure 4 Rainfall graph Waiwhetū Stream at Seaview WWTP 14 March 2022 to 2023

Greater Wellington Regional Council Environmental Monitoring and Research provides rainfall data for the region. Information for the closest rainfall station at Waiwhetū Stream at Seaview WWTP is provided below in Figure 4.

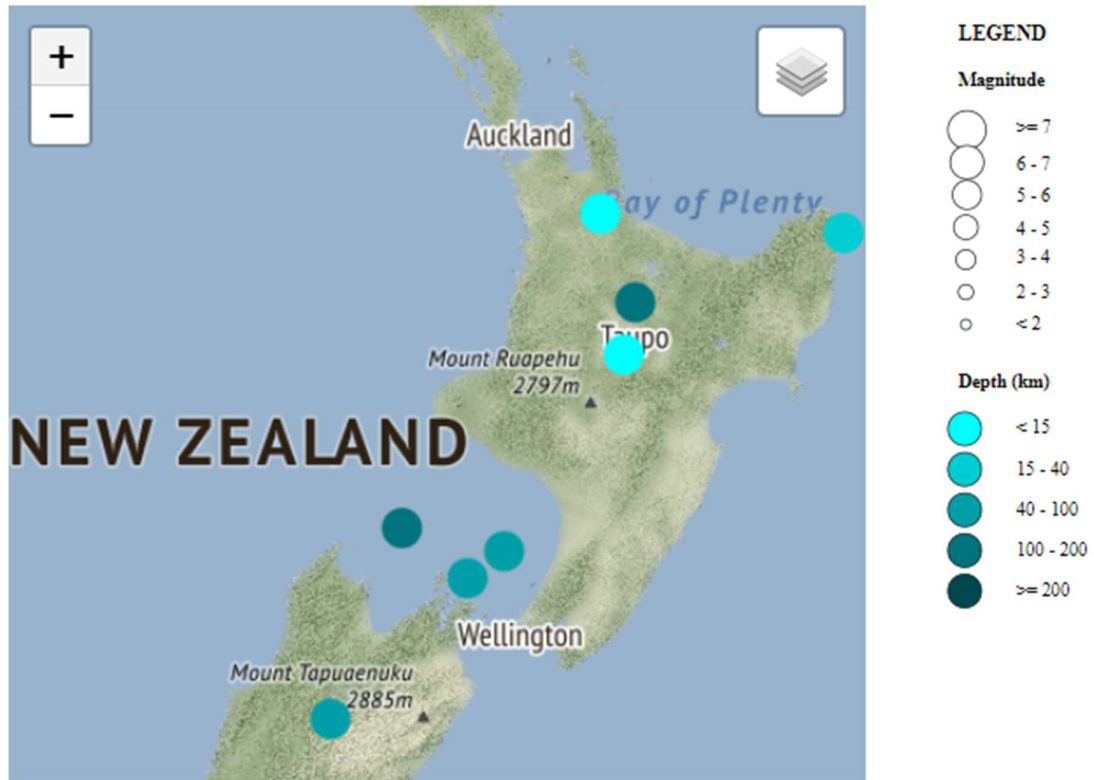
Figure 5 Earthquake above magnitude 5 for the 12 months ending 14 March 2023

The GeoNet Quake Search application provides information on earthquakes. Figure 5 provides the earthquakes above magnitude 5 in the last 12 months.

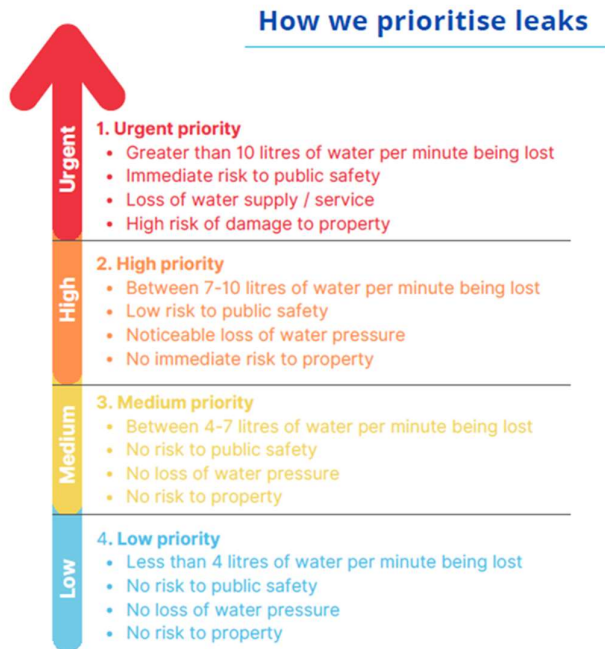
**Figure 8 WWL leak prioritisation framework**

The evidence of the nature of the leak and how it developed is within the information provided by the customers which indicated a leak that grew in size from 9 January 2023 until the slip occurred on 16 March 2023; with one exception on the 25<sup>th</sup> February 2023 where after a site visit WWL noted 'should be done soon'. During this period the leak received a range of prioritisations depending on the information provided by the customer and how the leak was assigned within Maximo. It was initially classed within Maximo as a P1 on 16<sup>th</sup> January 2023 but wrongly associated with a different leak, it was graded a P2 on 26<sup>th</sup> January 2023 when a unique work order for the leak was first created, and then assigned P3 status on the 13<sup>th</sup> March 2023 when the leak was repaired. Anecdotal evidence is that it was being treated as a P3 on completion of the site visit on 27<sup>th</sup> January 2023.

Customer information continued to be received which provided data indicating a higher prioritisation was appropriate but there was no reclassification of the leak as a P1 in Maximo. On 1<sup>st</sup> February 2023 a customer estimated the leak at 25 Lt/min which would meet the threshold for a P1; the same customer consistently advised of increasing rate of leakage and by the end of February was estimating 100 Lt/min.
