# INDEPENDENT STRUCTURAL INVESTIGATIONS REPORT

INVESTIGATIVE REPORT

| JOB NAME | Petone Grandstand |

| Corrosion survey on the Grandstand Petone. |

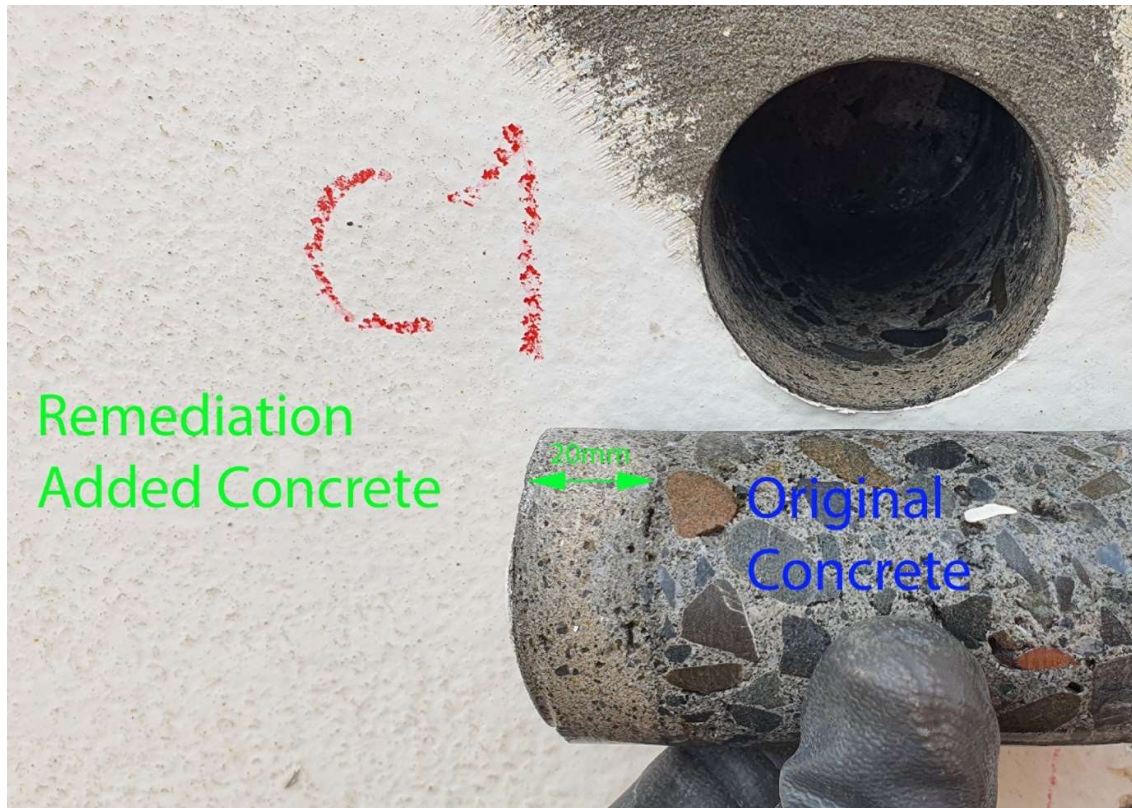
Figure 2: Wall - Added Layer

It was found that the walls on the outside have an added layer of cement (or concrete with small aggregate), see the photo below. The history of the remedial work is not known.

CSI assumes that widespread corrosion occurred on the reinforcement, and that low concrete cover was a contributor. Subsequently, the additional layer was applied to increase the cover depth to the steel. Sufficient cover can slow down or halt active corrosion. It is suspected that this approach has been partially successful, although the success was hampered by bad workmanship.

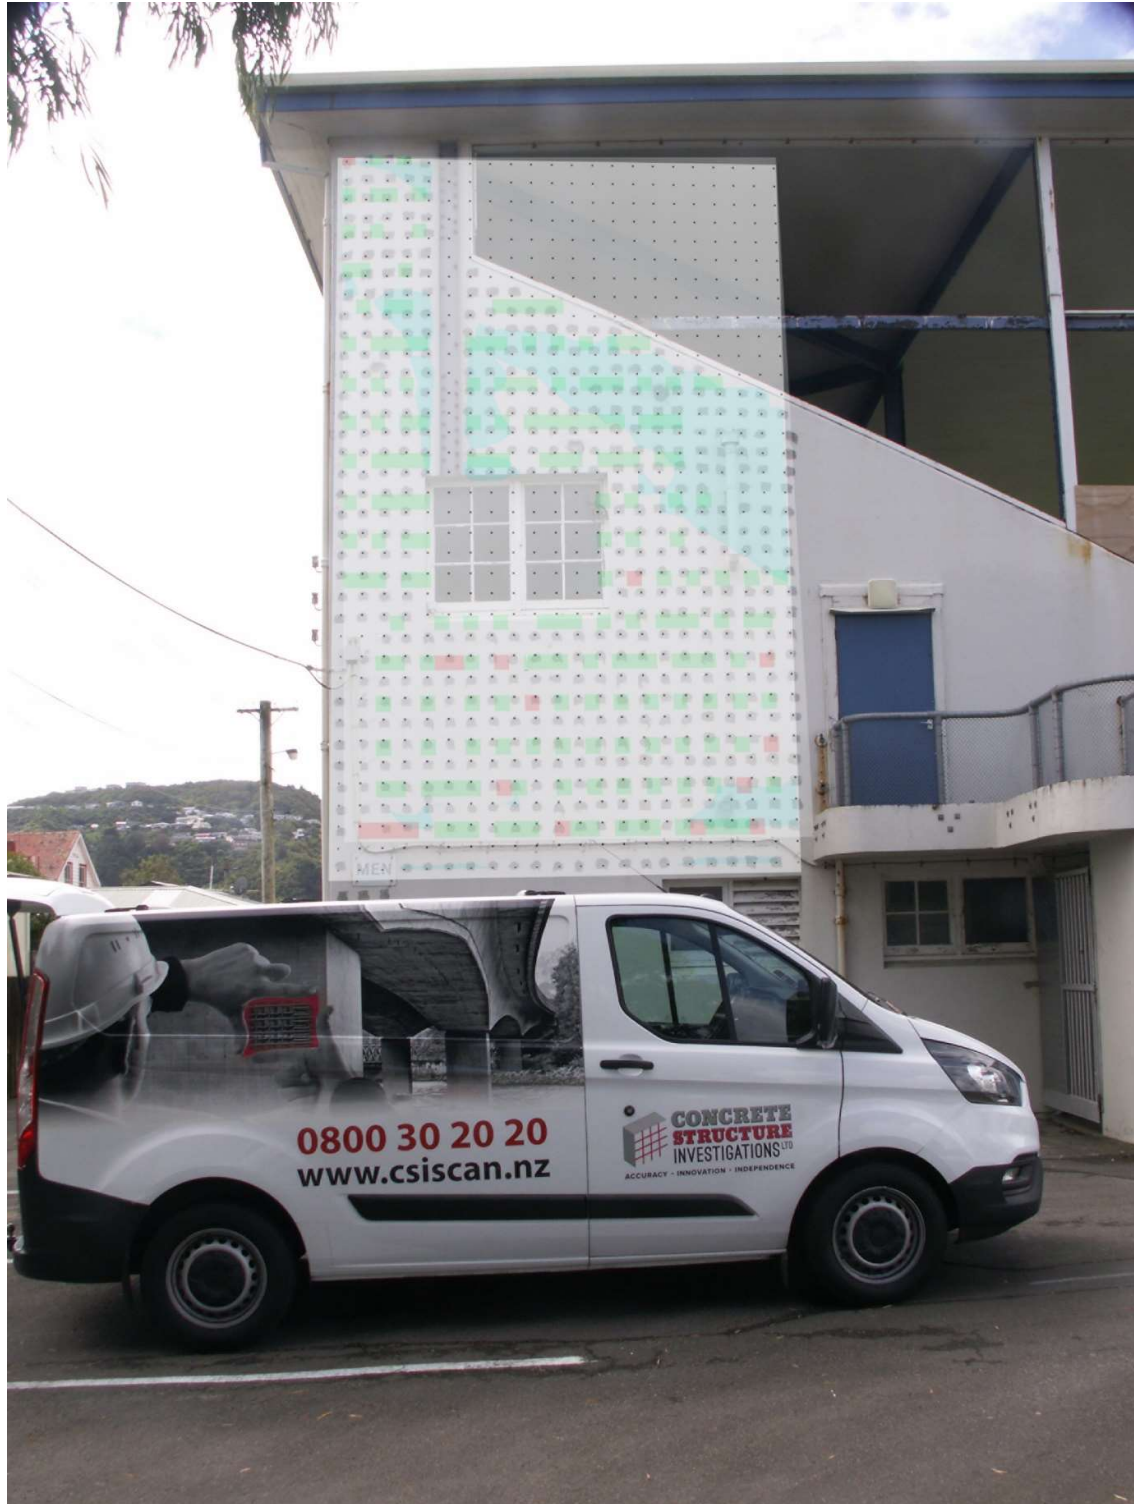
Figure 3: South Wall - Half-Cell - Cover Map

| Comment: | <p>South Wall</p> <p>Half-Cell Potential:</p> <ul style="list-style-type: none"><li>• Blue shaded areas have a 50% probability of active corrosion</li></ul> <p>Cover Map:</p> <ul style="list-style-type: none"><li>• The reinforcing cover is <math>\geq 30\text{mm}</math></li><li>• Most red data points are isolated detections, and likely relate to tie wires<ul style="list-style-type: none"><li>○ Ties with insufficient cover can initiate corrosion</li><li>○ The corrosion from ties migrates deeper into the structure till it reaches the reinforcing, causing the bars to corrode</li></ul></li></ul> | | |

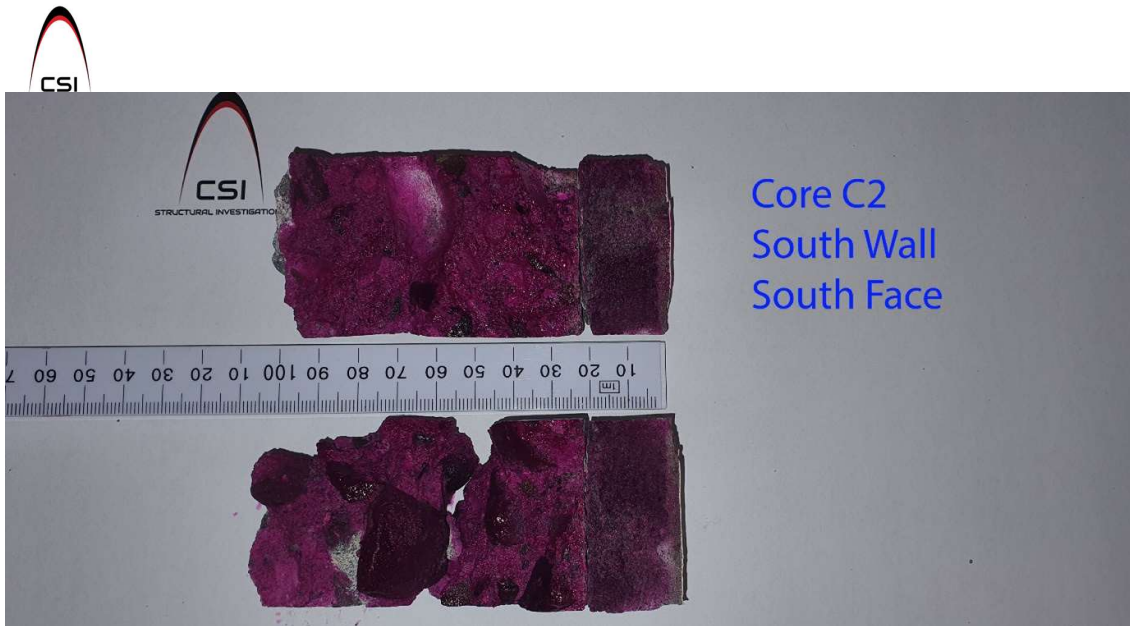
Figure 5: South Wall / South Face - Carbonation Testing

| Comment: | <p>South Wall</p> <p>Carbonation:</p> <ul style="list-style-type: none"> <li>• South Face: <ul style="list-style-type: none"> <li>◦ Core C2: No carbonation is induced</li> </ul> </li> <li>• North Face: <ul style="list-style-type: none"> <li>◦ Carbonation is apparent up to a depth of around 70mm</li> <li>◦ The concrete does not provide any passive protection against corrosion</li> </ul> </li> </ul> <p>Additional findings;</p> <ul style="list-style-type: none"> <li>• Shells are embedded in the concrete. It is possible that sand was sourced from estuaries containing potentially salts.</li> </ul> | | |

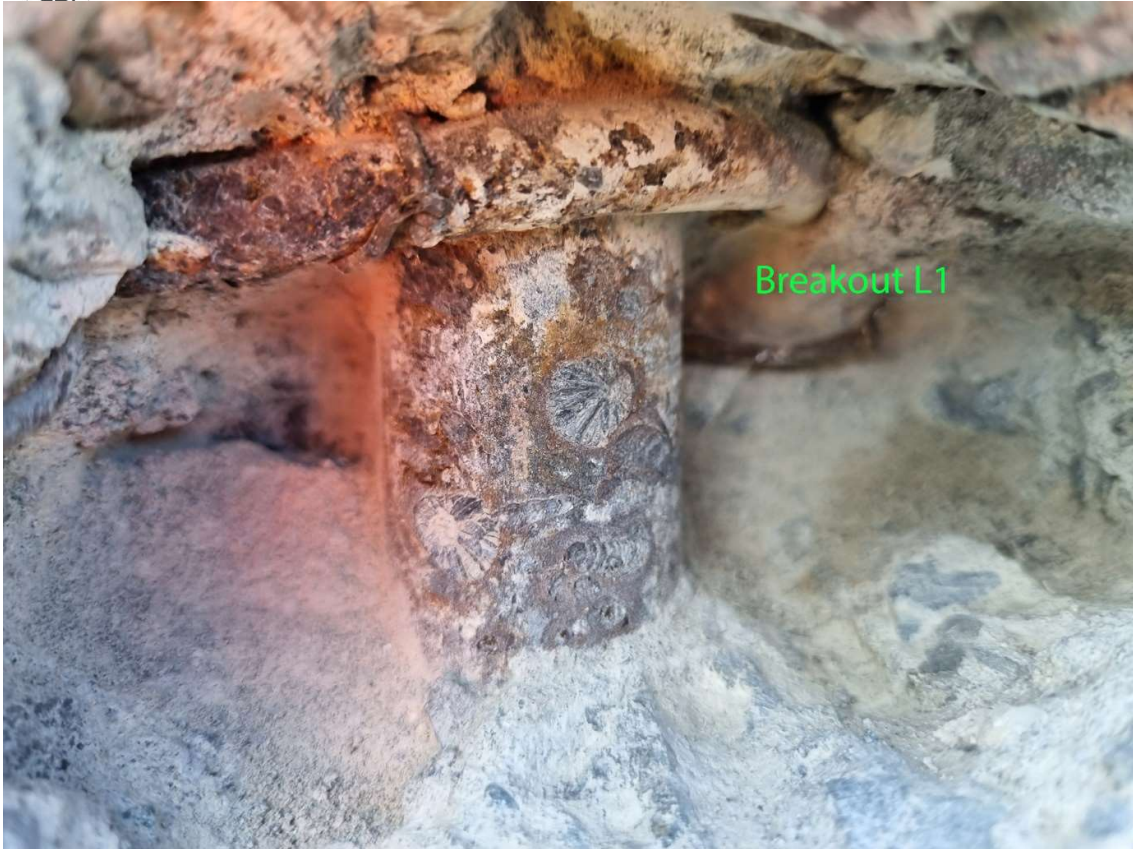
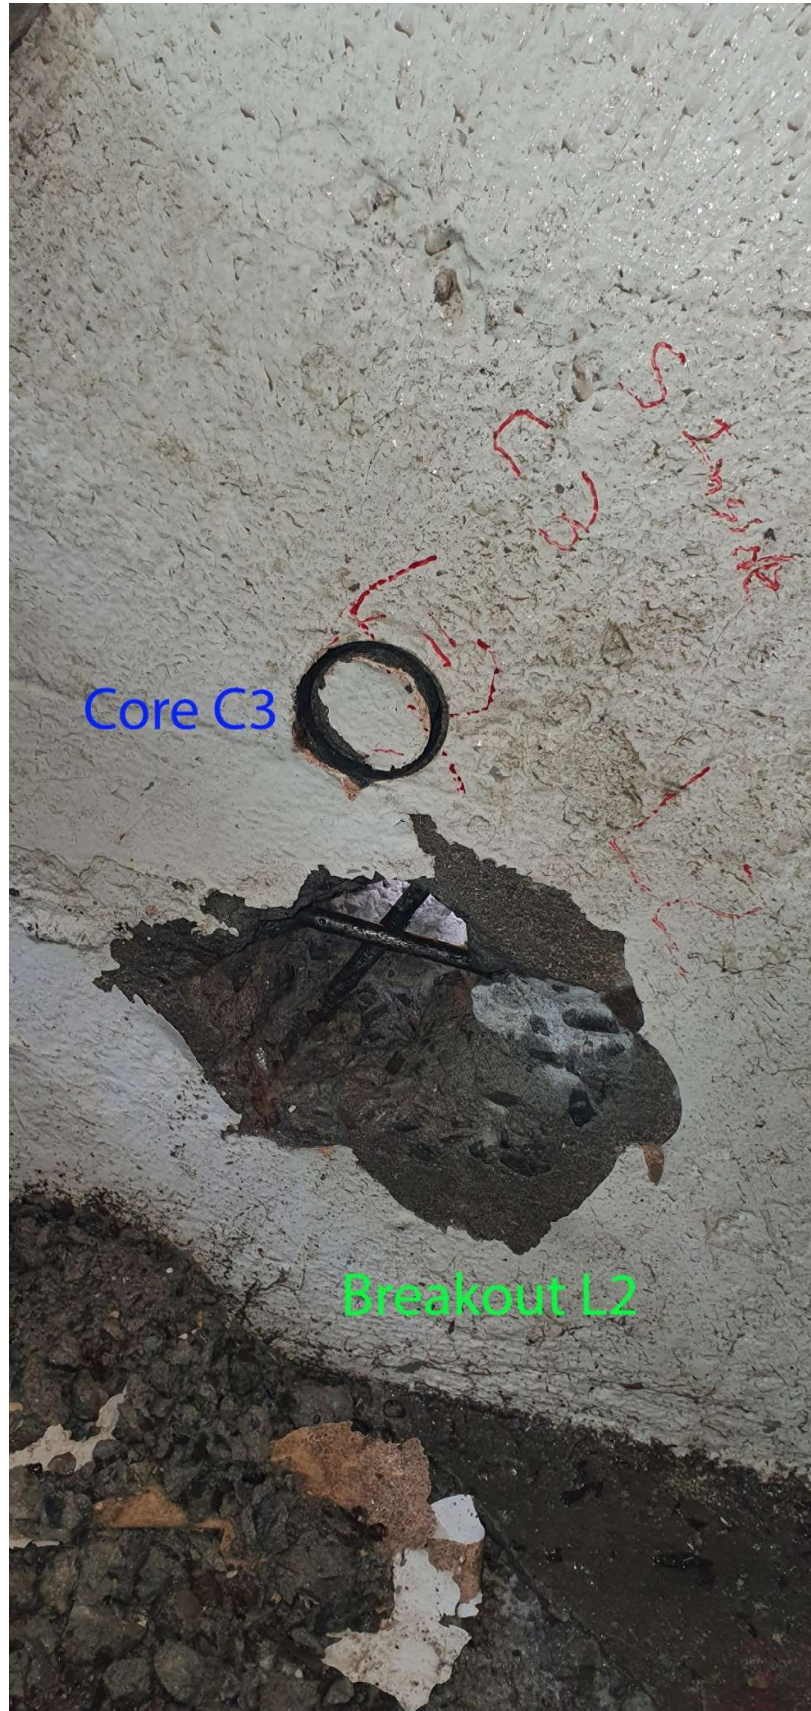
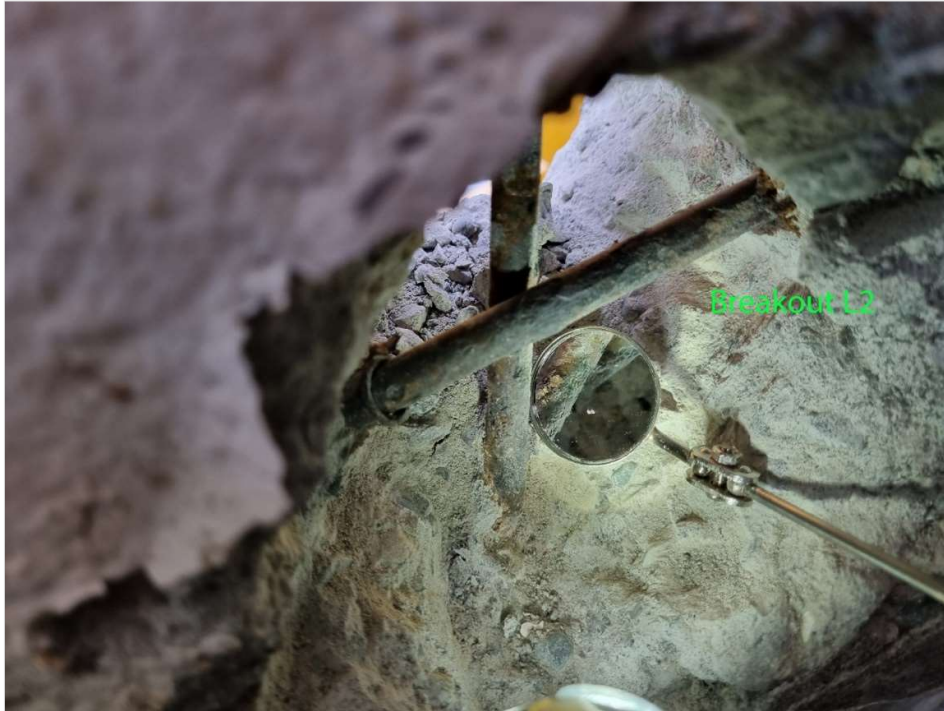
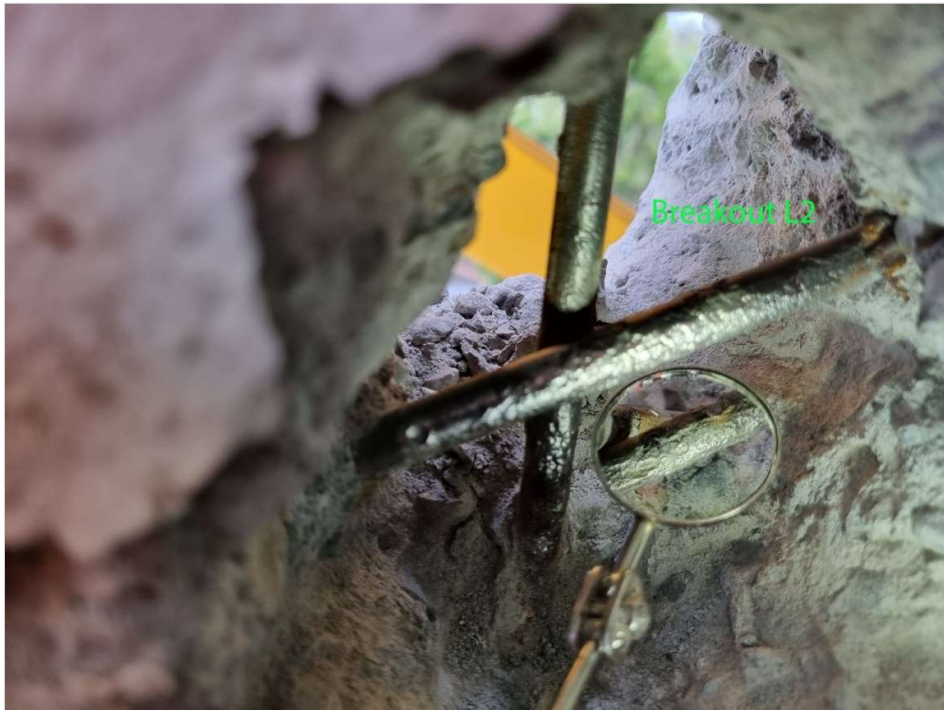
| Comment: | <p>South Wall</p> <p>Breakout:</p> <p>Breakout L1 – Column</p> <ul style="list-style-type: none"><li>• Corrosion doesn't seem to be active</li><li>• The main bar diameter is 32mm</li></ul> <p>Breakout L2:</p> <ul style="list-style-type: none"><li>• Active corrosion can be seen on the bars</li><li>• Pitting is visible on the polished bars</li><li>• The horizontal bar has a diameter of 9mm (the nominal diameter is assumed to be 9.5mm)</li></ul> | | |

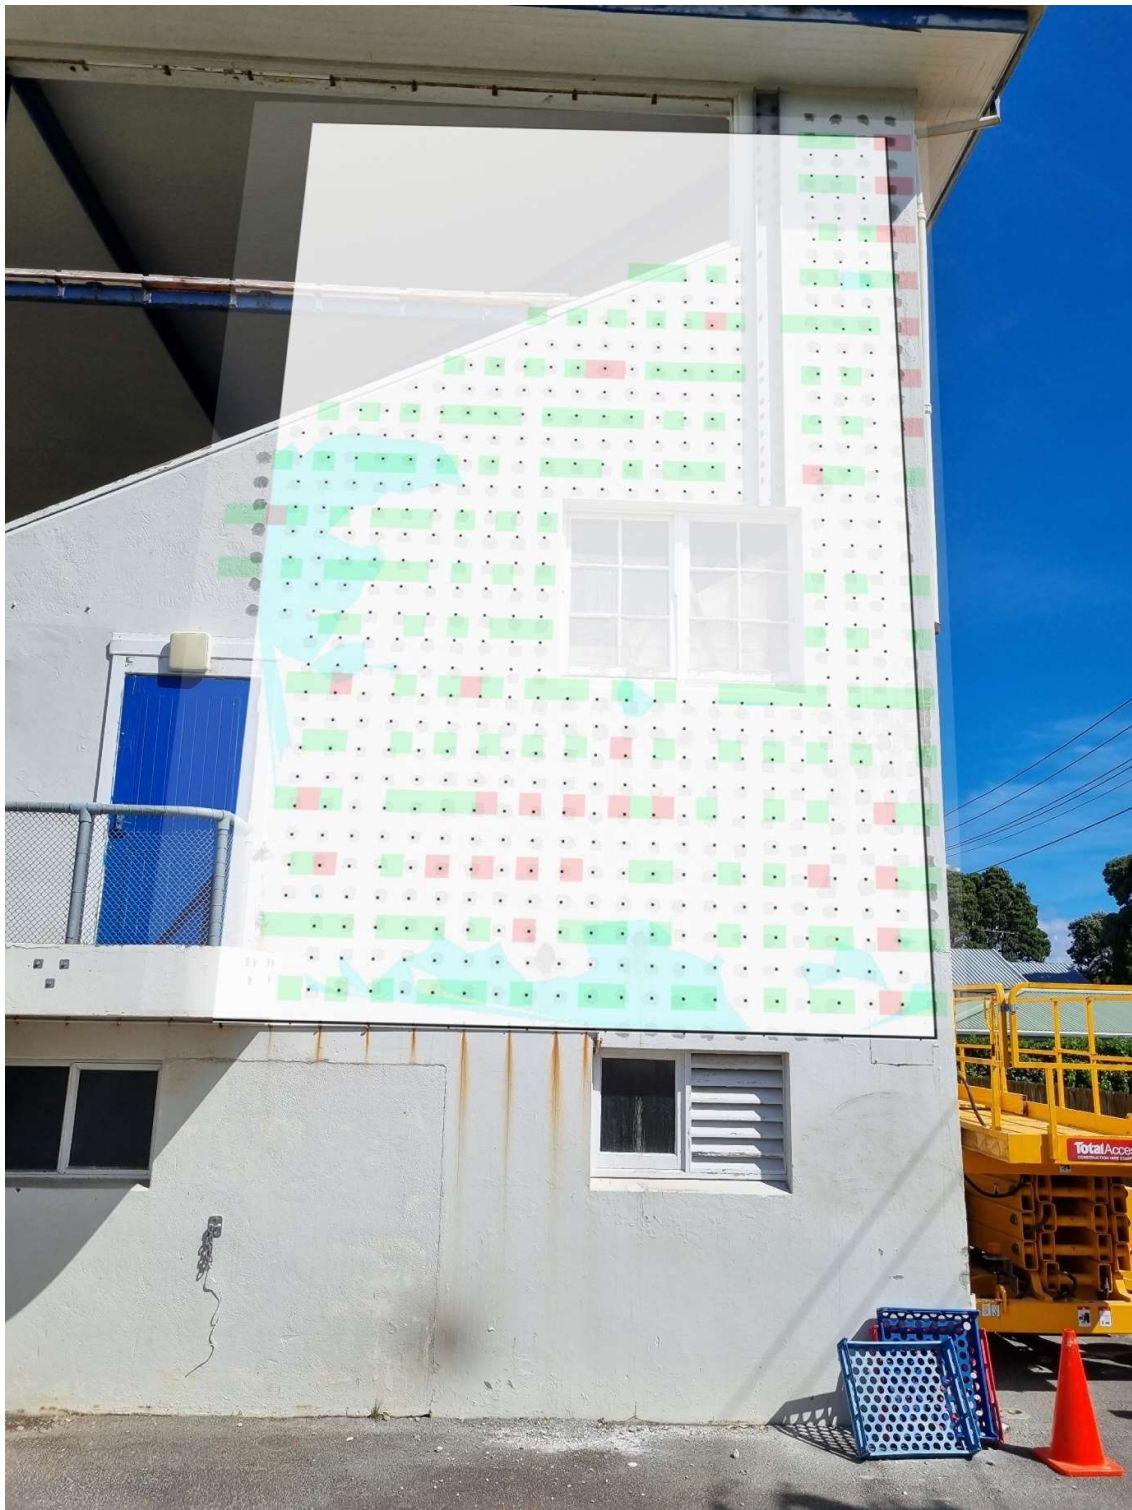
Figure 11 North Wall - Half-Cell - Cover Map

| Comment: | <p>North Wall</p> <p>Half-Cell Potential:</p> <ul style="list-style-type: none"><li>• Blue shaded areas have a 50% probability of active corrosion</li></ul> <p>Cover Map:</p> <ul style="list-style-type: none"><li>• The reinforcing cover is <math>\geq 30\text{mm}</math></li><li>• One area in the lower portion of the wall has cover values <math>&lt; 30\text{mm}</math></li><li>• Cover values <math>&lt; 30\text{mm}</math> (red) are observable for column reinforcing</li><li>• Single red data points likely relate to ties wires<ul style="list-style-type: none"><li>○ Ties with insufficient cover can initiate corrosion</li><li>○ The corrosion from ties migrates deeper into the structure till it reaches the reinforcing, causing the bars to corrode</li></ul></li></ul> | | |

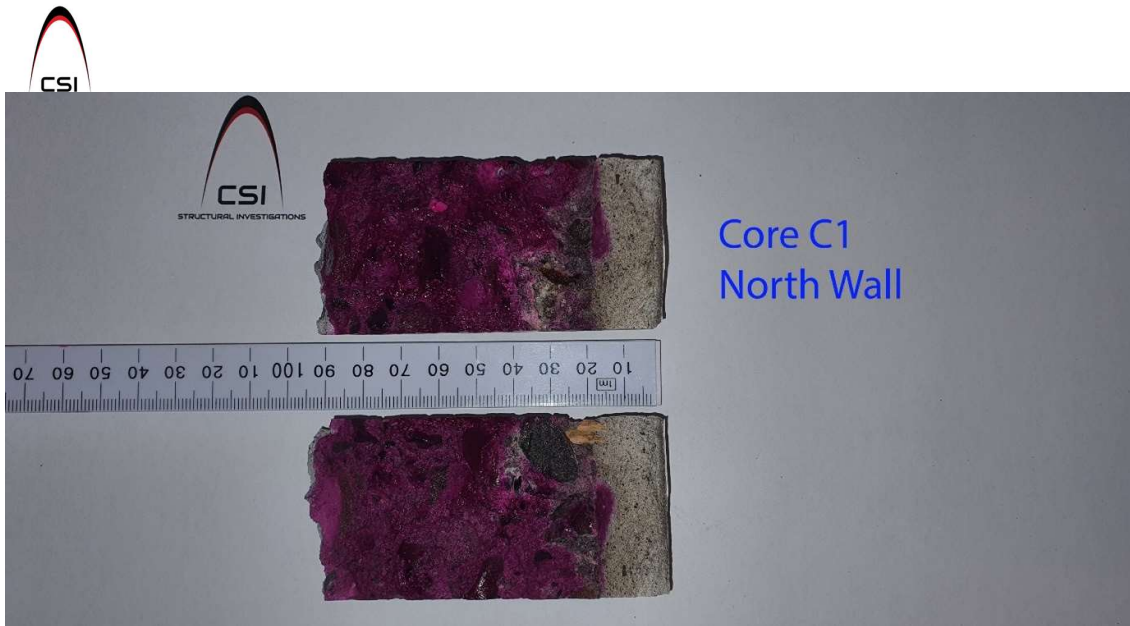
Figure 13: North Wall - Carbonation Testing

| Comment: | <p>North Wall</p> <p>Carbonation:</p> <ul style="list-style-type: none"> <li>• North Face: <ul style="list-style-type: none"> <li>○ Carbonation is apparent throughout the added layer</li> <li>○ The indicator suggests that the PH is lower for the first cm of the original concrete</li> <li>○ Overall, carbonation to some level is apparent up to 30mm</li> </ul> </li> </ul> <p>Additional findings:</p> <ul style="list-style-type: none"> <li>• Wood is embedded in the concrete</li> </ul> | | |

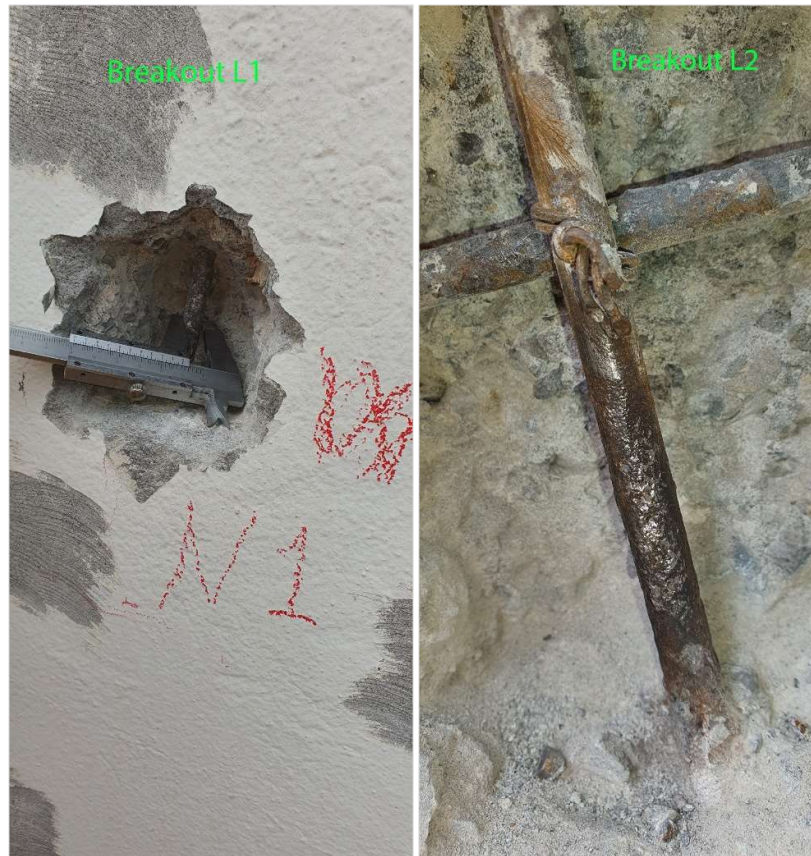
*Figure 14: North Wall - Breakout L1 & L2*

| Comment: | <p>North Wall</p> <p>Breakout L1</p> <ul style="list-style-type: none"><li>The unpolished bar was measured to have a diameter of just below 10mm, the increased diameter is due to the volume expansion iron-oxide.</li></ul> <p>Breakout L2</p> <ul style="list-style-type: none"><li>Half-Cell testing indicates a 50% probability for active corrosion occurring</li><li>Some pitting is visible on the polished bars</li><li>The unpolished bars were measured to have a diameter of 10mm, the increased diameter is due to the volume expansion iron-oxide.</li></ul> <p>Breakout L3 – Column</p> <ul style="list-style-type: none"><li>The main bar seems to have only a thin layer of corrosion</li><li>The diameter was measured to be 30mm (nominal diameter is 32mm)</li></ul> | | |

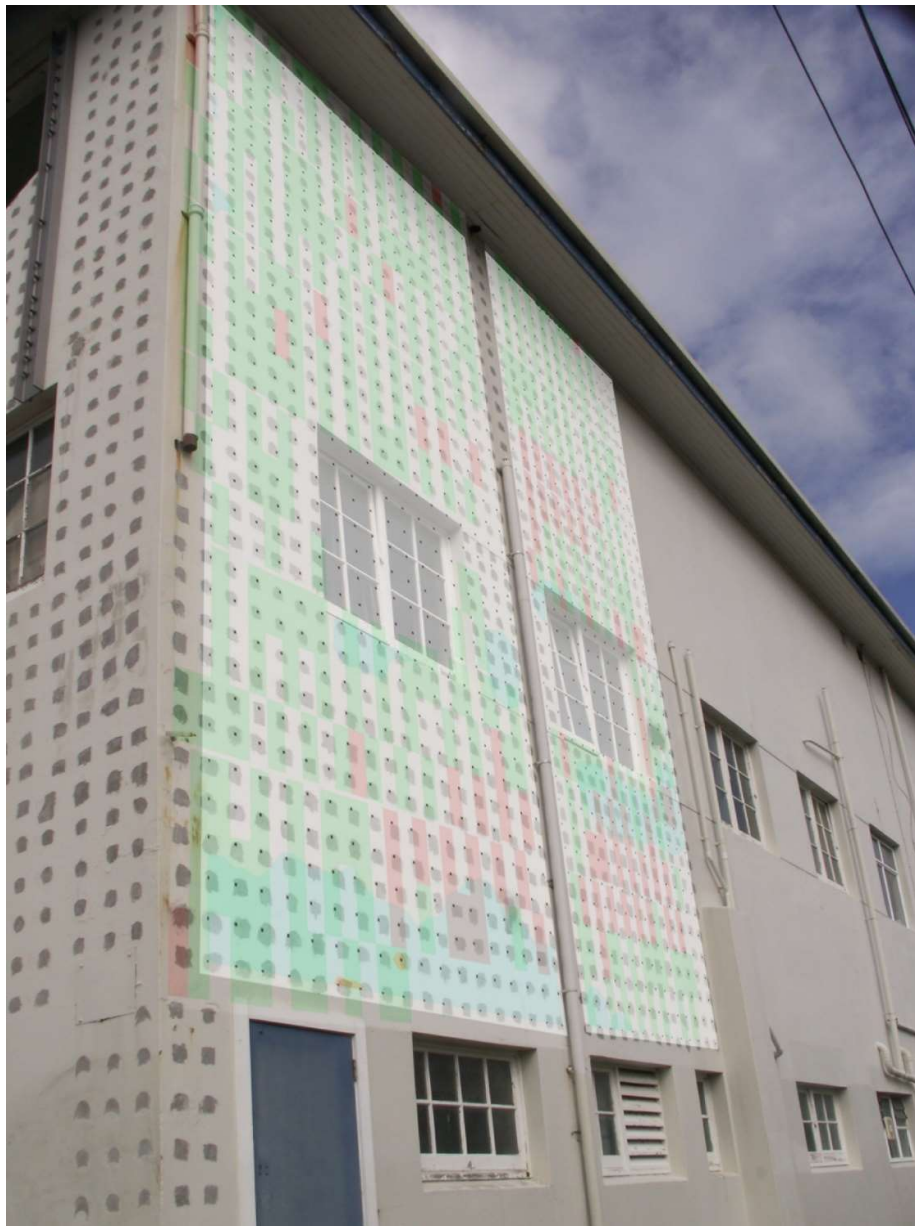
Figure 16: West Wall Grid E-F - Half-Cell - Cover Map

| Comment: | <p>West Wall<br/>Grid E-F</p> <p>Half-Cell Potential:</p> <ul style="list-style-type: none"> <li>Blue shaded areas have a 50% probability of active corrosion</li> </ul> <p>Cover Map:</p> <ul style="list-style-type: none"> <li>Large areas have reinforcing with covers &lt; 30mm (red) <ul style="list-style-type: none"> <li>Some low cover reinforcing is within areas where Half-Cell testing has a 50% probability of active corrosion</li> </ul> </li> </ul> | | |

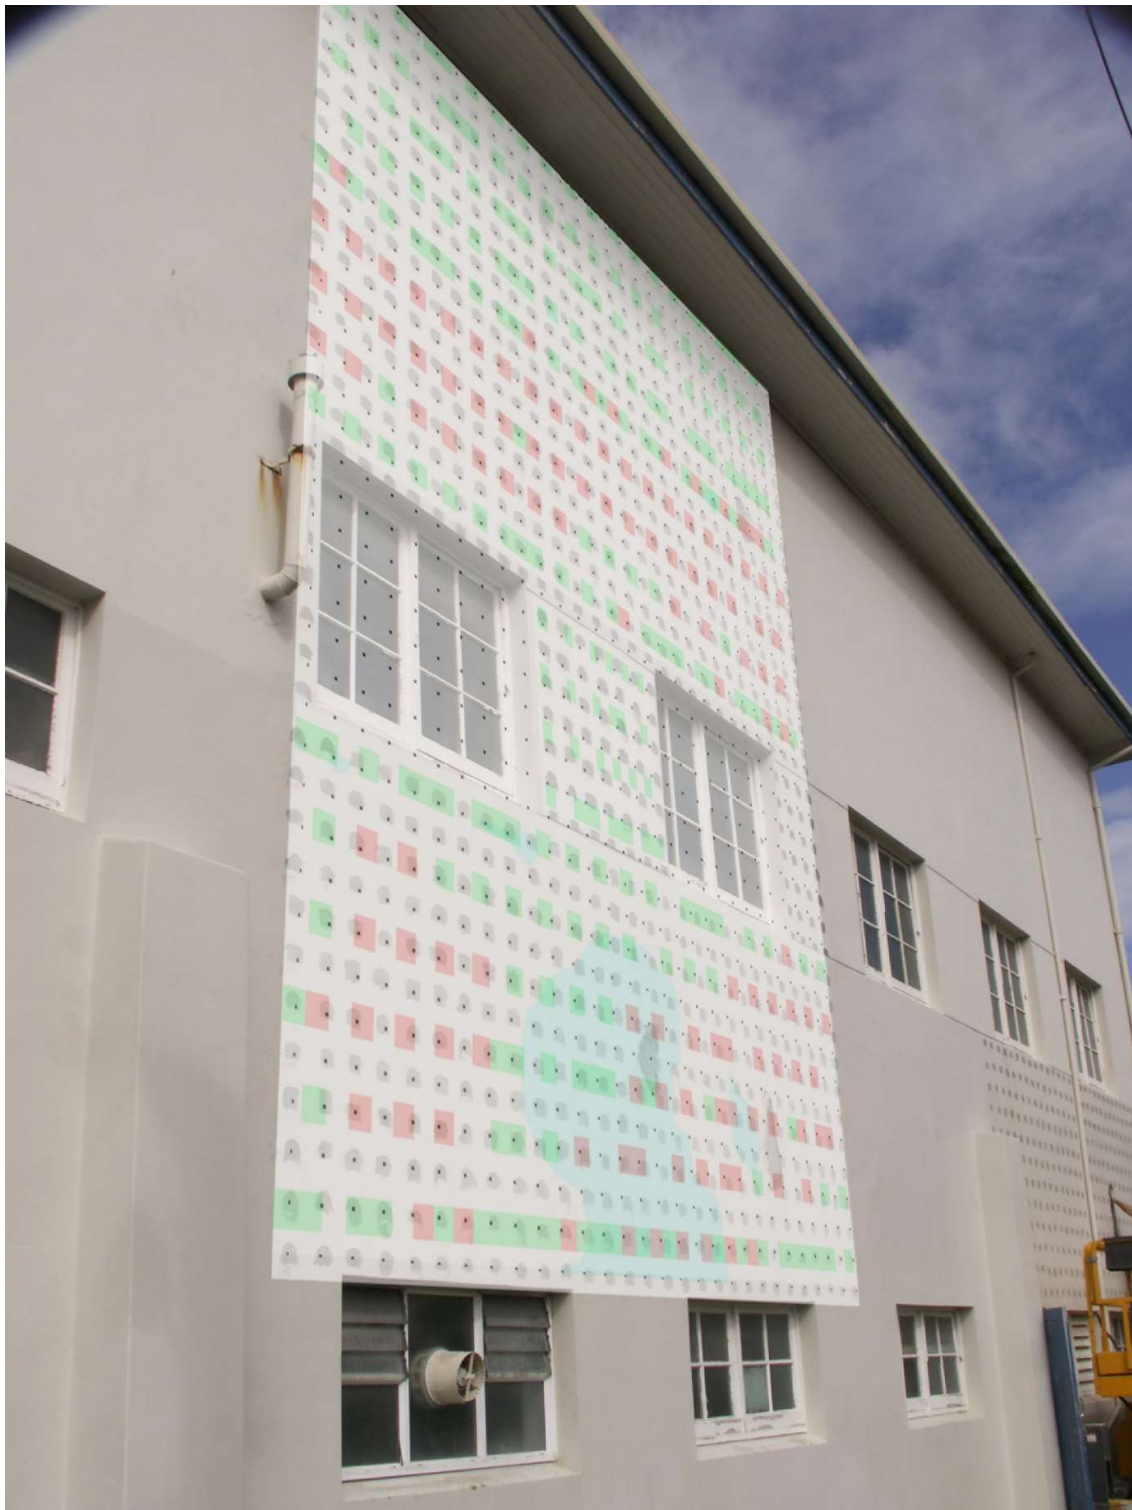
*Figure 20: West Wall – Grid B-C - Half-Cell - Cover Map*

| Comment: | <p>West Wall<br/>Grid B-C</p> <p>Half-Cell Potential:</p> <ul style="list-style-type: none"><li>• Blue shaded areas have a 50% probability of active corrosion</li></ul> <p>Cover Map:</p> <ul style="list-style-type: none"><li>• Large areas have reinforcing with covers &lt; 30mm (red)<ul style="list-style-type: none"><li>○ Some low cover reinforcing is within areas where Half-Cell testing has a 50% probability of active corrosion</li></ul></li></ul> | | |

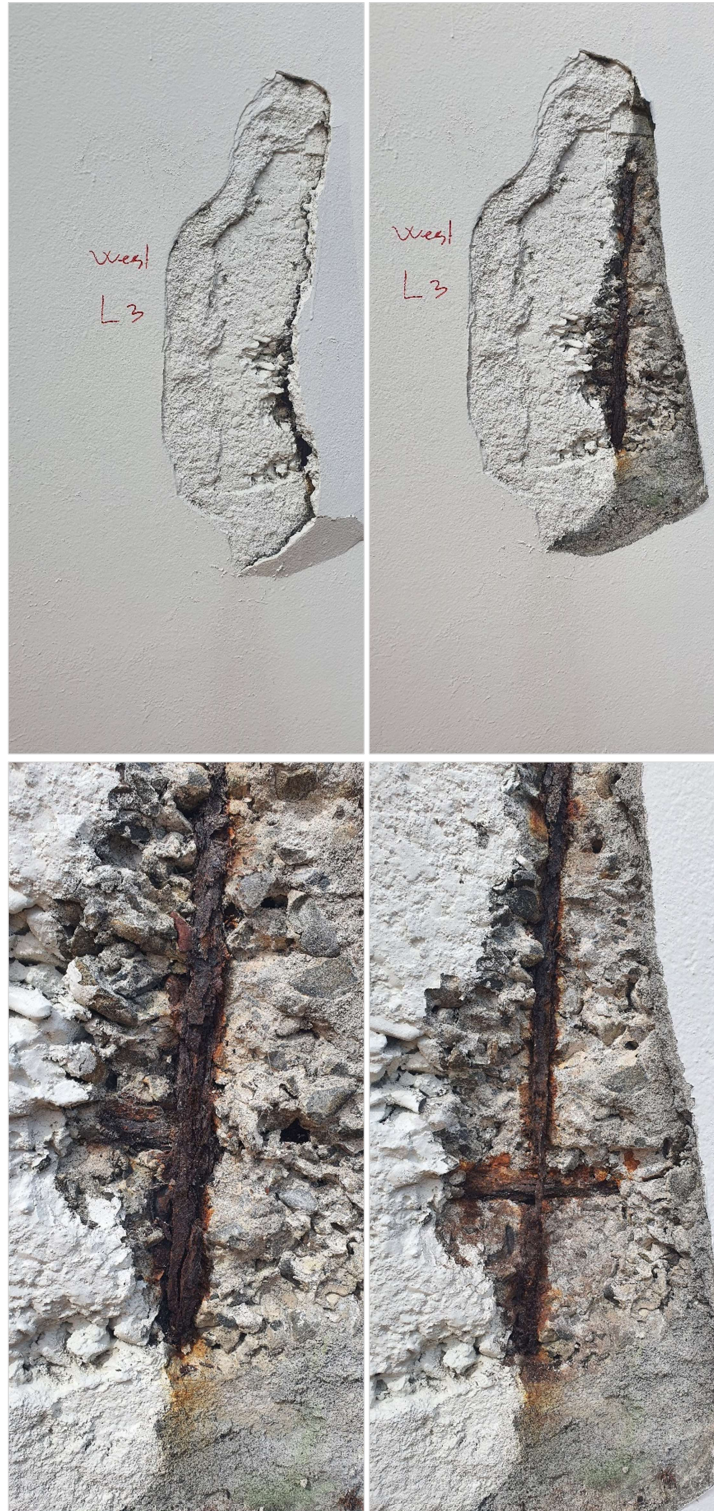
Figure 23: West Wall – Grid B-C - Breakout L3

| Comment: | <p>West Wall<br/>Grid B-C</p> <p>Breakout L3</p> <ul style="list-style-type: none"> <li>• The location had a spalled area, observed by CSI already two years ago</li> <li>• The reinforcing was exposed to the atmosphere and is severely corroded</li> <li>• The vertical bar has a remaining diameter of 3mm</li> <li>• The horizontal bar has a remaining diameter of 6mm</li> <li>• The concrete is porous, nested aggregates were found</li> </ul> | | |

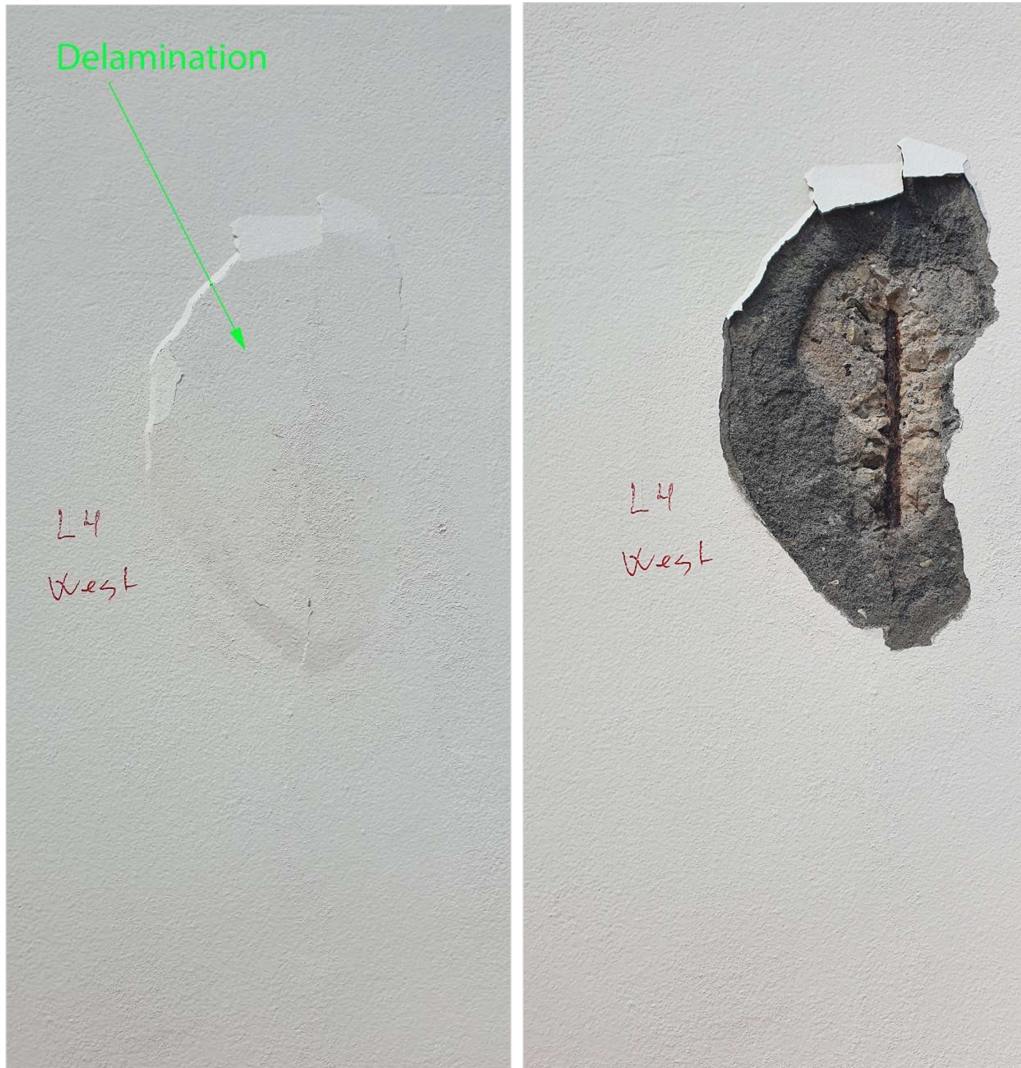
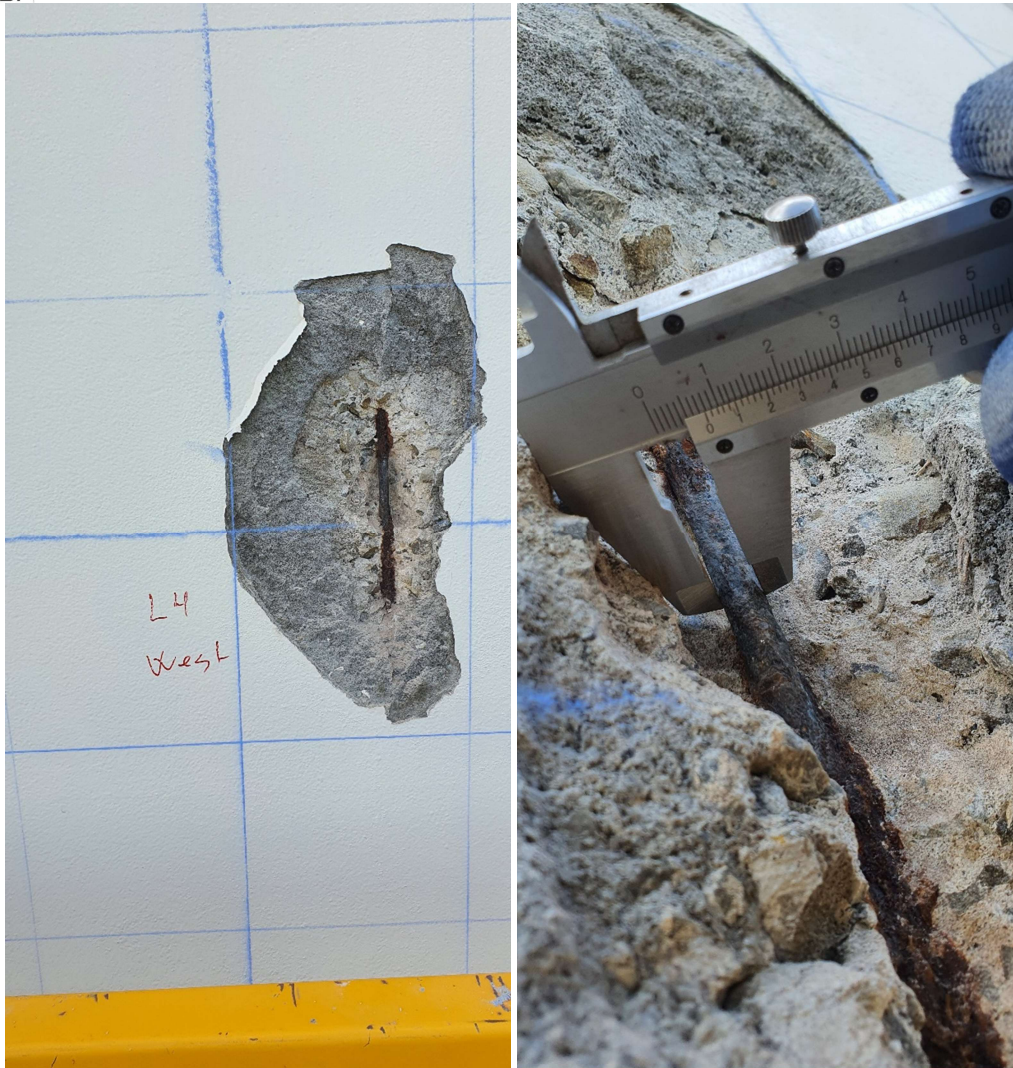
| Comment: | <p>West Wall<br/>Grid B-C</p> <p>Breakout L4</p> <ul style="list-style-type: none"> <li>• The location was delaminated</li> <li>• Although the delaminated material hadn't spalled, atmosphere getting to the reinforcing would have accelerated the corrosion process</li> <li>• The vertical bar has a remaining diameter of less than 8mm</li> </ul> | | |

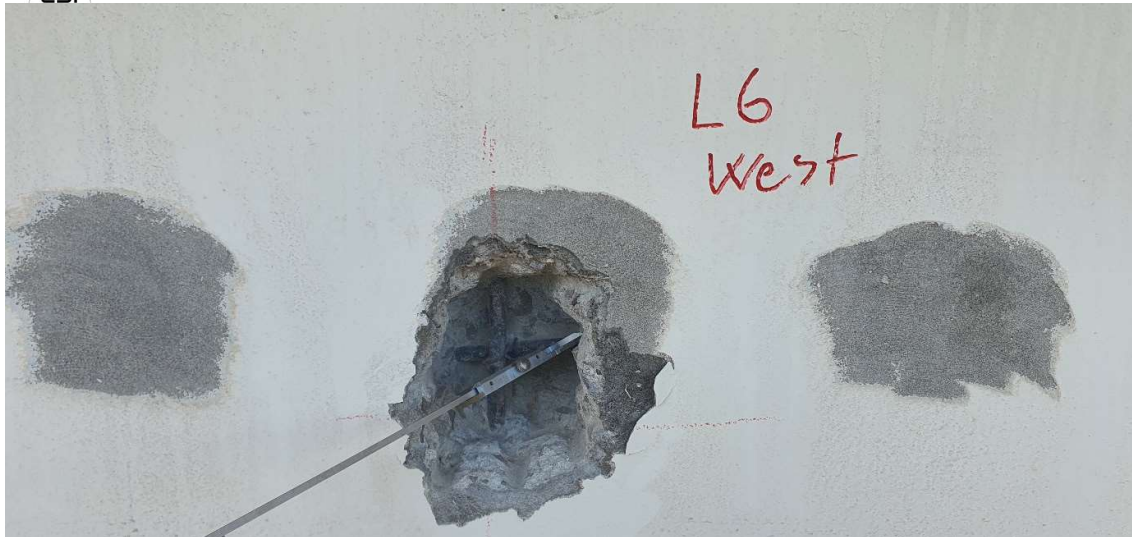
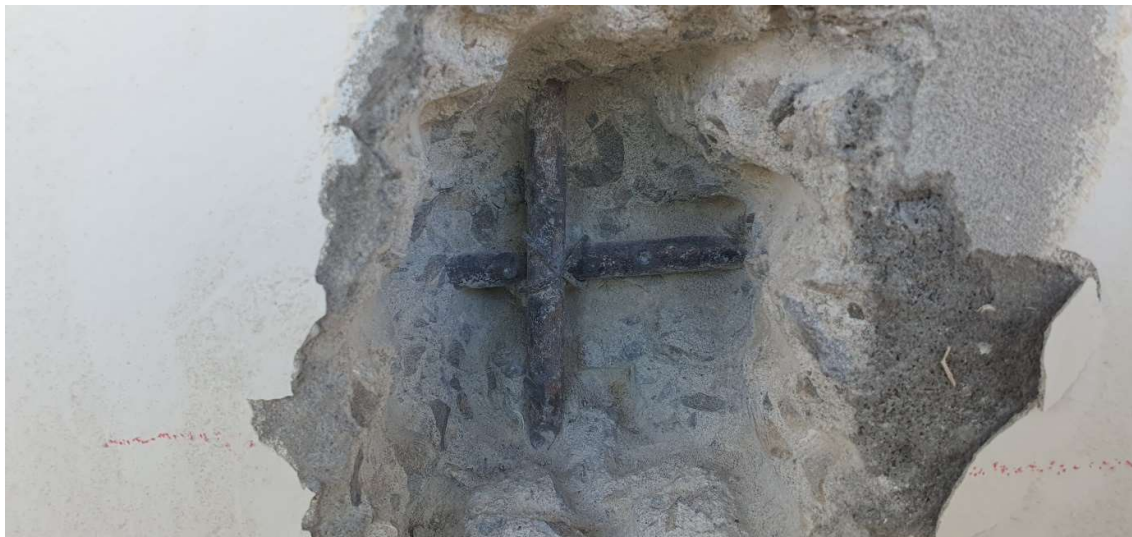
Figure 28: West Wall - Grid BC - Breakout L6

| Comment: | West Wall<br>Grid B-C<br><br>Breakout L6 <ul style="list-style-type: none"> <li>• Only surface corrosion on reinforcing bars is present</li> <li>• The bar diameter is 9.5mm</li> <li>• The cover was measured to be 75mm</li> </ul> | | |

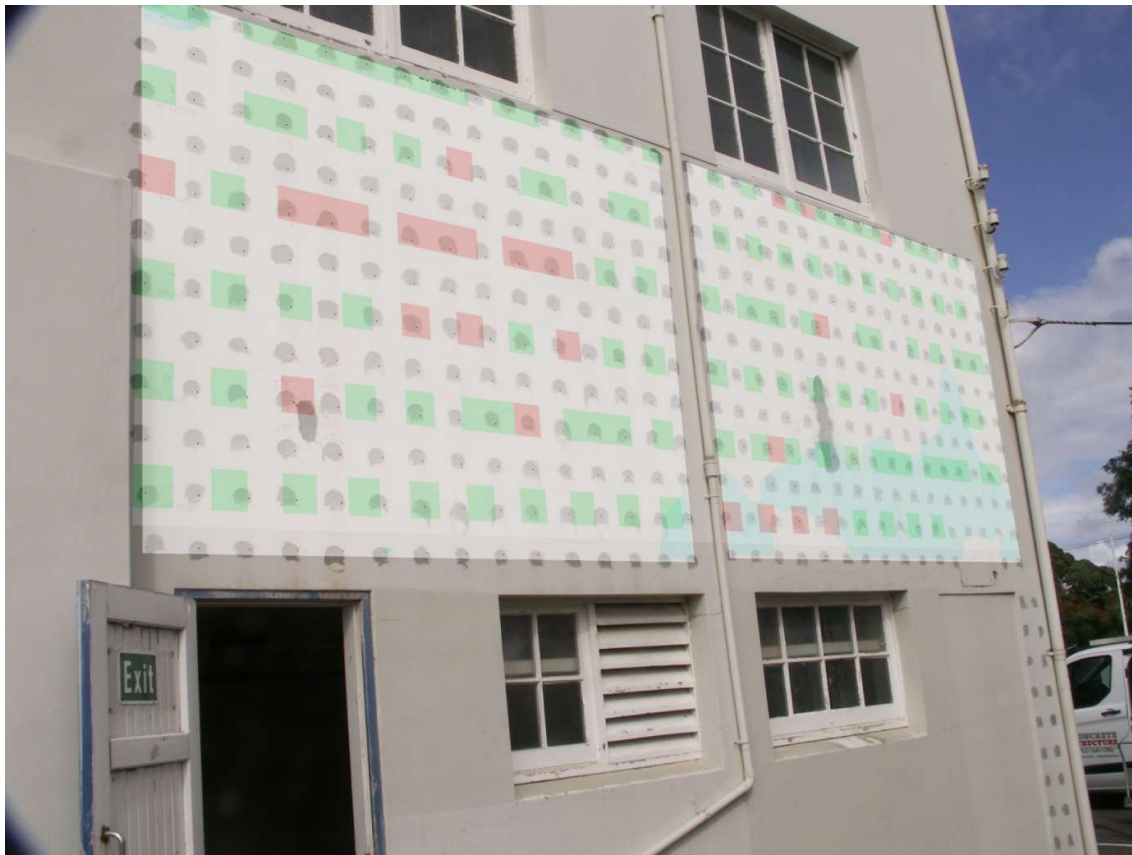
Figure 30: West Wall Grid A-B - Half-Cell - Cover Map

| Comment: | <p>West Wall<br/>Grid A-B</p> <p>Half-Cell Potential:</p> <ul style="list-style-type: none"><li>Blue shaded areas have a 50% probability of active corrosion</li></ul> <p>Cover Map:</p> <ul style="list-style-type: none"><li>Some reinforcing with cover values &lt; 30mm (red) is apparent</li><li>Isolated detections likely relate to ties wires<ul style="list-style-type: none"><li>Ties with insufficient cover can initiate corrosion</li><li>The corrosion from ties migrates deeper into the structure until it reaches the reinforcing, causing the bars to corrode</li></ul></li></ul> | | |

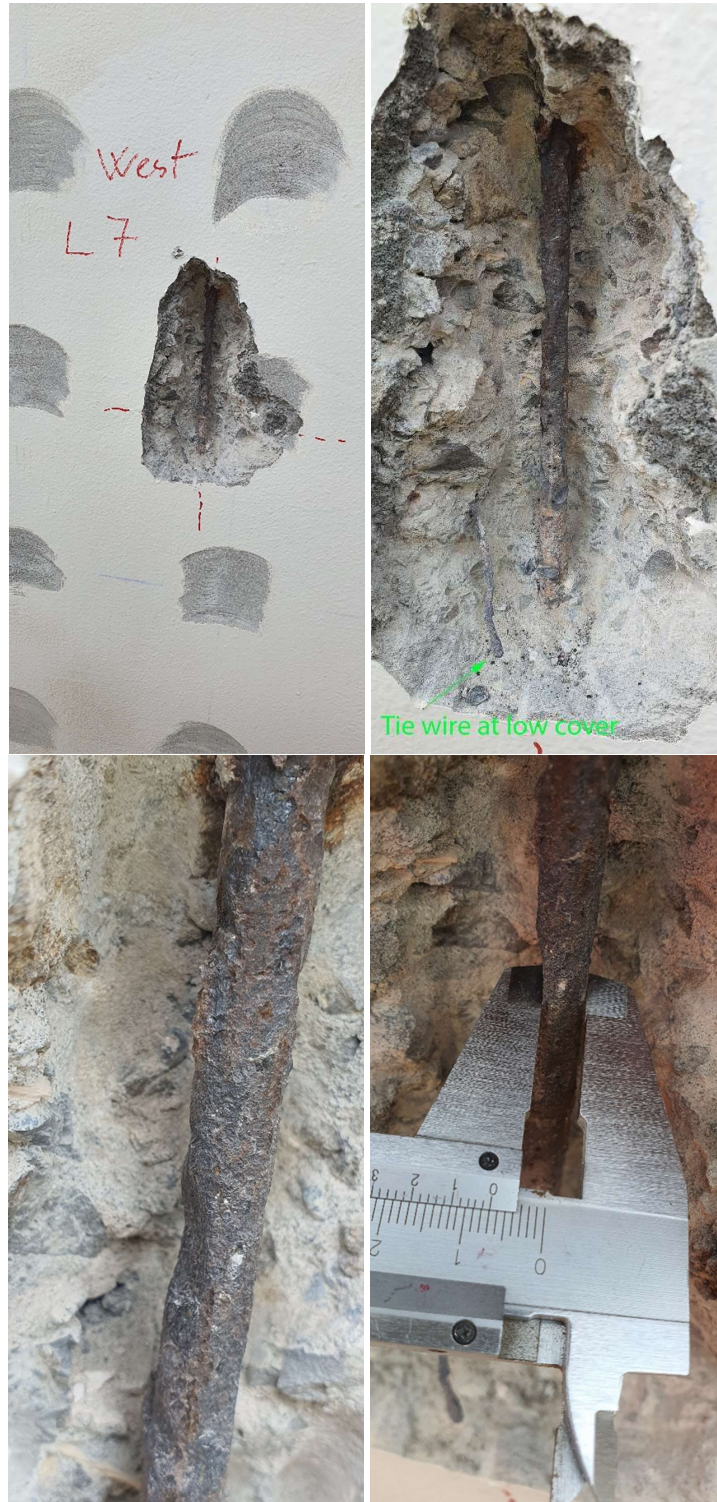
Figure 33: West Wall – Grid A-B - Breakout L7

| Comment: | <p>West Wall<br/>Grid A-B</p> <p>Breakout L7</p> <ul style="list-style-type: none"> <li>• No spalling was visible in this area</li> <li>• The bar is severely corroded</li> <li>• The vertical bar has a remaining diameter of 7mm</li> <li>• Corrosion seems to be active</li> <li>• It is likely that the tie wire found at low cover has contributed to the corrosion in this area</li> </ul> | | |

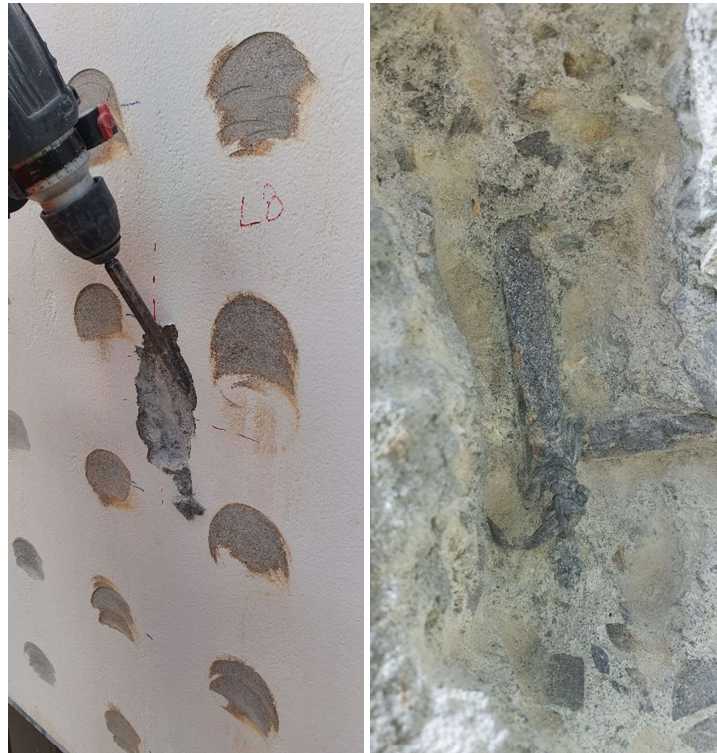
Figure 35: West Wall – Grid A-B - Breakout L8

| Comment: | <p>West Wall<br/>Grid A-B</p> <p>Breakout L8</p> <ul style="list-style-type: none"> <li>• No spalling was visible in this area</li> <li>• No corrosion was found at this location</li> <li>• The vertical bar diameter is 9.5mm</li> </ul> | | |
