# INDEPENDENT STRUCTURAL INVESTIGATIONS REPORT

INVESTIGATIVE REPORT

| JOB NAME | Petone Grandstand |

| Corrosion survey on the Grandstand Petone. |

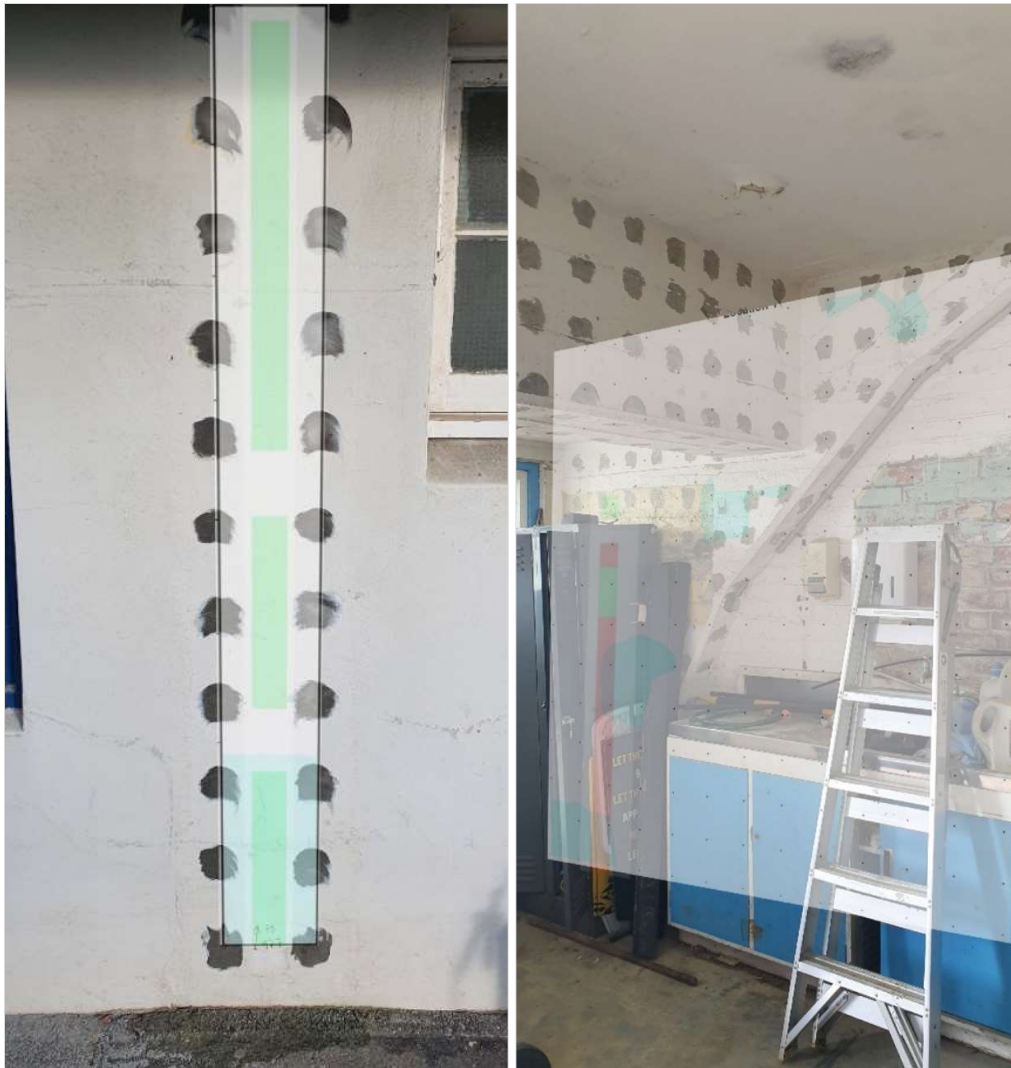
*Figure 36: Column Grid A-X - Half-Cell - Cover Map*

| Comment: | <p>Column<br/>Grid A-X</p> <p>Half-Cell Potential:</p> <ul style="list-style-type: none"> <li>Blue shaded areas have a 50% probability of active corrosion</li> </ul> <p>Cover Map:</p> <ul style="list-style-type: none"> <li>Some stirrups with cover values &lt; 30mm (red) is present on the inside</li> </ul> | | |

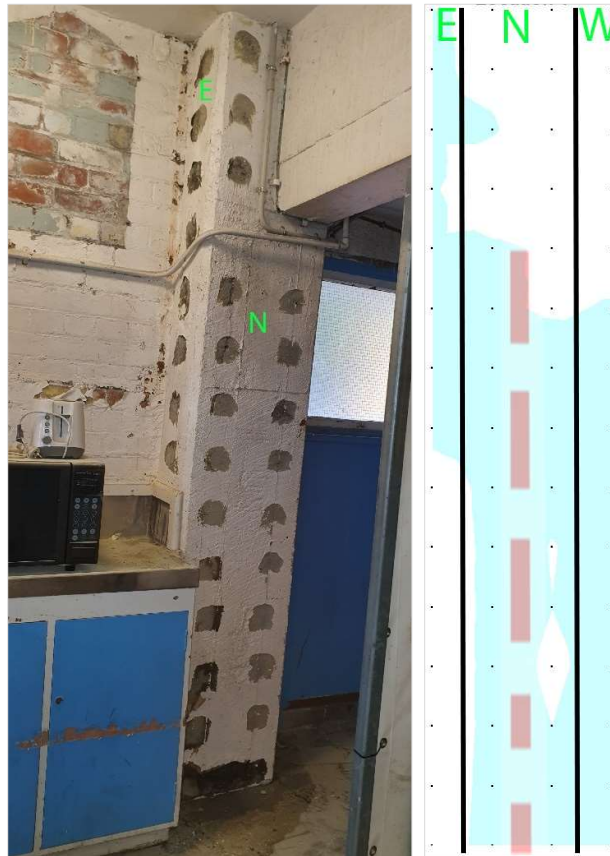
Figure 38: Column A-Y - Half-Cell - Cover Map

| Comment: | <p>Column<br/>Grid A-Y</p> <p>Data is displayed as flat projection</p> <ul style="list-style-type: none"> <li>Black lines indicate the column corners</li> <li>Green letters refer to orientation of the face</li> </ul> <p>Half-Cell Potential:</p> <ul style="list-style-type: none"> <li>Blue shaded areas have a 50% probability of active corrosion</li> </ul> <p>Cover Map:</p> <ul style="list-style-type: none"> <li>The stirrups have a cover &lt; 30mm (red)</li> </ul> | | |

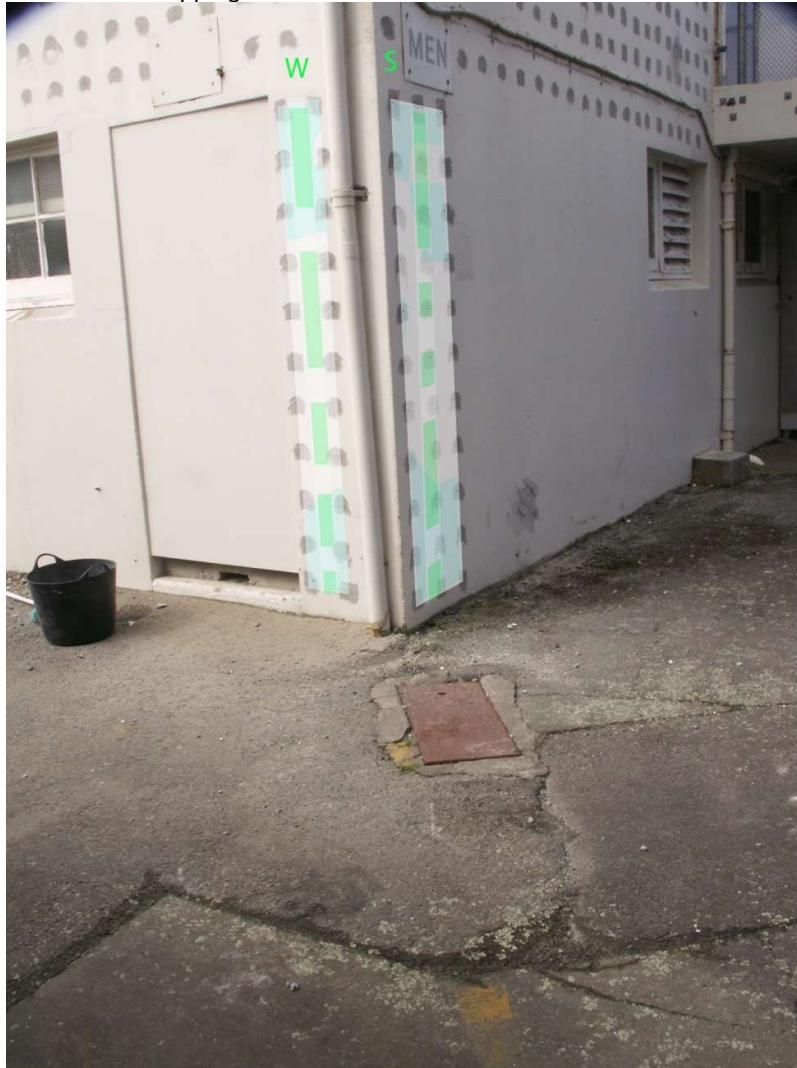
Figure 39: Column A-Z - Half-Cell - Cover Map

| Comment: | <p>Column<br/>Grid A-Z</p> <p>Half-Cell Potential:</p> <ul style="list-style-type: none"> <li>Blue shaded areas have a 50% probability of active corrosion</li> </ul> <p>Cover Map:</p> <ul style="list-style-type: none"> <li>The stirrups have cover values &gt; 30mm (green) on the outside</li> </ul> | | |

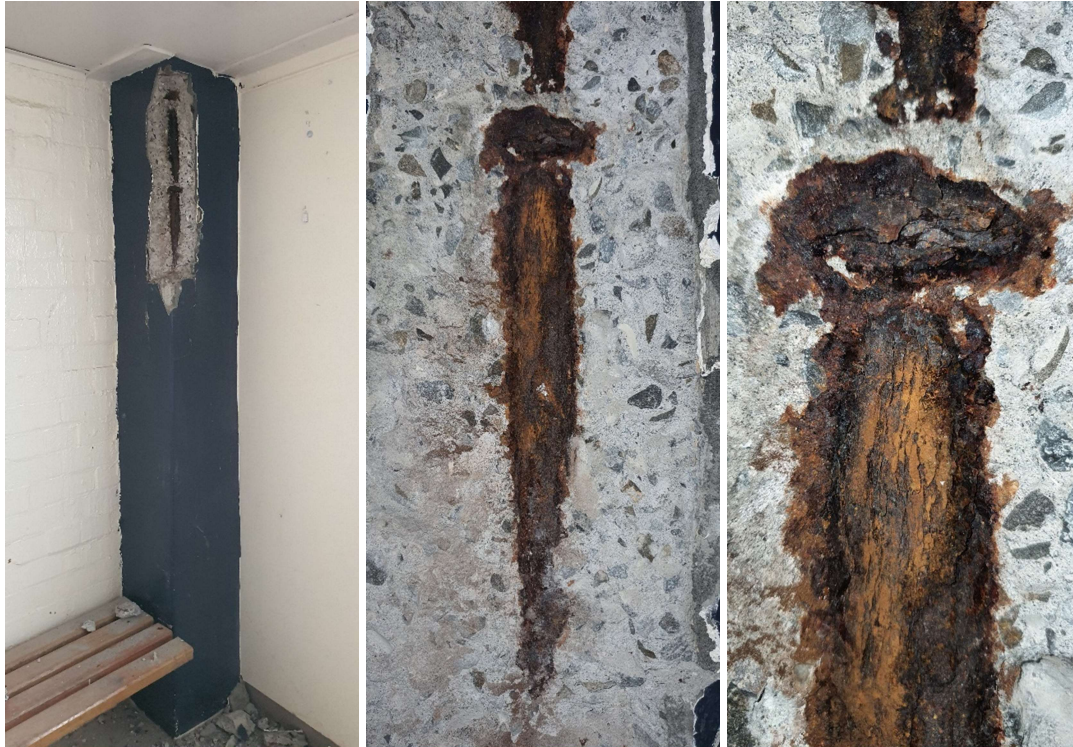
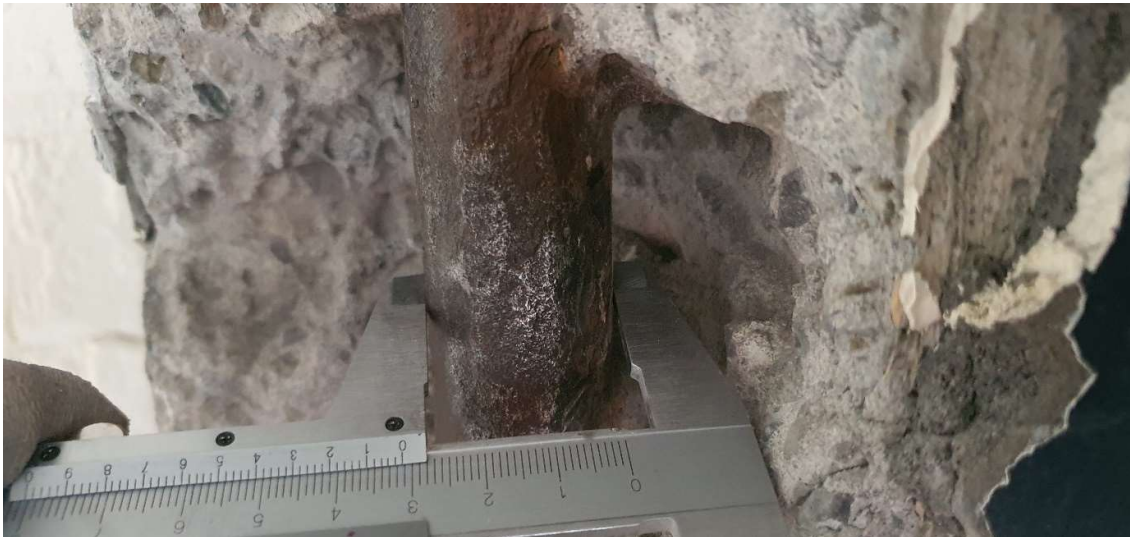
Figure 40: Column Grid A-Z - Breakout Location

| Comment: | <p>Column<br/>Grid A-Z (inside)</p> <p>Breakout</p> <ul style="list-style-type: none"> <li>• A large area was found to be spalled</li> <li>• The bars (main bar and stirrup) are severely corroded</li> <li>• The main bar has a remaining diameter of 31mm <ul style="list-style-type: none"> <li>◦ The back of the bar was not able to be polished</li> <li>◦ The residual diameter must be assumed to be lower than the measured one</li> </ul> </li> <li>• Corrosion is active</li> </ul> | | |

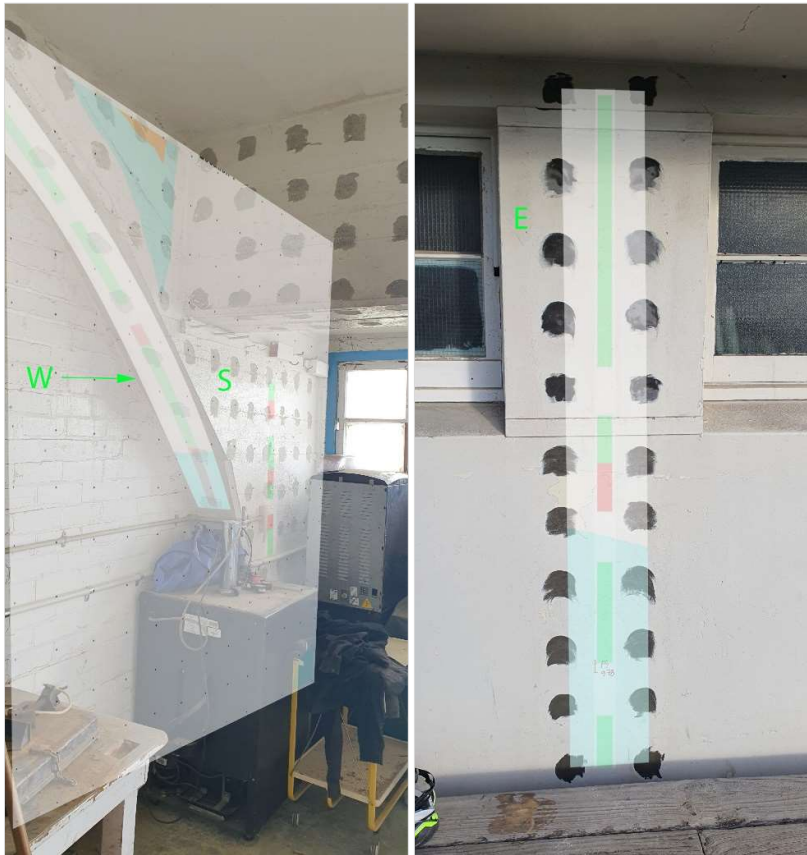
Figure 41: Column Grid B-X - Half-Cell - Cover Map

| Comment: | <p>Column<br/>Grid B-X</p> <p>Half-Cell Potential:</p> <ul style="list-style-type: none"> <li>Blue shaded areas have a 50% probability of active corrosion <ul style="list-style-type: none"> <li>An area at the bottom of the column towards the outside is within this range, though difficult to see on the graphic above</li> <li>The area next to the beam, and upwards the raking column is within this range</li> </ul> </li> <li>Orange shaded areas have a 90% probability of active corrosion <ul style="list-style-type: none"> <li>An area at the top of the map has a high probability of active corrosion</li> <li>It is likely that this progresses upwards the raking beam, although this cannot be confirmed without further investigations</li> </ul> </li> </ul> <p>Cover Map:</p> <ul style="list-style-type: none"> <li>Some stirrups with cover values &lt; 30mm (red) are present on the inside and outside</li> </ul> | | |

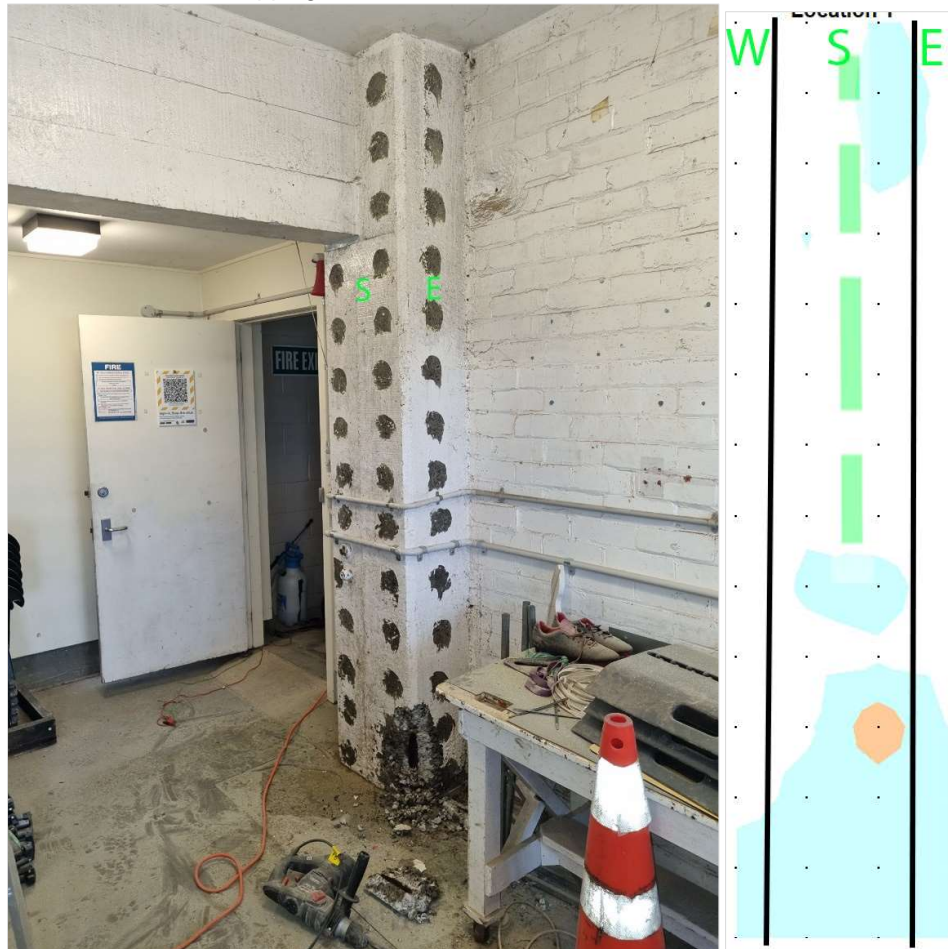
Figure 42: Column B-Y - Half-Cell - Cover Map

| Comment: | <p>Column<br/>Grid B-Y</p> <p>Data is displayed as flat projection</p> <ul style="list-style-type: none"> <li>Black lines indicate the column corners</li> <li>Green letters refer to orientation of the face</li> </ul> <p>Half-Cell Potential:</p> <ul style="list-style-type: none"> <li>Blue shaded areas have a 50% probability of active corrosion</li> <li>Orange shaded area has a 90% probability of active corrosion</li> </ul> <p>Cover Map:</p> <ul style="list-style-type: none"> <li>The stirrups have a cover &gt; 30mm (green)</li> </ul> | | |

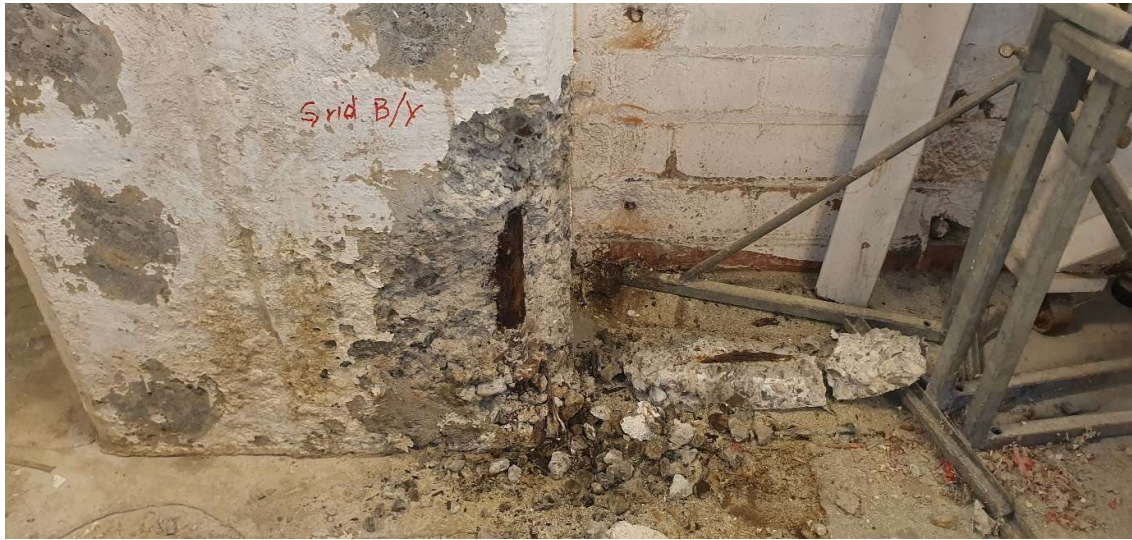
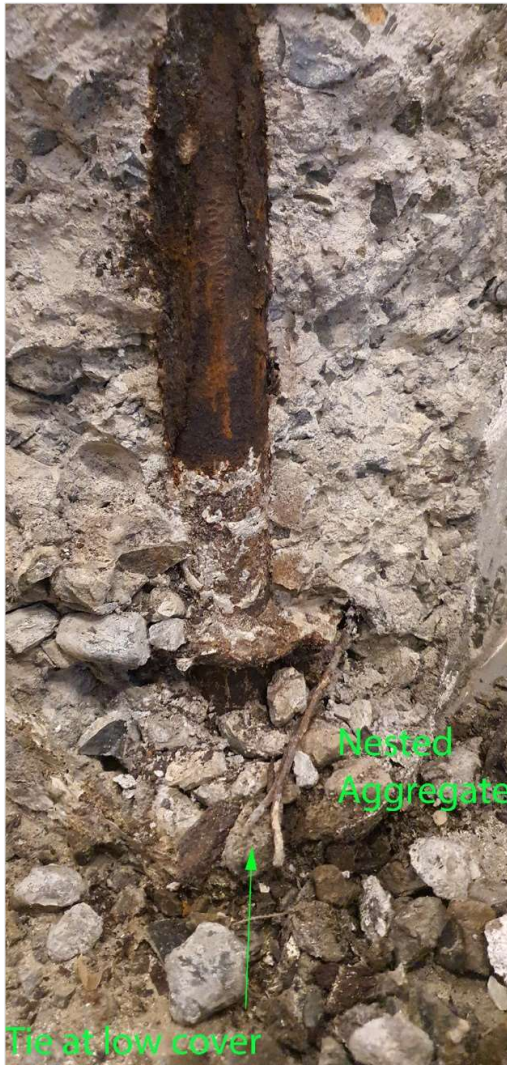
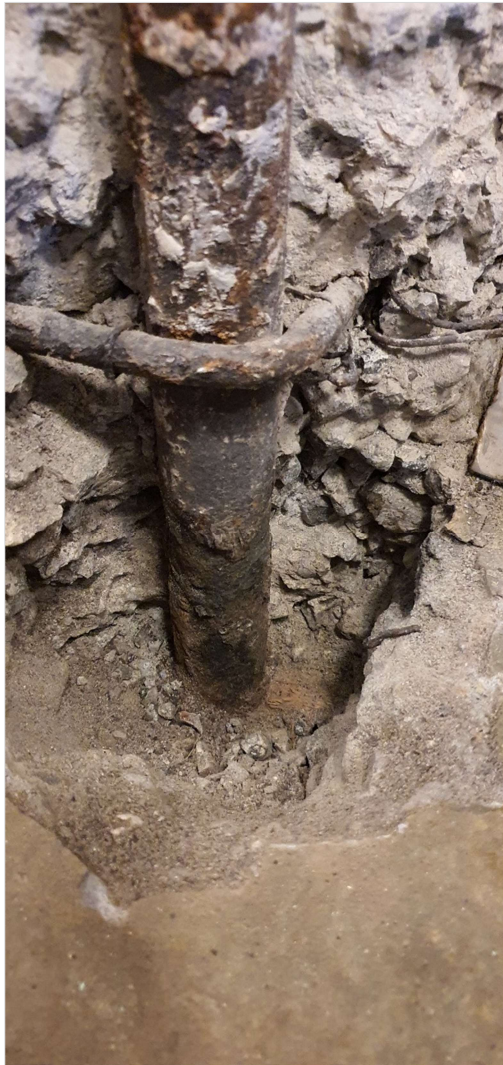
Figure 43: Column Grid B-Y - Breakout

| Comment: | <p>Column<br/>Grid B-Y</p> <p>Breakout<br/>Several factors have contributed to the deterioration of column B-Y</p> <ul style="list-style-type: none"> <li>• Nested aggregate was found in the bottom portion</li> <li>• A tie wire with virtually no cover, acting as a "slow burning fuse" was found</li> <li>• A piece of timber in contact with the bar was found approx. 80mm <ul style="list-style-type: none"> <li>◦ The timber was moist, indicating that it delivers consistently moisture to the bar</li> </ul> </li> <li>• Active corrosion is apparent</li> <li>• The main bar has a residual diameter of below 29mm (the nominal diameter is 32mm)</li> </ul> | | |

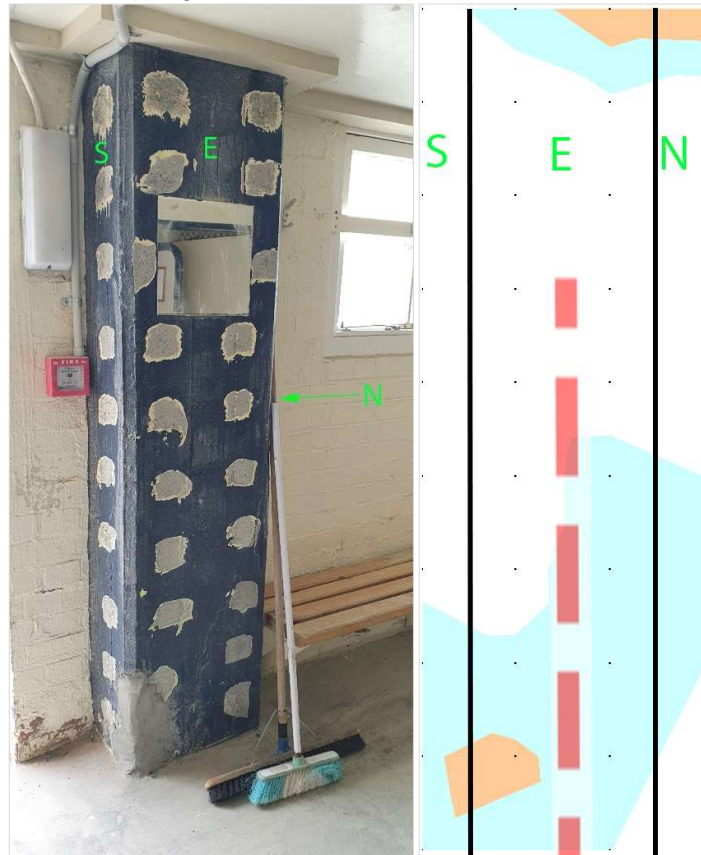
Figure 46: Column B-Z - Half-Cell - Cover Map

| Comment: | <p>Column<br/>Grid B-Z</p> <p>Data is displayed as flat projection</p> <ul style="list-style-type: none"> <li>Black lines indicate the column corners</li> <li>Green letters refer to orientation of the face</li> </ul> <p>Half-Cell Potential:</p> <ul style="list-style-type: none"> <li>Blue shaded areas have a 50% probability of active corrosion</li> <li>Orange shaded area has a 90% probability of active corrosion</li> </ul> <p>Cover Map:</p> <ul style="list-style-type: none"> <li>The stirrups have a cover &lt; 30mm (red)</li> </ul> | | |

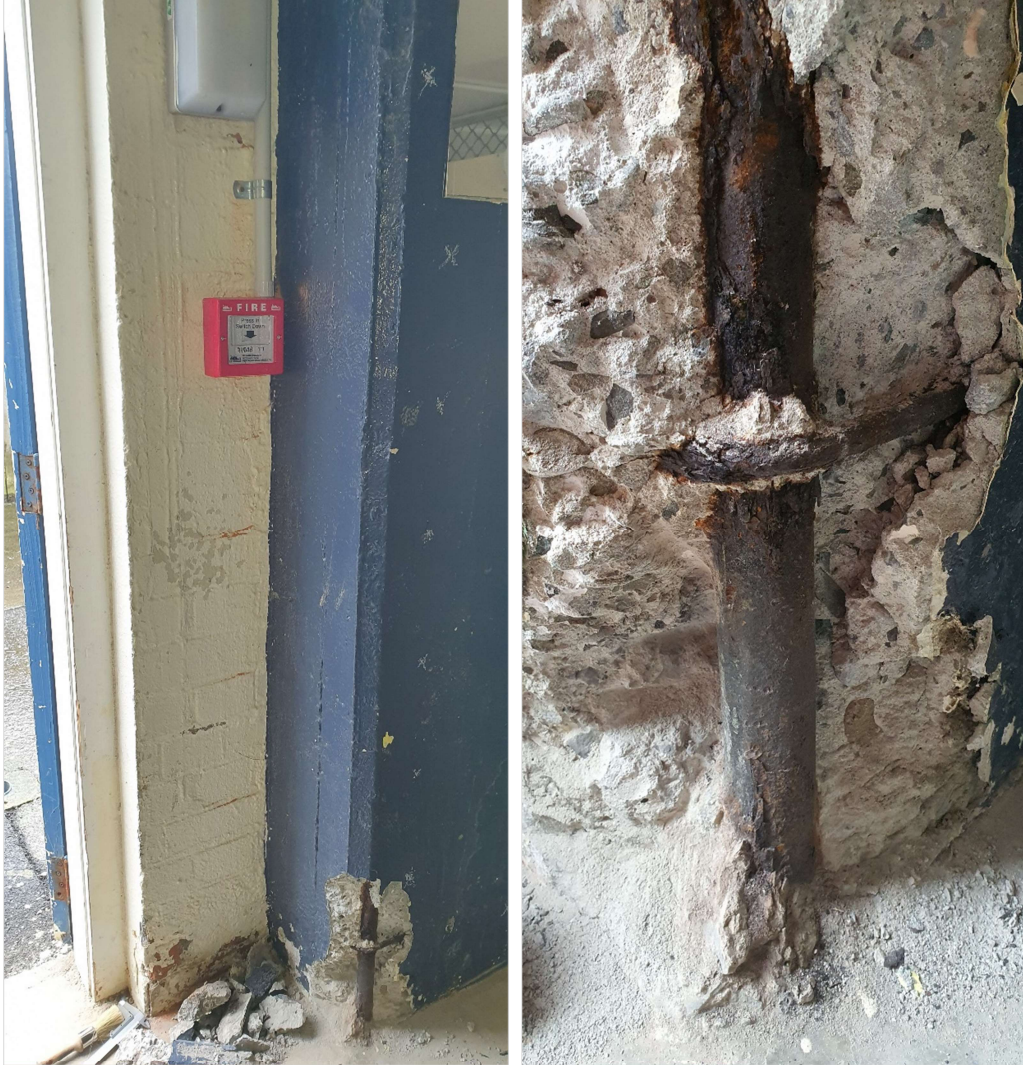
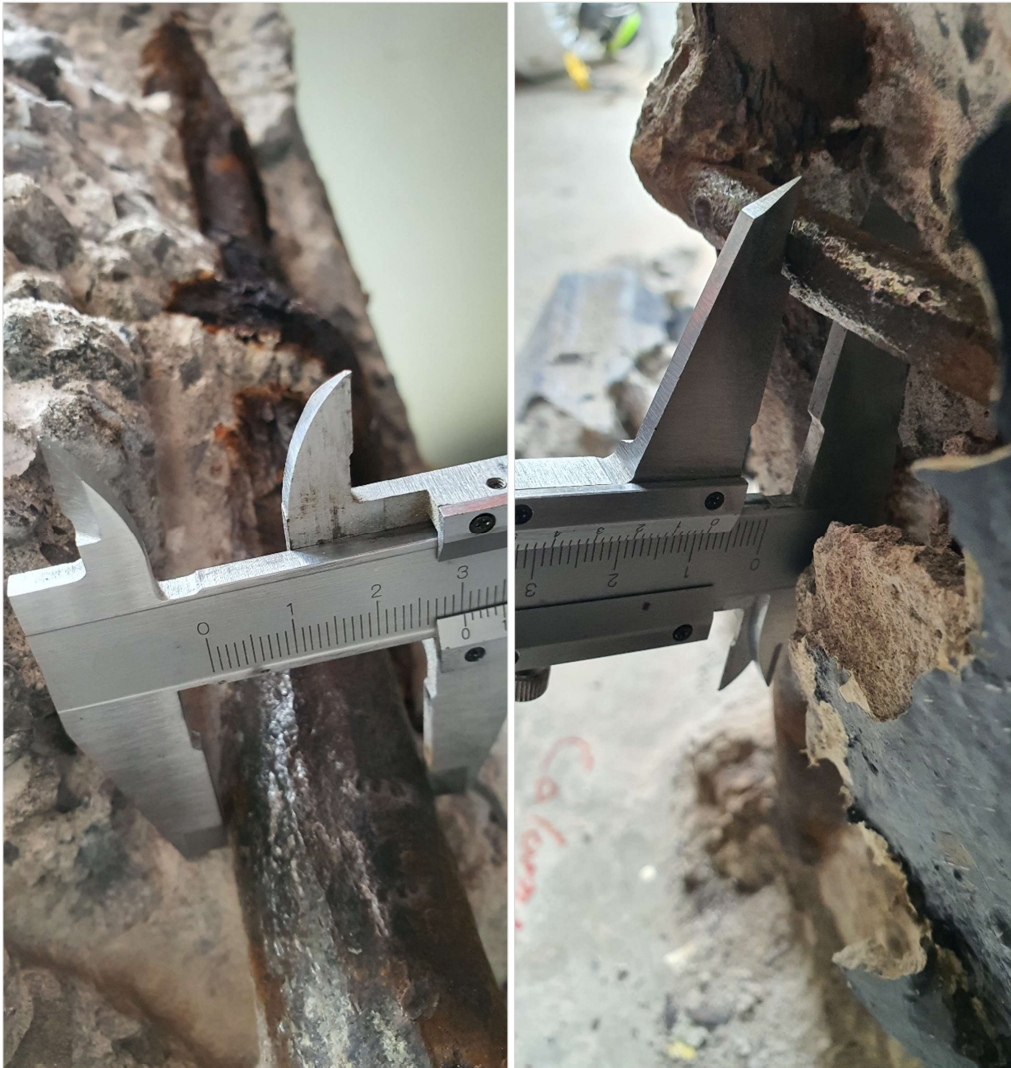
| Comment: | <p>Column<br/>Grid B-Z</p> <p>Breakout</p> <ul style="list-style-type: none"> <li>• A large area was found to be spalled</li> <li>• The bars (main bar and stirrup) are severely corroded</li> <li>• The main bar has a remaining diameter of 30mm</li> <li>• The stirrup has a remaining diameter of 8.5mm</li> <li>• Corrosion is active</li> </ul> | | |

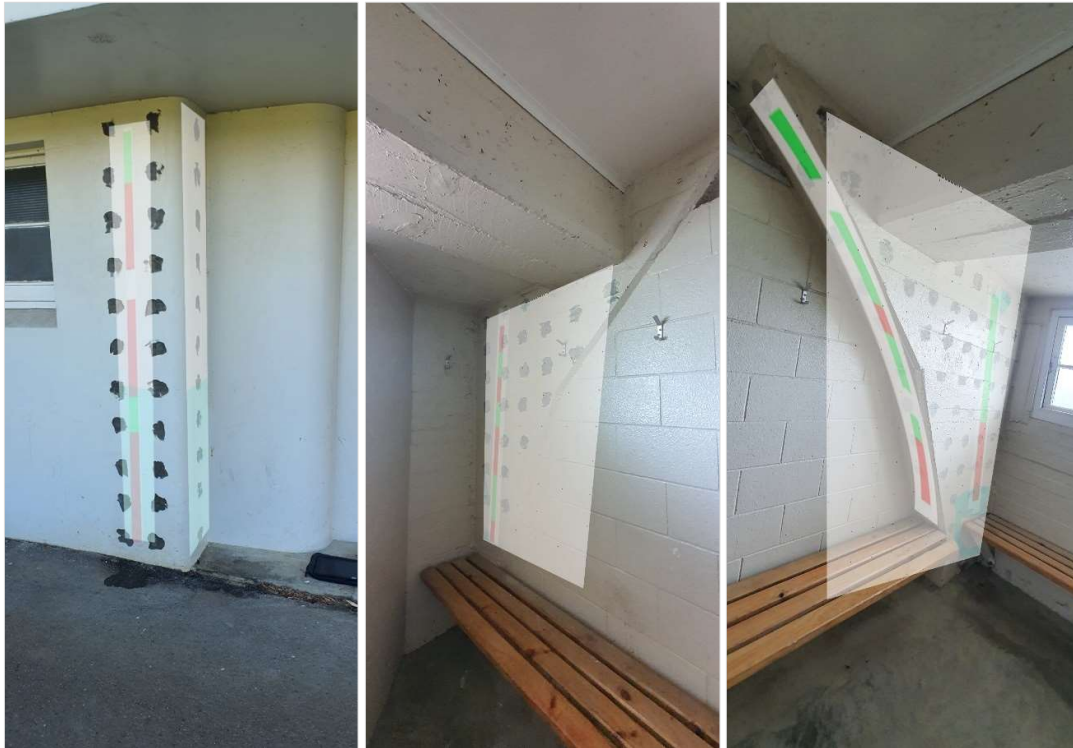
Figure 49: Column Grid C-X - Half-Cell - Cover Map

| Comment: | <p>Column<br/>Grid C-X</p> <p>Half-Cell Potential:</p> <ul style="list-style-type: none"> <li>Blue shaded areas have a 50% probability of active corrosion</li> </ul> <p>Cover Map:</p> <ul style="list-style-type: none"> <li>Stirrups with cover &lt; 30mm (red)</li> <li>Stirrups with cover &gt; 30mm (green)</li> </ul> | | |

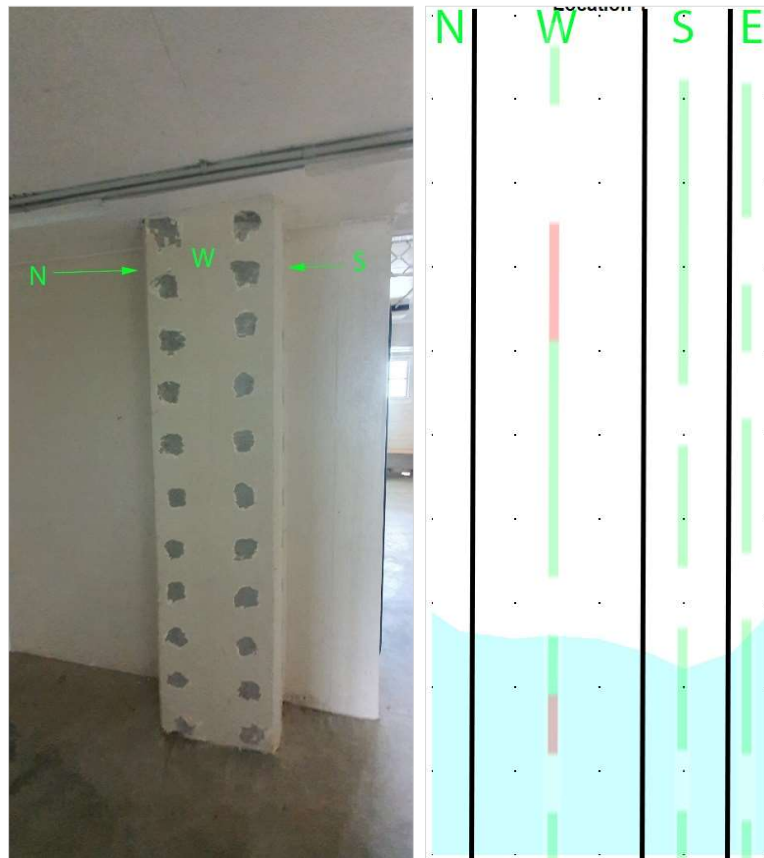
Figure 50: Column C-Y - Half-Cell - Cover Map

| Comment: | <p>Column<br/>Grid C-Y</p> <p>Data is displayed as flat projection</p> <ul style="list-style-type: none"> <li>Black lines indicate the column corners</li> <li>Green letters refer to orientation of the face</li> </ul> <p>Half-Cell Potential:</p> <ul style="list-style-type: none"> <li>Blue shaded areas have a 50% probability of active corrosion</li> </ul> <p>Cover Map:</p> <ul style="list-style-type: none"> <li>Stirrups with cover &lt; 30mm (red) are present on the West face</li> <li>Stirrups with cover &gt; 30mm (green)</li> </ul> | | |

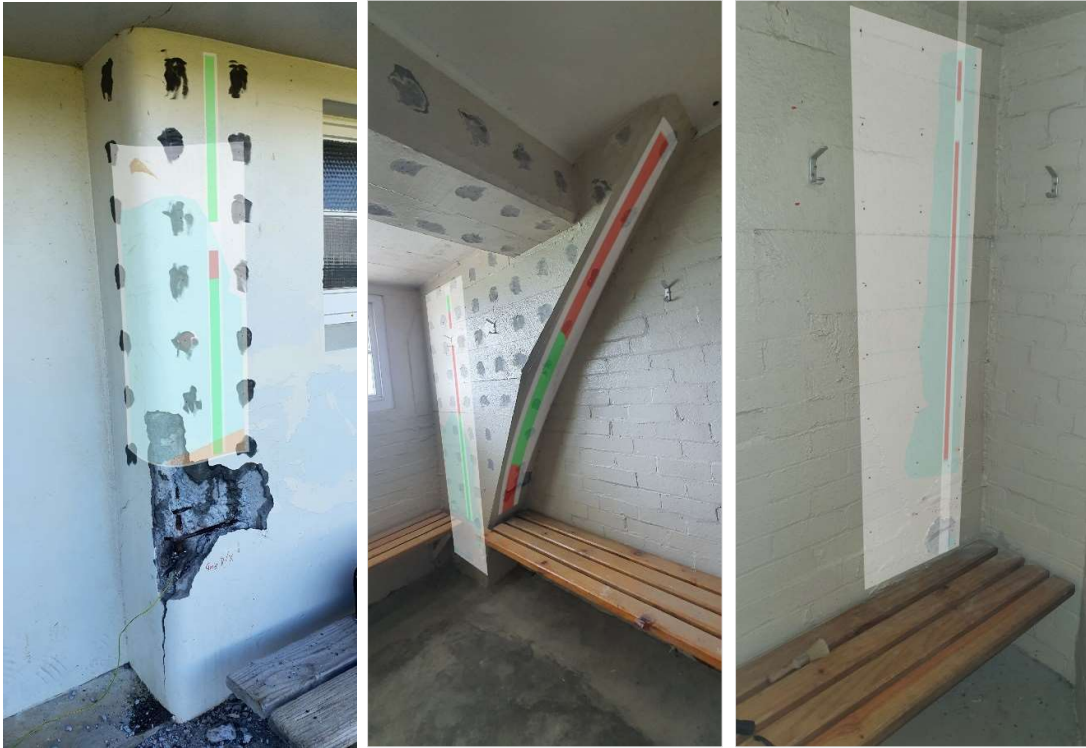
Figure 51: Column D-X - Half-Cell - Cover Map

| Comment: | <p>Column<br/>Grid D-X</p> <p>Half-Cell Potential:</p> <ul style="list-style-type: none"> <li>Blue shaded areas have a 50% probability of active corrosion</li> </ul> <p>Cover Map:</p> <ul style="list-style-type: none"> <li>Stirrups with cover &lt; 30mm (red)</li> <li>Stirrups with cover &gt; 30mm (green)</li> </ul> | | |

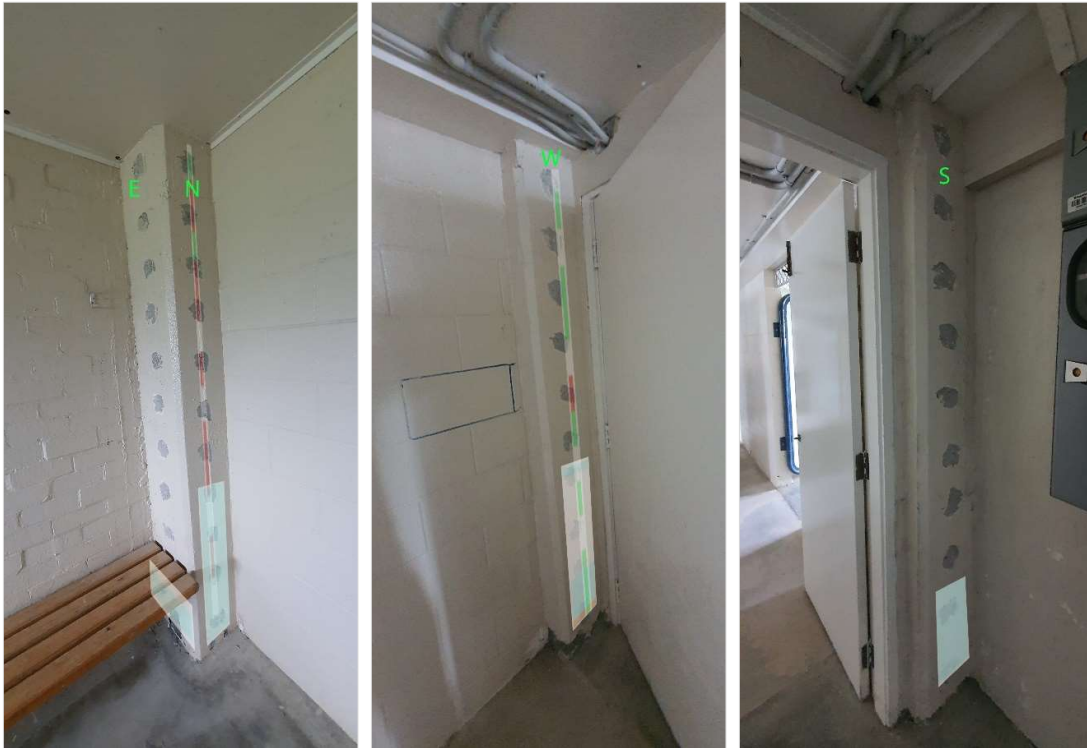
Figure 52: Column D-Y - Half-Cell - Cover Map

| Comment: | <p>Column<br/>Grid D-Y</p> <p>Half-Cell Potential:</p> <ul style="list-style-type: none"> <li>Blue shaded areas have a 50% probability of active corrosion</li> </ul> <p>Cover Map:</p> <ul style="list-style-type: none"> <li>Stirrups with cover &lt; 30mm (red) are present on the West face</li> <li>Stirrups with cover &gt; 30mm (green)</li> </ul> | | |

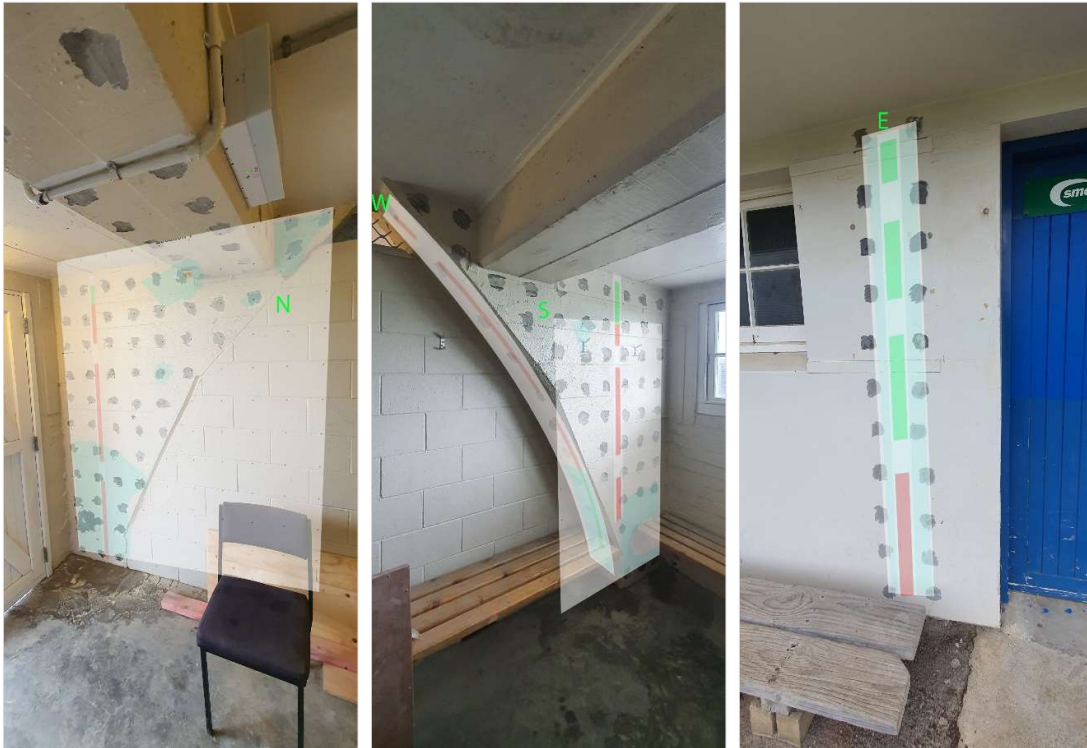
Figure 53: Column Grid E-X - Half-Cell - Cover Map

| Comment: | <p>Column<br/>Grid E-X</p> <p>Half-Cell Potential:</p> <ul style="list-style-type: none"> <li>Blue shaded areas have a 50% probability of active corrosion</li> </ul> <p>Cover Map:</p> <ul style="list-style-type: none"> <li>Stirrups with cover &lt; 30mm (red)</li> <li>Stirrups with cover &gt; 30mm (green)</li> </ul> | | |

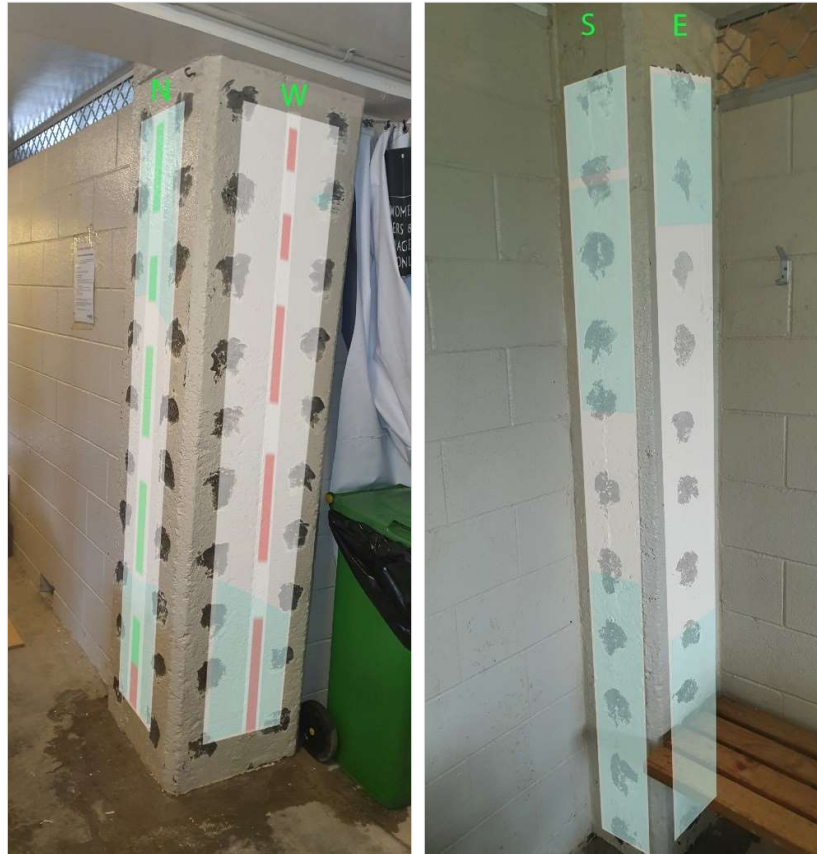
Figure 54: Column Grid E-Y - Half-Cell - Cover Map

| Comment: | <p>Column<br/>Grid E-Y</p> <p>Half-Cell Potential:</p> <ul style="list-style-type: none"> <li>Blue shaded areas have a 50% probability of active corrosion</li> </ul> <p>Cover Map:</p> <ul style="list-style-type: none"> <li>Stirrups with cover &lt; 30mm (red)</li> <li>Stirrups with cover &gt; 30mm (green)</li> </ul> | | |

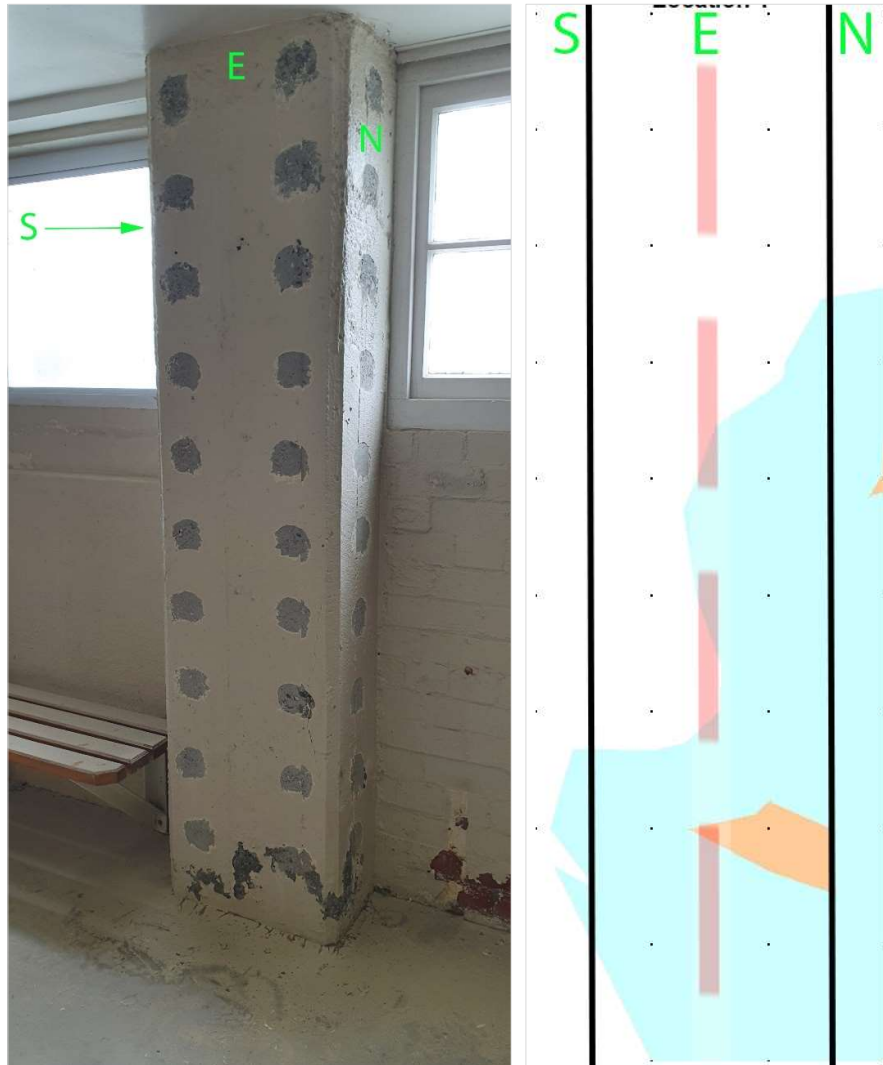
Figure 55: Column Grid E-Z - Half-Cell - Cover Map

| Comment: | <p>Column<br/>Grid E-Z</p> <p>Data is displayed as flat projection</p> <ul style="list-style-type: none"> <li>Black lines indicate the column corners</li> <li>Green letters refer to orientation of the face</li> </ul> <p>Half-Cell Potential:</p> <ul style="list-style-type: none"> <li>Blue shaded areas have a 50% probability of active corrosion</li> <li>Orange shaded areas have a 90% probability of active corrosion</li> </ul> <p>Cover Map:</p> <ul style="list-style-type: none"> <li>Stirrups with cover &lt; 30mm (red)</li> </ul> | | |

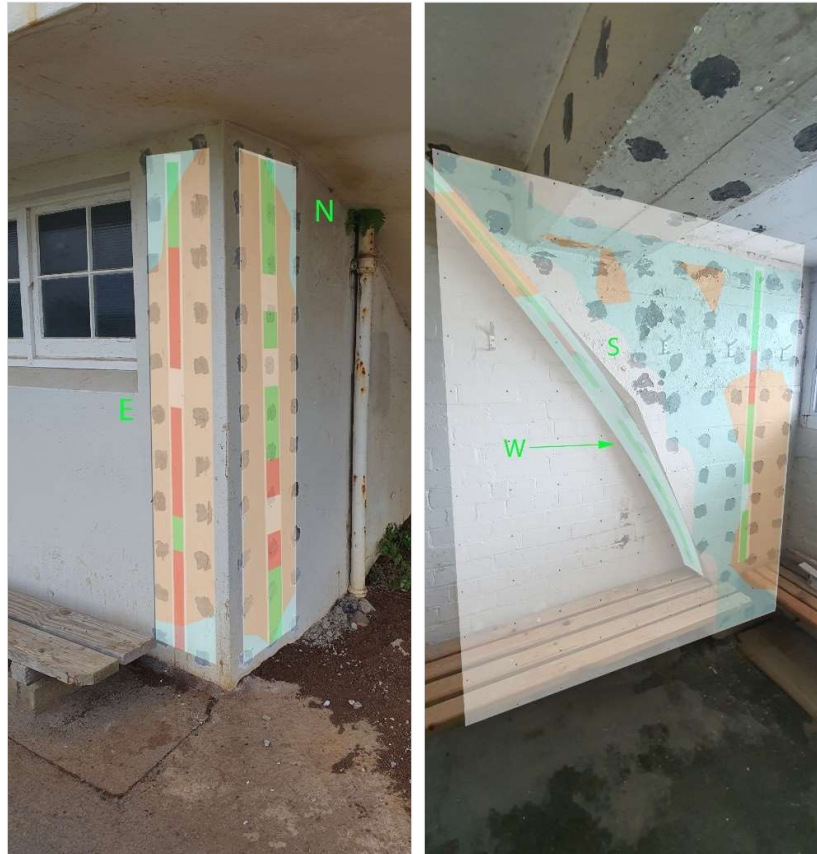
Figure 56: Column Grid F-X - Half-Cell - Cover Map

| Comment: | <p>Column<br/>Grid F-X</p> <p>Half-Cell Potential:</p> <ul style="list-style-type: none"> <li>Blue shaded areas have a 50% probability of active corrosion</li> <li>Orange shaded areas have a 90% probability of active corrosion</li> </ul> <p>Cover Map:</p> <ul style="list-style-type: none"> <li>Stirrups with cover &lt; 30mm (red)</li> <li>Stirrups with cover &gt; 30mm (green)</li> </ul> | | |

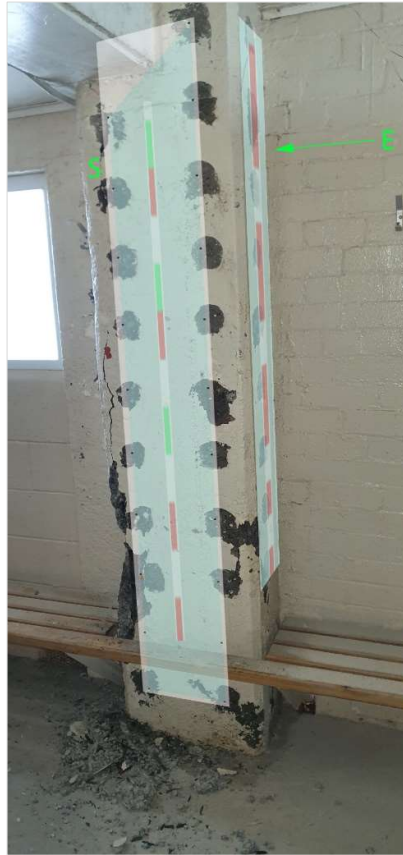
Figure 57: Column Grid F-Y - Half-Cell - Cover Map

| Comment: | <p>Column<br/>Grid F-Y</p> <p>Half-Cell Potential:</p> <ul style="list-style-type: none"> <li>Blue shaded areas have a 50% probability of active corrosion</li> </ul> <p>Cover Map:</p> <ul style="list-style-type: none"> <li>Stirrups with cover &lt; 30mm (red)</li> <li>Stirrups with cover &gt; 30mm (green)</li> </ul> | | |

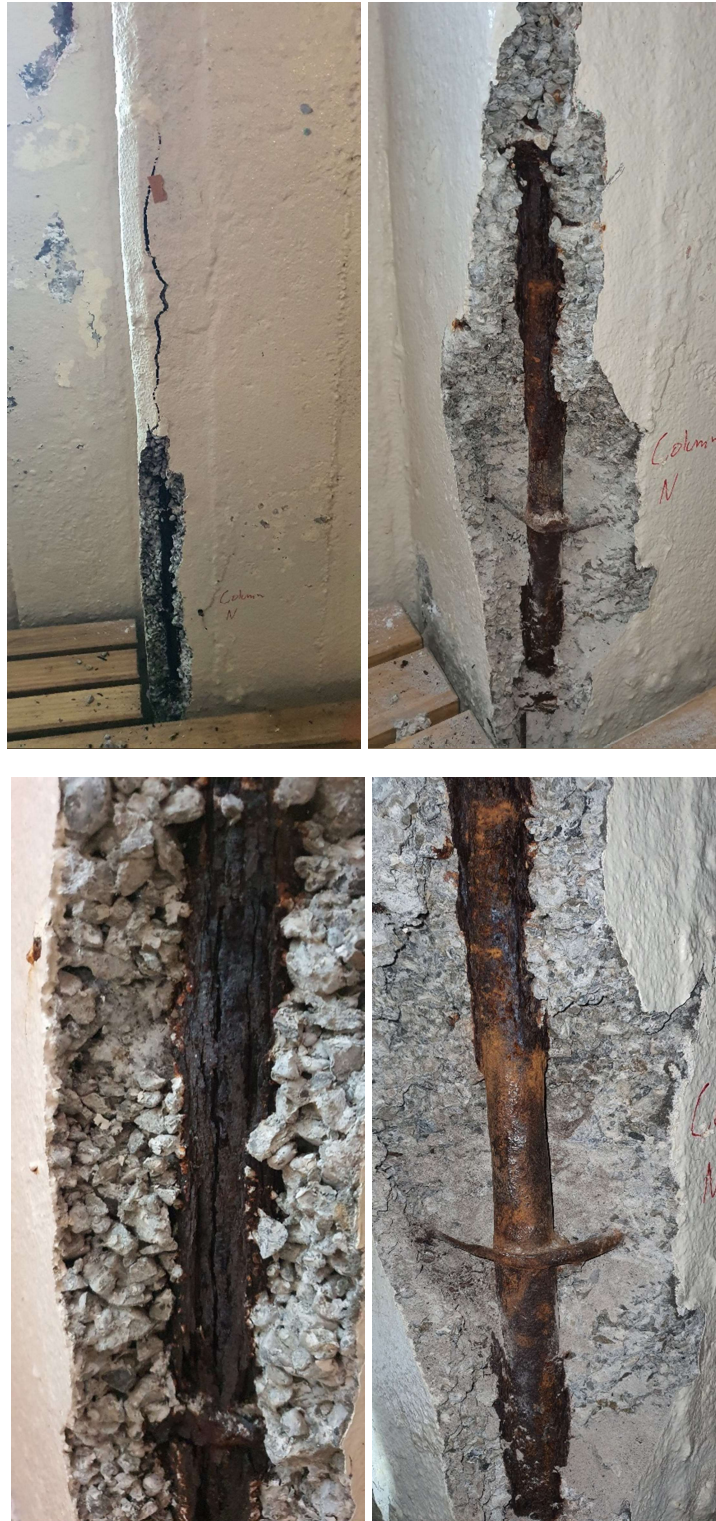
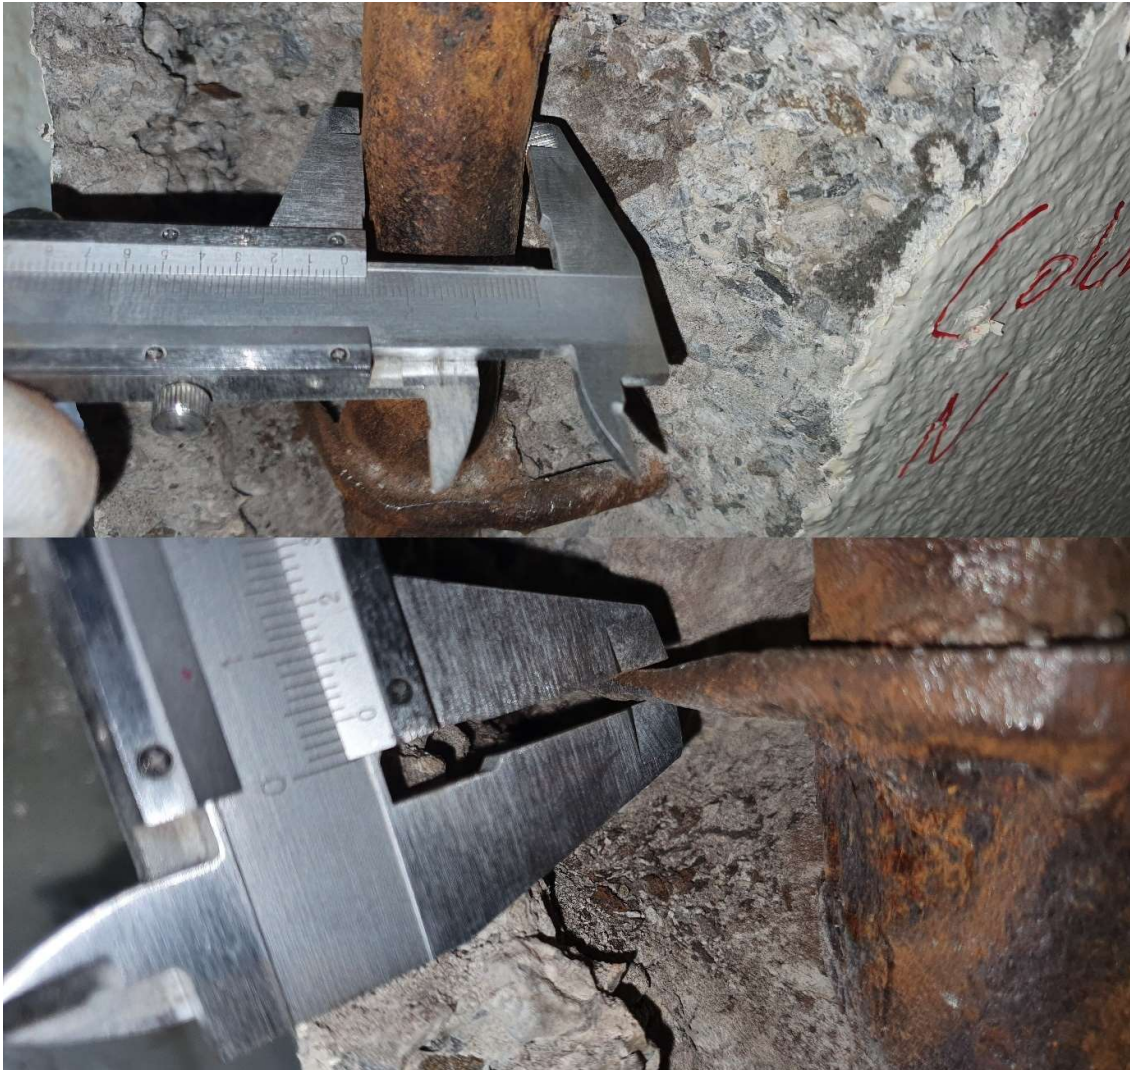
| Comment: | <p>Column<br/>Grid F-Y (inside)</p> <p>Breakout</p> <ul style="list-style-type: none"> <li>• A large area was found to be spalled</li> <li>• The concrete consists of nested aggregate</li> <li>• The bars (main bar and stirrup) are severely corroded</li> <li>• The main bar has a remaining diameter of 29mm (the nominal diameter is 32mm)</li> <li>• The stirrup has a remaining diameter of 3mm (the nominal diameter is 9.5mm)</li> <li>• Corrosion is active</li> </ul> | | |

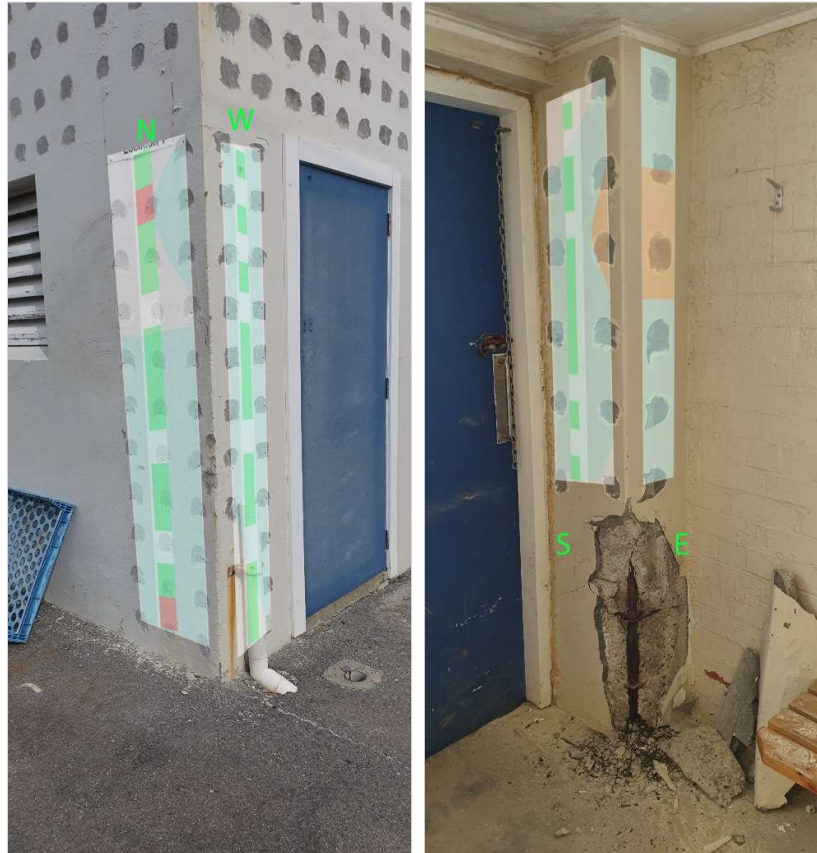
| Comment: | <p>Column<br/>Grid F-Z</p> <p>Half-Cell Potential:</p> <ul style="list-style-type: none"> <li>Blue shaded areas have a 50% probability of active corrosion</li> <li>Orange shaded areas have a 90% probability of active corrosion</li> </ul> <p>Cover Map:</p> <ul style="list-style-type: none"> <li>Stirrups with cover &lt; 30mm (red) <ul style="list-style-type: none"> <li>Single data points may relate to low cover tie wires</li> <li>Ties with insufficient cover can initiate corrosion</li> <li>The corrosion from ties migrates deeper into the structure till it reaches the reinforcing, causing the bars to corrode</li> </ul> </li> <li>Stirrups with cover &gt; 30mm (green)</li> </ul> | | |
