# INDEPENDENT STRUCTURAL INVESTIGATIONS REPORT

INVESTIGATIVE REPORT

| JOB NAME | Petone Grandstand |

| Corrosion survey on the Grandstand Petone. |

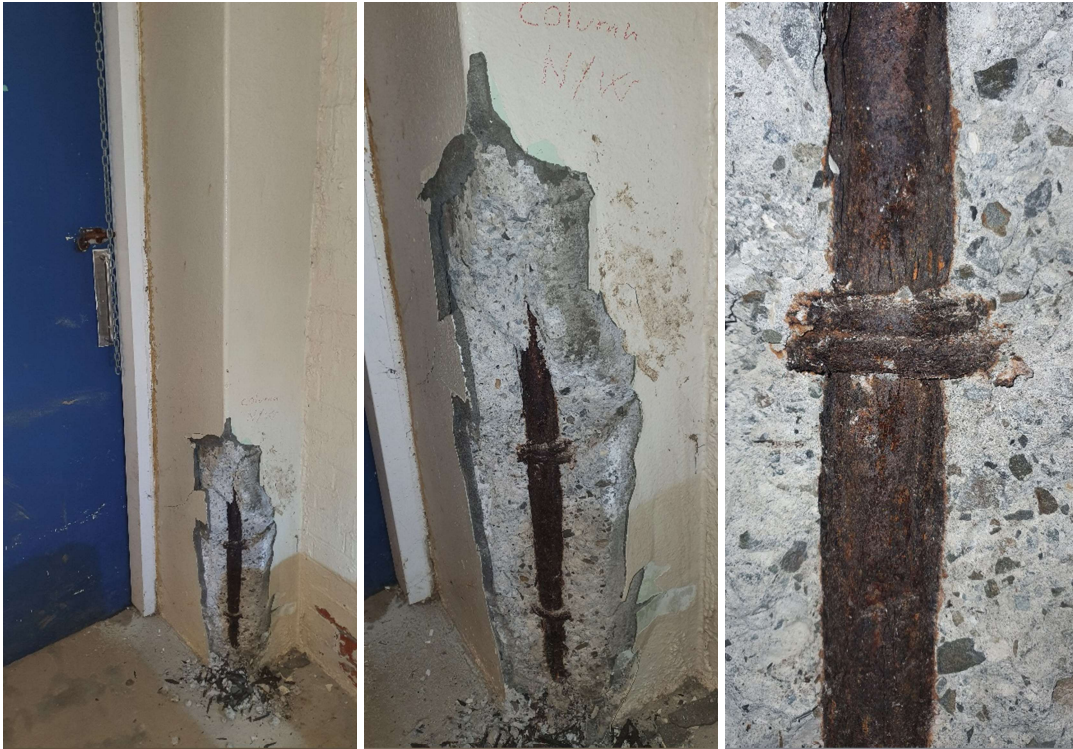
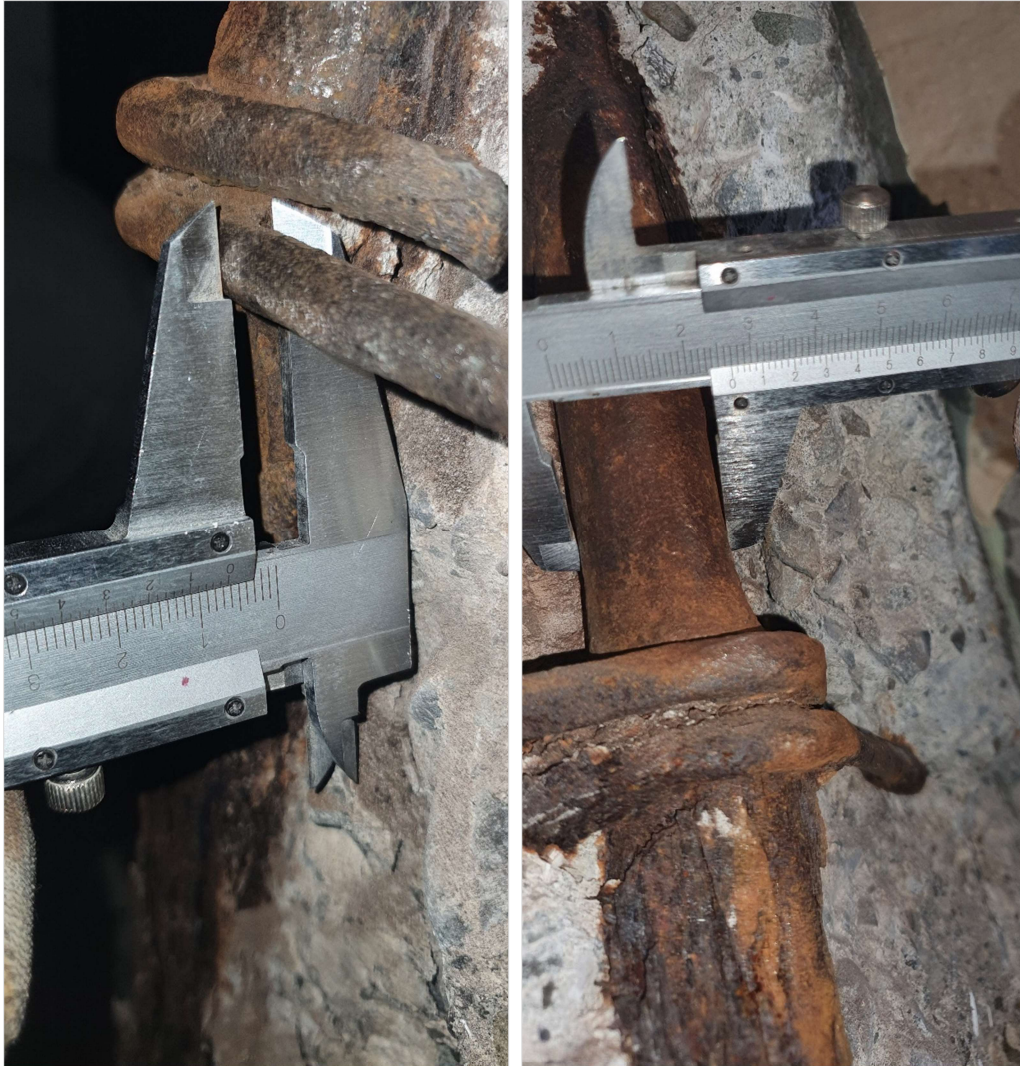
| Comment: | <p>Column<br/>Grid F-Z (inside)</p> <p>Breakout</p> <ul style="list-style-type: none"> <li>• A large area was found to be spalled</li> <li>• The bars (main bar and stirrup) are severely corroded</li> <li>• The main bar has a remaining diameter of 27mm (the nominal diameter is 32mm)</li> <li>• The stirrup has a remaining diameter of 6mm (the nominal diameter is 9.5mm)</li> <li>• Corrosion is active</li> </ul> | | |

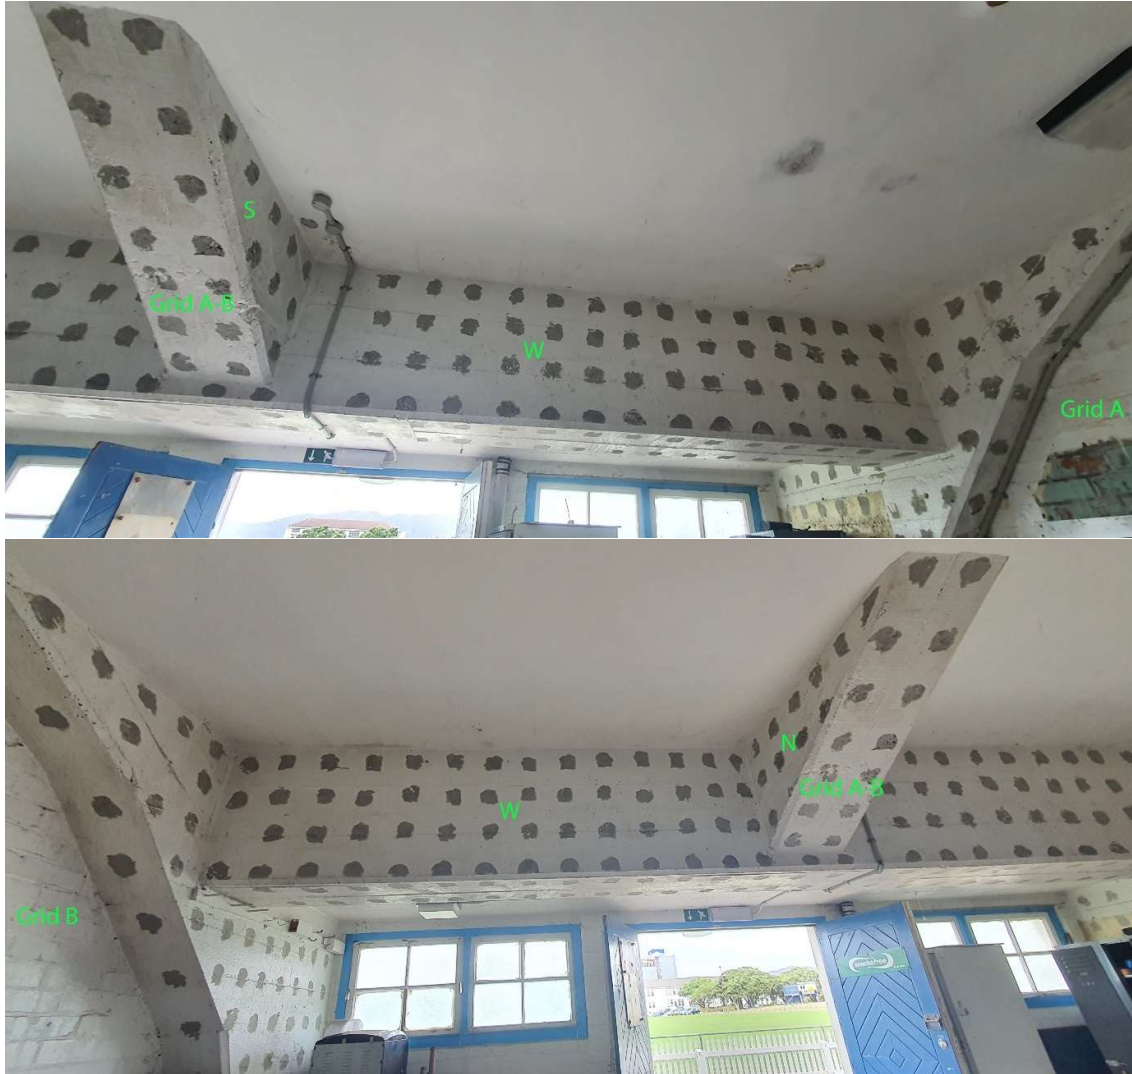
Figure 62: Beam Grid X/A-B

| Comment: | <p>Beam - Inside<br/>Grid X/A-B</p> <p>Data is displayed as flat projection</p> <ul style="list-style-type: none"><li>• Black lines indicate the beam corners</li><li>• Green letters refer to orientation of the face</li></ul> <p>Graphics:</p> <ul style="list-style-type: none"><li>• Top: Raking Beam – Grid A-B, at beam Grid X</li><li>• Middle &amp; Bottom: Beam Grid X</li></ul> <p>Half-Cell Potential:</p> <ul style="list-style-type: none"><li>• Blue shaded areas have a 50% probability of active corrosion</li><li>• Orange shaded areas have a 90% probability of active corrosion</li></ul> <p>Cover Map:</p> <ul style="list-style-type: none"><li>• Stirrups with cover &lt; 30mm (red)</li><li>• Stirrups with cover &gt; 30mm (green)</li></ul> | | |

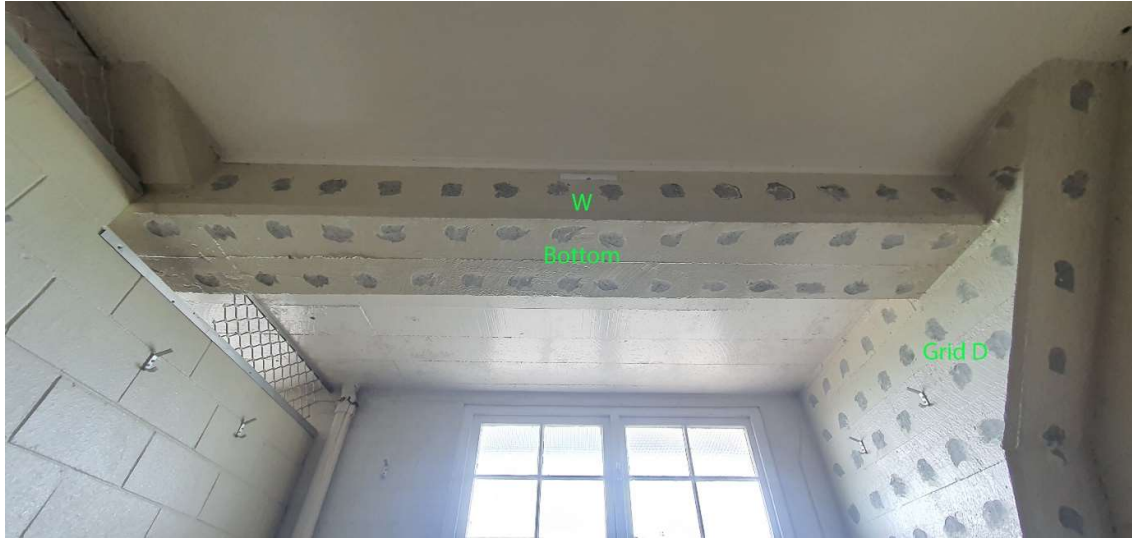
Figure 66: Beam Grid X/E-D

| Comment: | <p>Beam - Inside<br/>Grid X/C-E</p> <p>No maps are displayed for the locations.<br/>Data indicate a 90% probability that no active corrosion is occurring.<br/>The reinforcing of the raking beam shown in photo Figure 67 is heavily corroded from the top (stands). Corrosion has not progressed further down.</p> | | |

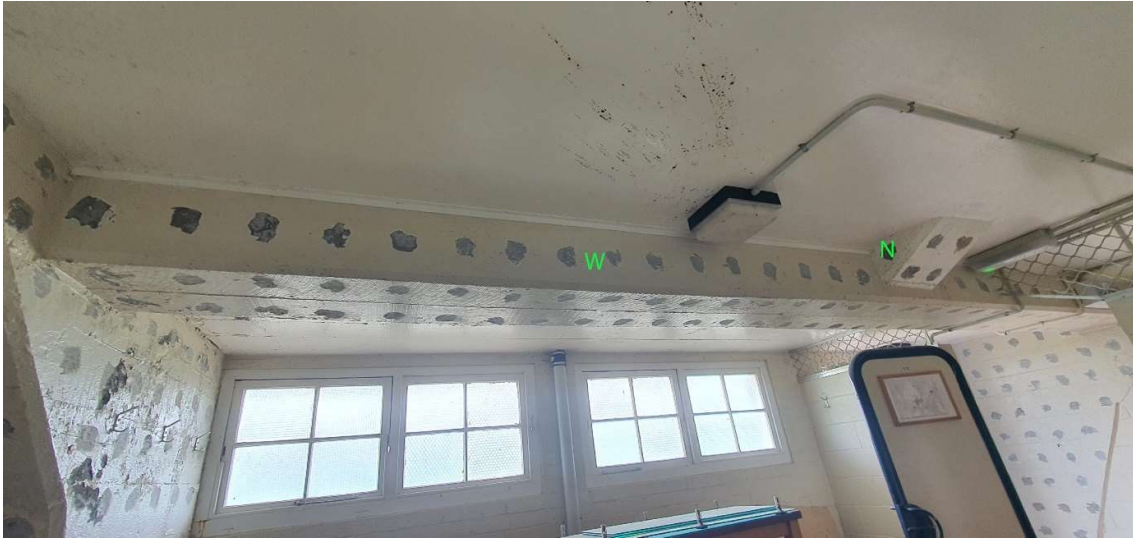
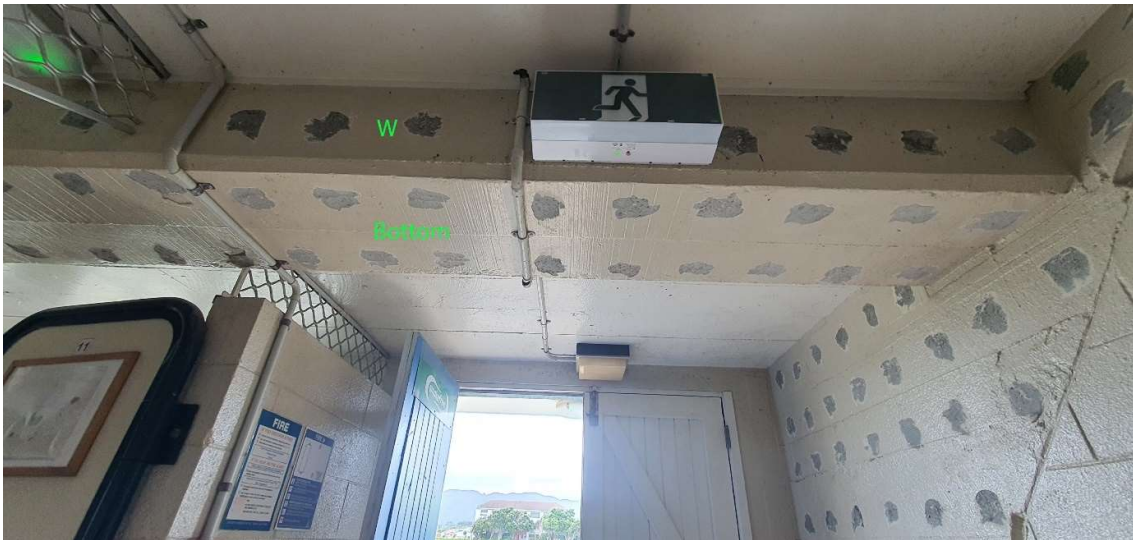
Figure 69: Beam Grid X/E-F

| Comment: | <p>Beam - Inside<br/>Grid X/E-F</p> <p>Data is displayed as flat projection</p> <ul style="list-style-type: none"> <li>Black lines indicate the beam corners</li> <li>Green letters refer to orientation of the face</li> </ul> <p>Graphics:</p> <ul style="list-style-type: none"> <li>Top: Raking Beam – Grid E, at beam Grid X</li> <li>Bottom: Beam Grid X</li> </ul> <p>Half-Cell Potential:</p> <ul style="list-style-type: none"> <li>Blue shaded areas have a 50% probability of active corrosion</li> <li>Orange shaded areas have a 90% probability of active corrosion</li> </ul> <p>Cover Map:</p> <ul style="list-style-type: none"> <li>Stirrups with cover &lt; 30mm (red)</li> <li>Stirrups with cover &gt; 30mm (green)</li> </ul> | | |

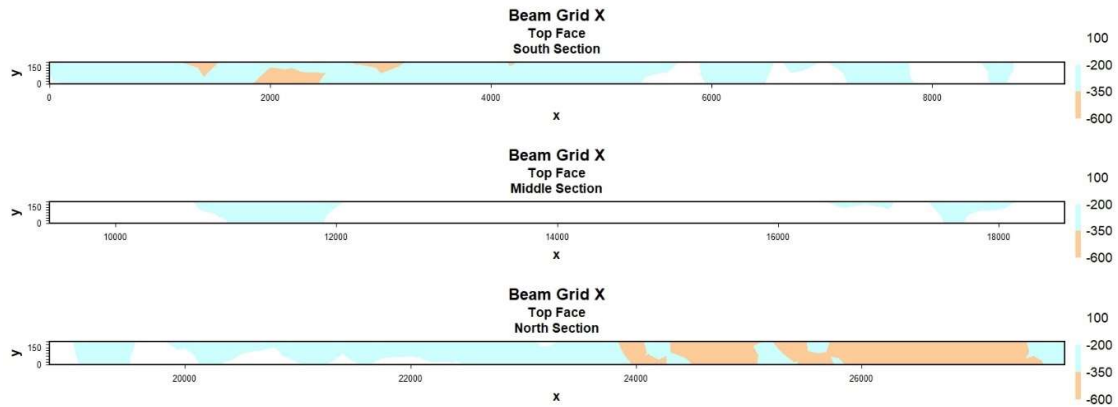
| Comment: | <p>Beam - Outside<br/>Grid X</p> <p>Half-Cell Potential testing was carried out on the top face of the beam on grid X. The data is displayed in three tiers. The top tier starts on the South side, and the bottom tier finishes at the North side.</p> <p>Half-Cell Potential:</p> <ul style="list-style-type: none"> <li>Blue shaded areas have a 50% probability of active corrosion</li> <li>Orange shaded areas have a 90% probability of active corrosion</li> </ul> <p>Cover Map:</p> <ul style="list-style-type: none"> <li>Stirrups with cover &lt; 30mm (red)</li> <li>Stirrups with cover &gt; 30mm (green)</li> </ul> <p>Note: Half-Cell Potential testing was not carried out on the vertical face (facing Eastward) due to the bad condition of the beam. No statement for this part of the beam can be made.</p> | | |

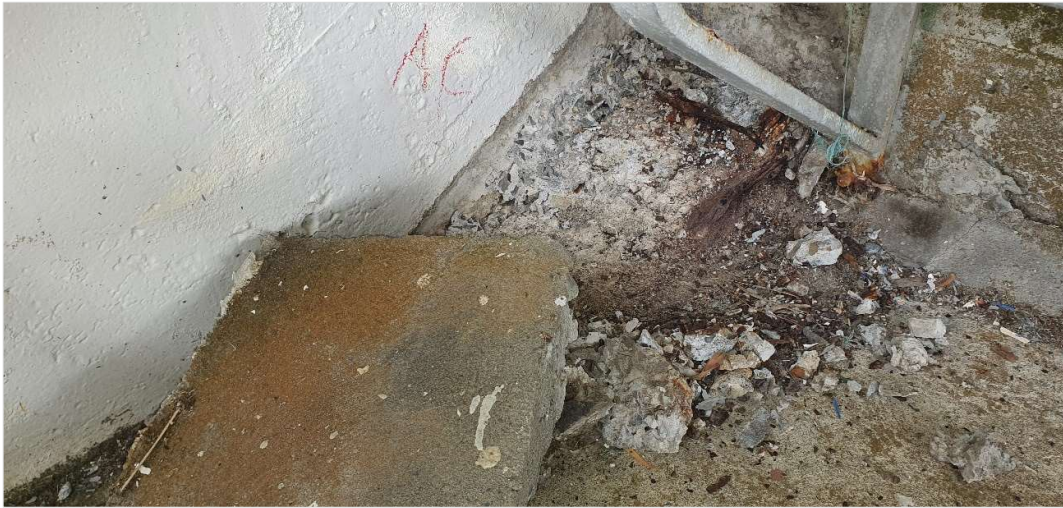
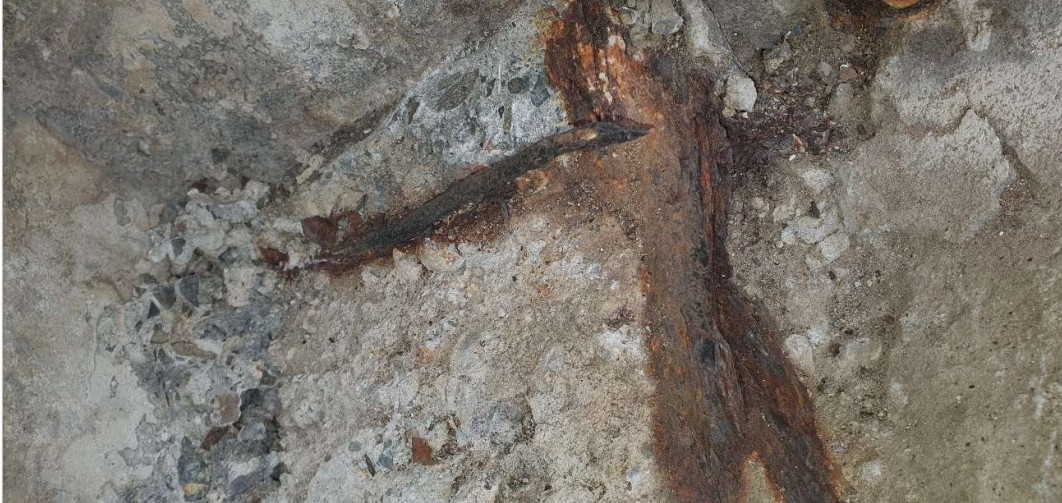
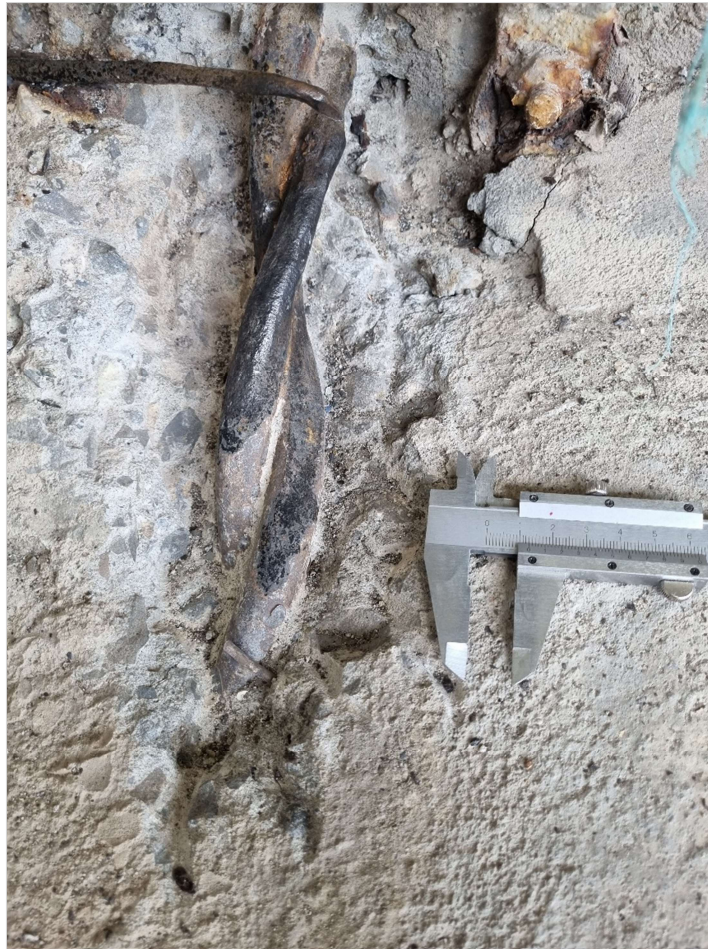
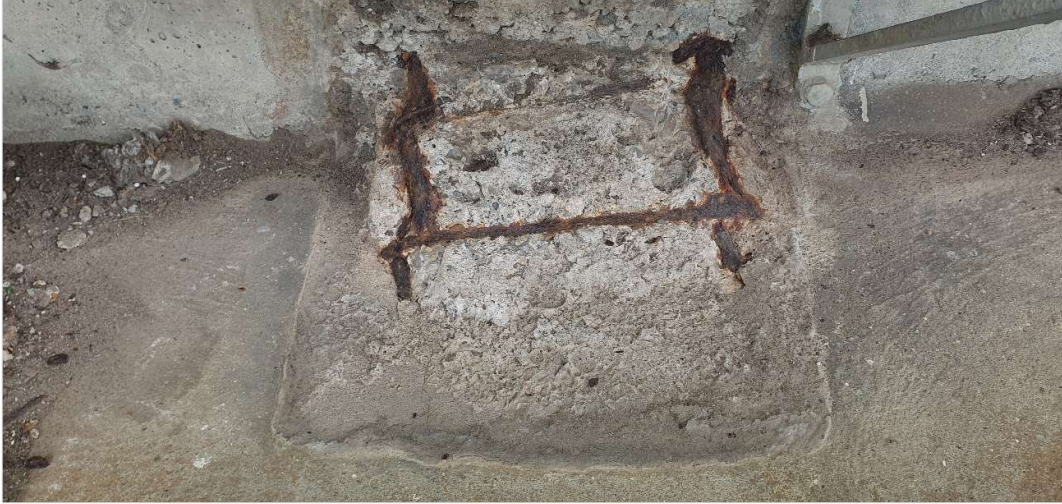
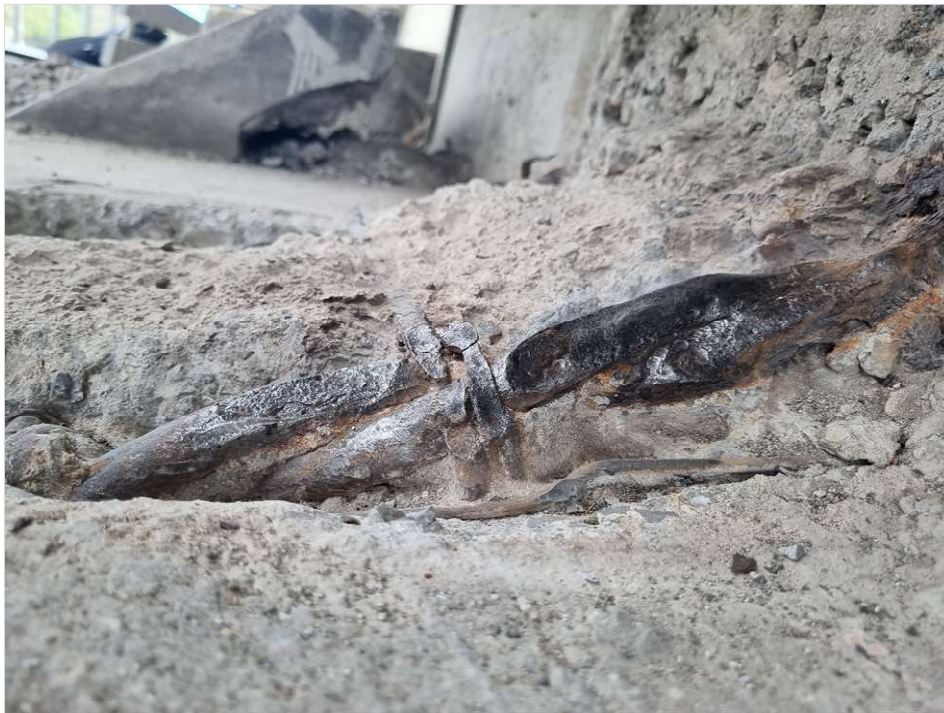
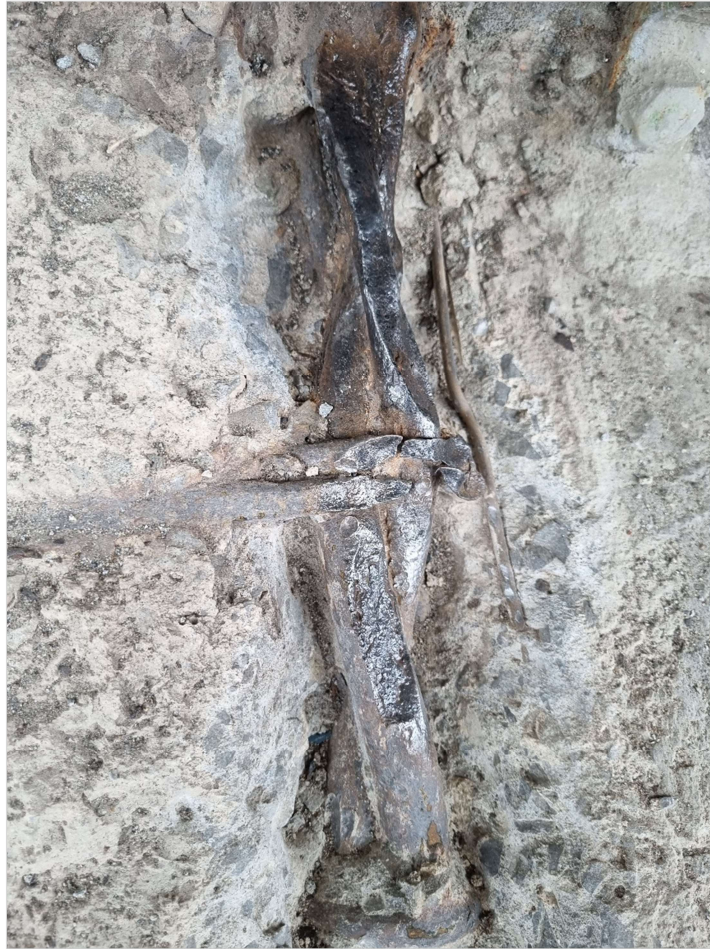
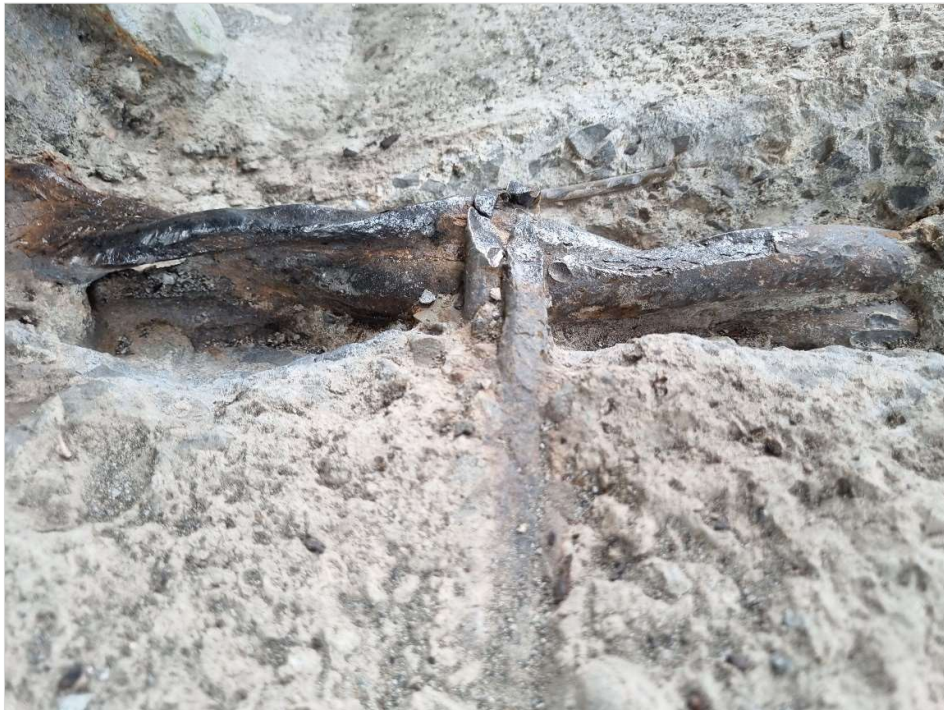
Remedial work was carried out at some stage in the stands. Large areas on the beam on Grid X have been patched. A lot of the raking beams, if not all have been also remediated. No information about this work is known, however, this was likely done due to corrosion of bars and spalling of concrete. A lot of the remediated areas show severe signs of deterioration, such as delamination, spalling, and corrosion. Some of the cover concrete on raking beams could be lifted in one piece.

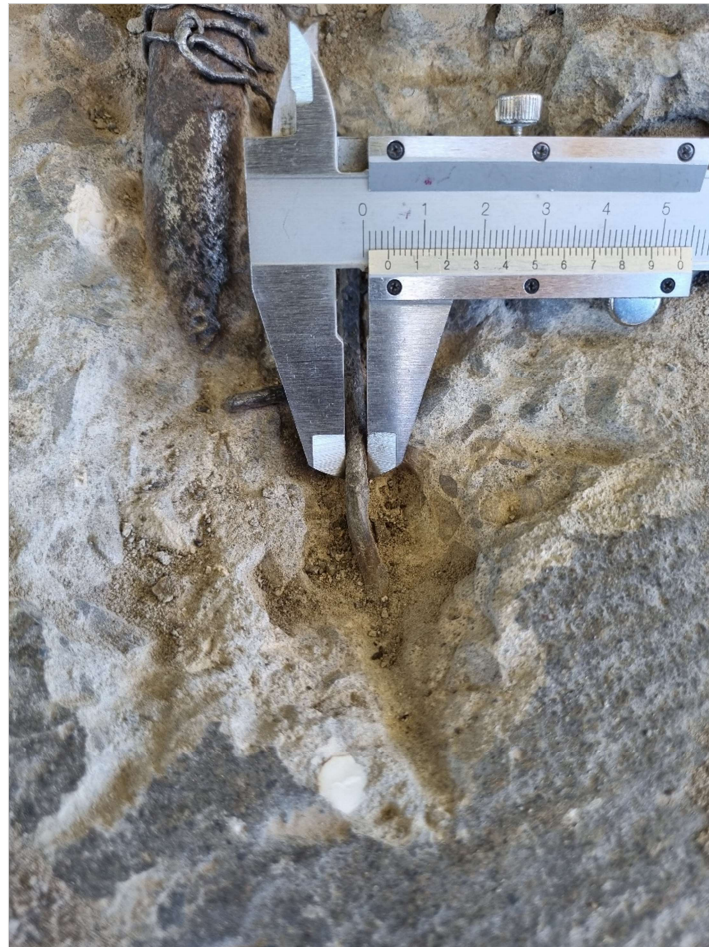
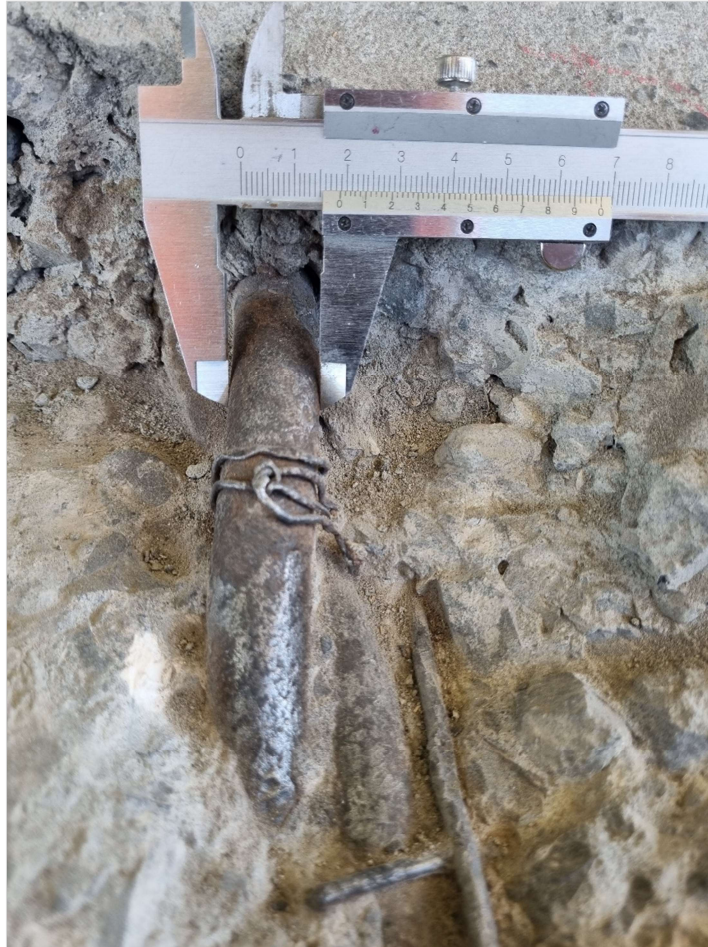
Raking Beam D2E:

After the initial findings of deteriorated raking beams, locations in seemingly good condition were investigated. The locations were chosen by visual inspection and sounding. An additional focus at these locations was to confirm the condition of the mesh of the bleachers. Five locations were broken out and inspected. None was found to have noticeable problems with corrosion.
