## **Asbestos Management Survey Report**

Petone Recreation Ground Grandstand  
16 Udy Street  
Petone  
Lower Hutt, 5012

**Hutt City Council**

Reference: W-00632

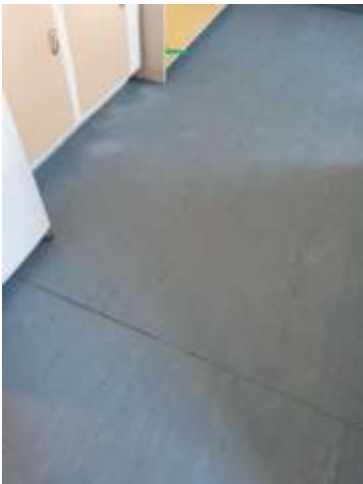
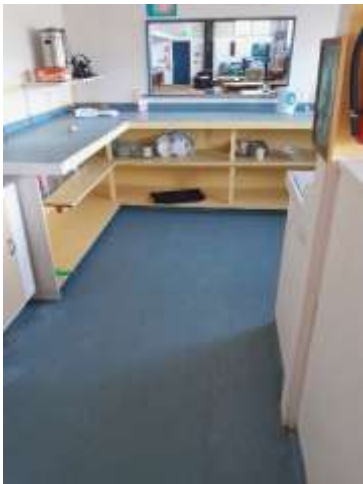
| Location | Petone Recreation Ground Grandstand, 1st Floor, Kitchen | | Sample Number | 1 (S) |

| Location | Petone Recreation Ground Grandstand, 1st Floor, Kitchen | | Sample Number | 1 (S) |
|---|---|---|---|---|
| | Item ID / Description | 001 / Vinyl Flooring Includes hallway | | |
| | Asbestos Type | NAD | N/A | |

| Location | Petone Recreation Ground Grandstand, 1st Floor, Kitchen | | Sample Number | 1 (S) |
|---|---|---|---|---|
| | Recommendation | No further action required | | |

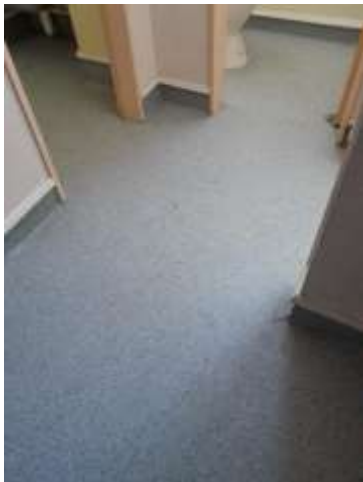
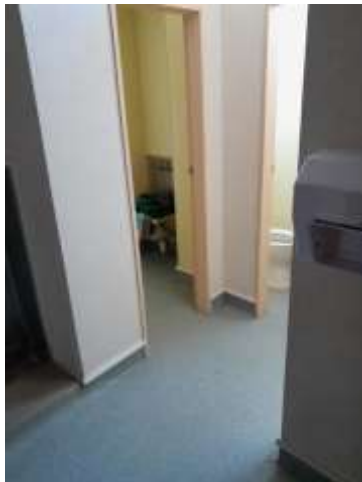
| Location | Petone Recreation Ground Grandstand, 1st Floor, Males Bathroom | | Sample Number | 2 (S) |

| Location | Petone Recreation Ground Grandstand, 1st Floor, Males Bathroom | | Sample Number | 2 (S) |
|---|---|---|---|---|
| | Item ID / Description | 002 / Vinyl Flooring | | |
| | Asbestos Type | NAD | N/A | |

| Location | Petone Recreation Ground Grandstand, 1st Floor, Males Bathroom | | Sample Number | 2 (S) |
|---|---|---|---|---|
| | Recommendation | No further action required | | |

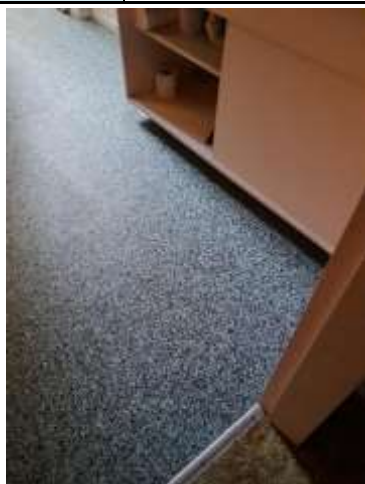
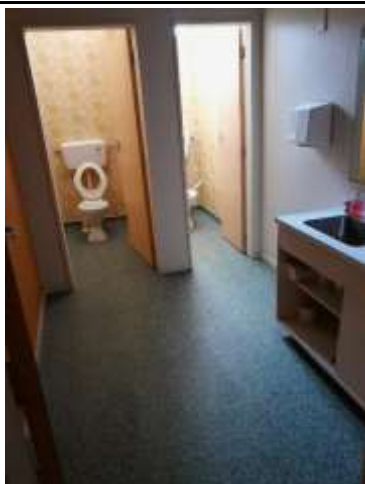
| Location | Petone Recreation Ground Grandstand, 1st Floor, Females Bathroom | | | Sample Number | 3 (S) |

| | Item ID / Description | 003 / Vinyl Flooring | | | |
| | Asbestos Type | NAD | | | N/A |

| | Recommendation | No further action required | | | |

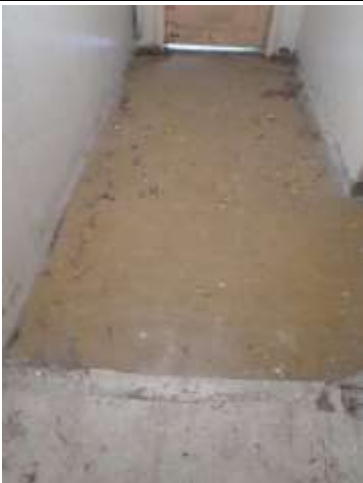
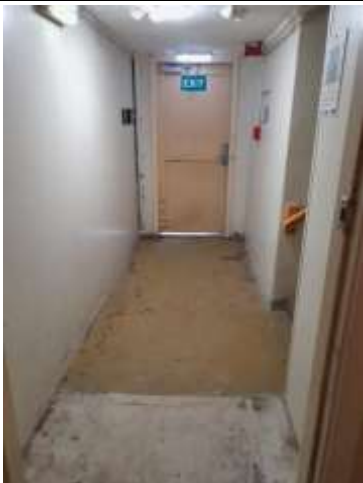
| Location | Petone Recreation Ground Grandstand, Ground Floor, Stairway Lobby | | Sample Number | 5 (S) |

| Location | Petone Recreation Ground Grandstand, Ground Floor, Stairway Lobby | | Sample Number | 5 (S) |
|---|---|---|---|---|
| | Item ID / Description | 005 / Vinyl Flooring | | |
| | Asbestos Type | NAD | N/A | |

| Location | Petone Recreation Ground Grandstand, Ground Floor, Stairway Lobby | | Sample Number | 5 (S) |
|---|---|---|---|---|
| | Recommendation | No further action required | | |

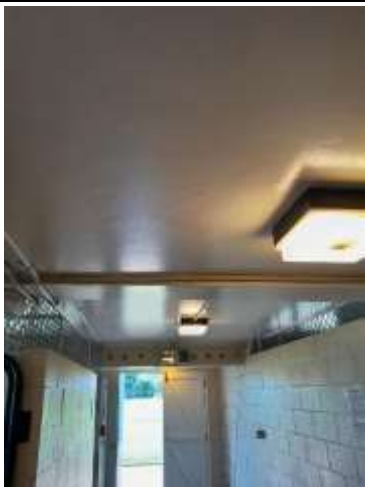
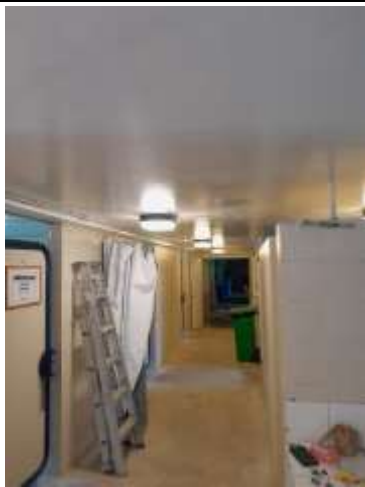
| Location | Petone Recreation Ground Grandstand, Ground Floor, Changing Rooms and Hallway | | Sample Number | 6 (S) |

| Location | Petone Recreation Ground Grandstand, Ground Floor, Changing Rooms and Hallway | | Sample Number | 6 (S) |
|---|---|---|---|---|
| | | Item ID / Description | 006 / Ceiling Lining | |
| | | Asbestos Type | NAD | N/A |

| Location | Petone Recreation Ground Grandstand, Ground Floor, Changing Rooms and Hallway | | Sample Number | 6 (S) |
|---|---|---|---|---|
| | | Recommendation | No further action required | |

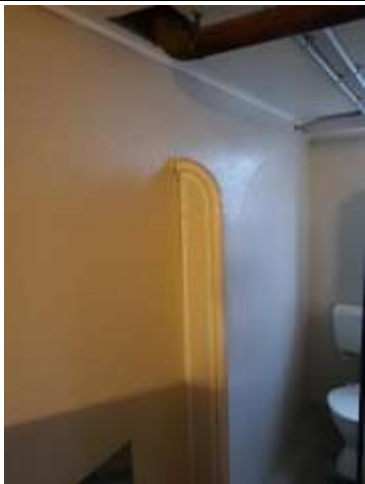
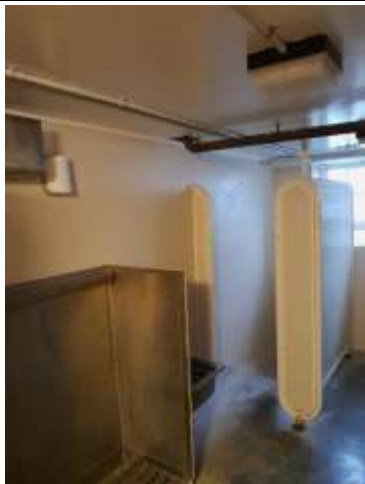
| Location | Petone Recreation Ground Grandstand, Ground Floor, Changing Rooms | | Sample Number | 7 (S) |

| Location | Petone Recreation Ground Grandstand, Ground Floor, Changing Rooms | | Sample Number | 7 (S) |
|---|---|---|---|---|
| | | Item ID / Description | 007 / Toilet Walls | |
| | | Asbestos Type | NAD | N/A |

| Location | Petone Recreation Ground Grandstand, Ground Floor, Changing Rooms | | Sample Number | 7 (S) |
|---|---|---|---|---|
| | | Recommendation | No further action required | |

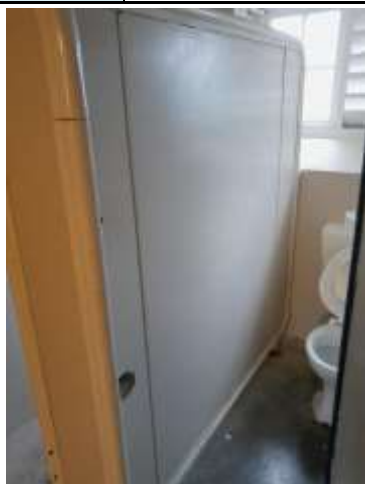
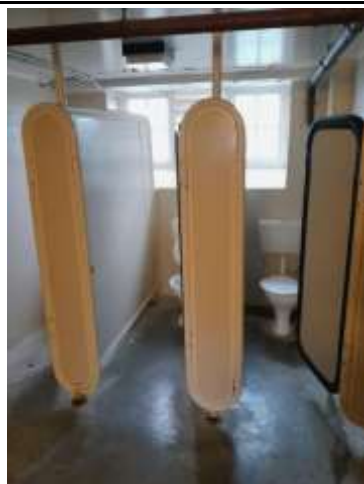
| Location | Petone Recreation Ground Grandstand, Ground Floor, Toilet partitions | | Sample Number | 8 (S) |

| Location | Petone Recreation Ground Grandstand, Ground Floor, Toilet partitions | | Sample Number | 8 (S) |
|---|---|---|---|---|
| | Item ID / Description | 008 / Cement lining | | |

| Location | Petone Recreation Ground Grandstand, Ground Floor, Toilet partitions | | Sample Number | 8 (S) |
|---|---|---|---|---|
| | Recommendation | No further action required | | |

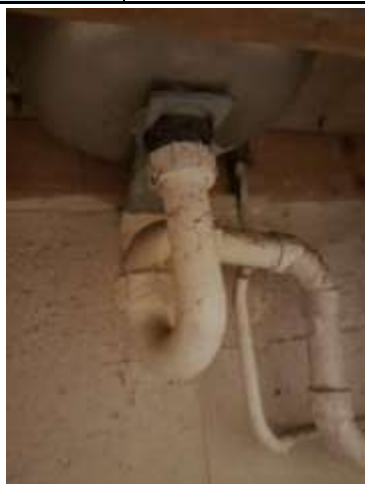
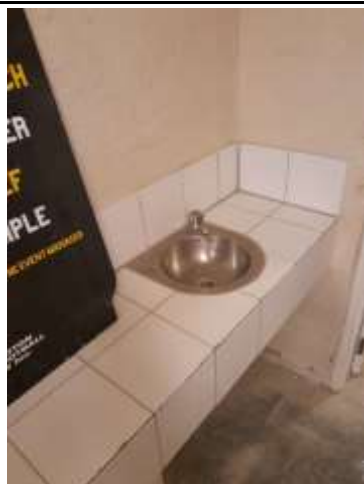
| Location | Petone Recreation Ground Grandstand, Ground Floor, Hallway | | Sample Number | 9 (S) |

| Location | Petone Recreation Ground Grandstand, Ground Floor, Hallway | | Sample Number | 9 (S) |
|---|---|---|---|---|
| | Item ID / Description | 009 / Sink Sealant | | |

| Location | Petone Recreation Ground Grandstand, Ground Floor, Hallway | | Sample Number | 9 (S) |
|---|---|---|---|---|
| | Recommendation | No further action required | | |

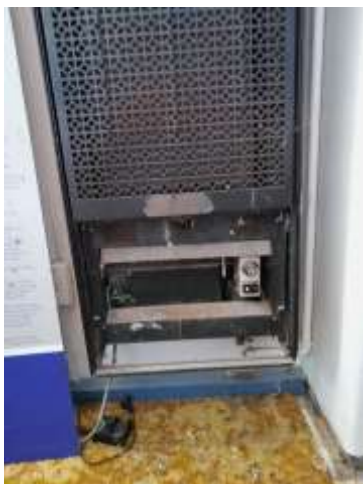
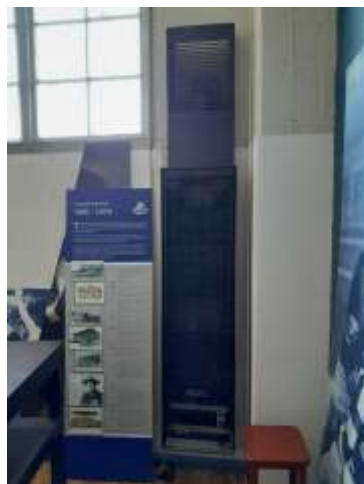
| Petone Recreation Ground Grandstand | | | | | |
|---|---|---|---|---|---|
| 1st Floor | Longroom | 004 / Heaters - Suspected Asbestos | P004 | Low (6) | Inspect, test prior to disturbance |

| | | Item ID / Description | 004 / Heaters | | |
| | | Product Type | Thermal insulation (eg pipe and boiler lagging), sprayed asbestos, loose asbestos, asbestos mattresses and packing. | 3 | |
| | | Condition | Good condition | 0 | |
| | | Comments: | Includes flue outside building. Item should be presumed to contain asbestos as a precaution, unless proven otherwise. | | |

| | | Recommendation | Inspect, test prior to disturbance | | |

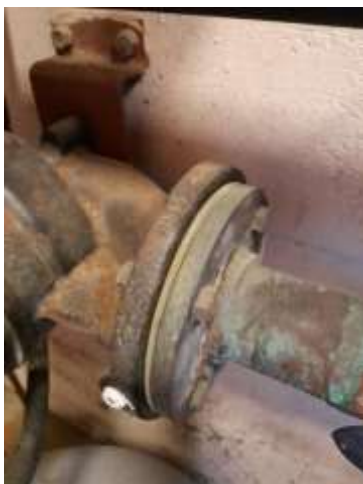
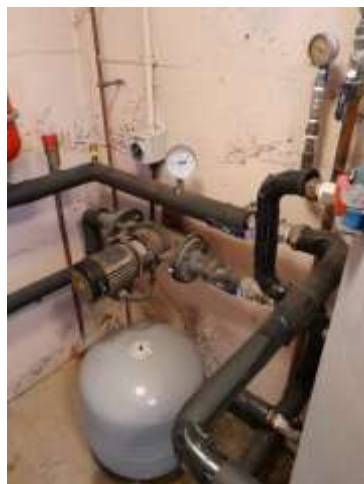
| Petone Recreation Ground Grandstand | | | | | |
|---|---|---|---|---|---|
| Ground Floor | Hot Water Cylinder Room | 010 / Gaskets - Gaskets (compressed) | P010 | Very Low (4) | Inspect, test prior to disturbance |

| | | Item ID / Description | 010 / Gaskets | |
| | | Condition | Good condition | 0 |
| | | Comments: | All non-rubber compressed gaskets should be presumed to contain asbestos as a precaution, unless individually sampled to prove otherwise. | |

| | | Recommendation | Inspect, test prior to disturbance | |

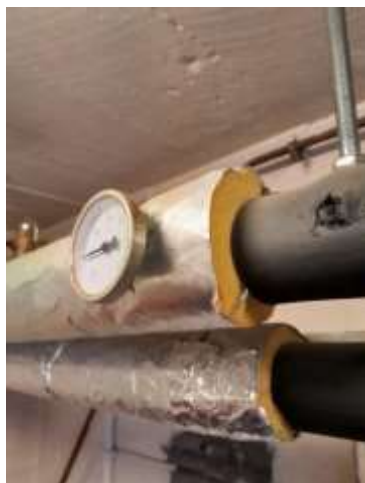
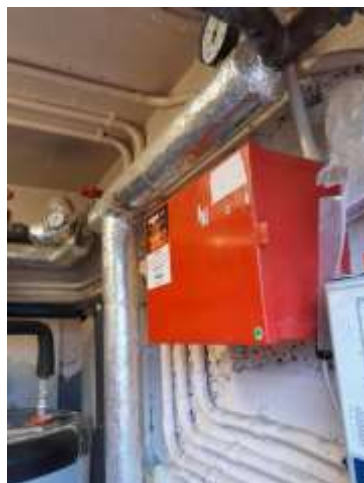
| Petone Recreation Ground Grandstand | | | | | |
|---|---|---|---|---|---|
| Ground Floor | Hot Water Cylinder Room | 011 / Pipe Lagging - Insulation | P011 | Low (6) | Inspect, test prior to disturbance |

| | Item ID / Description | 011 / Pipe Lagging | | | |
| | Product Type | Thermal insulation (eg pipe and boiler lagging), sprayed asbestos, loose asbestos, asbestos mattresses and packing. | | | 3 |
| | Condition | Good condition | | | 0 |
| | Comments: | Item should be presumed to contain asbestos as a precaution, unless proven otherwise. | | | |

| | Recommendation | Inspect, test prior to disturbance | | | |

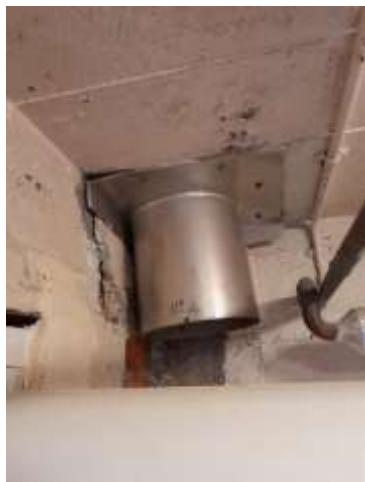
| Petone Recreation Ground Grandstand | | | | | |
|---|---|---|---|---|---|
| Ground Floor | Hot Water Cylinder Room | 012 / Flue into Ceiling - Suspected Asbestos | P012 | Low (6) | Inspect, test prior to disturbance |

| | Item ID / Description | 012 / Flue into Ceiling | | | |
| | Product Type | Thermal insulation (eg pipe and boiler lagging), sprayed asbestos, loose asbestos, asbestos mattresses and packing. | | | 3 |
| | Condition | Good condition | | | 0 |
| | Comments: | Item should be presumed to contain asbestos as a precaution, unless proven otherwise. | | | |

| | Recommendation | Inspect, test prior to disturbance | | | |

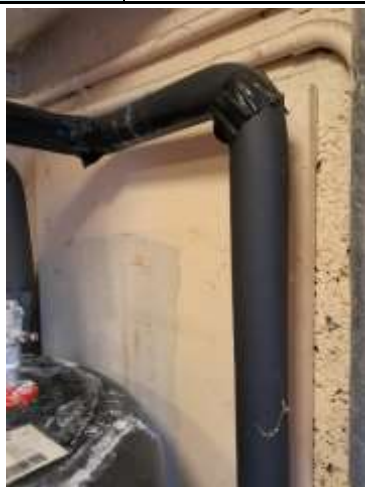
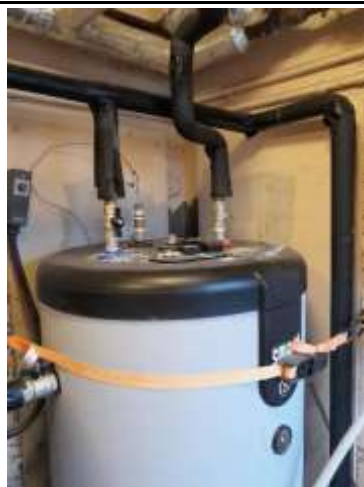
| Petone Recreation Ground Grandstand | | | | | |
|---|---|---|---|---|---|
| Ground Floor | Hot Water Cylinder Room | 013 / Cement Boards - Cement Product | P013 | Very Low (4) | Inspect, test prior to disturbance |

| <div></div> | Item ID / Description | 013 / Cement Boards | | | |
| | Condition | Good condition | | | 0 |
| | Comments: | Behind and below Hot Water Cylinders | | | |

| | Recommendation | Inspect, test prior to disturbance | | | |

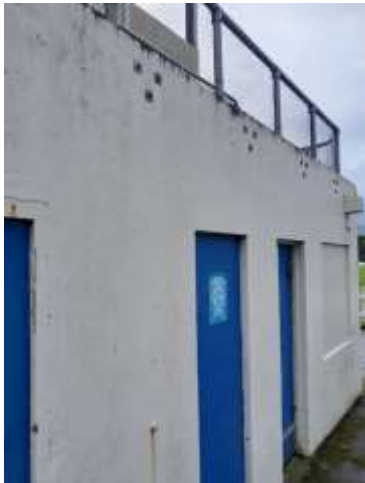
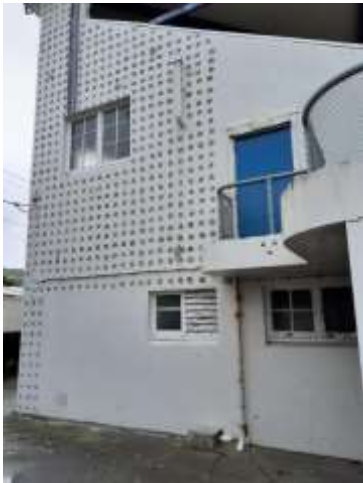
| Petone Recreation Ground Grandstand | | | | | |
|---|---|---|---|---|---|
| External | Exterior | 014 / Render - Suspected Asbestos | P014 | Low (6) | Inspect, test prior to disturbance |

| <div></div> | Item ID / Description | 014 / Render | | | |
| | Product Type | Thermal insulation (eg pipe and boiler lagging), sprayed asbestos, loose asbestos, asbestos mattresses and packing. | | | 3 |
| | Condition | Good condition | | | 0 |
| | Comments: | Item should be presumed to contain asbestos as a precaution, unless proven otherwise. | | | |

| | Recommendation | Inspect, test prior to disturbance | | | |

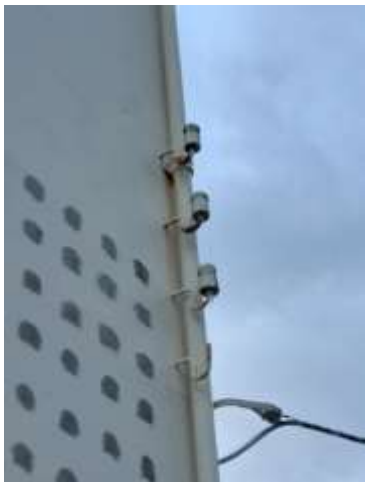
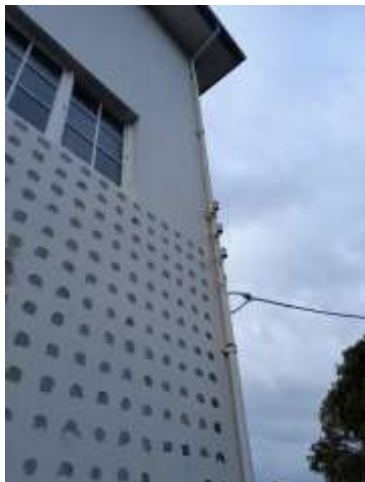
| Petone Recreation Ground Grandstand | | | | | |
|---|---|---|---|---|---|
| External | Exterior | 015 / Power insulators - Suspected Asbestos | P015 | Low (6) | Inspect, test prior to disturbance |

| Location | Petone Recreation Ground Grandstand, External, Exterior | | Sample Number | 15 (P) |
|---|---|---|---|---|
| | | Item ID / Description | 015 / Power Insulators | |
| | | Product Type | Thermal insulation (eg pipe and boiler lagging), sprayed asbestos, loose asbestos, asbestos mattresses and packing. | 3 |
| | | Condition | Good condition | 0 |

| Location | Petone Recreation Ground Grandstand, External, Exterior | | Sample Number | 15 (P) |
|---|---|---|---|---|
| | | Recommendation | Inspect, test prior to disturbance | |
