HUTT CITY COUNCIL

REPORT ON FUTURE OPTIONS

FOR POINT HOWARD WHARF

FEBRUARY 1999

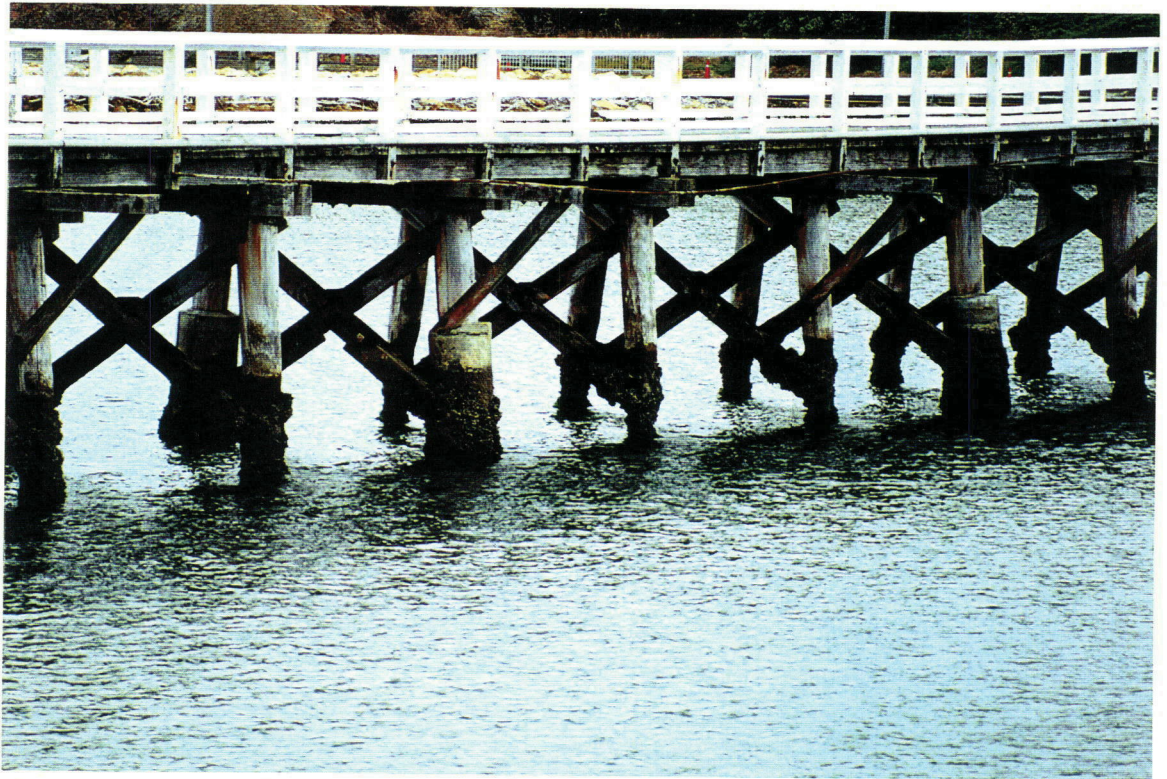
A few of the concrete pile jackets installed in 1994 have cracks in their outer faces, and some of the new timber members, particularly those fully exposed to the sun have longitudinal splits. These do not affect the structural integrity of the wharf.

Photo 1: South side of Wharf Approach
Note concrete pile jackets

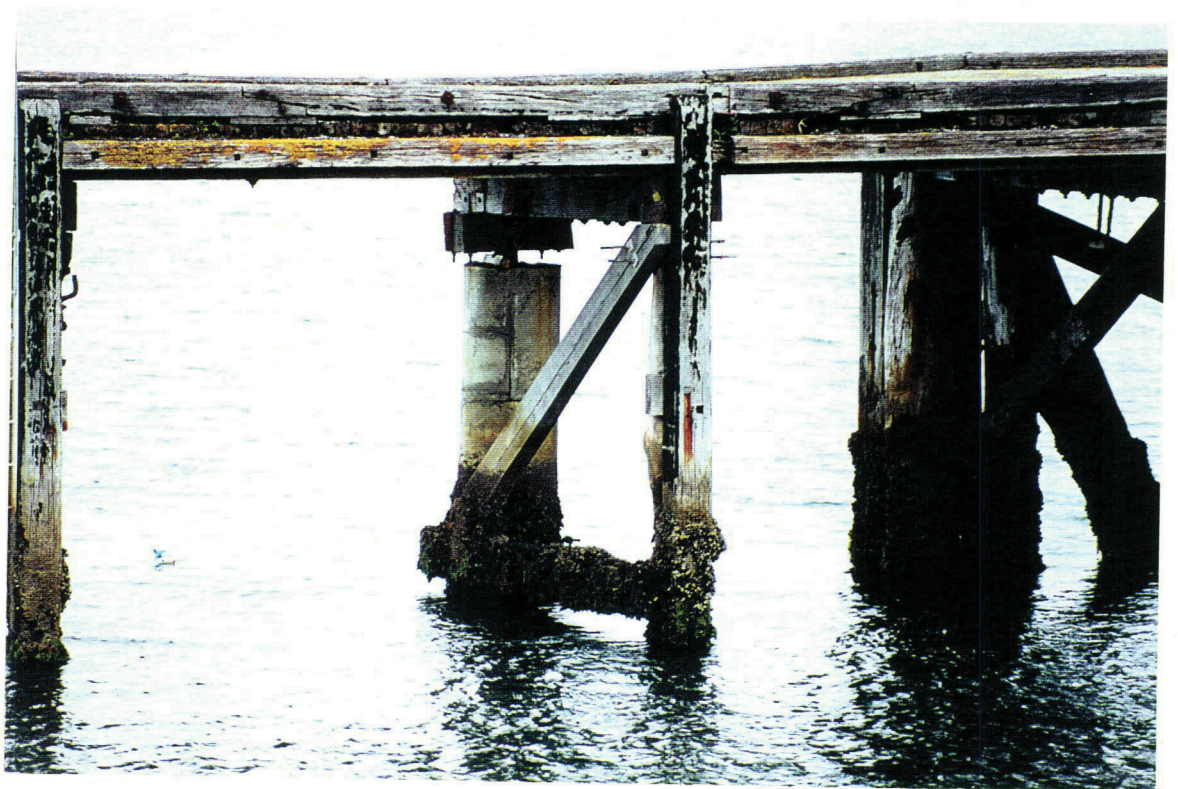
Photo 2: North Head
Note Concrete jacket on pile AA41

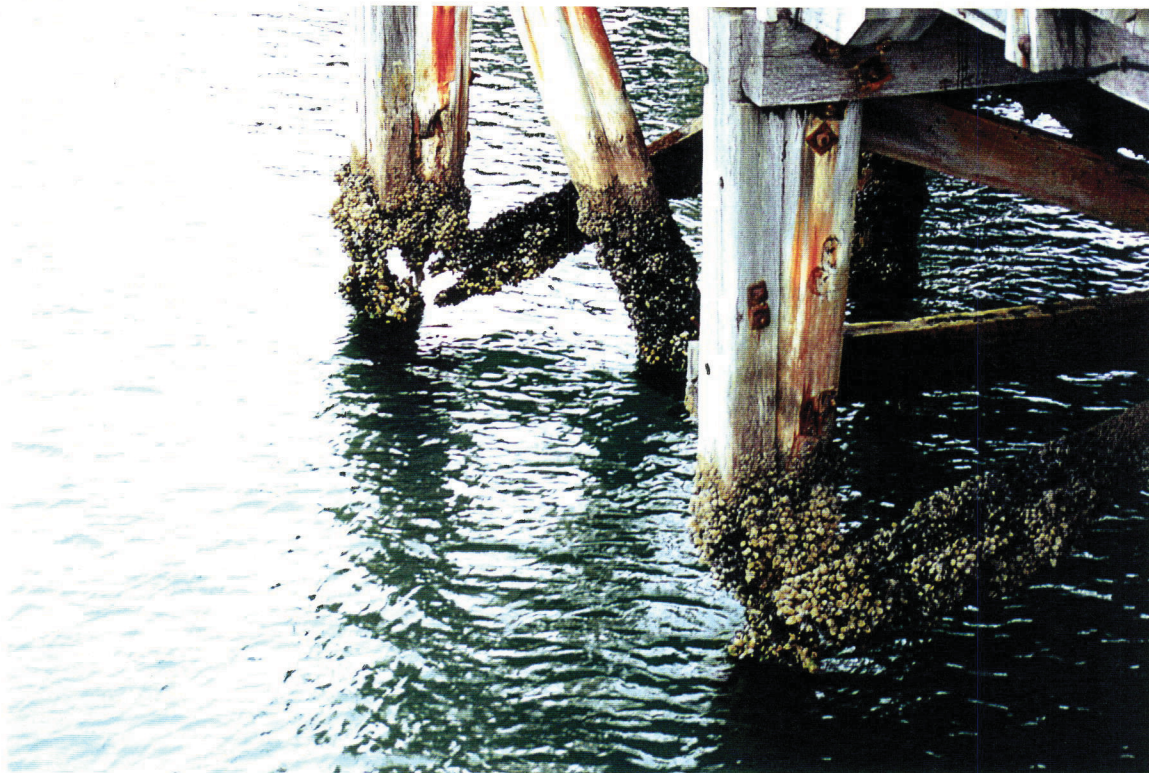
Although the loads applied to the wharf are considerably less than the original design loads, there are a considerable number of wales and braces, and a few piles, beams, areas of deck and smaller members that should be repaired if the wharf is to remain open to the public. Some of these members had been scheduled for repair in stages two to five of the rehabilitation programme, and have not been repaired. Others have deteriorated further since the earlier survey.

Photo 3: Corner of Central Head
Pile Q38 very severely damaged

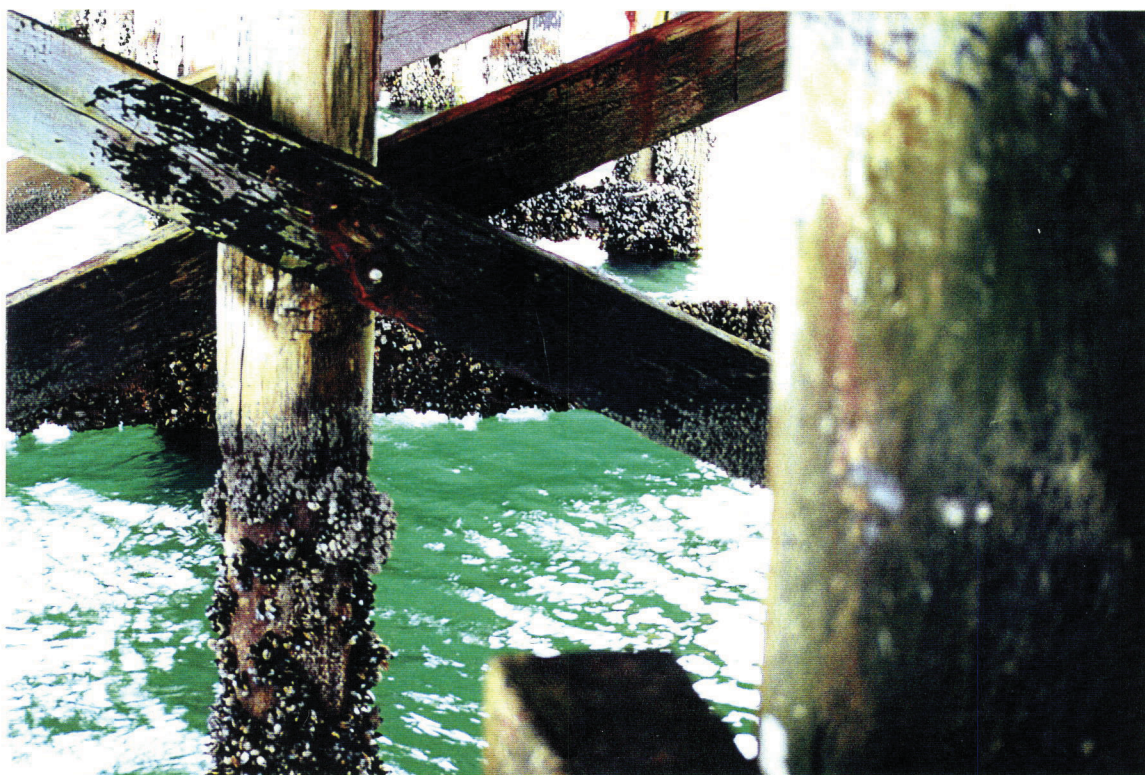
Photo 4: Typical view under Central Head
(Looking South)
