**Arboricultural Report:
Tree protection around development site,
Protection Plan/Tree Health Assessment**

Relating to site location:
758-760 High St, Lower Hutt

Date Prepared: 9th August, 2020

Prepared By:
Sydney Wainwright, Climbing Arborist
Company Director
JSW Contracting Group Ltd
Ph: 021 133 4255
Email: sydney@jswcontracting.co.nz

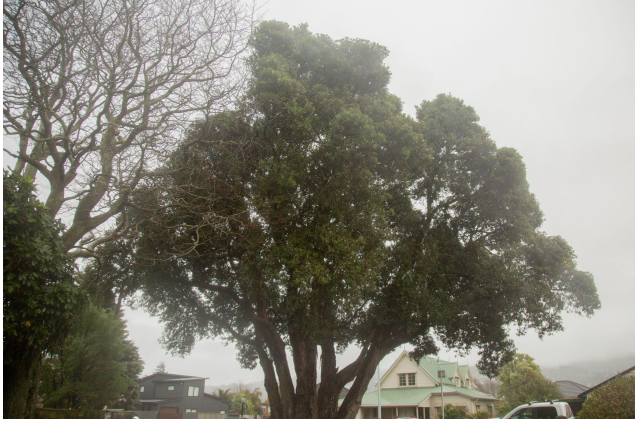
Appendix 3 (left), Symmetrical specimen Pōhutukawa, photo taken from north

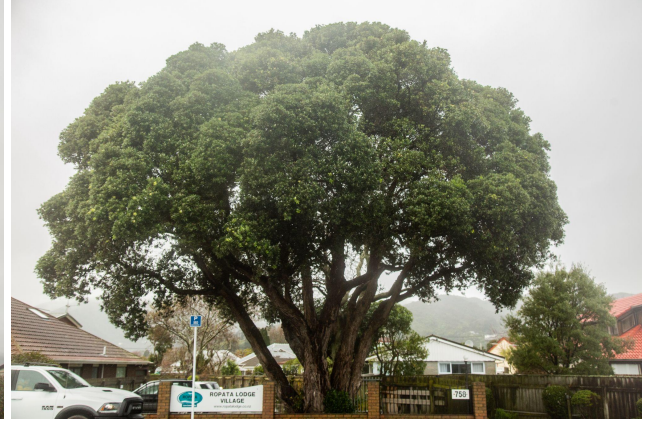
Appendix 4 (right), slightly longer pattern in a north south orientation, taken from the west, looking east.

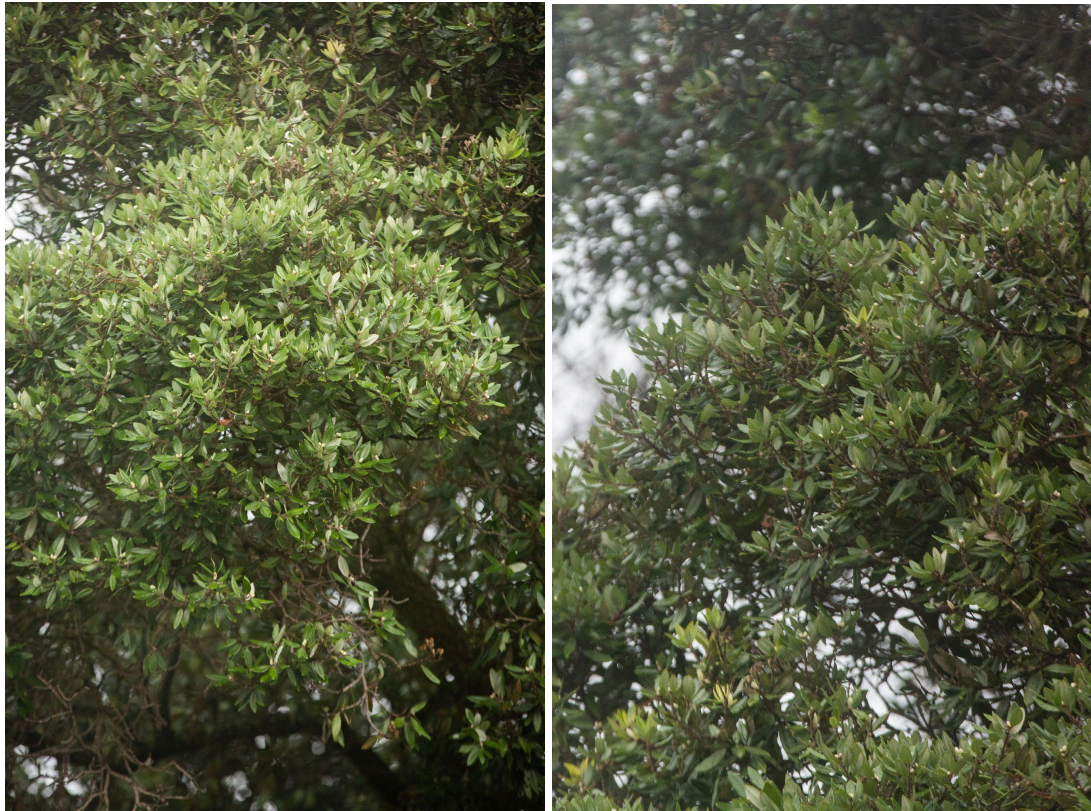
Appendix 5 (left), new leaf and bud growth at the tips of all branches around the tree, minimal dead wood/branches observed

Appendix 6 (right), new leaf and bud growth at the tips of all branches around the tree, minimal dead wood/branches observed

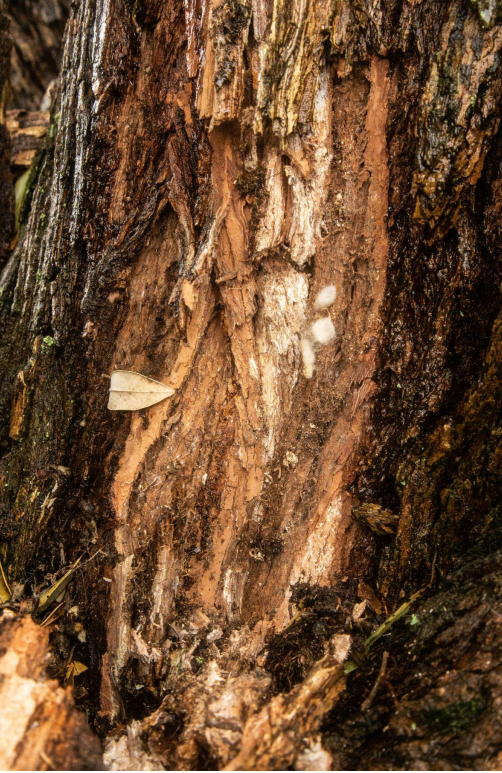
Appendix 7 (left): Flaked off bark showing hard, solid trunk beneath, minimal rot, cracks, insects or signs of poor health

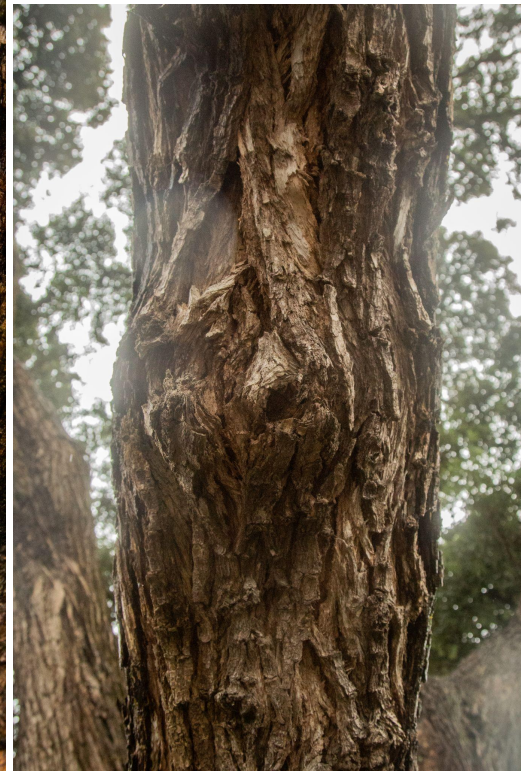
Appendix 8 (right): Previous prune marks almost entirely healed, repeated throughout the tree

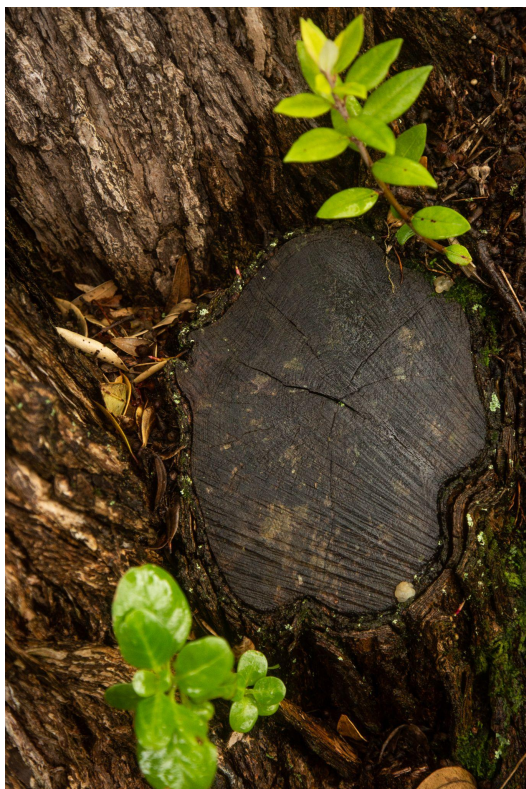
Appendix 9 (left): Previous prune marks healing well, repeated throughout tree.

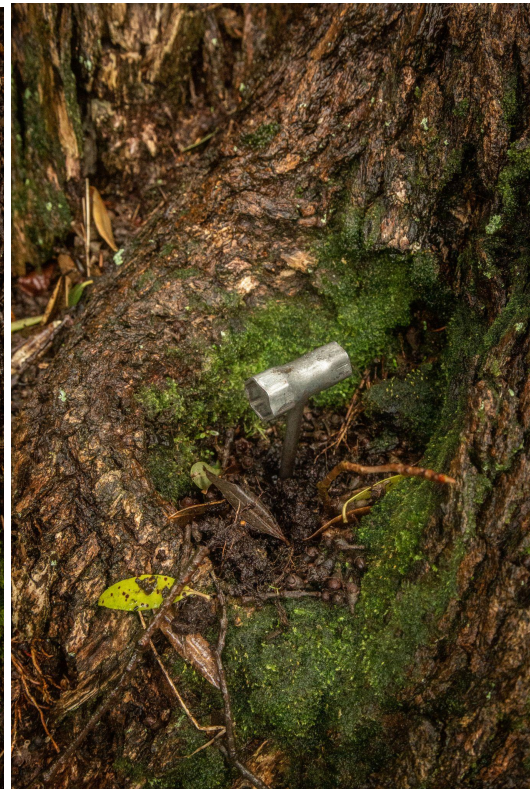
Appendix 10 (right), All major unions/forks in tree tested for rot, 10mm-50mm of rotten material on top (all old leaves/dirt) with hard trunk of the Pōhutukawa below, prime health

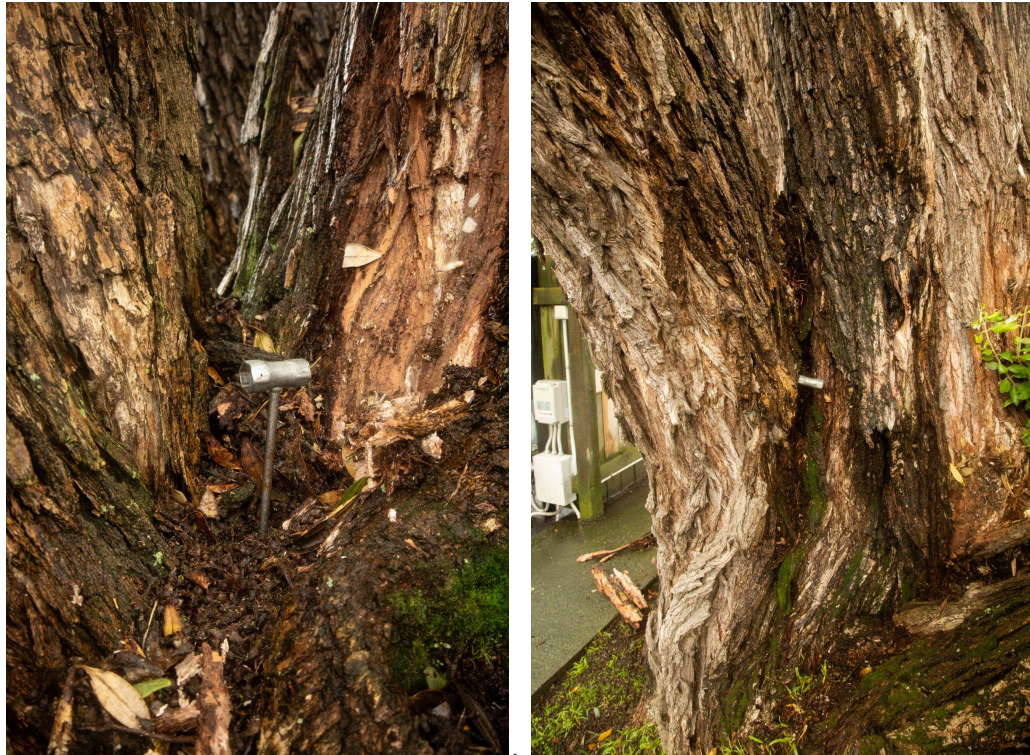
Appendix 11 (left): All major unions/forks in tree tested for rot, 10mm-50mm of rotten material on top (all old leaves/dirt) with hard trunk of the Pōhutukawa below, prime health

Appendix 12 (right): All major unions/forks in tree tested for rot, 10mm-50mm of rotten material on top (all old leaves/dirt) with hard trunk of the Pōhutukawa below, prime health

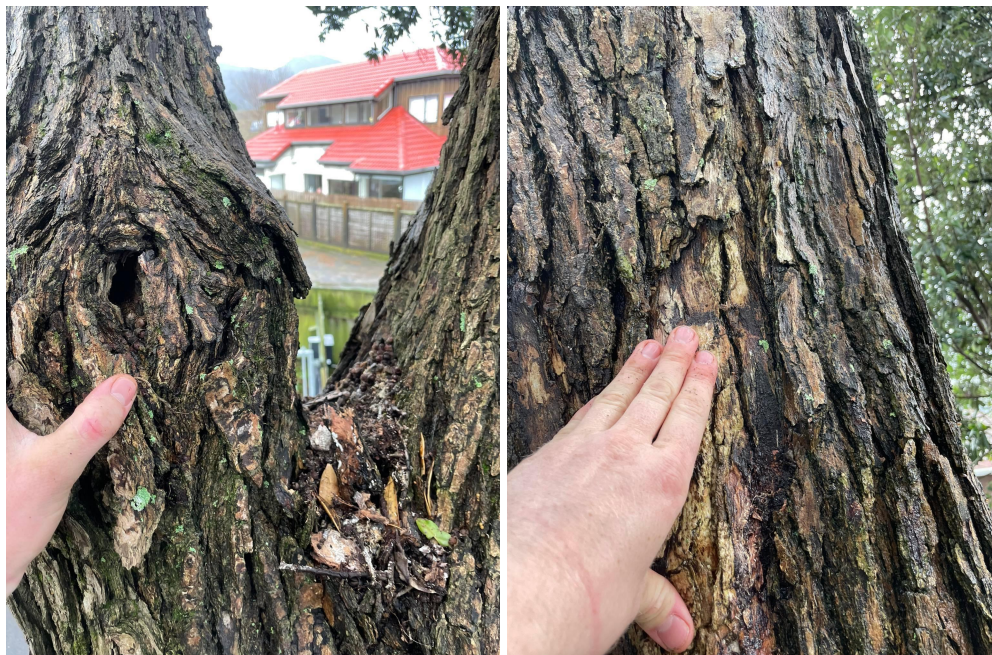
Appendix 13 (left): Previous prune marks almost entirely healed upon inspection

Appendix 14 (right): Minor crack found in main trunk, very old, starting to heal over, not to be concerned about. No others found

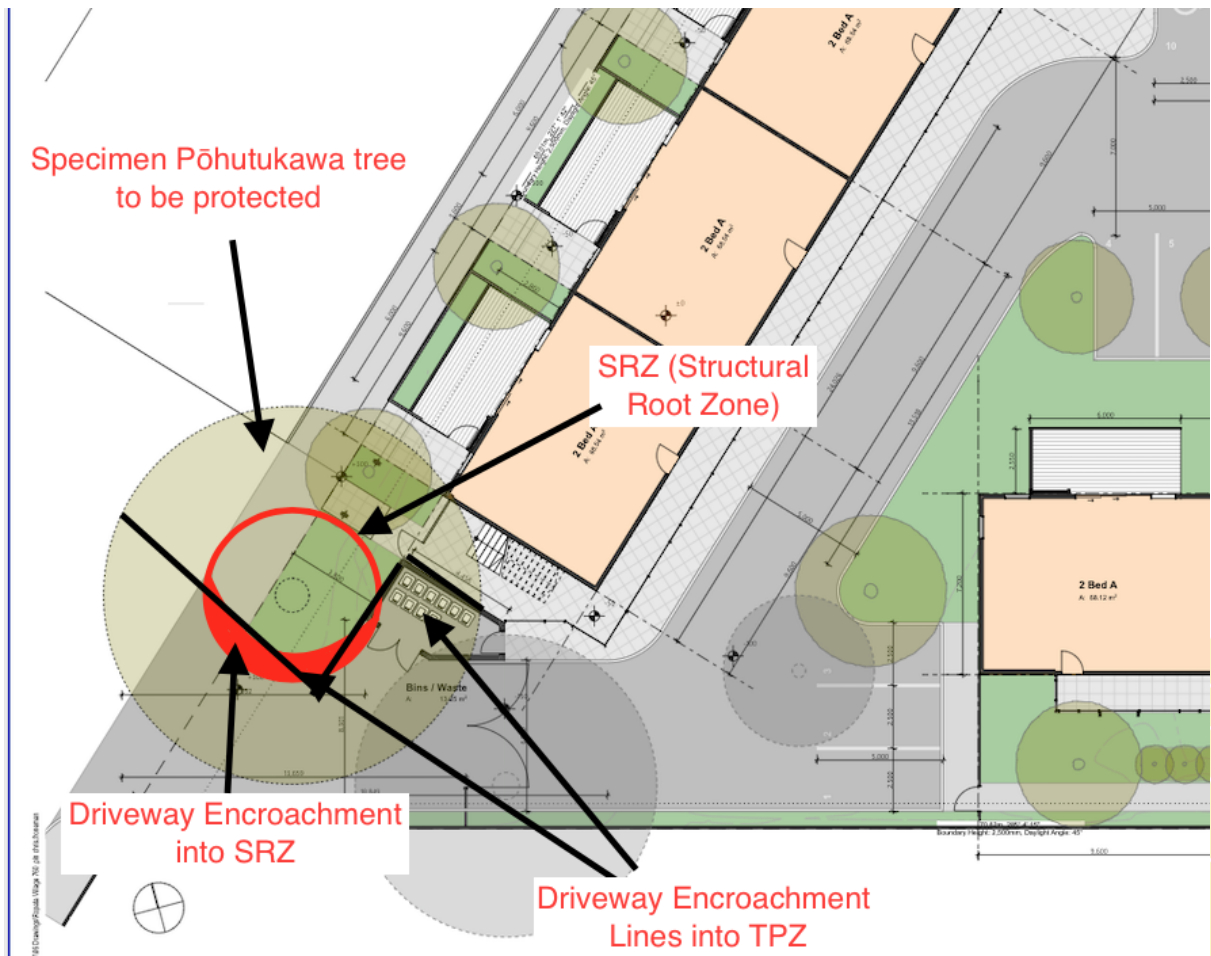
However due to the location of the driveway specified in the development plan, there will be a breach of well over the allowed for 10% encroachment into the TPZ as specified in *AS4970-2009 (Australian Standard, protection of trees on development sites)*. There is also an encroachment into the TPZ with some proposed landscape work. The following recommendations are split into five sections below.

Appendix 15: See specific area where driveway is proposed (grey tone), where it is encroaching into the SRZ (Structural Root Zone), and into the TPZ (Tree Protection Zone)

- **Move/narrow driveway as close to .** If it is possible to move the driveway further south, right up against the boundary line would free up approximately 600mm of otherwise intrusive driveway over the Structural Root Zone. **UPDATE: Since original recommendations were made, the driveway has been shifted and narrowed freeing up a additional metre of space from the centre of the Pōhutukawa tree**

- **Build over the top of the existing ground height/driveway height.** On site heights of the existing driveway and Root Buttress were taken with a rotational laser to determine how much excavatio would need to be done. Minimal excavatio would be required as the new driveway could be **crowned** over the SRZ and be sitting at a finished height of approximately 250mm above the existing driveway. With the additional 30mm of asphalt the the current driveway has over it, there is strong confidence that minimal impacts to the trees root system will occur with the proposed raised driveway height.

- **Air excavation.** In the event that there has to be excavation around the structural root systems, excavating as carefully as possible around the roots (possibly with compressed air) and redirecting them away from the driveway instead of cutting them, and backfilling back around the roots as quickly as possible to avoid long term damage to the Pohutukawa would be recommended.

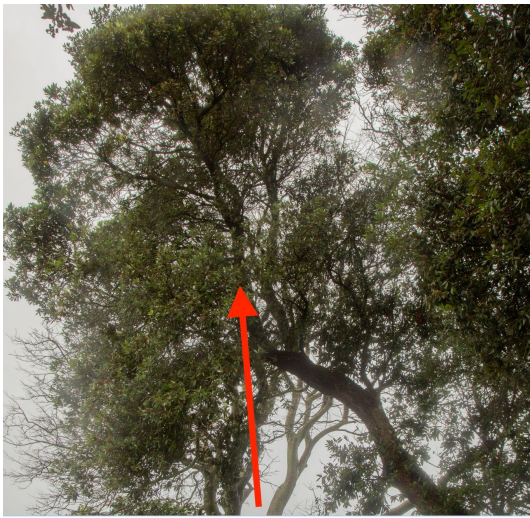
Branch to prune
To low, will clip trucks/machines
as driven into site

Pruning: There is one branch above the existing/proposed driveway which is low hanging (just over 3.3 metres off the ground) which is advised to be pruned off prior to development as the risk of it being clipped by trucks/machines is too high. It is the lower of a double union branch, meaning little aesthetic change will come from the pruning. See Appendix 14 for details.

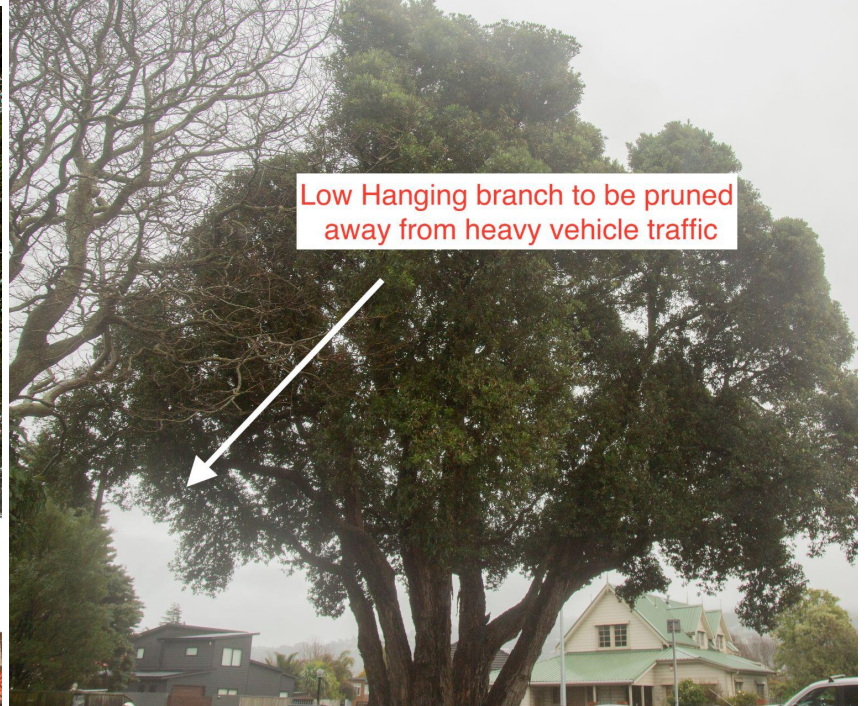
Appendix 16 (left): Lower branch of the two where the trunk forks, to be pruned off. Hanging significantly over the driveway, too low for heavy trucks/machinery to pass through without risking clipping and damaging the branch.

Appendix 17: (right): Lower branch on the left to be removed, wider shot to show scale.

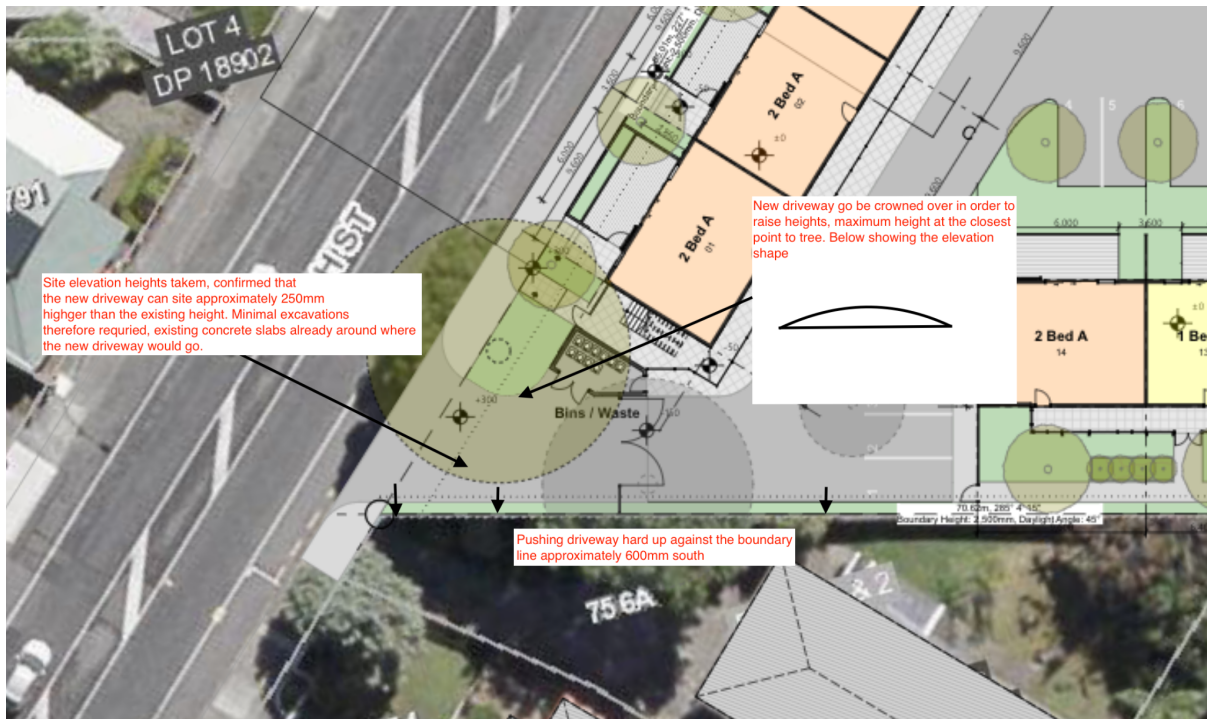
Appendix 18: Showing where to shift driveway south/elevation view of how driveway crown would look with peak of crown as close to the trunk as possible.

Conclusions: Upon initial inspections, there was strong concern over excavation methods causing damage to the SRZ. After meetings on site and dimensions, heights and methodology were taken/discussed. There is strong confidence that the SRZ will be unaffected by the now raised/crowned driveway and shifted position. In the event any further excavation needs to happen, the use of an 'air spade' is recommended. *See Appendix 18 for details*

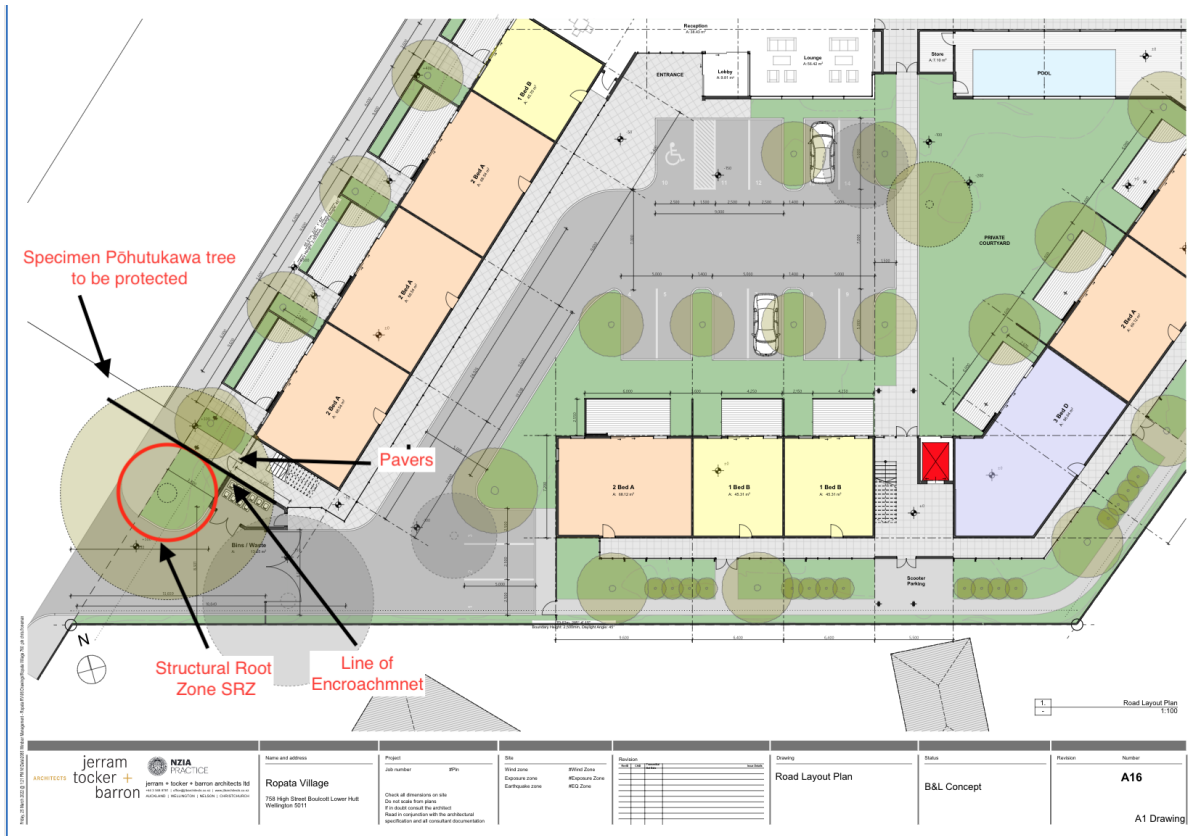
Outside the nearest unit there is a proposed paved area that encroaches the Tree Protection Zone by approximately 40%. However, the Pōhutukawa tree in question already has (upon initial site visit date) a paved area around where cars park. Given the tree is in extremely good health, and the paved parking area has been around some time, if this area were to be paved again or **lifted** in height, there would be no encroachment on the non-woody root system of the tree.

Appendix 19: The line of encroachment for the paved area breaches the TPZ but not the SRZ, so long as the non-woody roots are kept moist and cool and the finish height of the pavers is no different to the original heights, minimal recommendations are suggested

Therefore, so long as the excavation work was kept moist and given cover when left unattended (to shelter any exposed roots) and the new paved area is either at the **same** or a **lifted** finished height to the current carpark. There would be minimal protection work required. Keeping the roots moist and only opening the

TPZ for the specific paving work, with no fill/material left on the roots is JSW's recommendation. A diagram can be seen in Appendix 16.

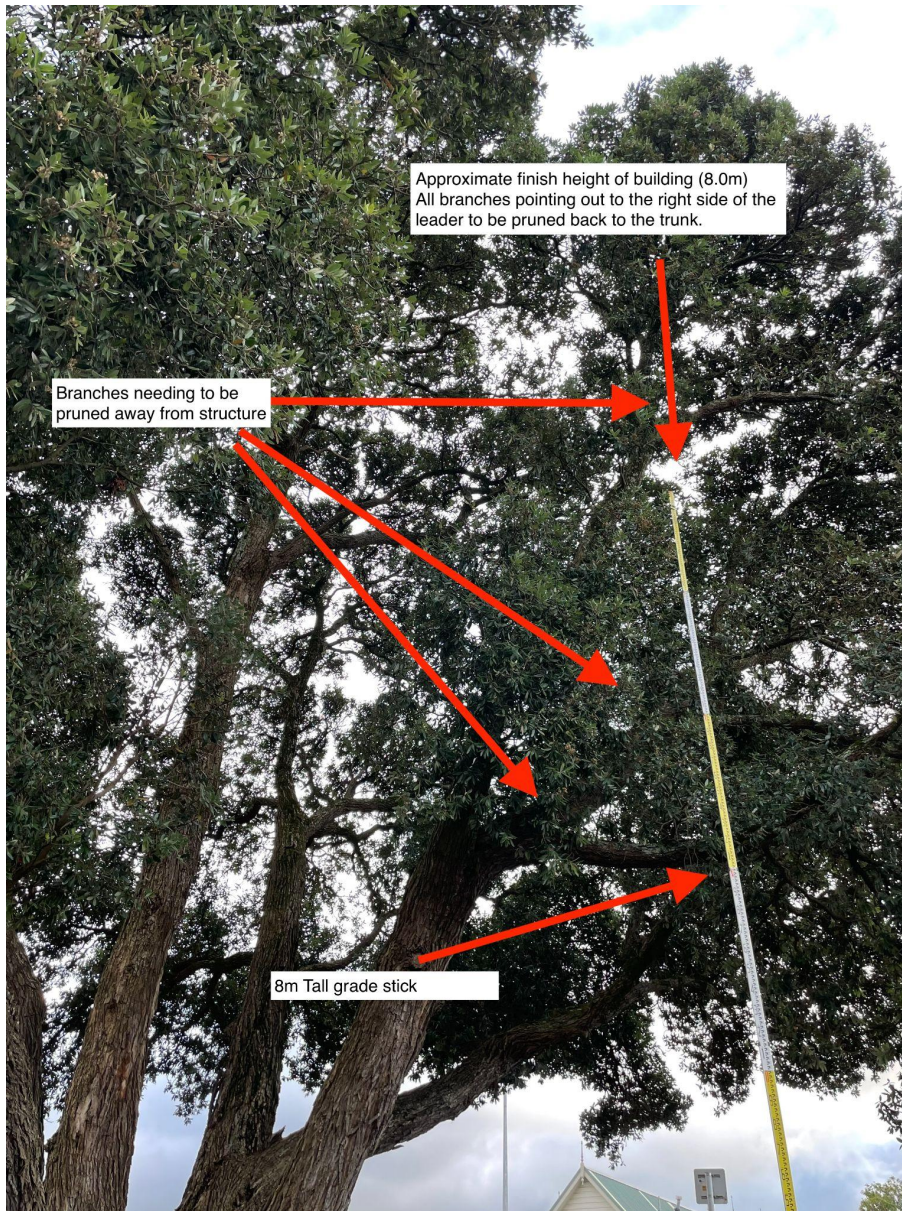
There is a proposed unit (last unit on the building) which would finish approximately 8.0 metres away from the centre of the Pōhutukawa tree to the north east. The house very narrowly encroaches the TPZ, some minor pruning may be required at the tips of the branches for this, otherwise it is recommended that a meeting with the earthworks contractor or any crane operators is carried out prior to works commencing to ensure the process of movements is kept out of range from accidentally clipping branches of the Pōhutukawa tree. Following a site visit with finished heights taken a number of branches will need to be pruned and can be seen in Appendix 20 below.

Appendix 20: All branches to be pruned away from the building line as it will currently hit it.

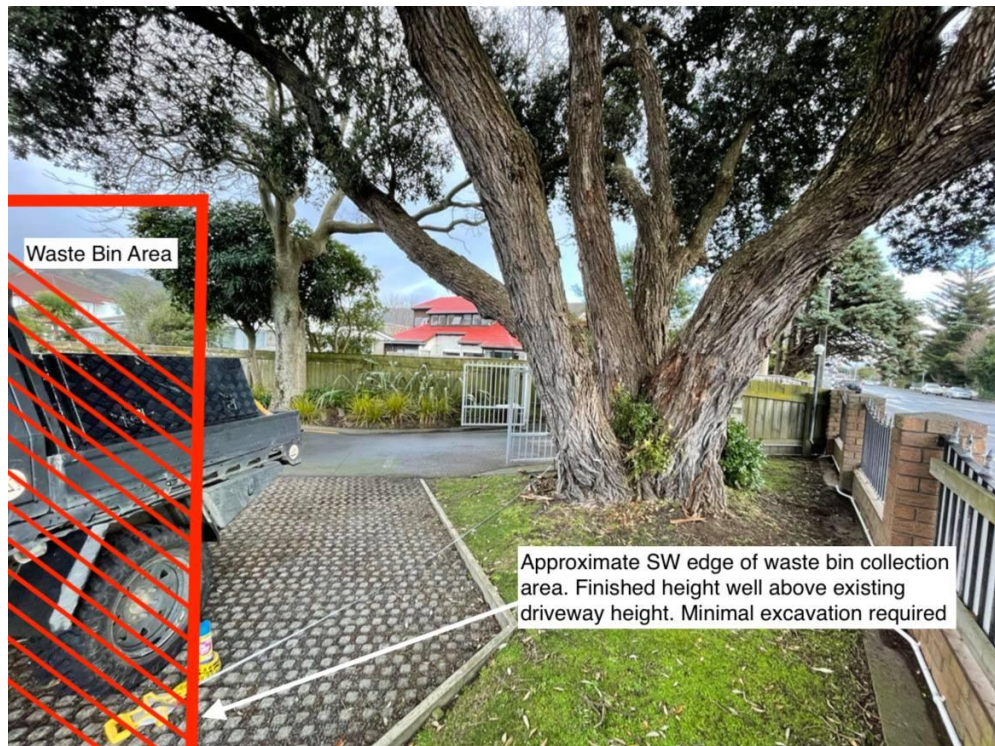
Appendix 21: Attached approximate edges and finished height of waste bin collection area

While the area does not encroach on the SRZ it does encroach into the TPZ. It is recommended for construction not to start until all other heavy demolition and earthmoving work has been completed, and the bulk of the construction work. This is to ensure that when the TPZ is decommissioned or altered, there will be minimal heavy machines causing damage to the tree root structure.

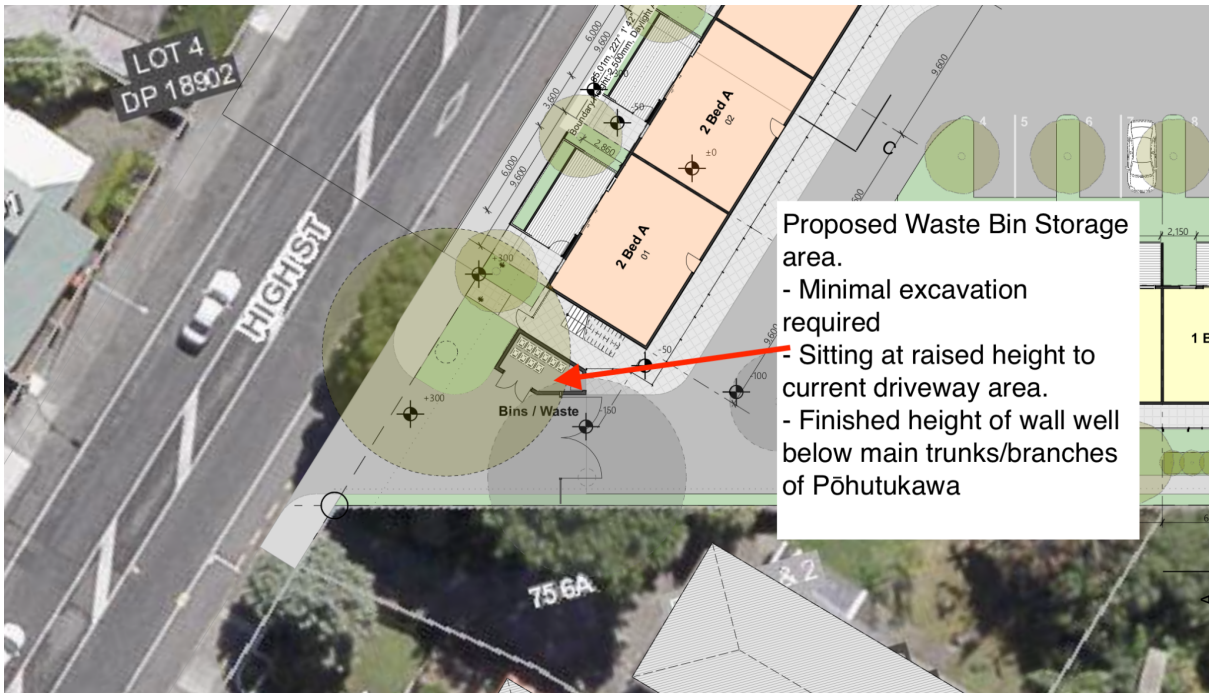
Appendix 22: See plan view of proposed waste bin storage area.
