PETONE WHARF FUTURE OPTIONS

PREPARED FOR HUTT CITY COUNCIL (HCC)

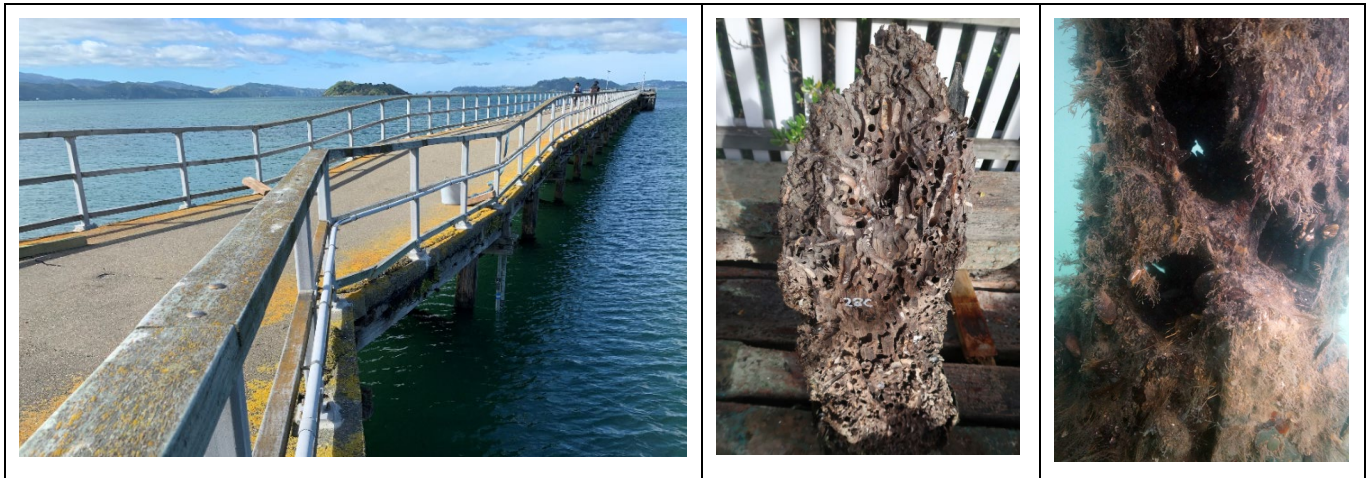
During a sequence of moderate earthquakes in late 2020, nine piles failed around the cart refuge and were repaired in February – March 2021. The failed piles were found to have severe damage due to Teredo worm and it is likely that other piles on the wharf will have similar deterioration. The 2021 dive inspection noted the piles on the wharf head to be in poor condition while the piles located along the western edge and outer half of the wharf head are generally in poor or very poor condition.

Figure 2 Dip in wharf deck over grid 28, and a length of the removed pile from this location showing severe deterioration from teredo worm. Worm damage to a pile on wharf head

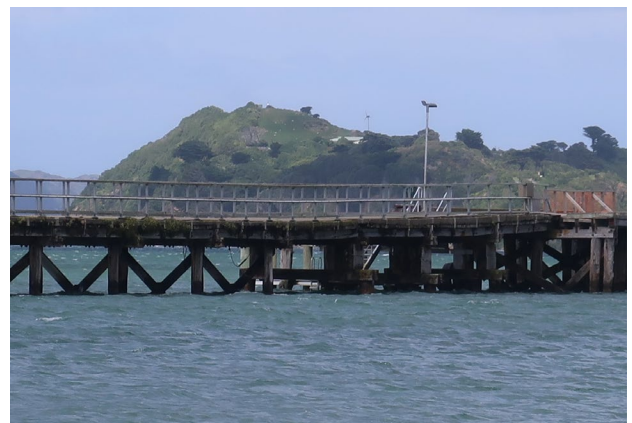
Figure 5: Ramping of final bents on approach

The wharf has a slight ramp at the end of the approach which is not shown on the construction drawings. Options would include either retaining the ramp or building the wharf head at the same level as the approach.

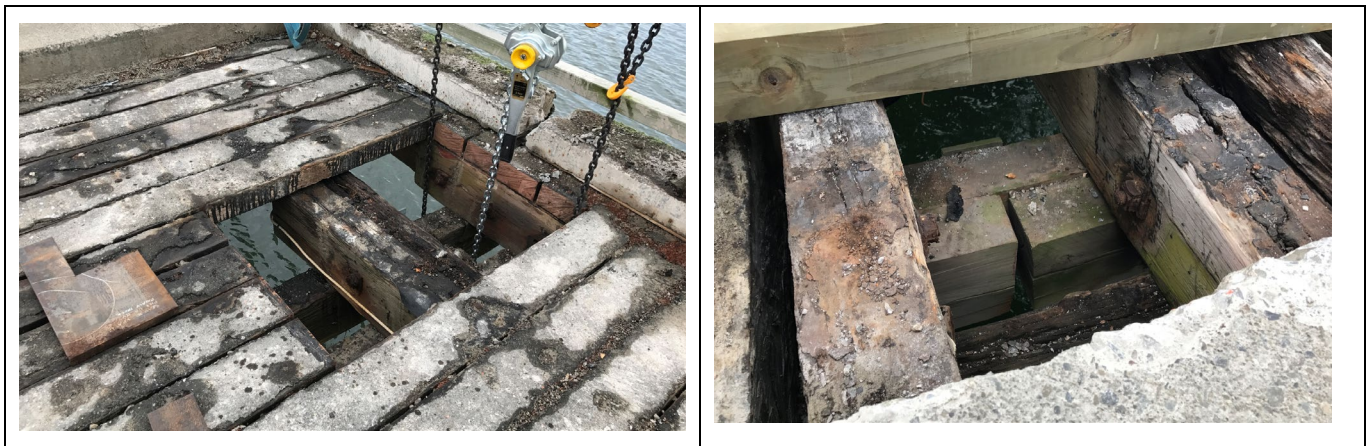
The outer stringer beams are in very poor condition and the inner beams are in moderate – poor condition. Decay has been found to the top of the beams where the deck has been removed for repairs. The ends of the beams typically have splitting meaning little of the existing stringer beams are suitable for reuse, it is expected that beams can be repurposed as shorter bracing members.

Figure 7: Exposed decking and stringer beams on Petone Wharf, note severe splits to exposed upper face of stringers.

The stringer beams (joists) are typically 300 mm deep x 150 wide and 6m long, replacement with similar Australian hardwood or concrete is preferred for the new wharf.

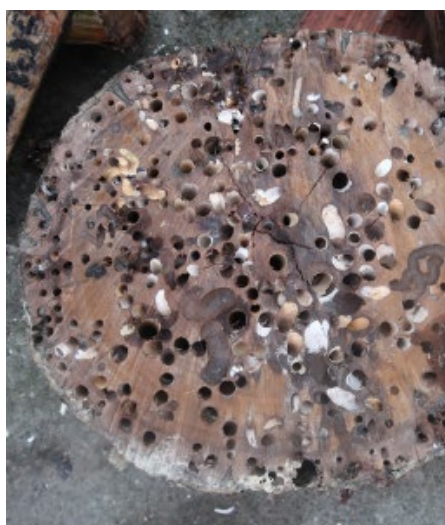
Hardwood timber is prone to marine borer such as Toredos which can reduce the life of the structure in the inter-tidal zone. Petone wharf has significant Toredos damage to the piles (Figs. 8 & 9). The risk of deterioration from marine borer can be partially mitigated by the use of timber treatments. Providing barriers around the piles such as fibre-reinforced plastic (FRP) jackets (Fig 10) or Denso wrap is also effective at reducing worm damage. Although visually intrusive, these treatments can be hidden behind timber fenders.

Figure 8: Marine borer damage to a section of pile removed from Petone wharf

The timber piles generally have deteriorated in the inter-tidal zone with some also having damage at the seabed. It is proposed that for piles in very poor condition the deteriorated section is removed and a new timber pile is connected to the existing pile. Moderate damage can be mitigated with an FRP jacket around the affected area. Both options retain some of the original pile fabric and importantly the pile location is unchanged allowing the footprint / silhouette of the wharf to remain similar.

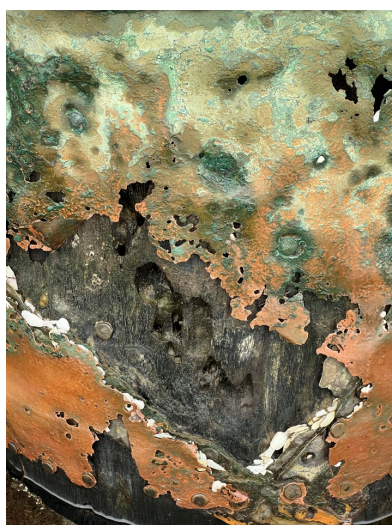
Figure 9: Failed copper sheathing and worm damage

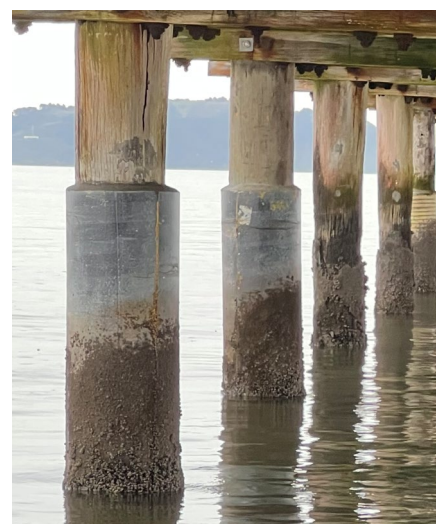
Figure 10: Piles with FRP jackets at Petone Wharf
