Manor Park Road Level Crossing Safety Impact Assessment

PREPARED FOR ROSCO ICE CREAM LIMITED | JUNE 2022

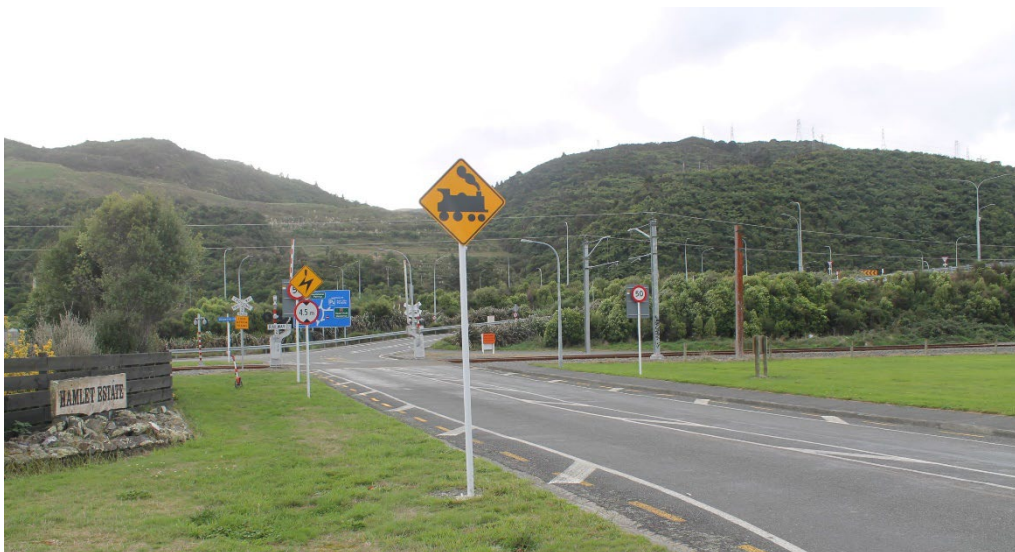
Figure 3-3: Manor Park Level Crossing View From East

An overview of the level crossing from the eastern approach is shown in Figure 3-3, while a closer view from the western approach is provided in Figure 3-4.

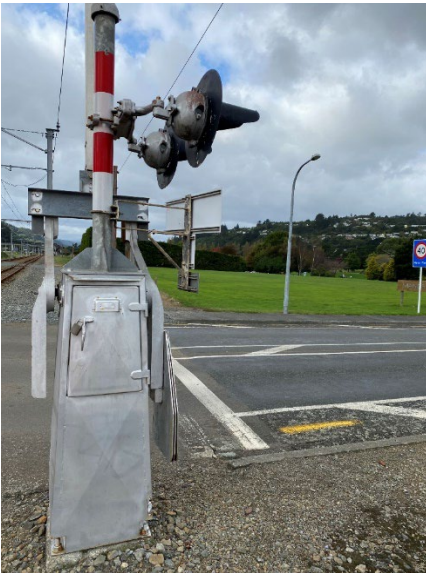
Figure 3-5: 1960's HAB Assembly

The level crossing is controlled by FLBs and HABs. A single FLB / HAB assembly is provided on each approach. The FLB and HABs are of considerable age and were installed in the 1960s (Figure 3-5). Stantec has been advised by KiwiRail that they are due for replacement with new equipment in the next one-to-two years.

5. **Age of the HAB/ FLB apparatus.** The HAB/ FLB apparatus is approximately 50 years old and approaching obsolescence. This raises the potential of equipment failure which would reduce the warning provided to crossing users.

3. Replace the HABs			
Replace the existing old HABs, which were first installed in the 1960’s. KiwiRail note this is scheduled to occur within the next 1-2 years.	Rail Corridor	ASAP	Maintenance

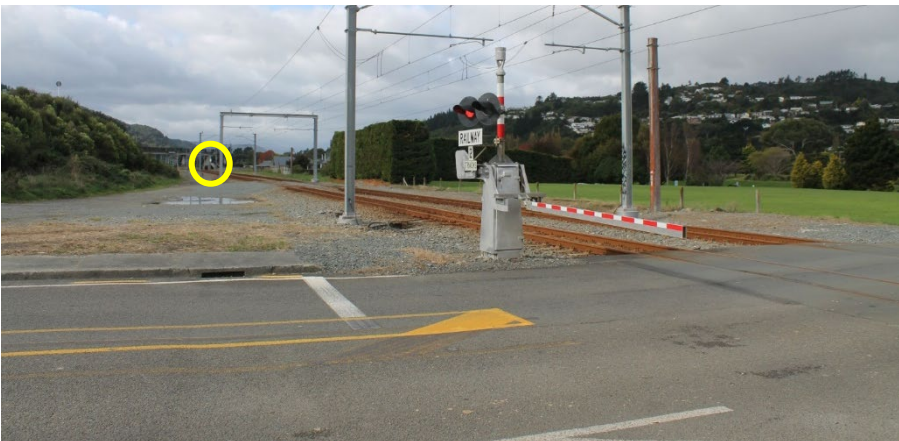
Figure 3-6: FLBs, HABs in Operation, Circle Shows Train at the Manor Park Station

It is noted that FLBs and HABs are activated when southbound trains are stopped at Manor Park Station, which is 800m away. This increases the duration of the barrier down time because the barriers are down for the time the train is waiting at in the station, plus the approach time from station (around three minutes in total). This situation is shown Figure 3-6.

The Signals Engineer noted that it would be feasible to adjust the barrier activation so that it was not triggered by southbound trains stopping at the Manor Park Station.

4.	Reconfigure signalling at Manor Park Station to reduce barrier down times	Rail Corridor	ASAP	Criterion 2
5.	Install a second WX31 sign on the western approach	Local Road	ASAP	Criterion 2

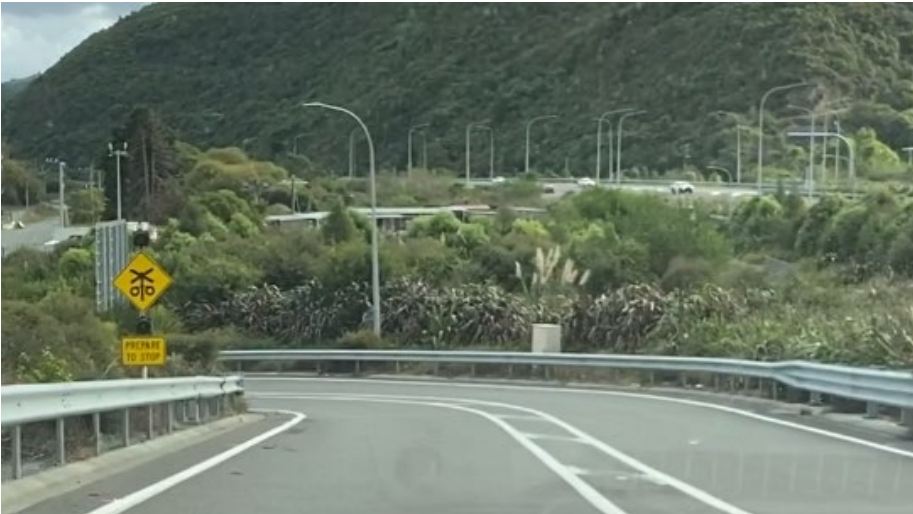
Figure 3-7: Active Warning Signage on Western Approach

For the western approach (from the SH2/ SH58 interchange) additional warning is provided by an active warning WX31 sign (Figure 3-7) while on the eastern approach there is a single WX1L sign.

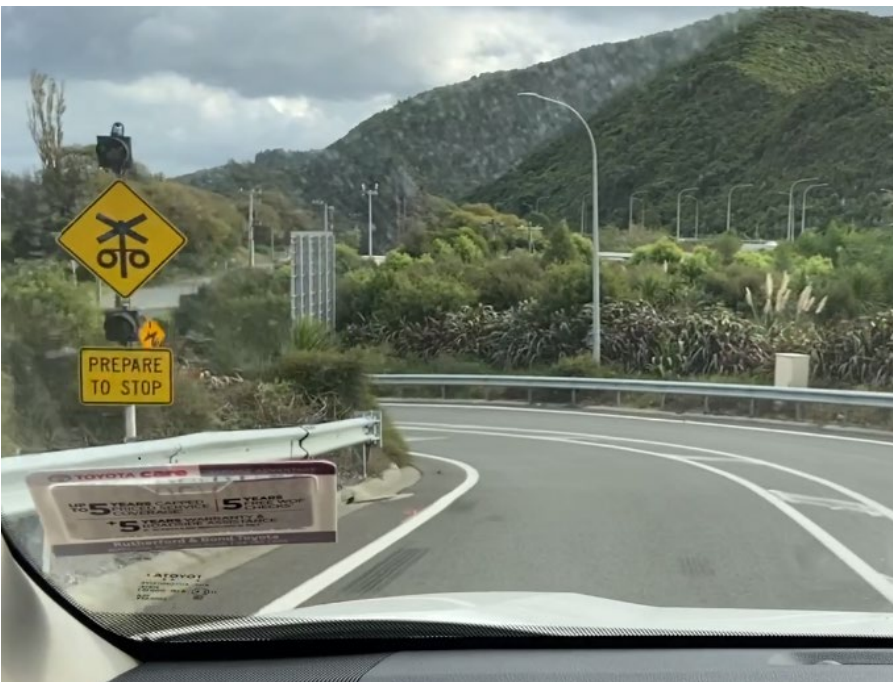
Figure 3-8: Curved Approach Limiting Forward Visibility of Crossing

The active warning sign provides additional warning of the level crossing and the potential need to stop. Due to the curved alignment when a driver is at the position of the WX31 sign neither the crossing nor the FLBs are visible (the start of the "Rail X" marking is just visible) as seen in Figure 3-8.

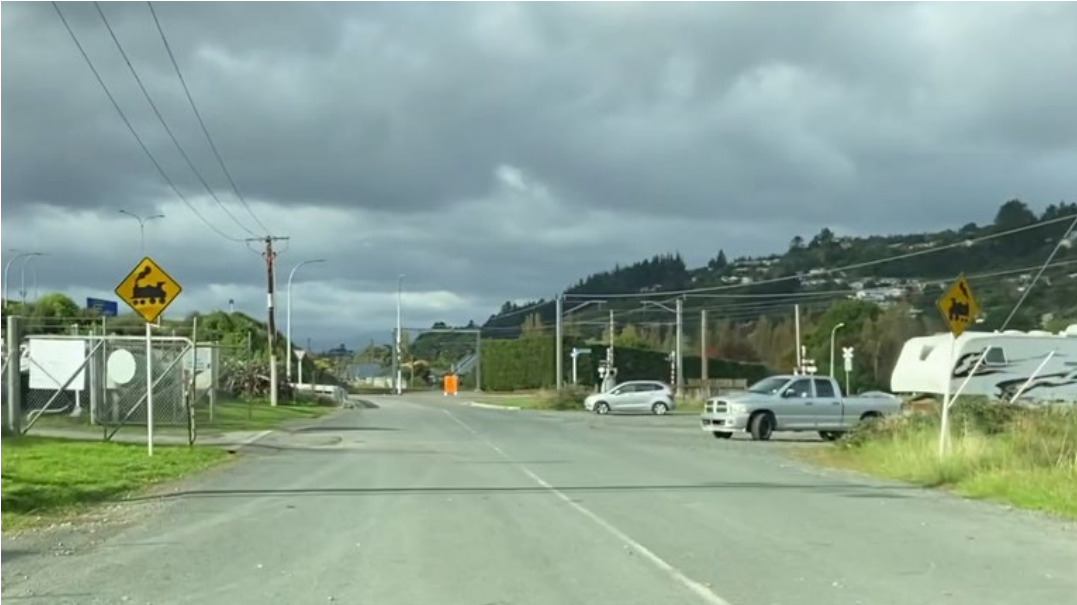
Figure 3-9: Incorrect Benmore Crescent Signage

On Benmore Crescent warning is provided by “Rail X” markings and WX1L/R signage. However, it is noted that the WX1L/R has been installed incorrectly, instead of showing the train heading towards the centre of the road from the left and right sides, instead the trains are moving away from the road. The sign on the right-hand side is also tilted away from the road (Figure 3-9). Technically WX1L/R signage should not be installed on Benmore Crescent as the level crossing is on a side road – inside the correct sign would be a WXR5.

Safety Recommendation	Infrastructure Affected	When is it Required?	Level of Necessity
7. Refresh all road markings			
Refresh all road markings	Local Road	Proposed Design	Maintenance
8. Replace incorrectly installed road signage			
Install WX1R sign on Manor Park Road east approach. Replace signage on Benmore Crescent with correct sign WXR5 sign.	Local Road	Proposed Design	TCD Pt.9

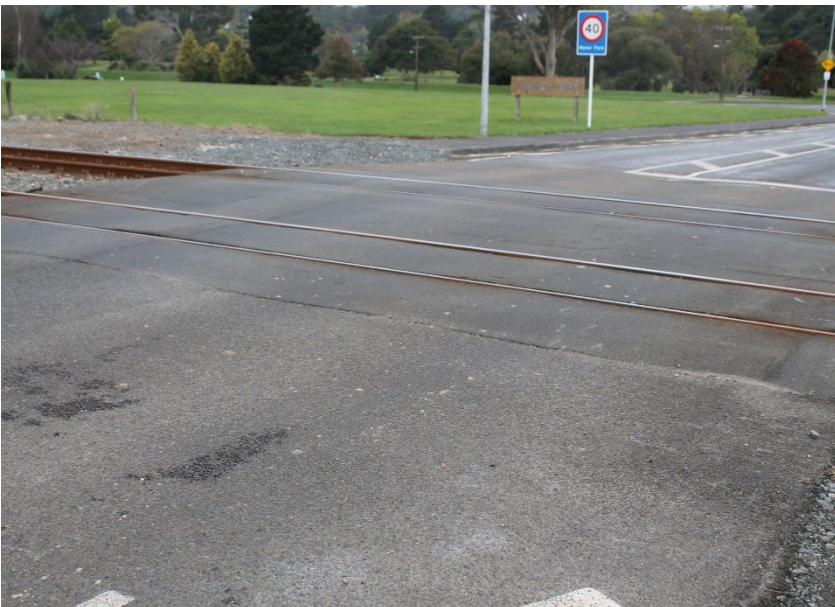
Figure 3-10: Crossing Panel

The crossing panel is constructed of asphalt, and while showing some signs of wear is generally in fair condition, refer to Figure 3-10 and Figure 3-11. However, it is probable that an upgrade or repairs to the crossing panel will be required in the next ten years

Whilst the crossing panel is generally in fair condition, there are observable defects and cracks. Without maintenance, it is likely that those cracks and defects will extend and increase in scale. Consequently, water could enter the underlying structure of the road and further accelerate damage or the creation of potholes. Such defects would be hazardous to cyclists or users of small, wheeled devices (e.g. scooters).

6. Repair the crossing panel defects			
Repair the crossing panel to address minor surfacing and pavement defects	Rail Corridor	Future	Maintenance

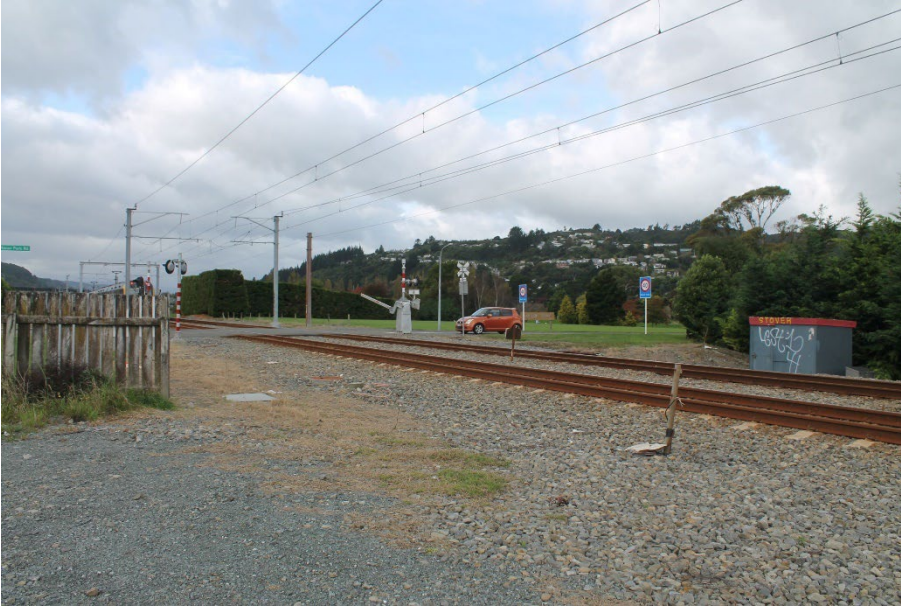
Figure 3-12: Benmore Crescent, Showing Lack of Rail Corridor Fencing

There are no pedestrian crossing facilities at the level crossing currently, although on the uptrack side footpaths extend up to the edge of the rail corridor on both approaches. From the site visit, a single pedestrian and dog were witnessed crossing on the downtrack side, having come from Benmore Crescent and continued to the residential area of Manor Park. On the downtrack side the nearest footpath stops by the Manor Park Road / Mary Huse Grove intersection some 50m before the level crossing. Wear on the grass berm at the corner of Benmore Crescent suggests some pedestrian usage on the downtrack side (refer to Figure 3-4). It was also observed on-site that along Benmore Crescent the rail corridor is open (Figure 3-12), and pedestrian shortcutting/ trespass could occur.

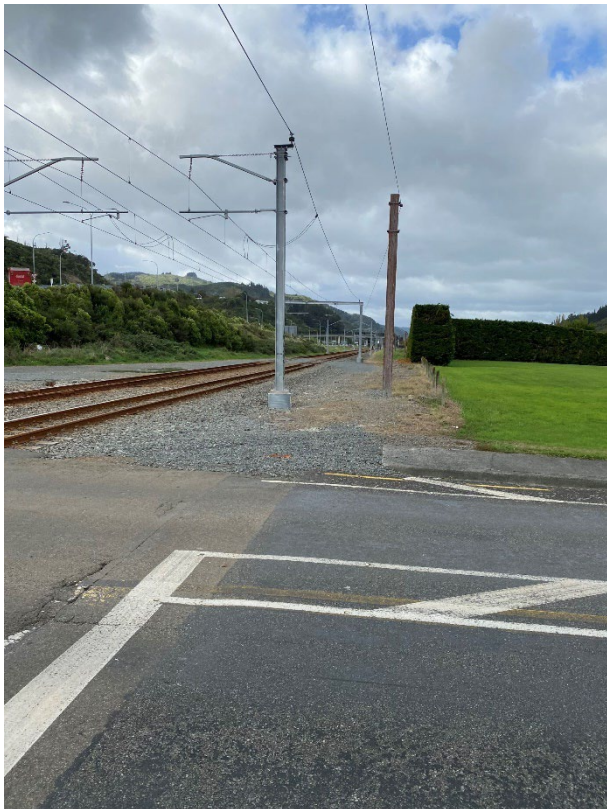
Figure 3-13: East Carriageway Approach Uptrack Sightline, also Showing Footpath Stopping Short of Rail Corridor

Sight lines for drivers and pedestrians at the level crossing extend towards the Manor Park train station approximately 400m to the north, but are constrained to approximately 200m to the south by the curvature of the track. Figure 3-13 to Figure 3-16 show the some of the available sightlines.
