**Drainage Investigations
Team**
**‘Knowing Your Pipes’
Hutt Valley Project Update**
August 2023

Hutt City Council Update

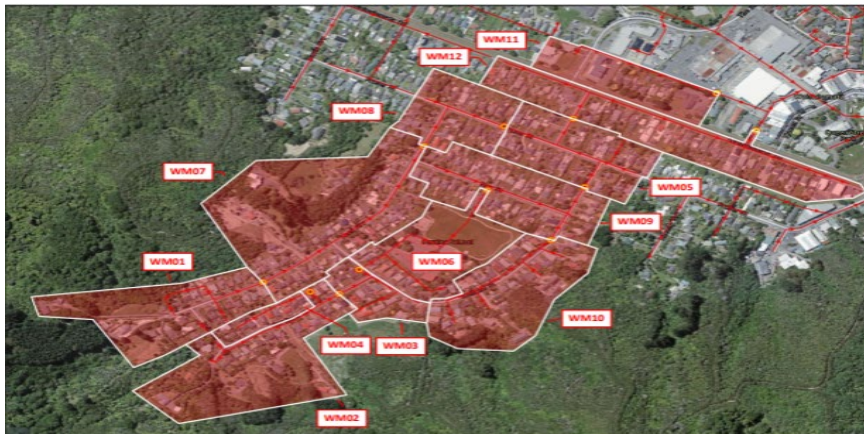
Inflow and Infiltration Investigation undertaken at Lees Grove - Wainuiomata

- Set up rain gauge, and 12 level sensing inflow and infiltration monitors
- Confirmed significant amount of ground water and rain water infiltration was both entering the sewer network increasing volume of flow in waste water system and risk of wastewater escaping pipe infrastructure.
- Based on inspections some of this seepage is not visible indicating to enable isolated repairs to resolve noting infrastructure to be in poor condition.
- 12 x Catchments containing, High levels of inflow and infiltration
