**DETAILED SEISMIC ASSESSMENT FOR  
38 NORMANDALE ROAD, MINOH  
HOUSE, LOWER HUTT.**

DSA REPORT

91 WESTERN HUTT ROAD,  
NORMANDALE, LOWER HUTT 5010

P330

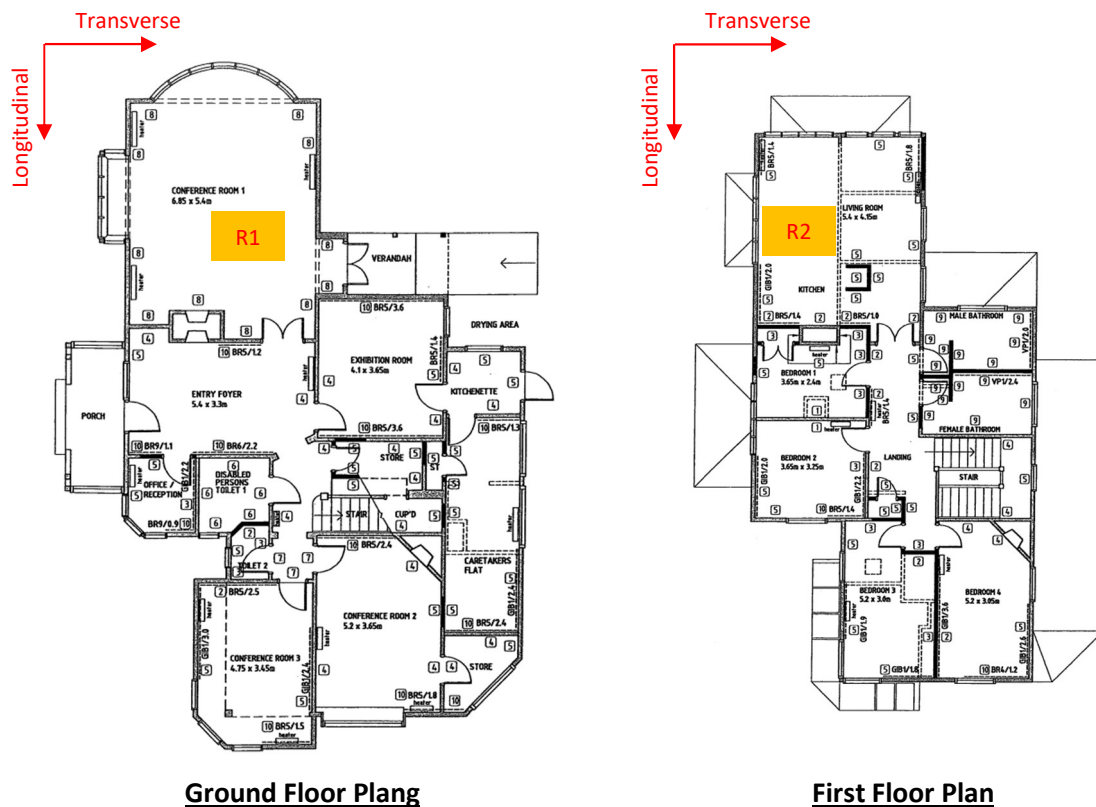
**Figure 1.** Existing Plan of the property located at 38 Normandale Road, Minoh House, Lower Hutt.

As can be seen on Figure 1, several walls have been removed (shown with dashed line in the figure) due to the 1998 upgrade. There is no evidence in the HCC archives showing adequate compensating actions carried out after the wall removal, which would negatively affect the lateral bracing capacity of the building specifically along the transverse direction. This weakness can be a significant issue in regions R1 and R2 as marked in Figure 1. The presence of two heavy/tall brick chimneys (Figure 2), making them earthquake-prone non-structural elements, in the building can pose a life safety risk and can decrease the building room score to values < 34% NBS (IL2) corresponding to seismic grade D (High Risk)

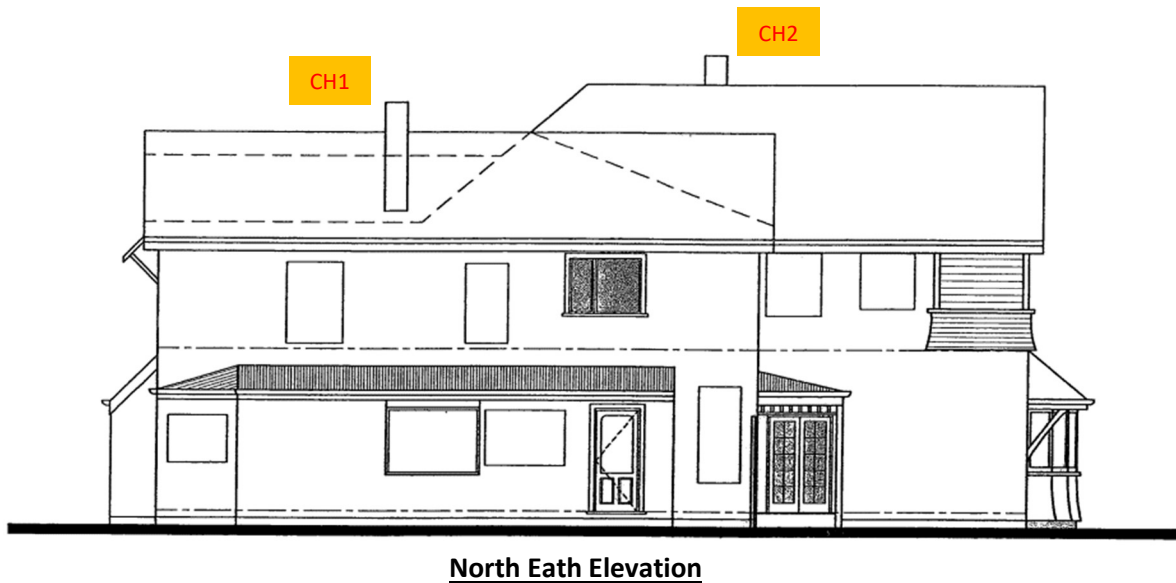
Two main factors contribute to this poor %NBS score: 1- Insufficient bracing capacity in the transverse direction on both ground and first floors for external walls along Grid A. 2- The existing earthquake-prone chimneys.

**Figure 2.** North east elevation of the property located at 38 Normandale Road, Minoh House, Lower Hutt, showing the chimneys marked CH1 and CH2.

The addition of timber bracing walls along Grid A at both floors and the removal of chimneys above the ceiling level (**Option 3**) level would result in **43% NBS (IL2) >40%**, which is the given criteria by the client.

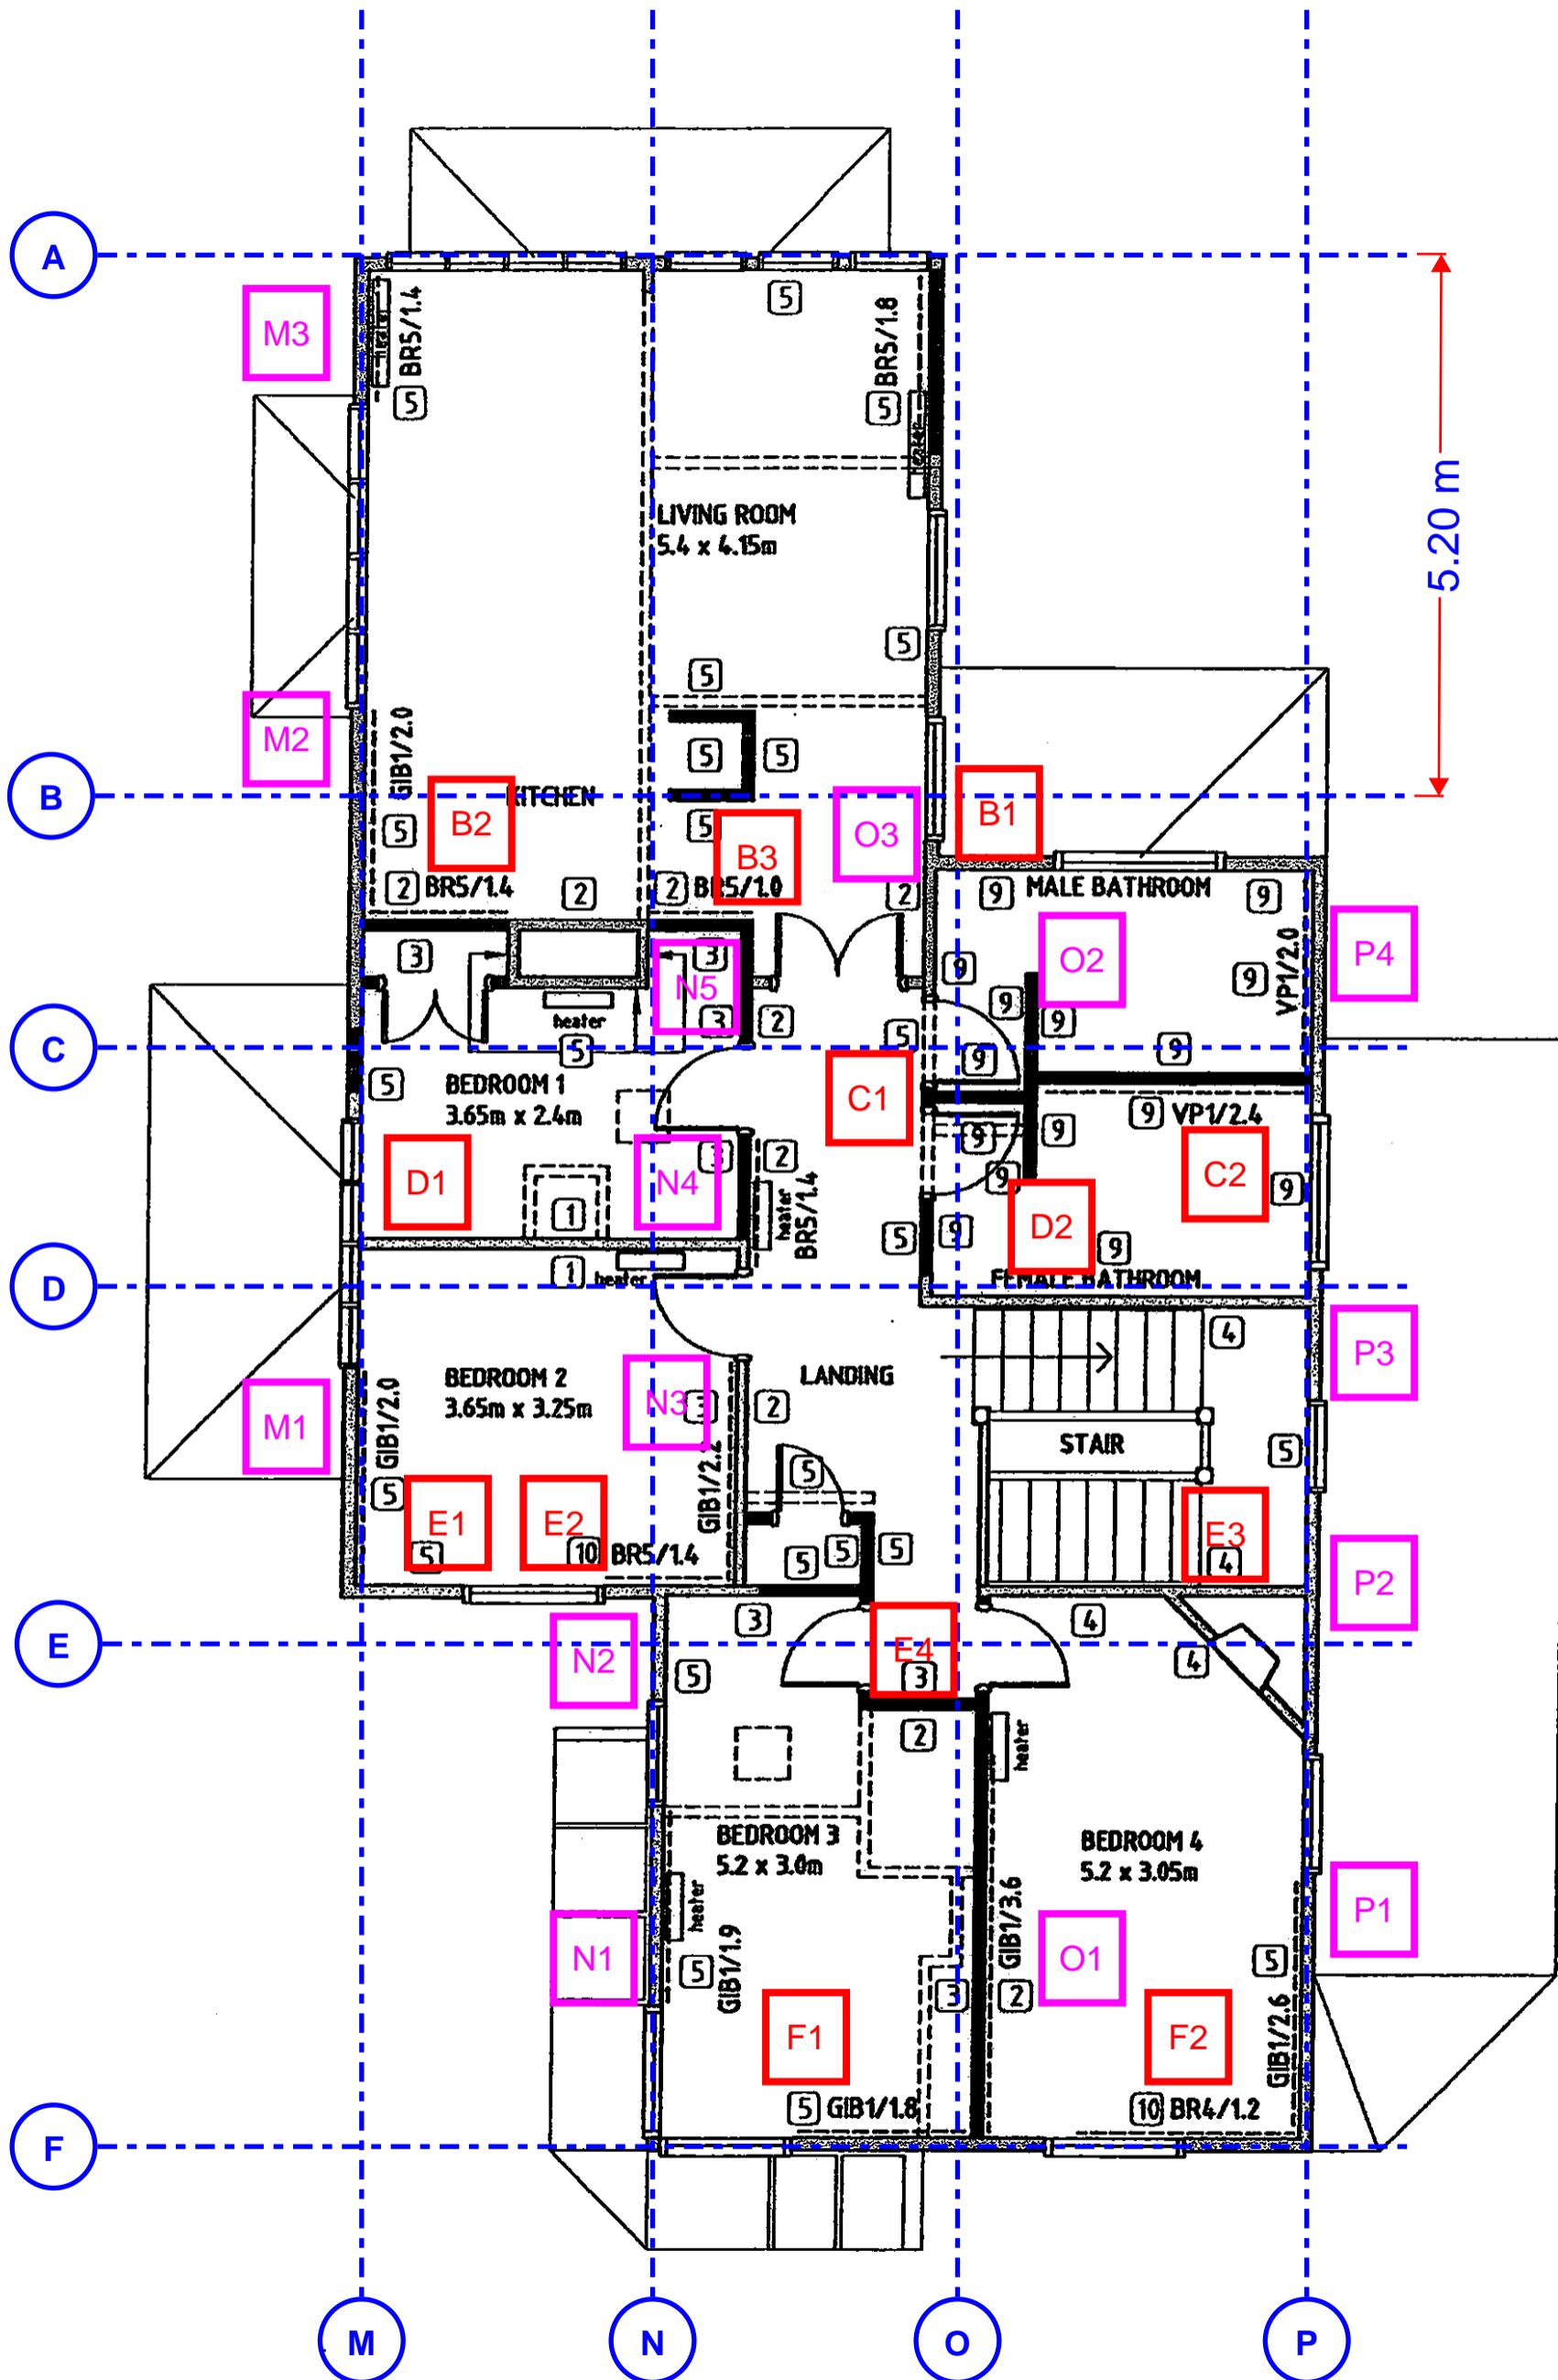
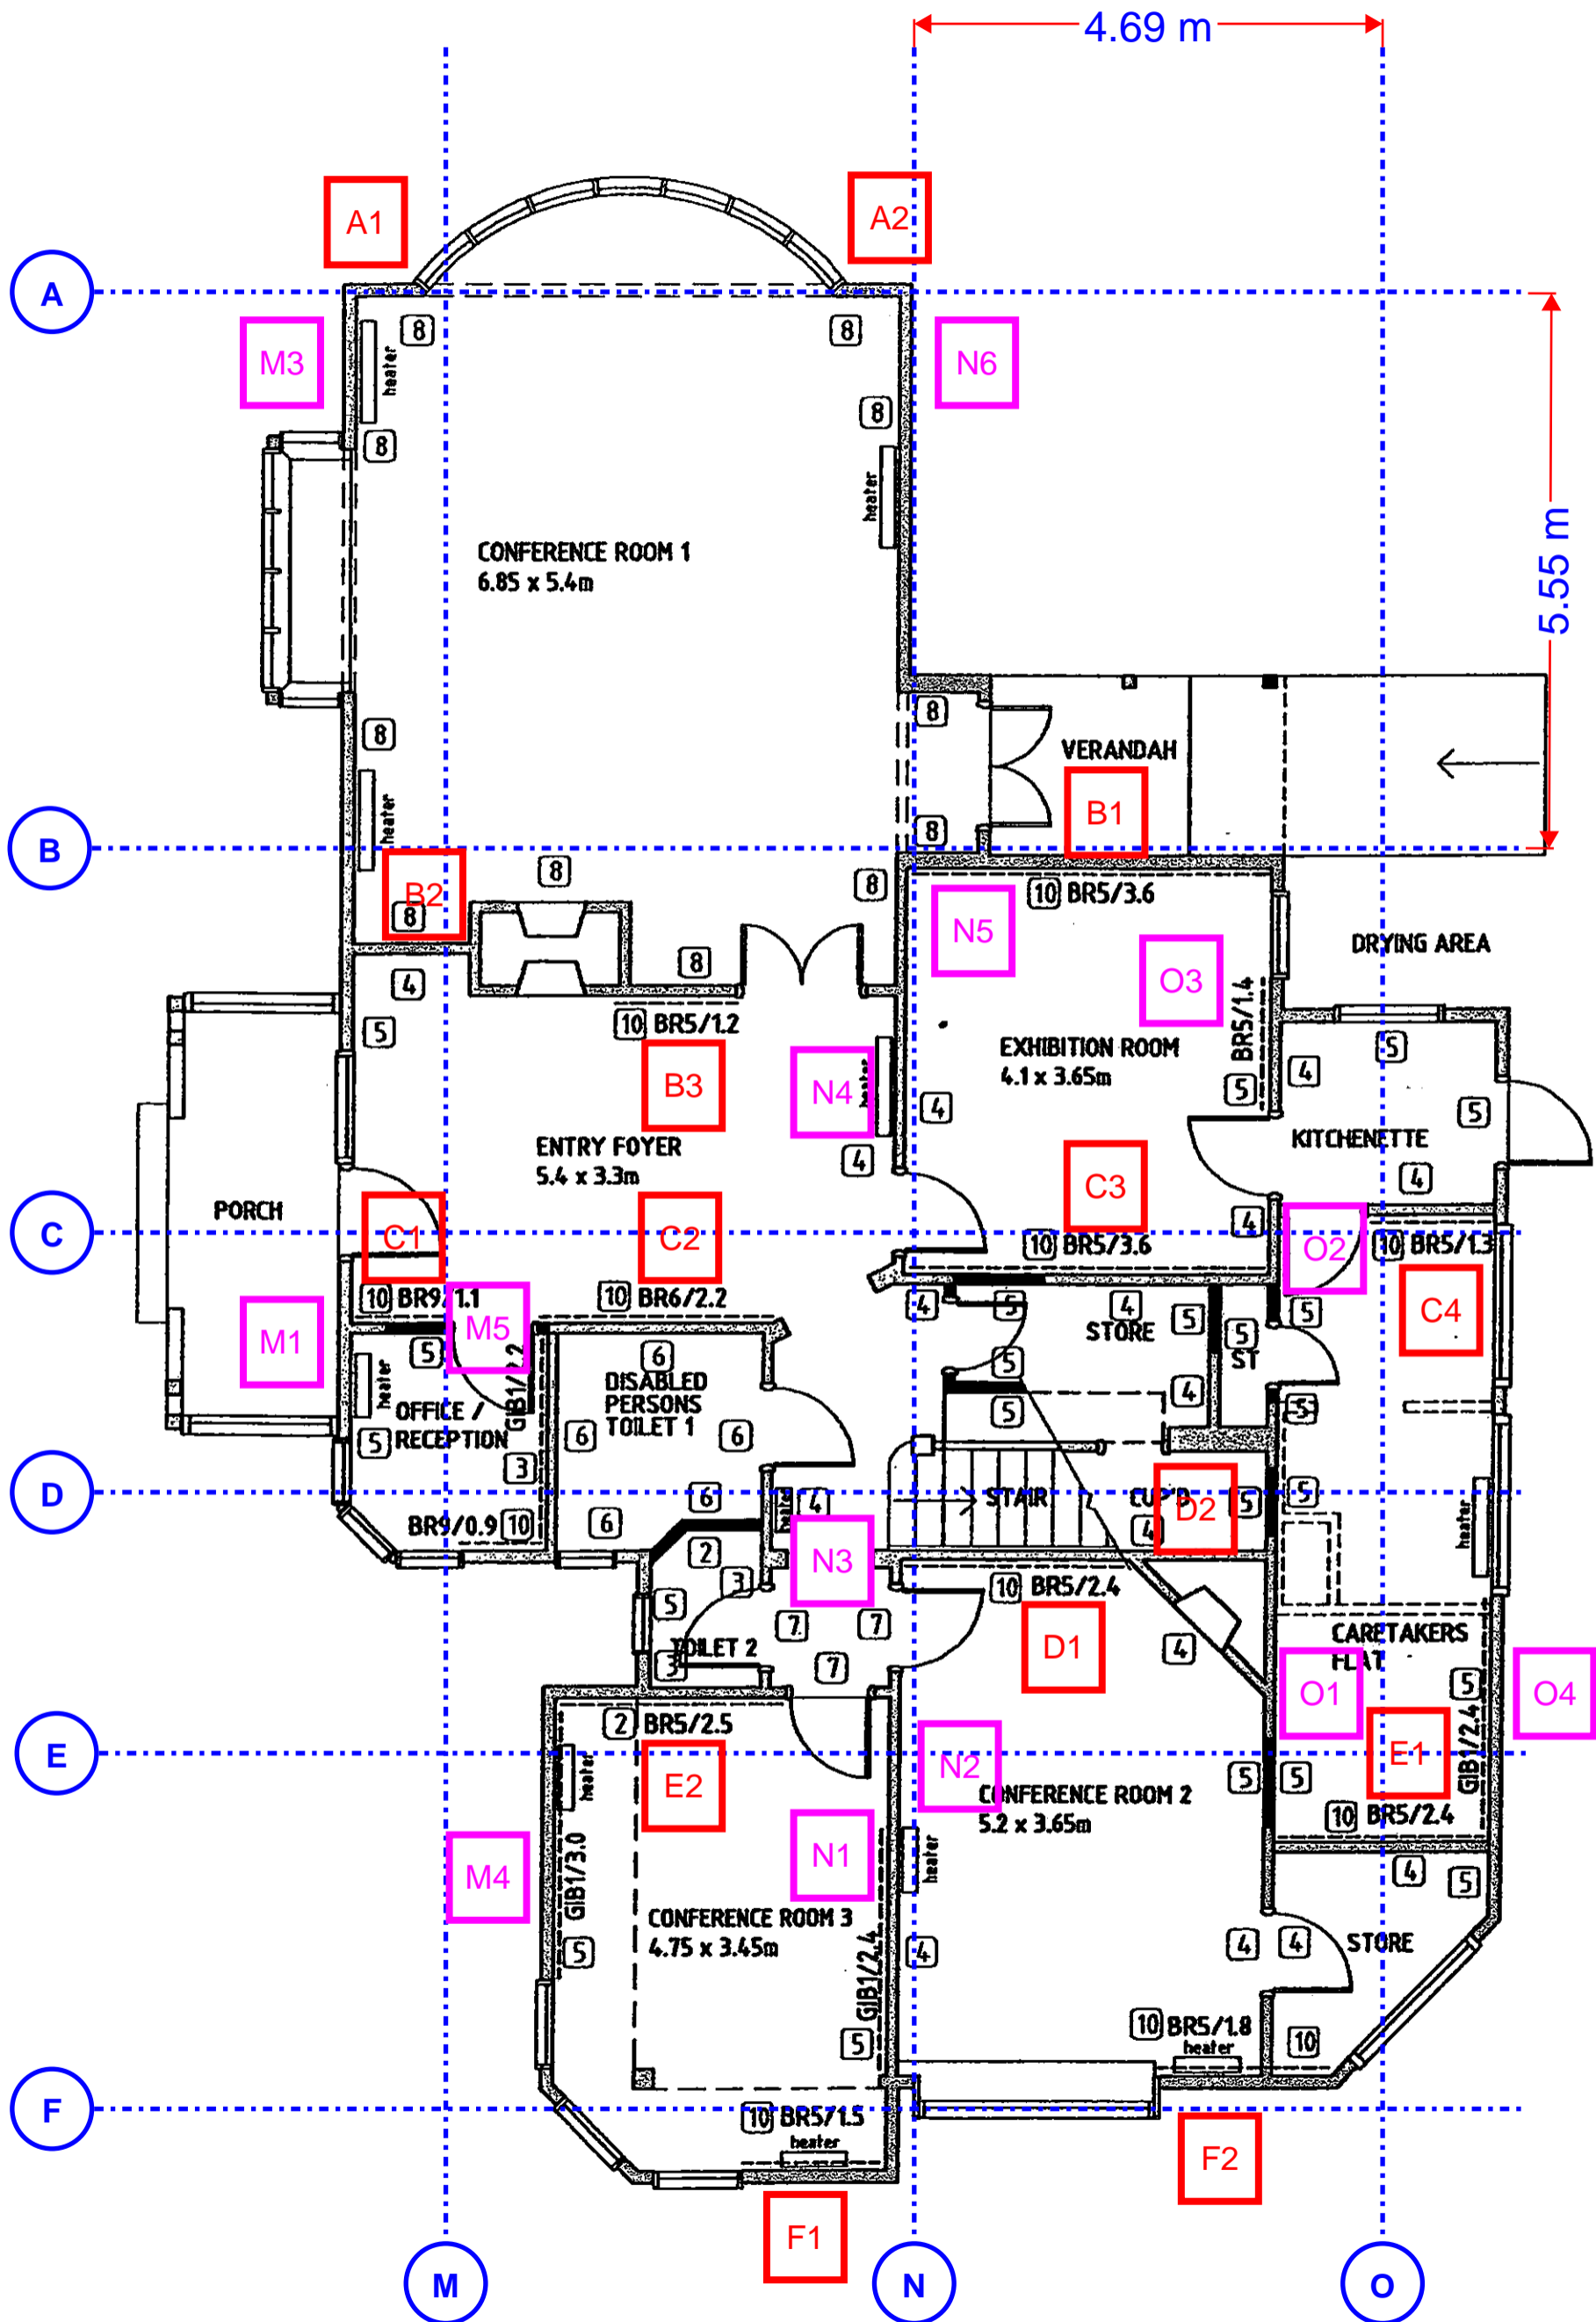
**First Floor Bracing Mark-up Plan (Option 1)**

It was noted that the building is highly possible to undergo shear failure at ULS loading. This shear failure is expected to initiate along the transverse direction at Grid A in the marked-up plan for Option 1 (see APPENDIX B).

Element	Description	Part Score	NZSEE Grade	Description of Failure
<b>Transverse Direction (Option 1)</b>					
First Floor	Total bracing	-	52% NBS	C	-
	Bracing per line	Insufficient bracing capacity - Grid A	<34% NBS	D	Shear failure Grid A
	Bracing external wall	Insufficient bracing capacity - Grid A	<34% NBS	D	Shear failure Grid A
Ground Floor	Total bracing	-	59% NBS	C	-
	Bracing per line	Insufficient bracing capacity - Grid A	<34% NBS	D	Shear failure Grid A
	Bracing external wall	Insufficient bracing capacity - Grid A	<34% NBS	D	Shear failure Grid A
<b>Longitudinal Direction (Option 1)</b>					
First Floor	Total bracing	-	62% NBS	C	-
	Bracing per line	-	100% NBS	A	-
	Bracing external wall	-	100% NBS	A	-
Ground Floor	Total bracing	Insufficient bracing capacity - Grid N	38% NBS	C	-
	Bracing per line	-	63% NBS	C	-
	Bracing external wall	-	100% NBS	A	-
<b>Non-Structural Element (Option 1)</b>					
The presence of two heavy earthquake-prone chimneys imposes life safety risk <34%NBS (IL2)

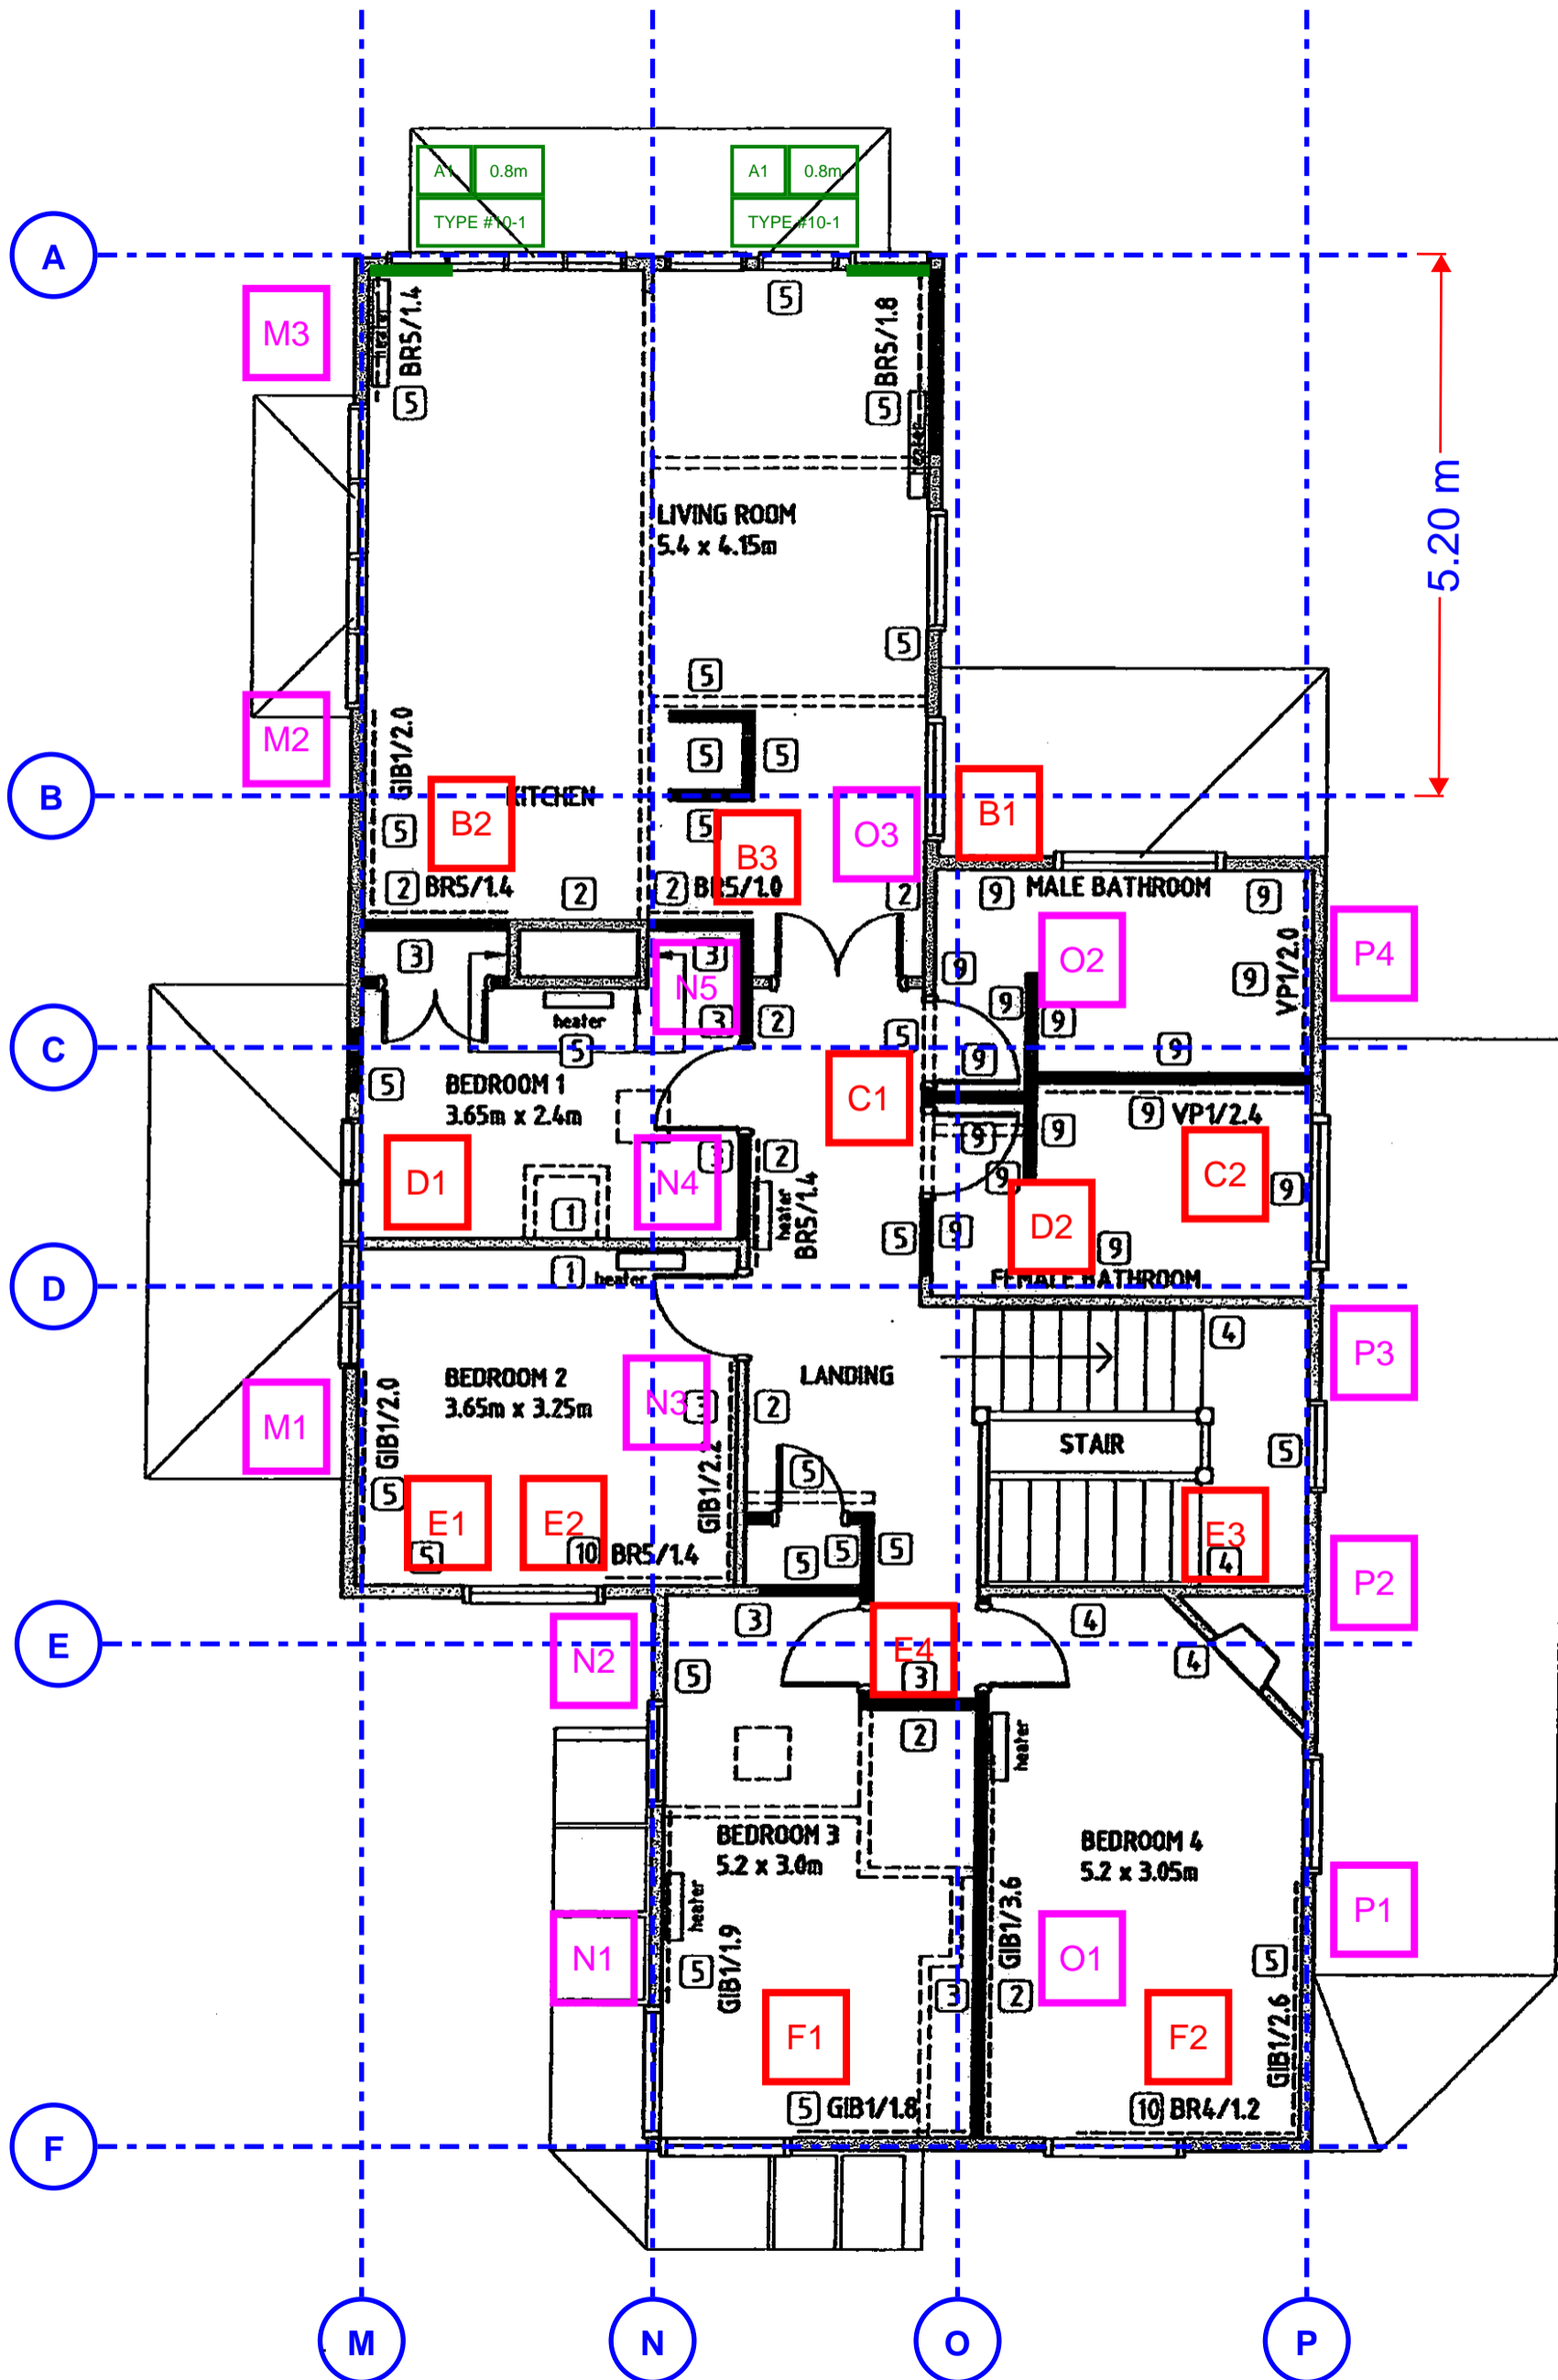
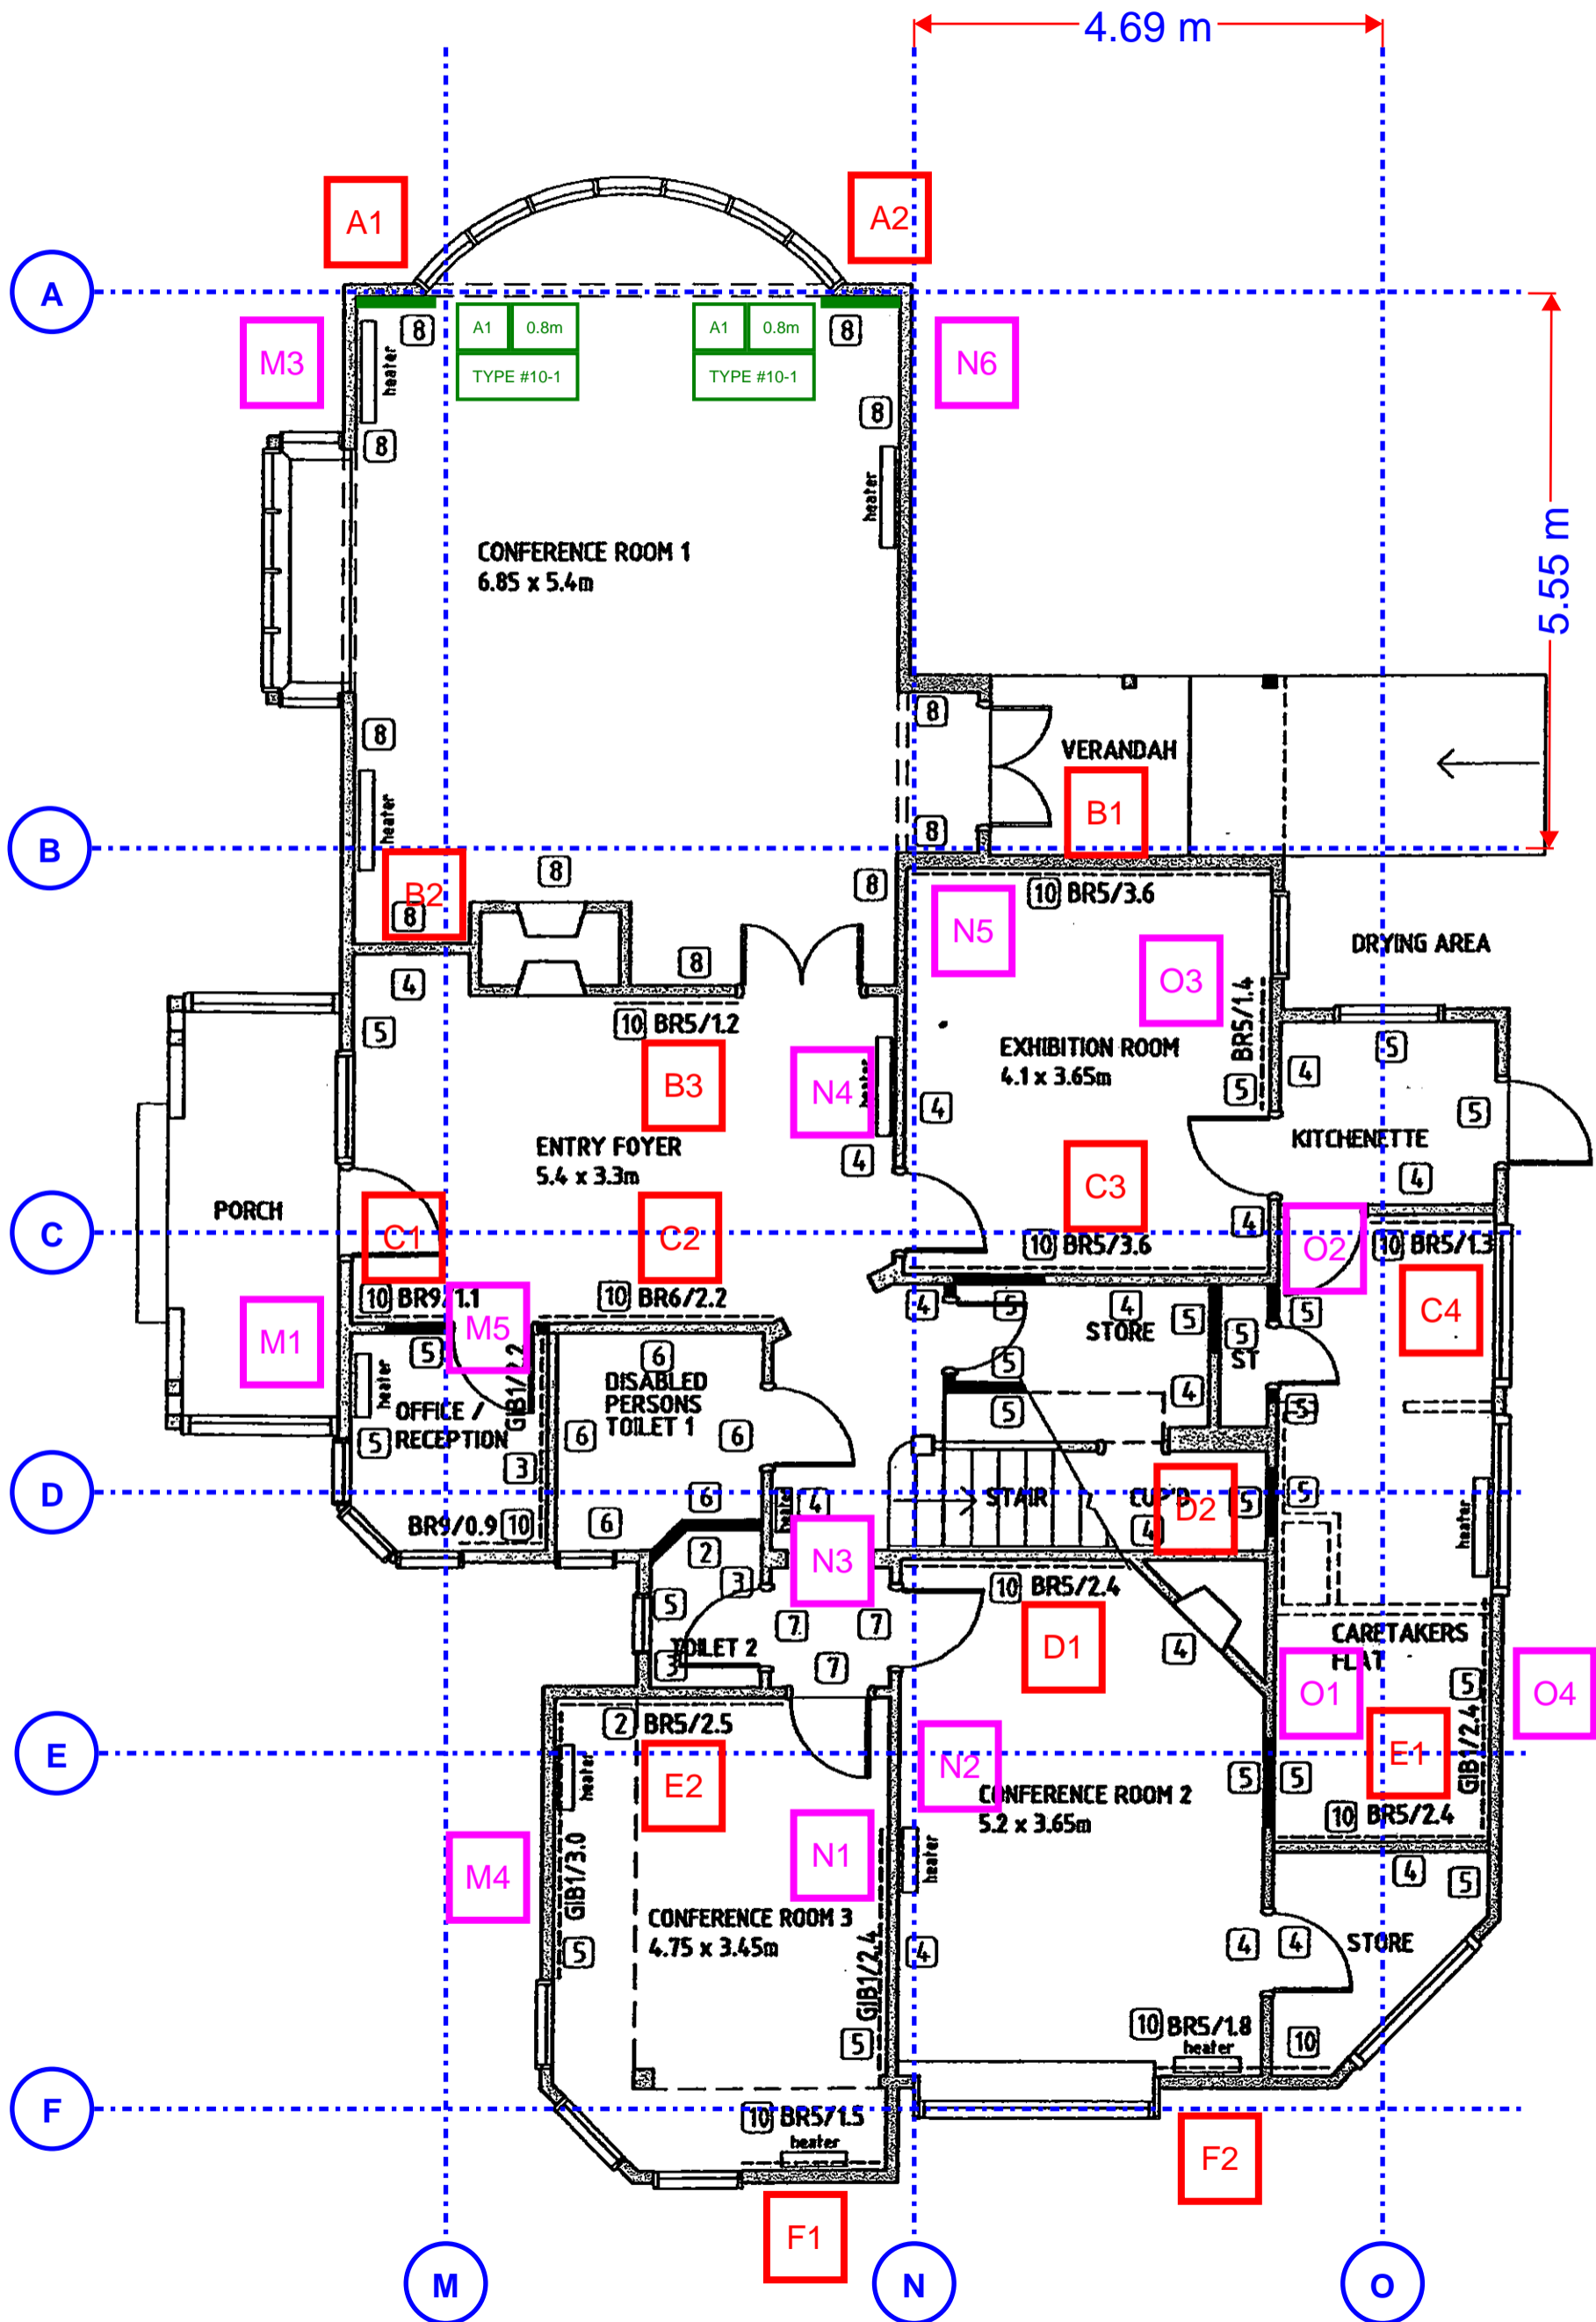
**First Floor Bracing Mark-up Plan (Options 2 & 3)**

Element	Description	Part Score	NZSEE Grade	Description of Failure
<b>Transverse Direction (Option 2)</b>					
First Floor	Total bracing	-	58% NBS	C	-
	Bracing per line	-	78% NBS	B	-
	Bracing external wall	-	90% NBS	A	-
Ground Floor	Total bracing	-	63% NBS	C	-
	Bracing per line	-	46% NBS	C	-
	Bracing external wall	-	64% NBS	C	-
<b>Longitudinal Direction (Option 2)</b>					
First Floor	Total bracing	-	62% NBS	C	-
	Bracing per line	-	100% NBS	A	-
	Bracing external wall	-	100% NBS	A	-
Ground Floor	Total bracing	Insufficient bracing capacity - Grid N	38% NBS	C	Shear failure Grid N
	Bracing per line	-	63% NBS	A	-
	Bracing external wall	-	100% NBS	A	-
<b>Non-Structural Element (Option 2)</b>					
The presence of two heavy earthquake-prone chimneys impose life safety risk <34%NBS (IL2)

Element	Description	Part Score	NZSEE Grade	Description of Failure
<b>Transverse Direction (Option 3)</b>					
First Floor	Total bracing	-	74% NBS	C	-
	Bracing per line	-	99% NBS	B	-
	Bracing external wall	-	90% NBS	A	-
Ground Floor	Total bracing	-	71% NBS	C	-
	Bracing per line	-	53% NBS	C	-
	Bracing external wall	-	64% NBS	C	-
<b>Longitudinal Direction (Option 3)</b>					
First Floor	Total bracing	-	79% NBS	B	-
	Bracing per line	-	100% NBS	A	-
	Bracing external wall	-	100% NBS	A	-
Ground Floor	Total bracing	-	43% NBS > 40%NBS	C	Shear failure Grid N
	Bracing per line	-	72% NBS	B	-
	Bracing external wall	-	100% NBS	A	-
<b>Non-Structural Element (Option 3)</b>					
Chimneys are removed.
