**DETAILED SEISMIC ASSESSMENT FOR  
38 NORMANDALE ROAD, MINOH  
HOUSE, LOWER HUTT.**

DSA REPORT

91 WESTERN HUTT ROAD,  
NORMANDALE, LOWER HUTT 5010

P330

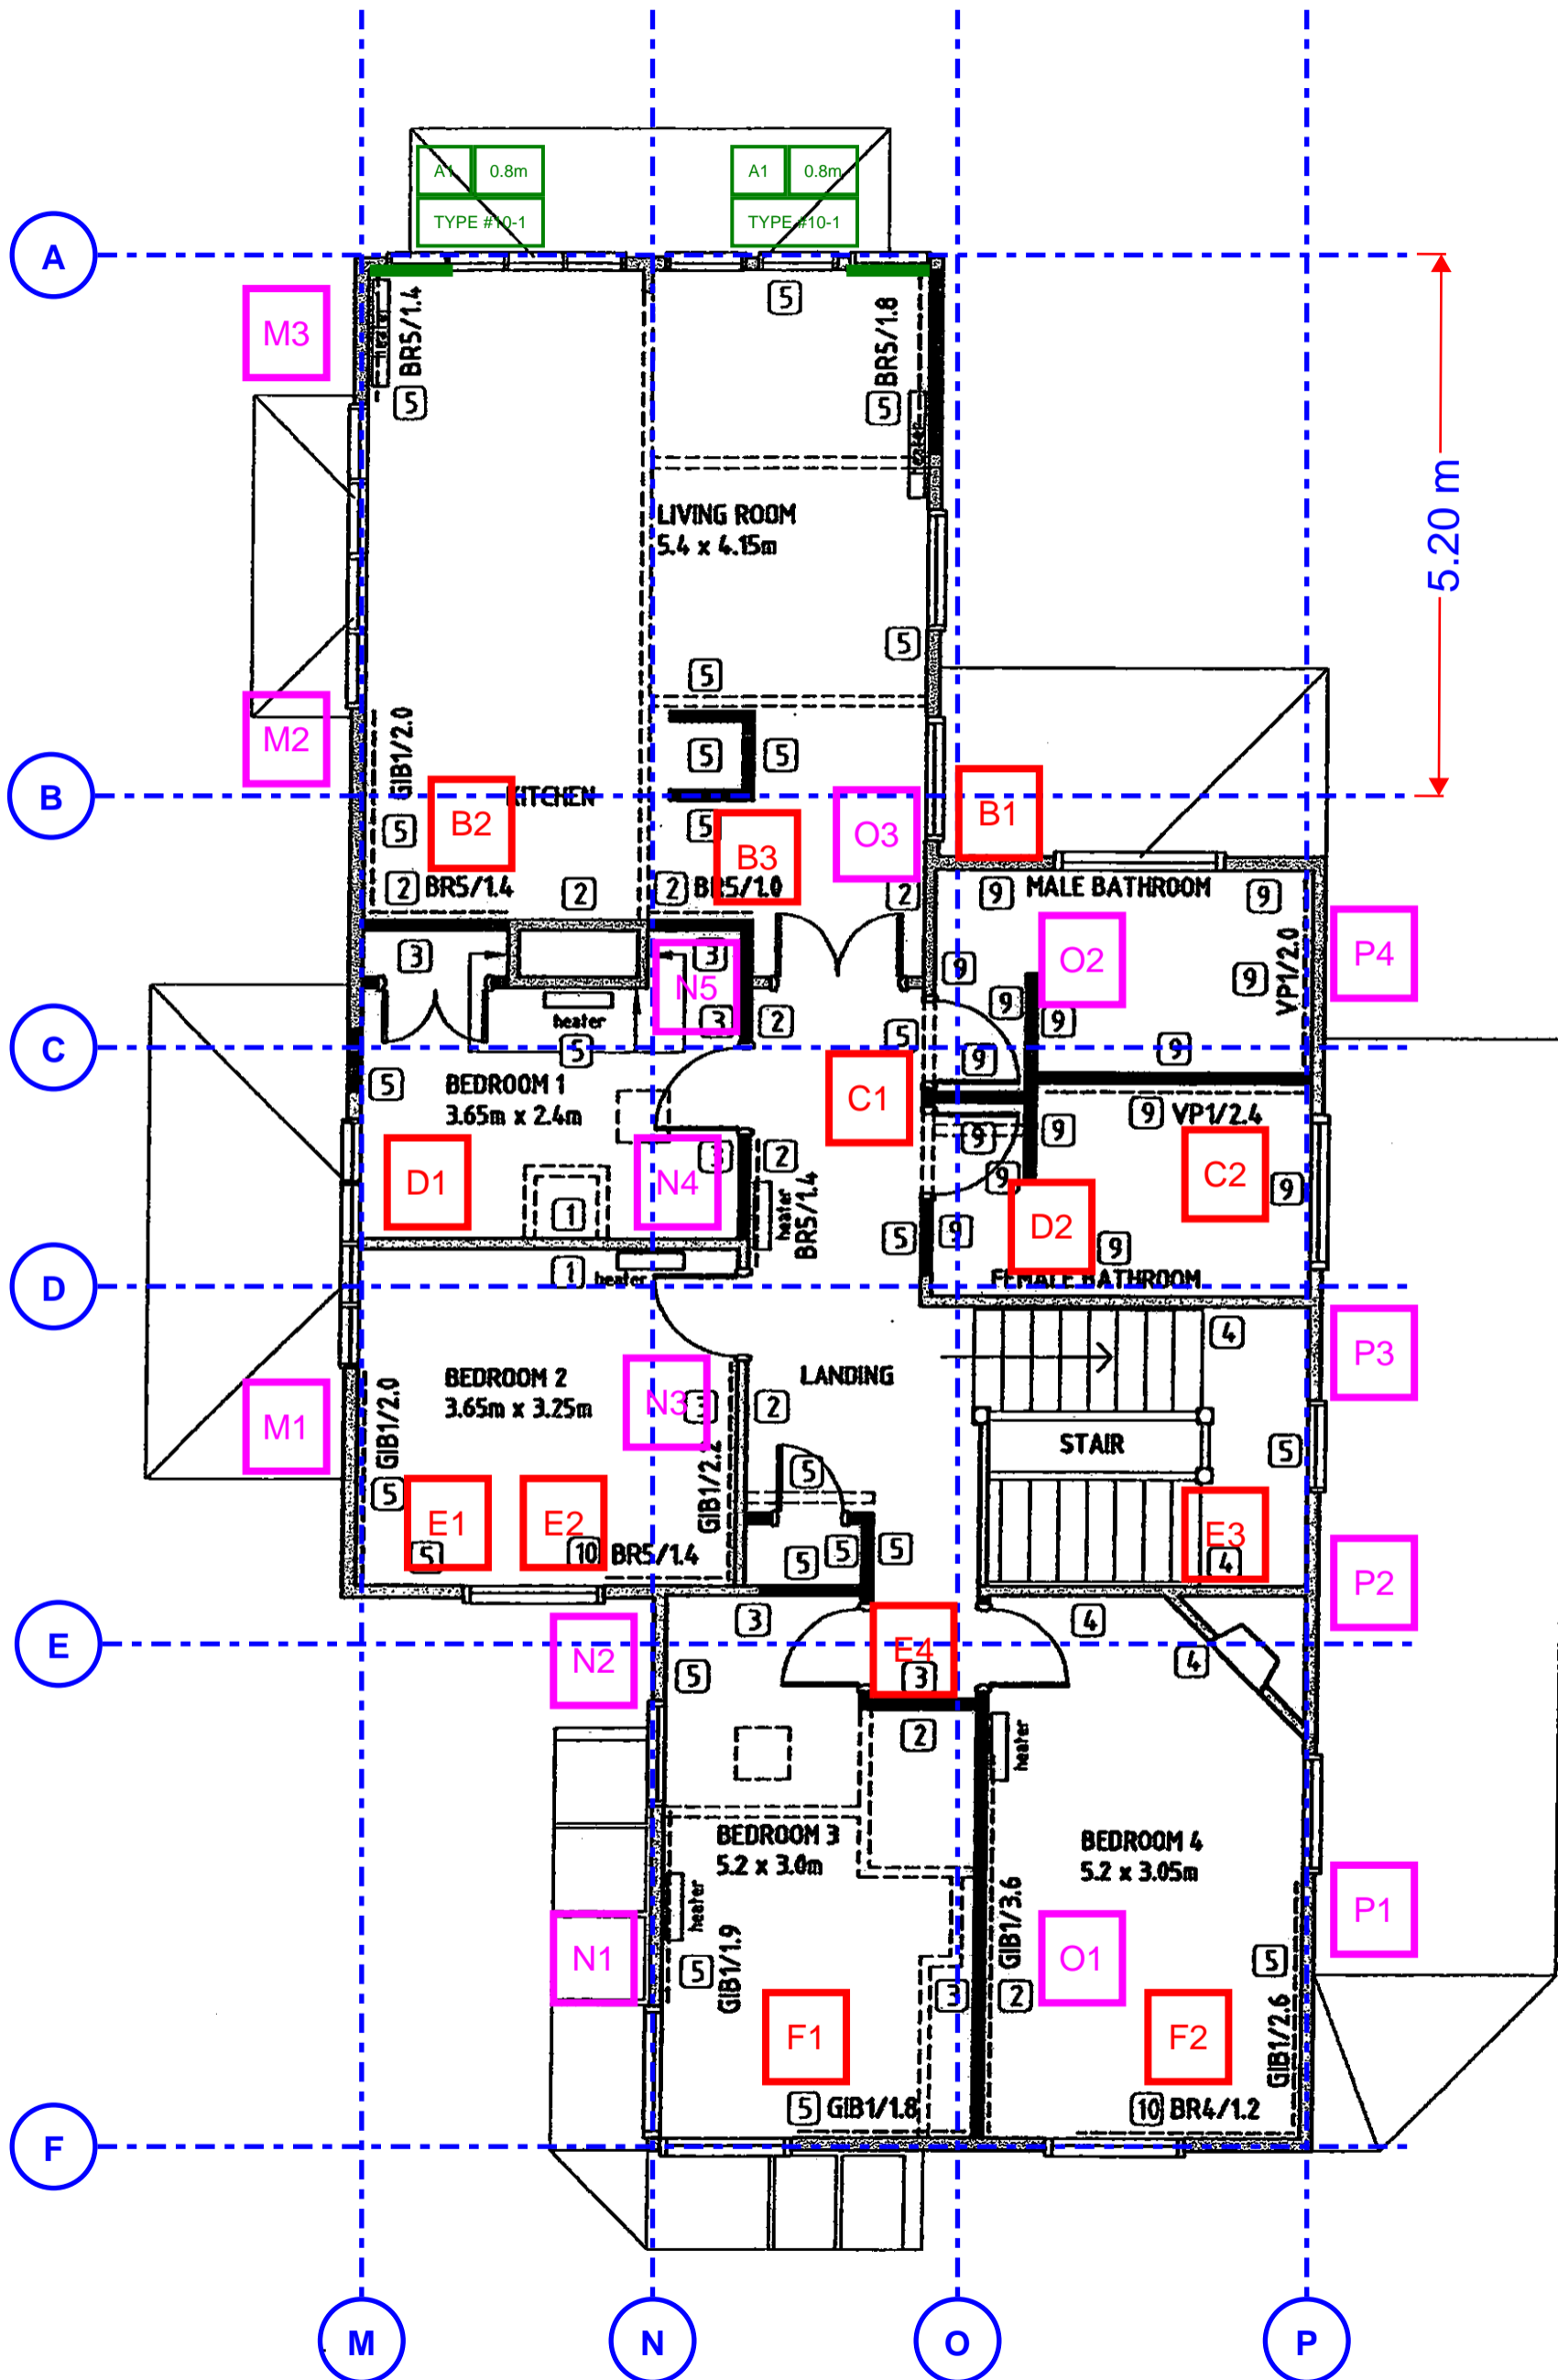
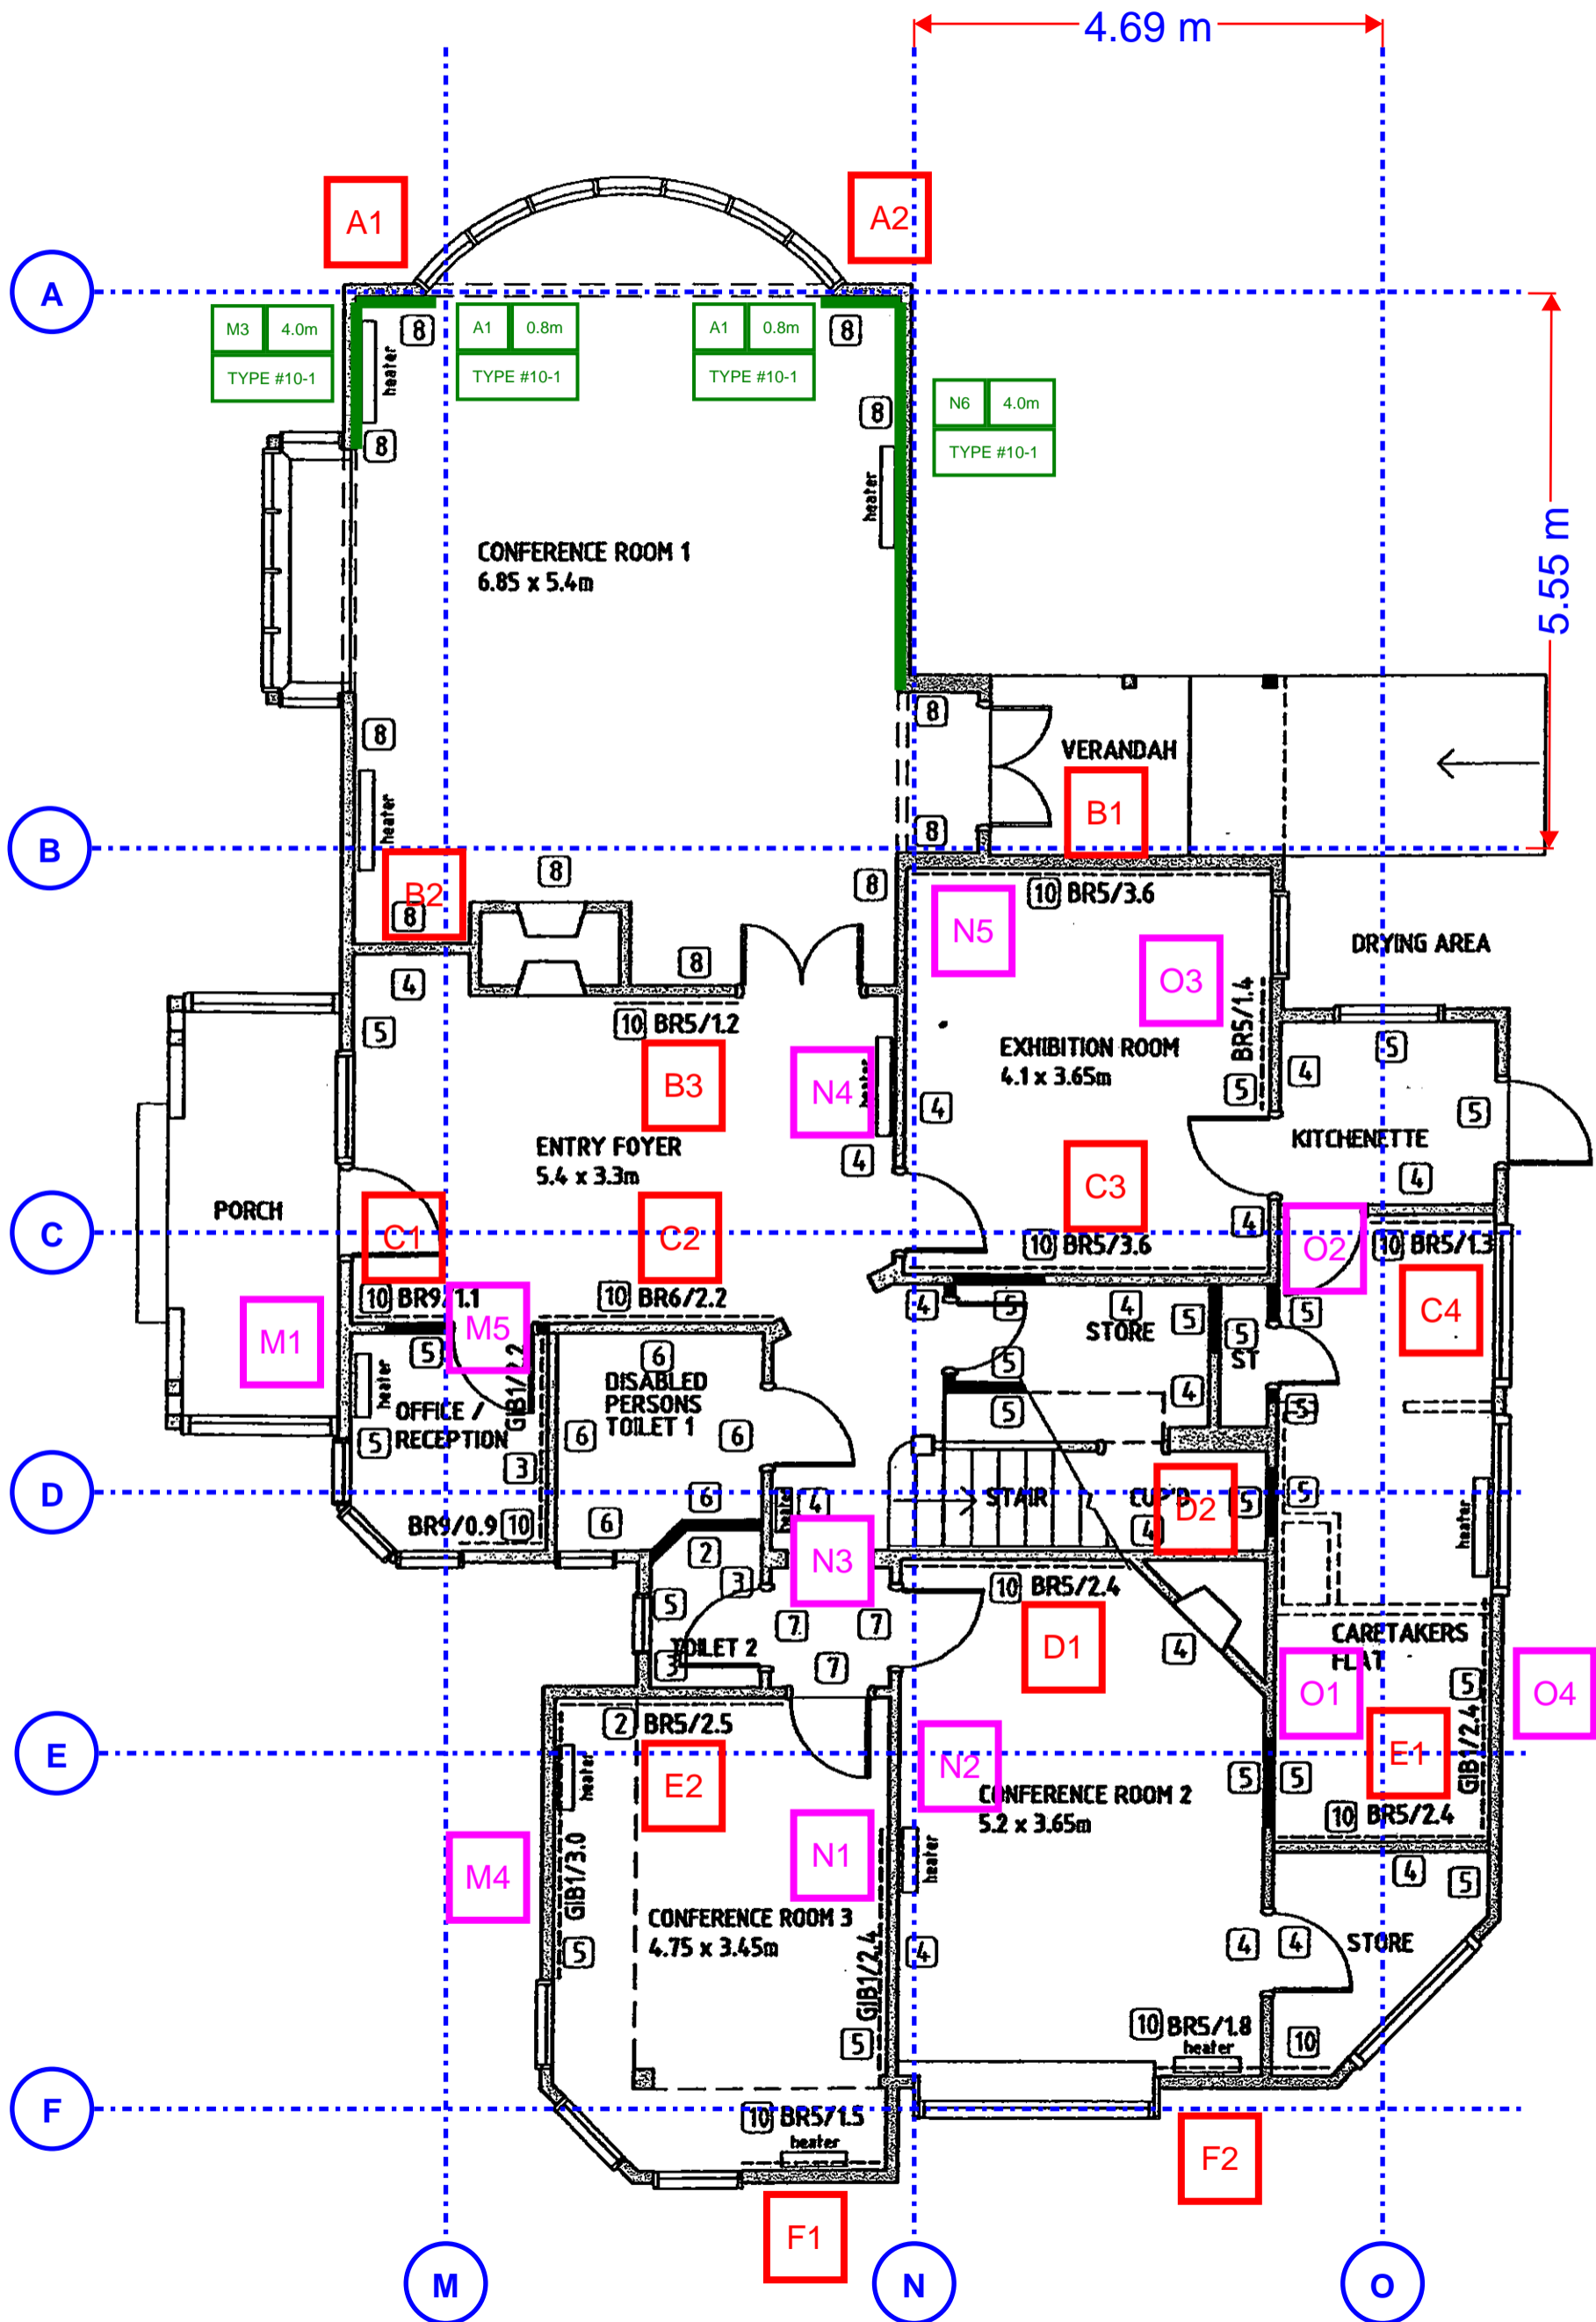
**First Floor Bracing Mark-up Plan (Option 4)**

Element	Description	Part Score	NZSEE Grade	Description of Failure
<b>Transverse Direction (Option 4)</b>					
First Floor	Total bracing	-	74% NBS	B	-
	Bracing per line	-	99% NBS	A	-
	Bracing external wall	-	90% NBS	A	-
Ground Floor	Total bracing	-	71% NBS	B	-
	Bracing per line	-	53% NBS > 40%NBS	C	Shear failure Grid A
	Bracing external wall	-	64% NBS	C	-
<b>Longitudinal Direction (Option 4)</b>					
First Floor	Total bracing	-	79% NBS	B	-
	Bracing per line	-	100% NBS	A <sup>+</sup>	-
	Bracing external wall	-	100% NBS	A <sup>+</sup>	-
Ground Floor	Total bracing	-	54% NBS > 40%NBS	C	Shear failure Grid N
	Bracing per line	-	93% NBS	B	-
	Bracing external wall	-	100% NBS	A <sup>+</sup>	-
<b>Non-Structural Element (Option 4)</b>					
Chimneys are removed.

Additional bracing walls in the longitudinal direction at the ground floor (**Option 4**) can result in **53% NBS (IL2)**, which is recommended.

<b>Option 4</b>	Option 3 + additional bracing walls along Grids M & N for ground floor	<b>53%</b>	<b>C</b>	<b>Medium</b>	- recommended for better seismic performance in the middle medium life safety risk range -%NBS rating is almost the same along both orthogonal directions (~53%-54%)
