# Naenae Olympic Pool Facility - Seismic Assessment

Prepared for Hutt City Council  
Prepared by Beca Limited

22 July 2019

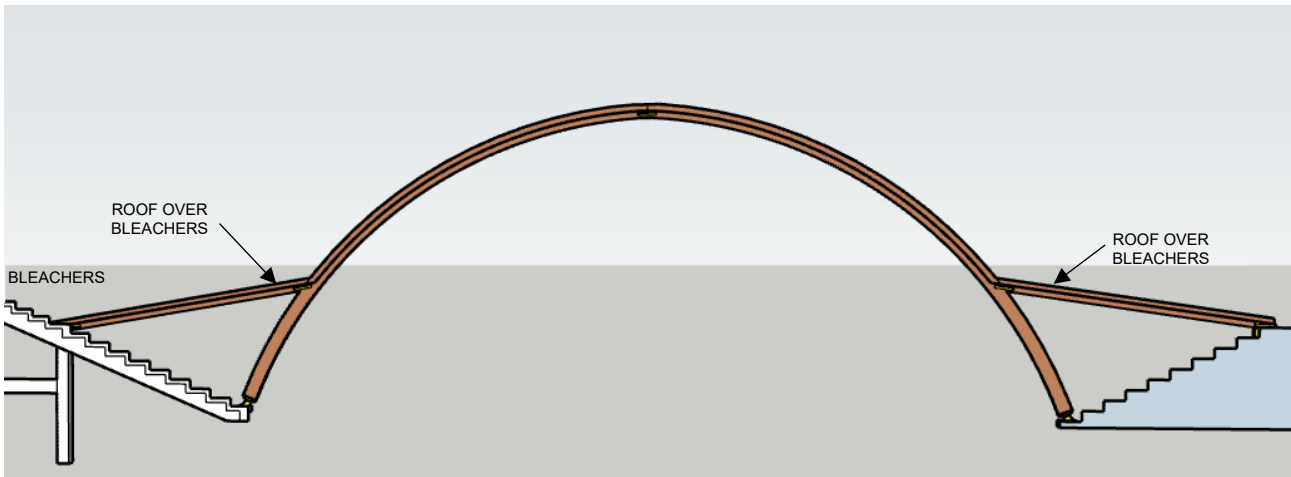
- The seismic loads are resisted predominantly by the glulam timber arches.
- There are three main types of arches with varying capacity for lateral-load resistance – a plain arch at each end of the building, an arch with one ‘prop’ to the bleachers, and an arch with a ‘prop’ to the bleachers on each side.
- It is assumed, that the arches resist loads based on the tributary area associated with each.
- The end arches are quite flexible and have limited lateral-load resistance.
- The elevated plant platform adds additional mass and load to the arches that it is suspended from.
- It is assumed, that the arches transfer the load in to the concrete bleachers which then transfer it to the ground.

Figure 2.2 – Transverse section showing typical timber arch with props (looking north)

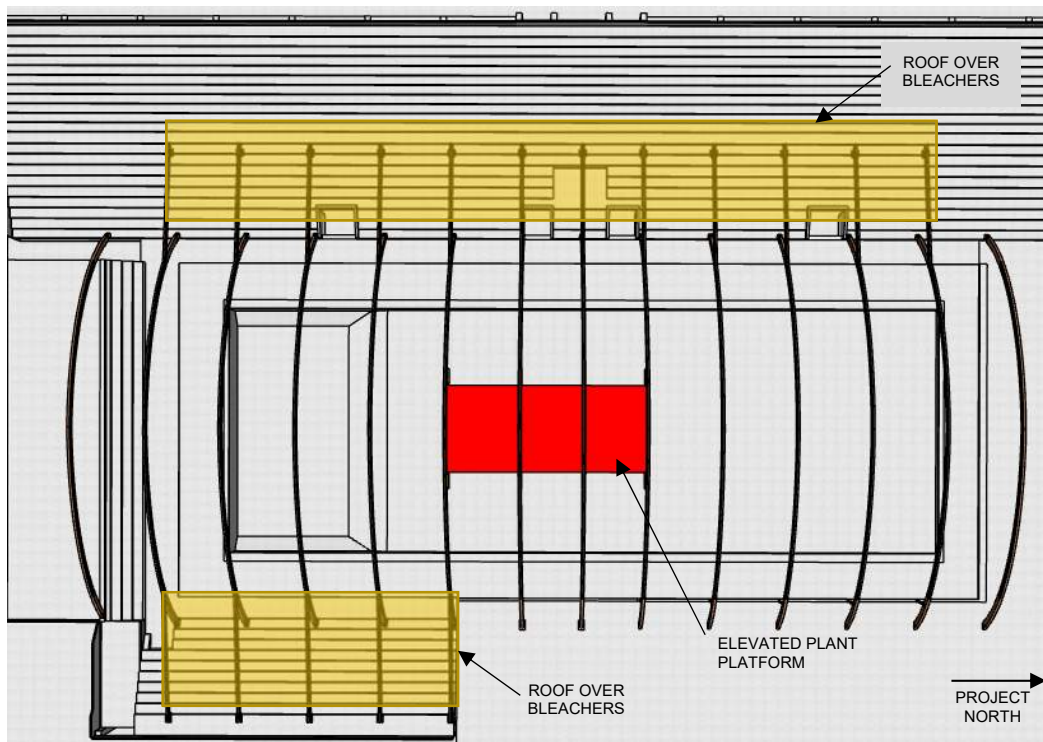
- The seismic loads are resisted predominantly by the plywood roof structure. At the time that the assessment was undertaken, the construction details for the plywood structure were unknown and it was assumed that these could act as a diaphragm. Further investigations have now concluded that these are not reliably fixed to the arches as required to provide a dependable transfer of seismic loads.
- The load is distributed to the concrete bleachers through the ‘roof over the bleachers’ which runs most of the length of the building on the western side, however is only over half the length of the building on the eastern side.

Figure 2.3 – Plan of building

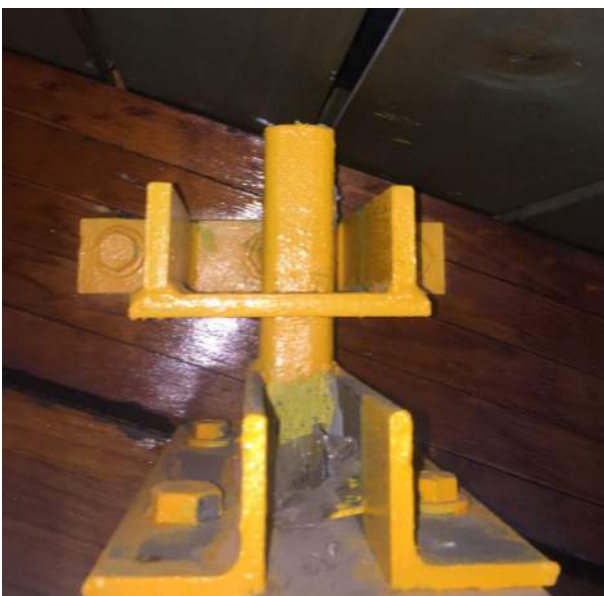
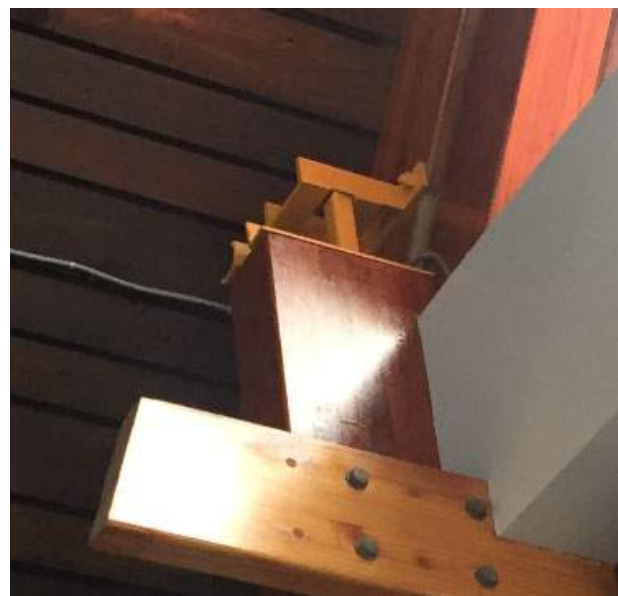
When both buildings deflect, this connection may rack and cause damage to the ceiling/roof that it supports, and it may also cause the wind columns to twist. The twisting and movement of this column will further load the top connection that is already under capacity. Refer 4.2 below.

For a new building, glazed façades are normally designed to accommodate the building’s deformations. The connections of the glazed end walls of the Main Pool Hall indicate that some thought was given to separate the façade and there are slotted holes at the top of the wind posts that allows movement. However, the movement allowances are not adequate to accommodate the required earthquake displacements. In places, the connections are already hard up against one side of the slot. At one location, the pin has bent as it has run out of travel before the required amount of movement has been accommodated. As a result, movement of the main arches cannot be accommodated, and the seismic load will be transferred directly to the glazed walls. Displacement of the main arches could also result in loss of contact of the top post pins, and therefore loss of restraint at the top of the façade wind posts.

Figure 4.1 – Glazed End wall top connection with little to no travel room
