BEFORE THE HUTT CITY COUNCIL

IN THE MATTER
of the Proposed Lower Hutt District Plan

STATEMENT OF EVIDENCE OF Ian Roderick Brown
Consulting engineer

5 June 2026

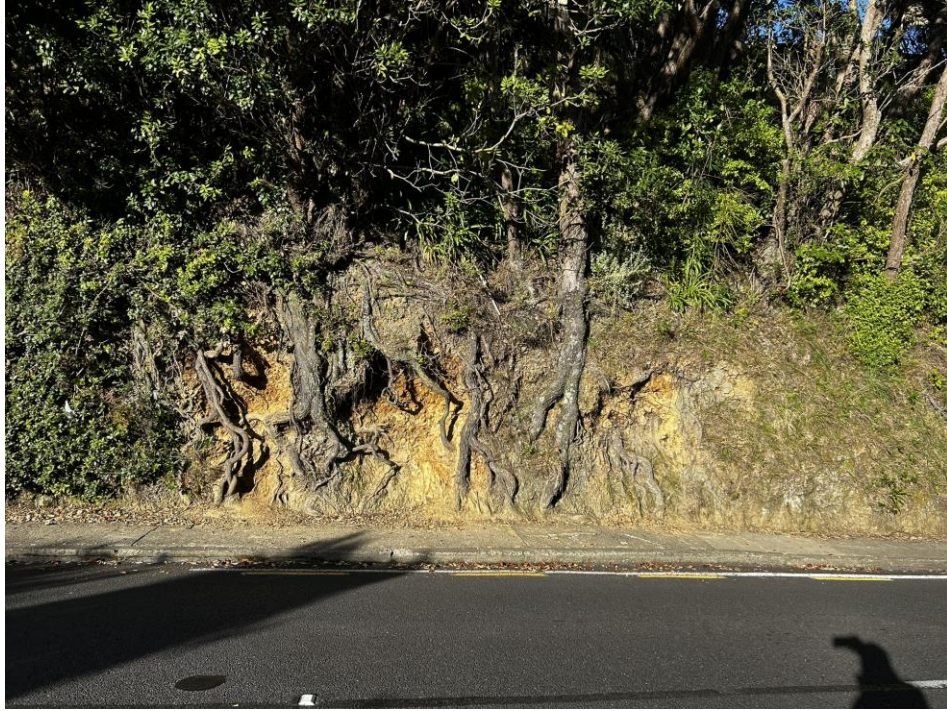
18. The gravels are well exposed in a cutting below 12 Park Road (Figures 3 and 4). This exposure shows gravel overlying weathered sandstone and siltstone (greywacke).
19. The gravel is also exposed on the eastern slope above Park Road north of 12 Park Road.

Figure 4. Gravel overlying weathered greywacke below 12 Park Road.

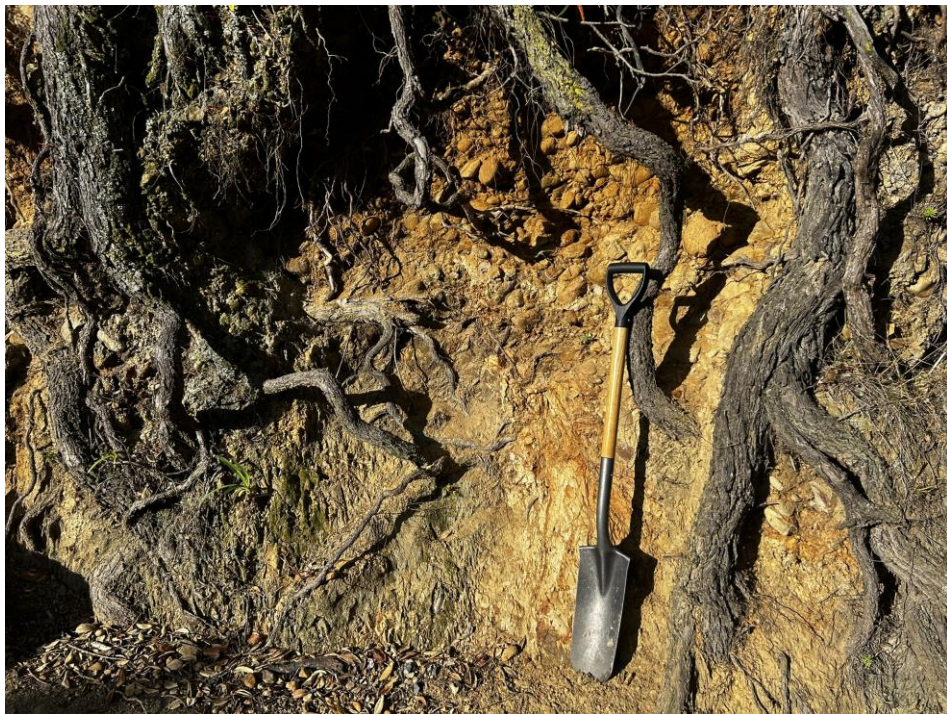
Figure 5. Detail of gravel overlying weathered greywacke.

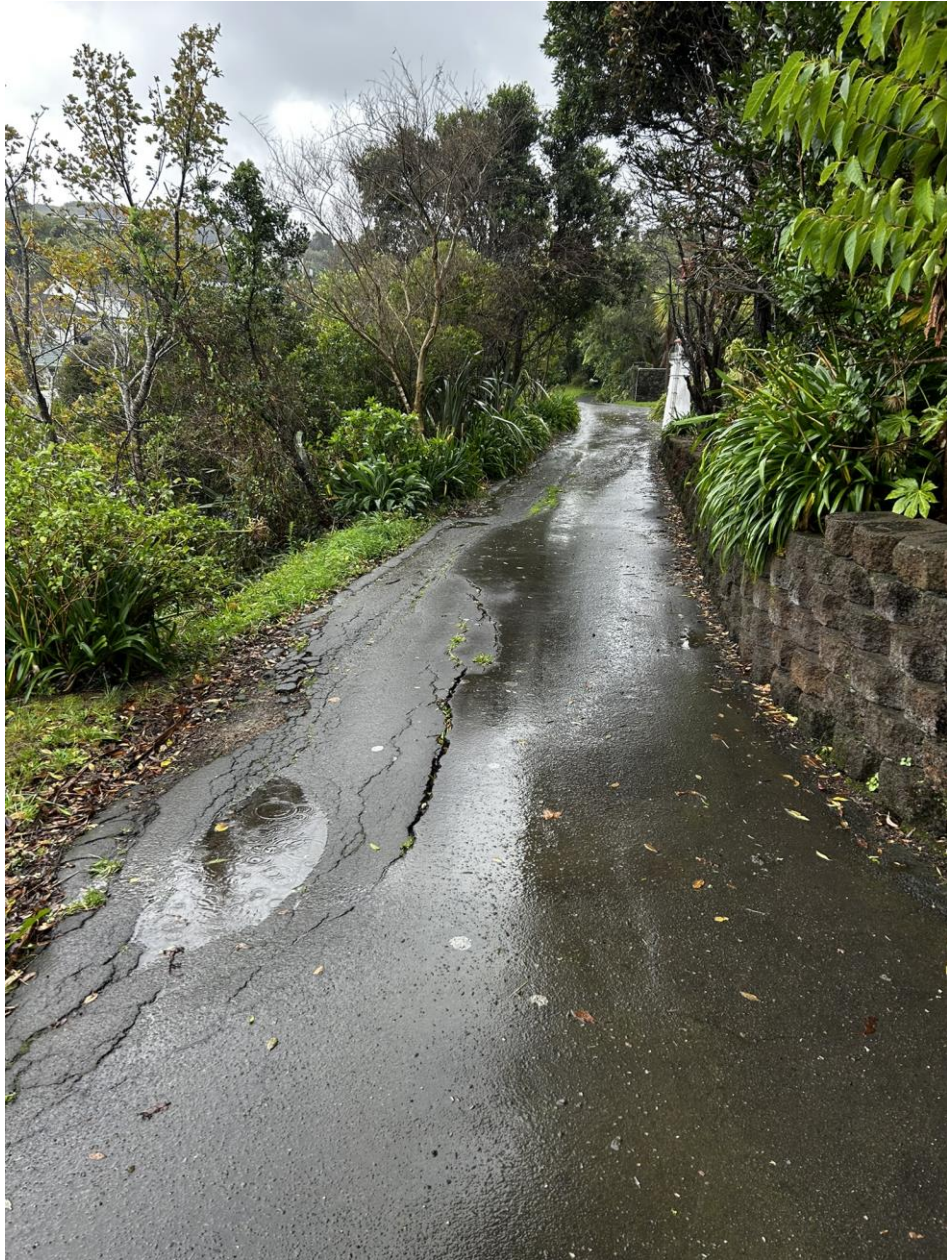
29. In recent years, the slope on the uphill side of Park Road between 12 and 38 Park Road has shown signs of impending failure. This is evidenced by surface cracking on the tar seal surface of the upper part of the Park Road carriageway (Figure 7). This area is critical for access to the adjacent right of way servicing seven properties.

Figure 7. Tension cracks disrupting sealed upper carriageway.

39. Over a number of years, I have had many discussions with Hutt City Council regarding the need to maintain, repair, and provide public safety benefits to the area of road reserve along the road frontages of 12 – 40 Park Road. In my view a comprehensive program of slope stabilisation is required; it is much easier to stabilise a slope than provide a repair once failure has occurred.

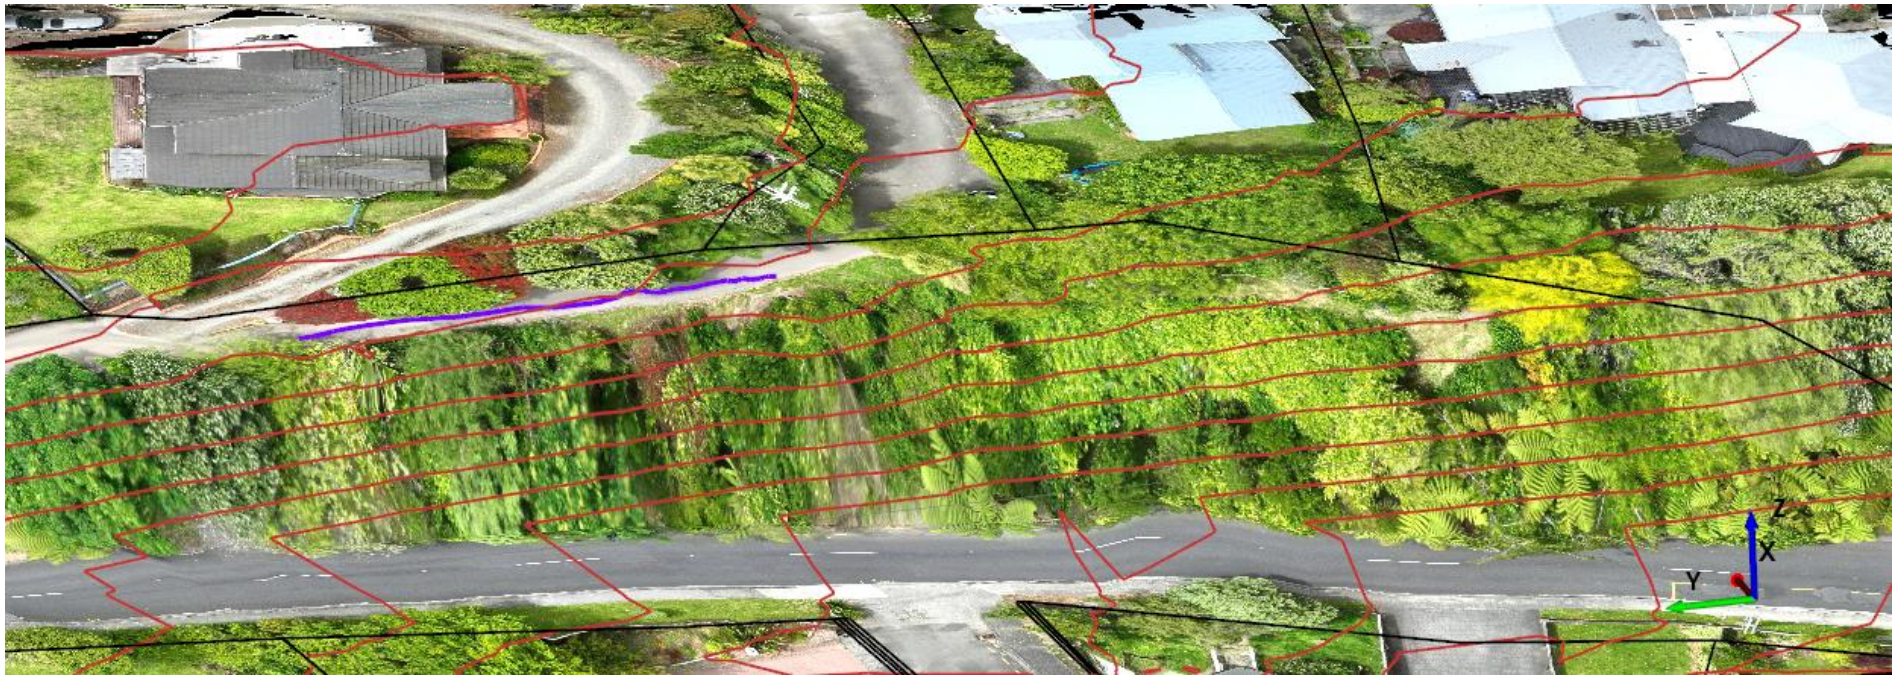
30. I have prepared a 3D model of this part of Park Road, using TSLOPE, a 2D and 3D limit equilibrium software package⁸. A perspective view of the modelled slope is shown on Figure 8, with a section across the model used for stability calculations shown on Figure 9. These views show the relationship of the steep slope that is immediately adjacent to the main carriageway of Park Road, and the upper carriageway.

Figure 8. Perspective view of slope between 36 and 18 Park Road. Tension crack shown in purple on upper carriageway. Contour interval 1m.

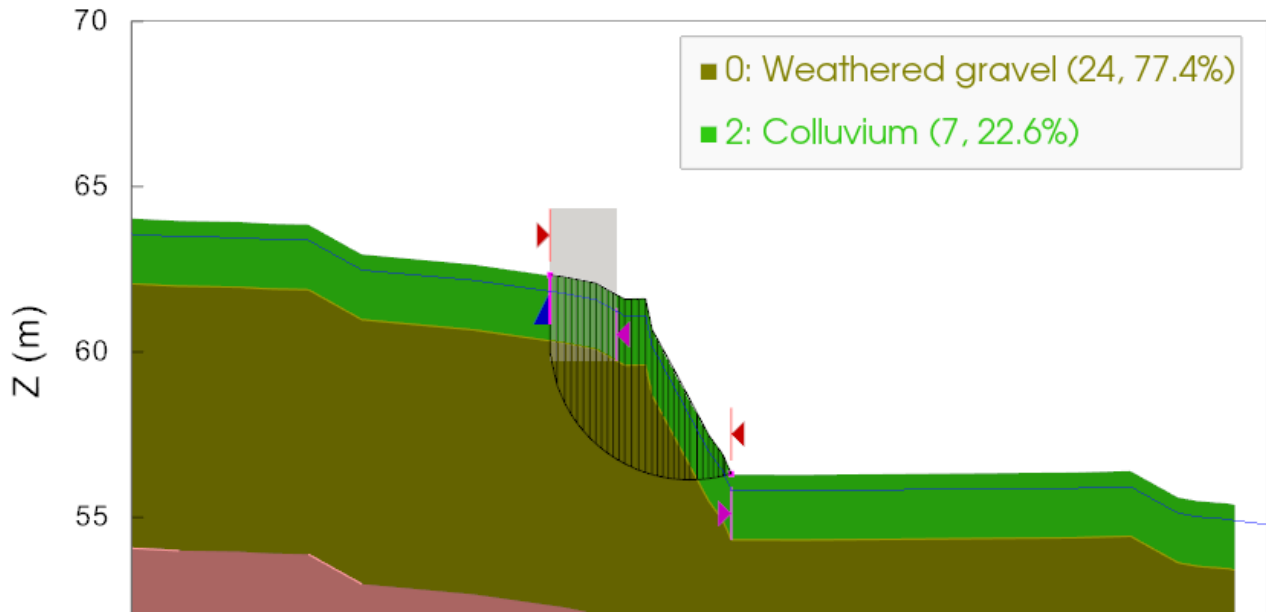
Figure 9. Cross section showing potential slope failure through tension crack.

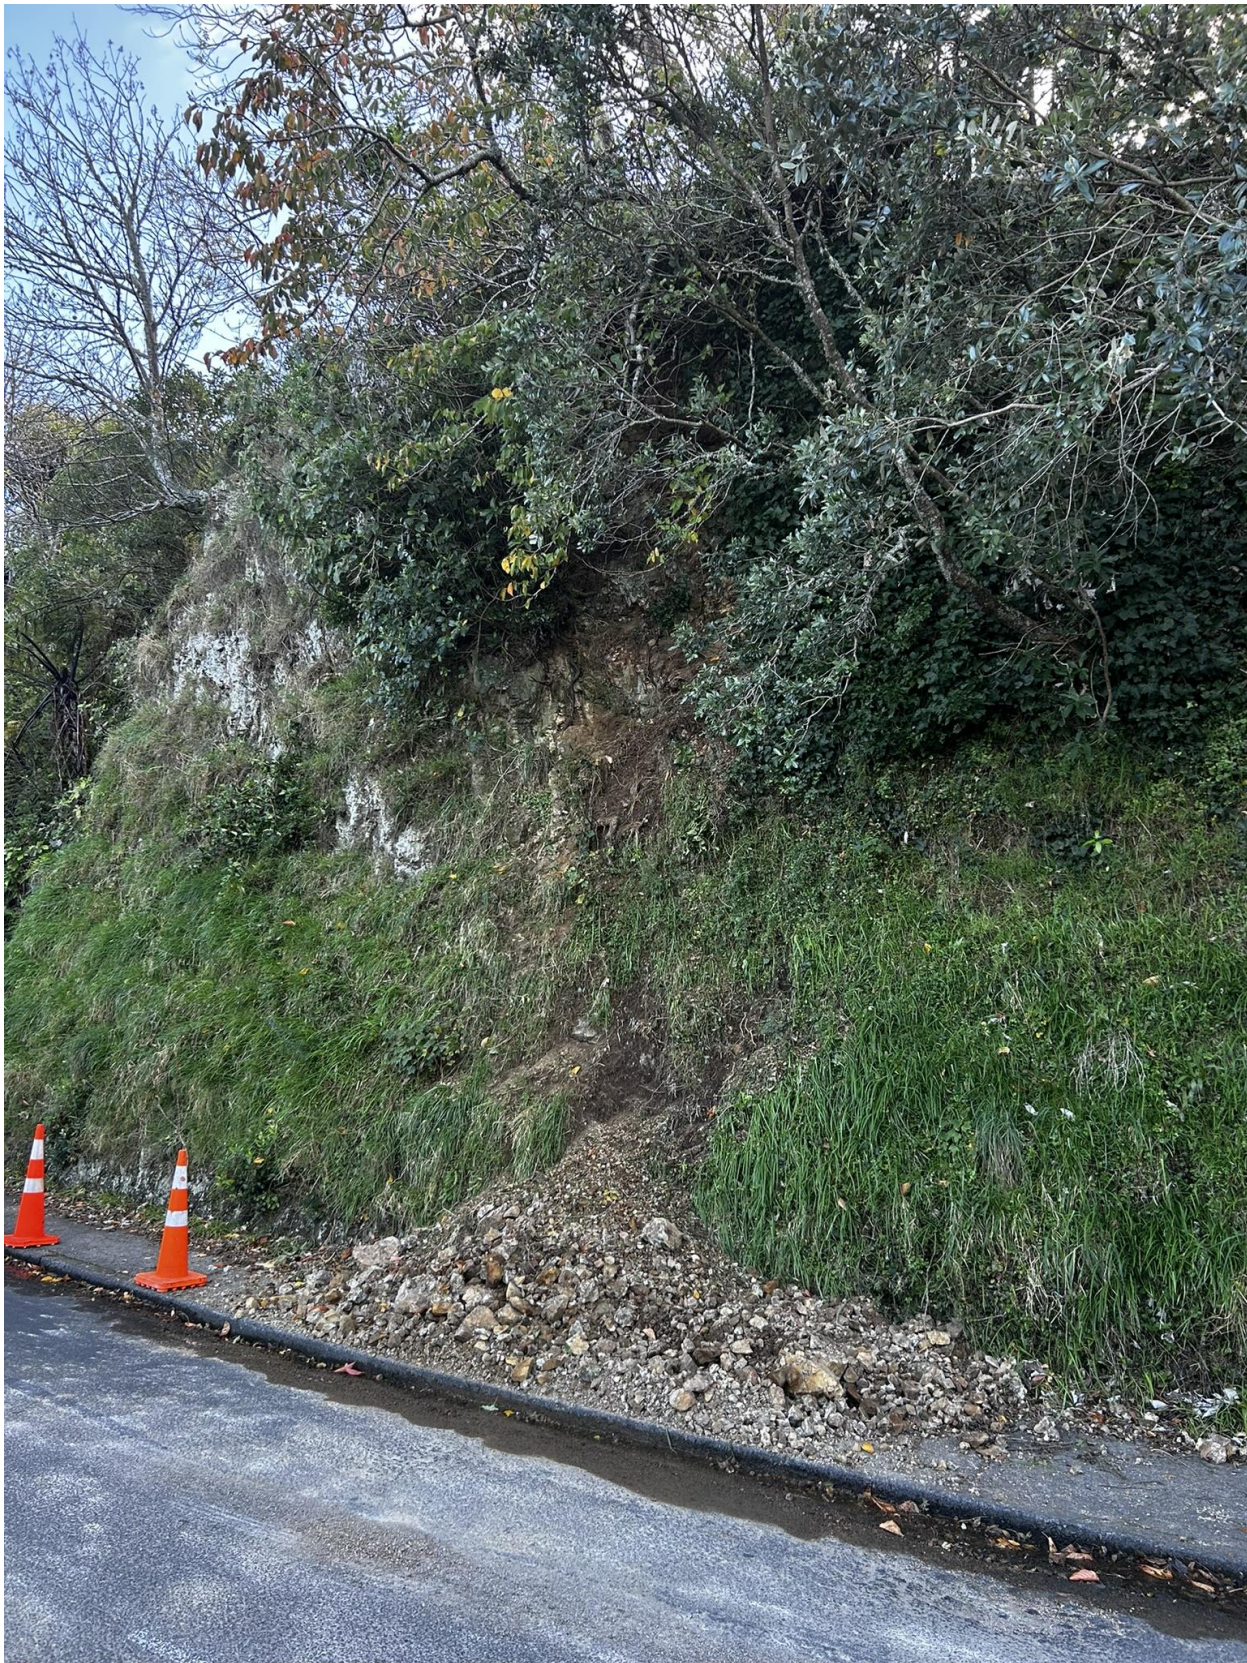
31. A rock fall that occurred on May 13, 2026 at the slope adjacent to 10 Park Road (Figure 10). The rock is weathered greywacke; the contact with overlying gravel is much higher in the slope.

32. This rock fall left an area of overhanging weathered rock that will lead to further rock falls with potential to harm users of the footpath and the road.

Figure 10. Rock fall from slope below 10 Park Road, debris covering pedestrian footpath.

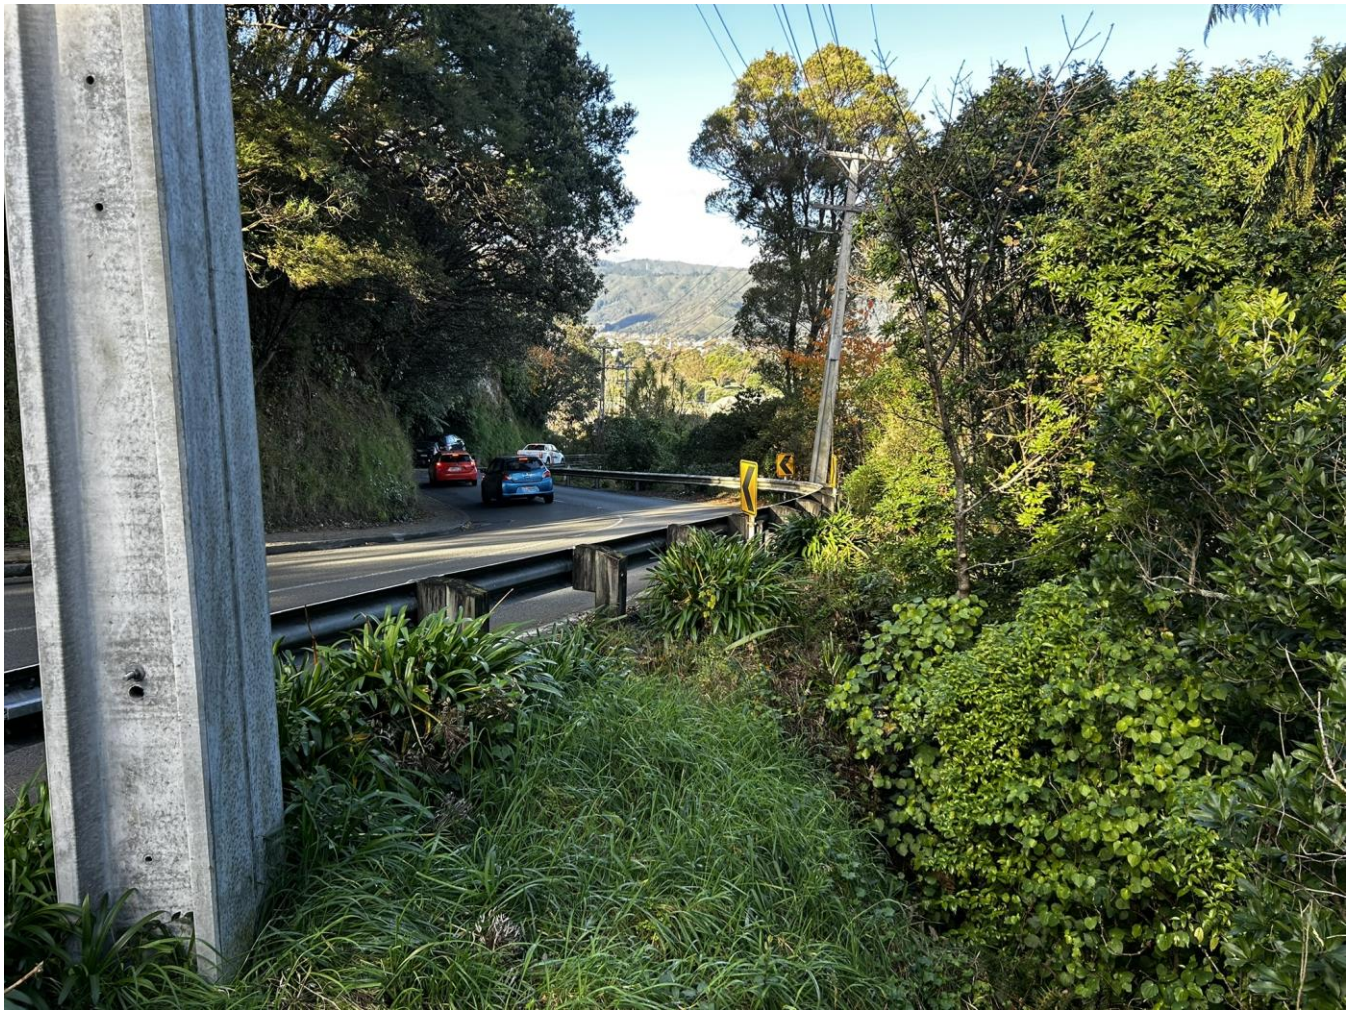
33. I also observed a leaning power pole in this area (Figure 11). I recall when these poles were replaced, and they took great care to stand them vertically. The current lean indicates underlying ground movement. I have prepared a TSLOPE model to show the configuration of the slope in this area.

Figure 11. Slope below 12A Park Road showing lean on power pole.

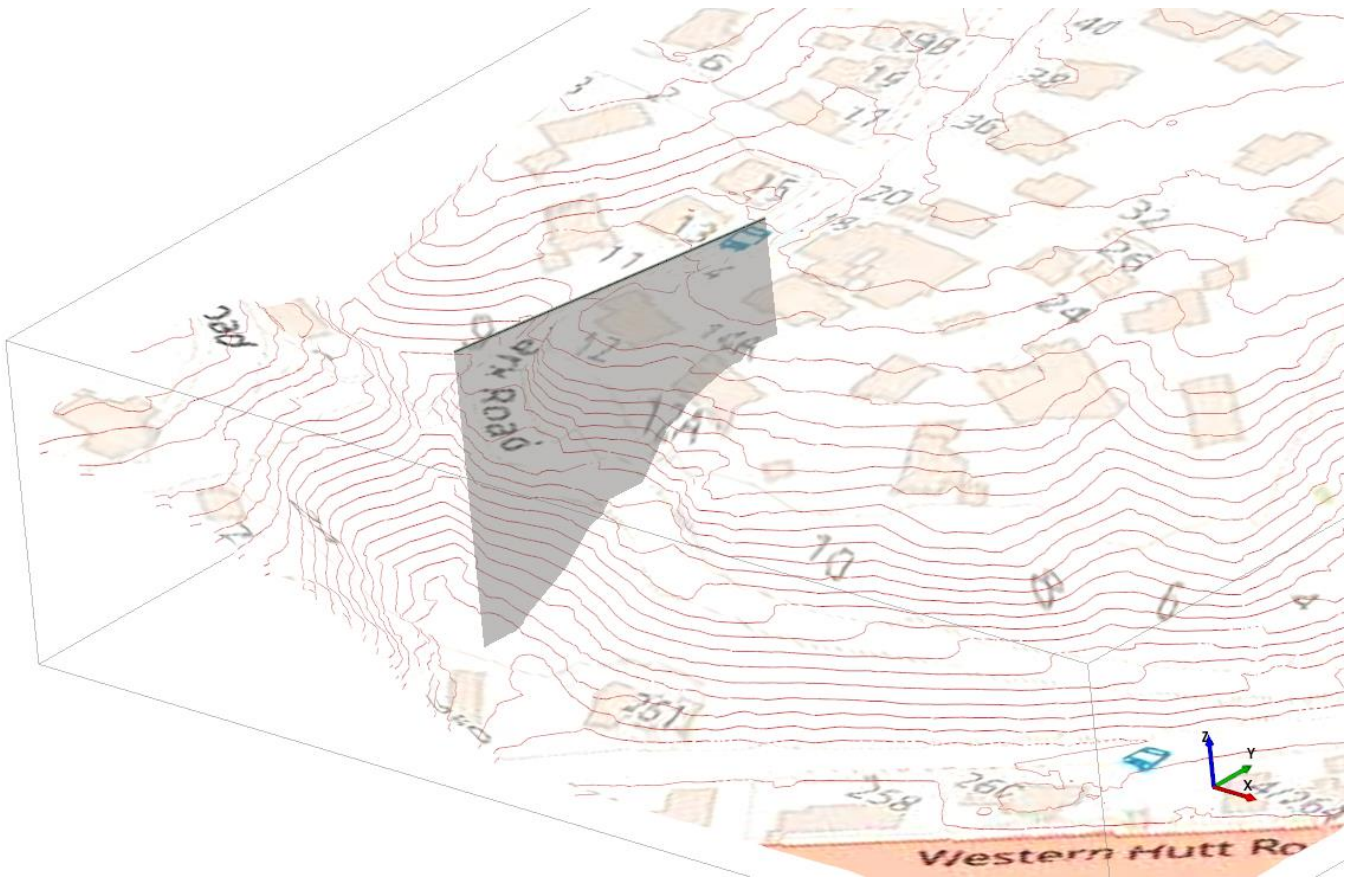
34. Figure 12 shows a perspective view of the area, with a cross section location used for 2D limit equilibrium analysis. The slope behaviour at Park Road level is controlled by the slope within the property at 2 Natusch Road. That land is uninhabited, and it is unlikely that any early signs of slope failure would be noticed until the road was directly affected.

Figure 12. TSLOPE model, perspective view. Contour interval 2m. Grey panel shows section location.

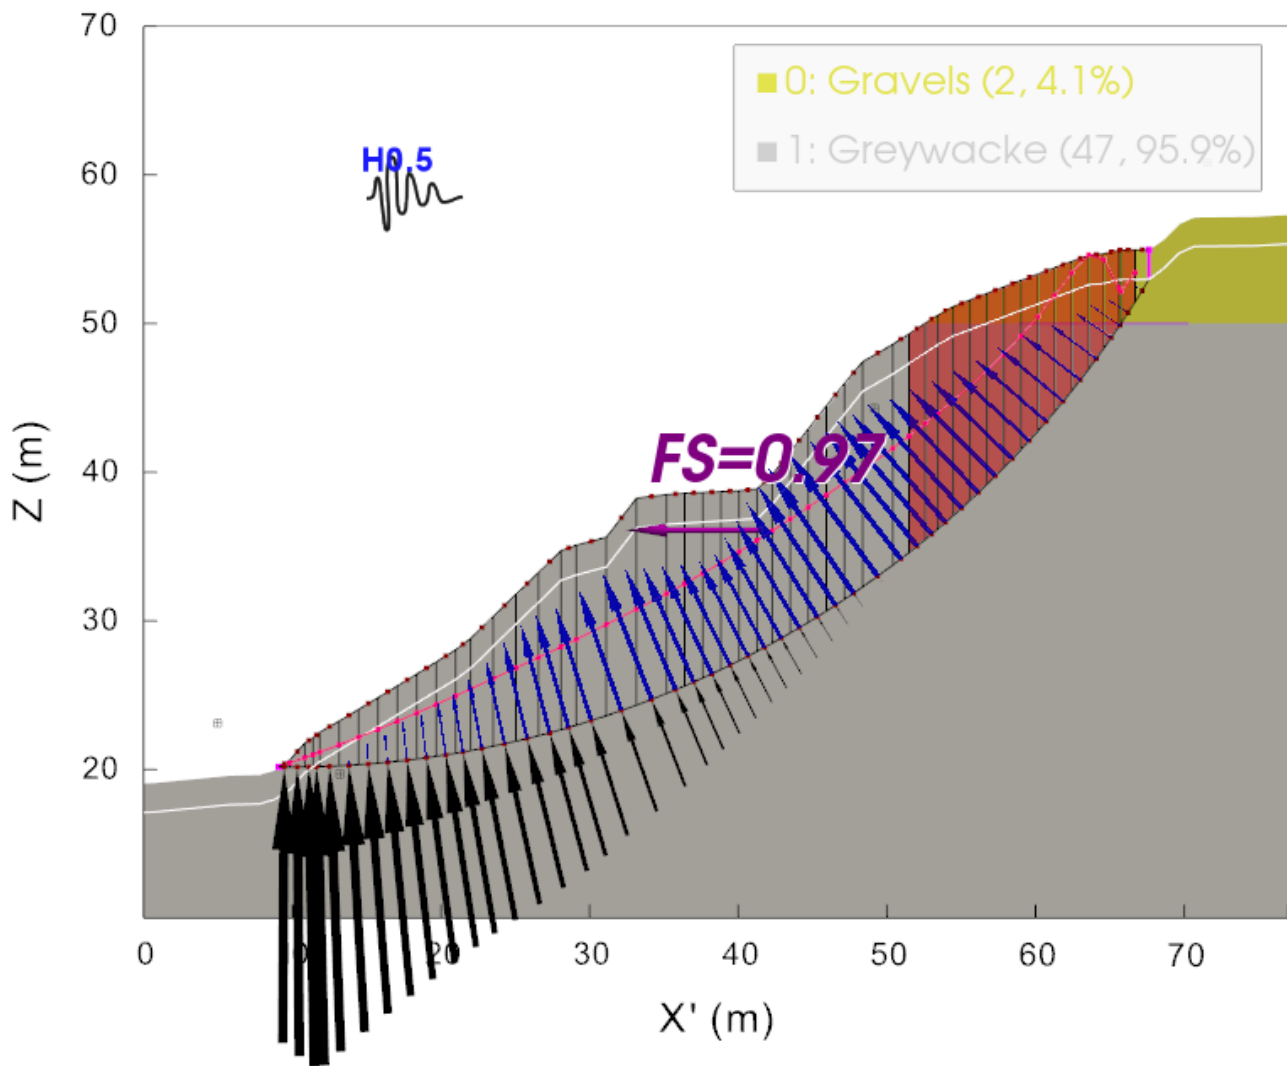
35. I have carried out a simple stability analysis using a pseudo static acceleration that models strong earthquake shaking (Figure 13). The

calculated Factor of Safety (less than 1) indicates poor slope performance during a large earthquake.

Figure 13. TSLOPE 2D slope case with earthquake loading. Park Road bench mid way up slope.
