Request for Information pursuant to the Local Government Official Information and Meetings Act 1987 (LGOIMA)

Could you please provide me with copies of reports you have on hand relating to the stability of the slope located above Eastern Hutt Road and below Holborn Drive (in particular relating to the area below the land at 58 and 60 Holborn Drive).

Claim for Natural Disaster (Landslip) Damage

60 Holborn Drive Slope Re-Assessment and Remedial Works

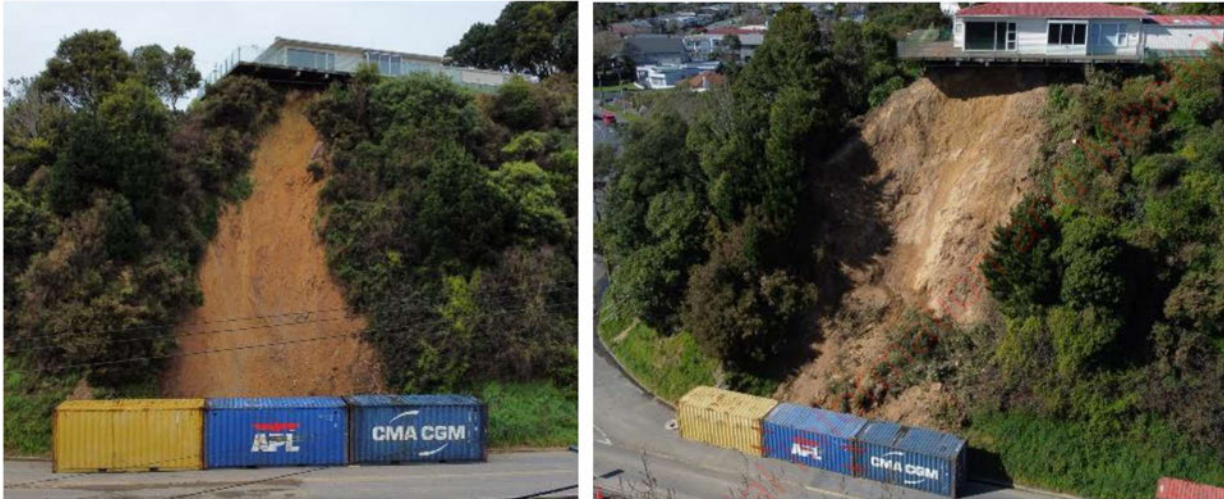
Figure 1 Left: Initial slip (24 July 2022). Right: Slope condition following scaling works (9 September 2022)

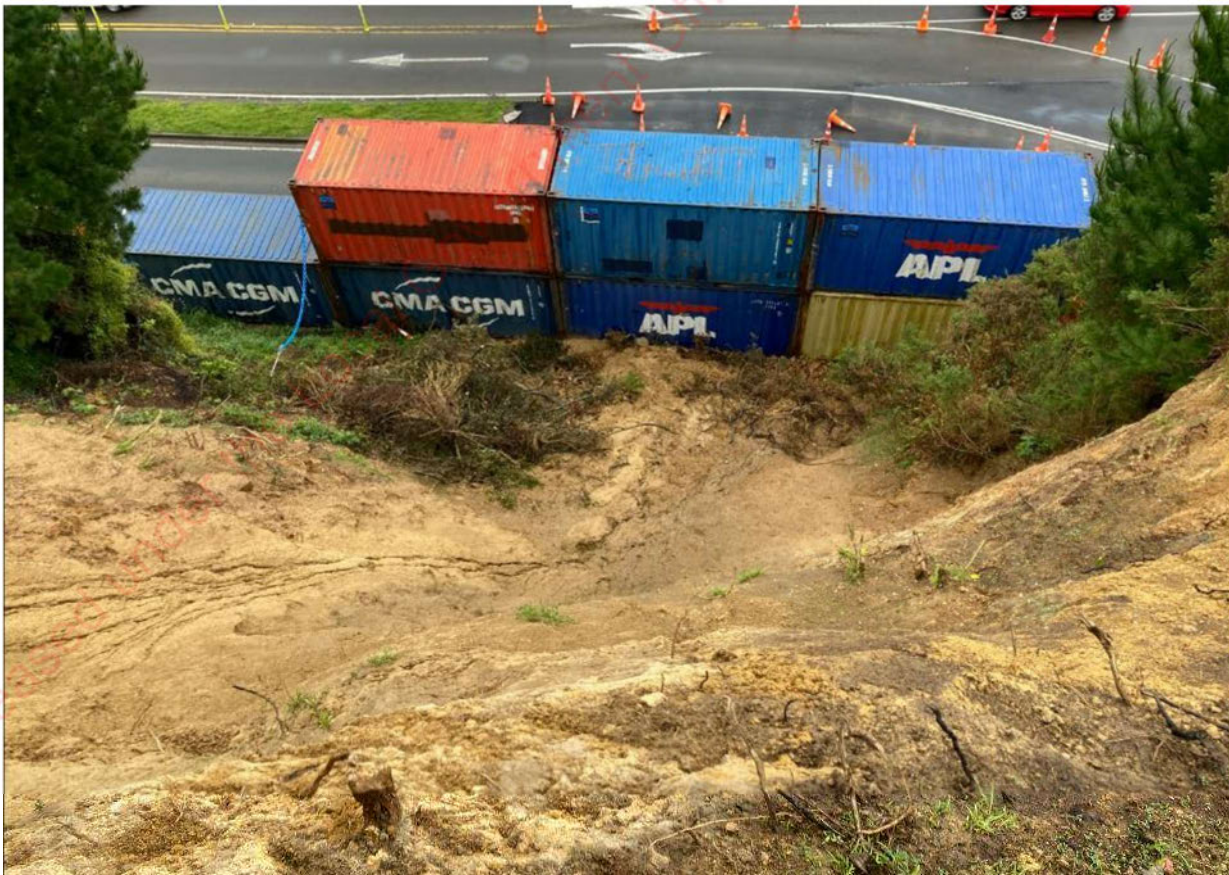
Figure 2 View behind the containers following completion of the temporary works

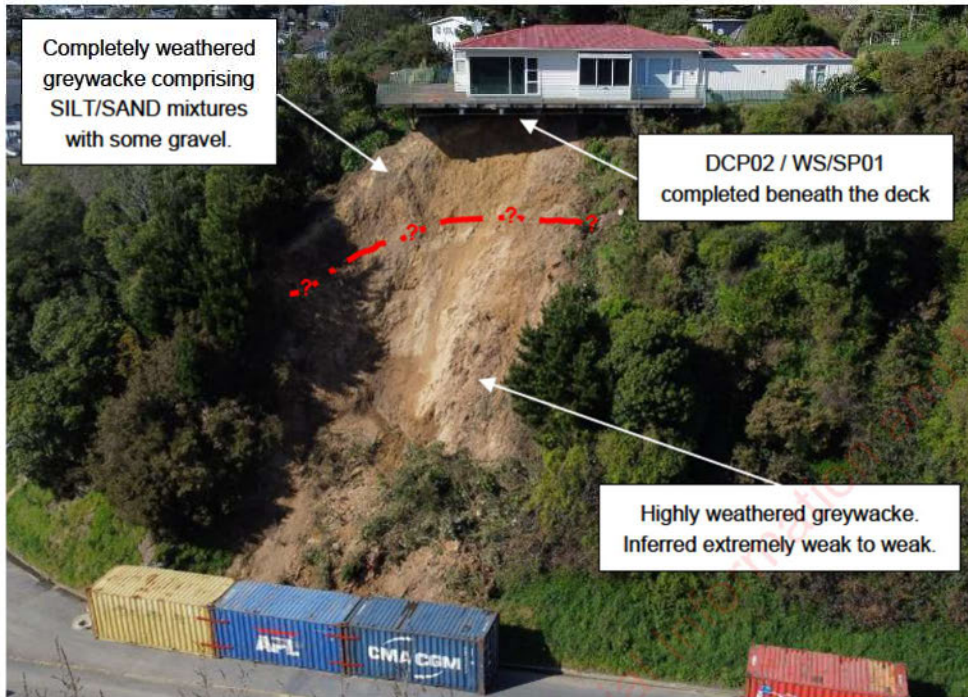
Figure 4 Approximate extent of completely weathered soil

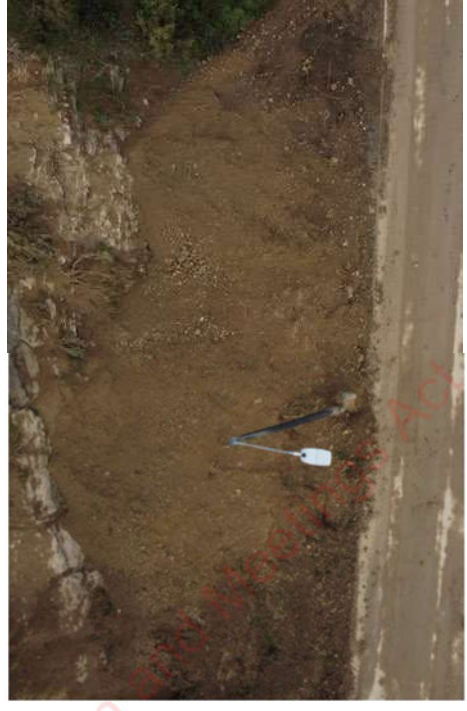
Figure 10 Debris accumulated along the shoulder

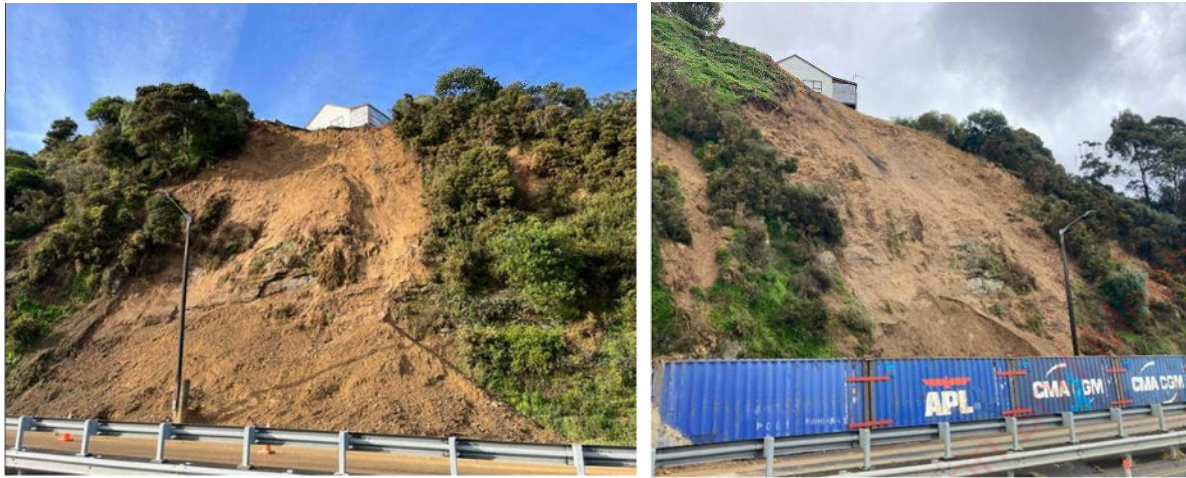
Figure 1 Left: Initial slip (21 July 2022). Right: Current slope condition following temporary works (14 September 2022)

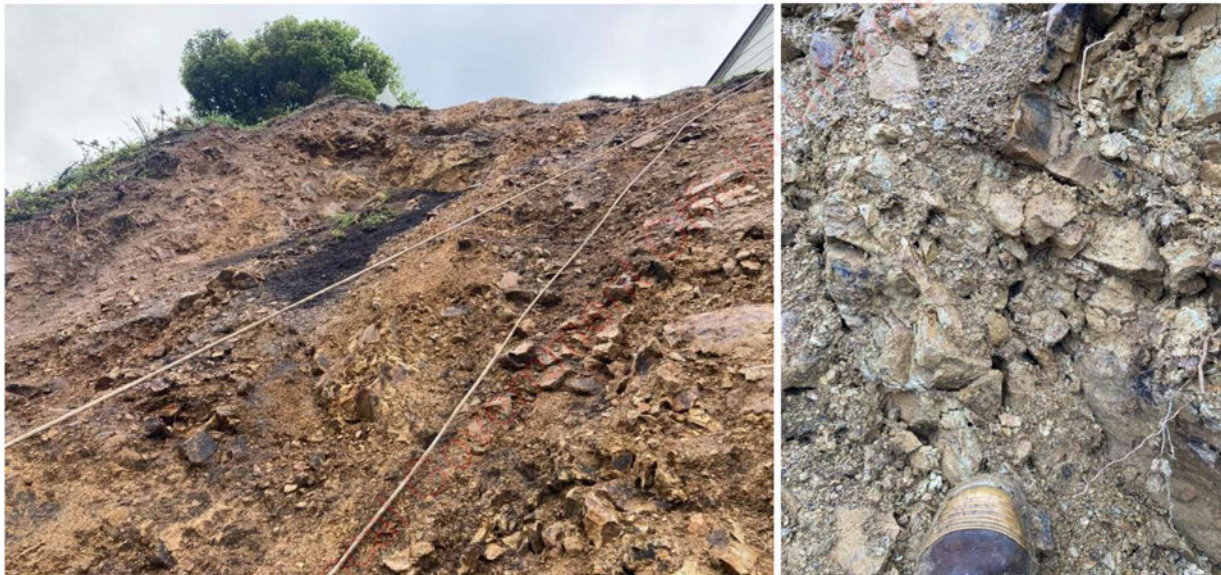
The upper ~10-15 m of the slope has been partially scaled and forms a ~60 degree slope with local undulations. This portion of the slope typically comprises of loosened/dilated rock (highly weathered greywacke) and colluvium as shown in Figure 2. Throughout the abseil inspection on 13 October 2022 ongoing fretting of the slope was observed and the lateral extents of the slip appear to have increased slightly due to the regression of the scarp (particularly evident towards No. 58 Holborn Drive). Debris is deposited on top of the containers at the slope toe and by the median barriers indicating rockfall is still making its way into the carriageway (Figure 3). The slope remains unvegetated due to the instability and no retaining or erosion control measures are currently in place.

Figure 2 Dilated rock mass and loose colluvium ravelling from the upper reaches of the slope

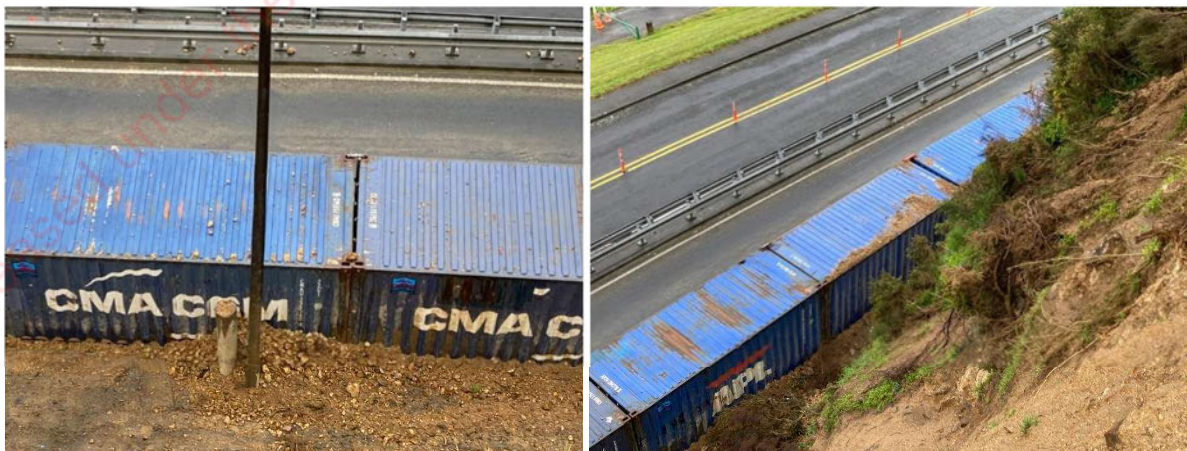
Figure 3 Debris accumulation on the containers

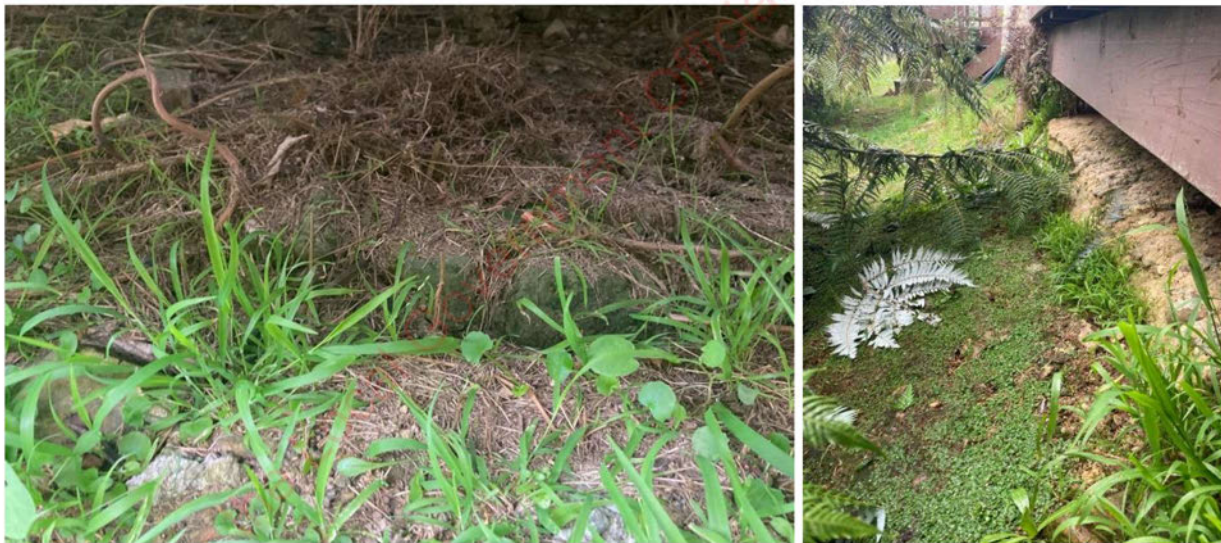
Highly to moderately weathered rock outcrops beneath a portion of the house indicating the building to be founded on both soil and rock. The property slopes gently to the west. Tension cracks are evident along the western perimeter of the building and up to ~200 mm of subsidence was identified, as presented in Figure 4. Although this subsidence appears to be gradual and independent of the instability along Eastern Hutt Road, it provides further evidence that the soil in the vicinity of the dwelling may be marginally stable.

Figure 4 Left: Tension cracks along the western perimeter of the building. Right: ~200 mm of subsidence

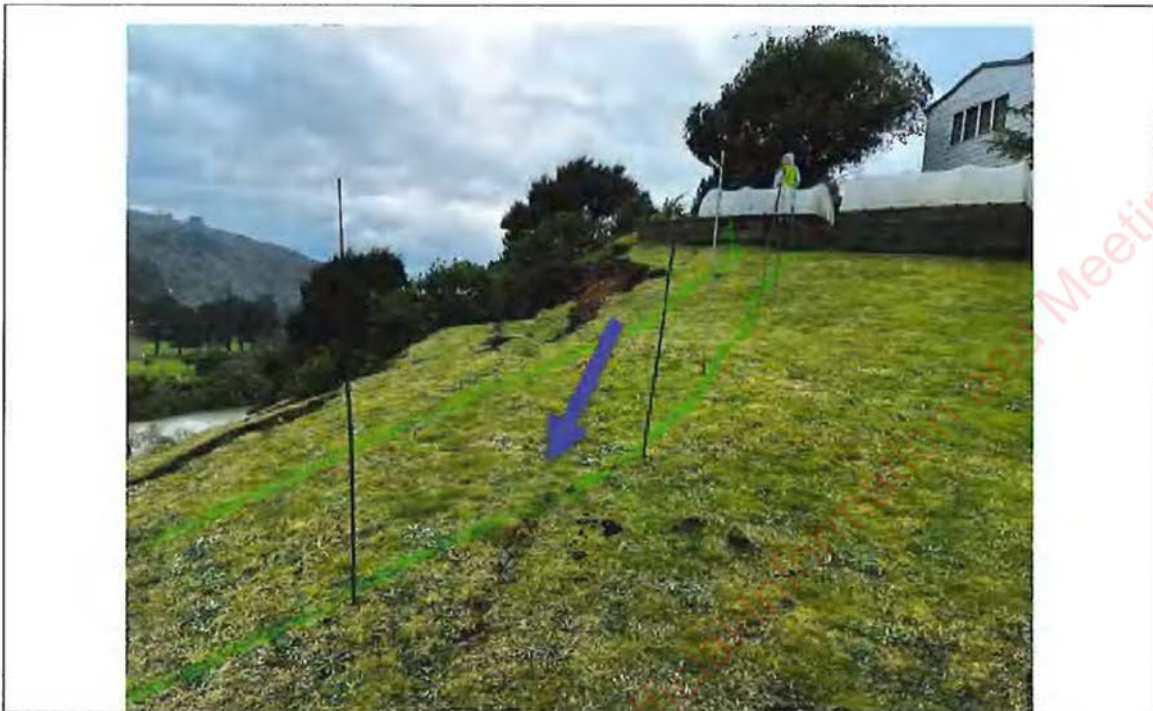
Photograph 1: View facing east from property, showing tension crack in the foreground (arrow). Taken 26 July 2022.

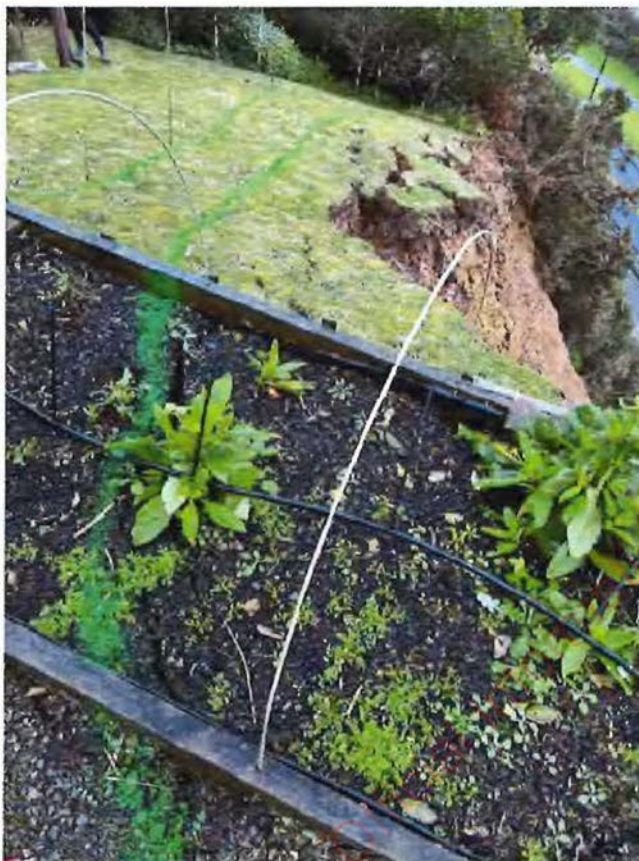
Photograph 2: View looking west along the length of the landslip headscarp and tension cracking. Taken 26 July 2022.

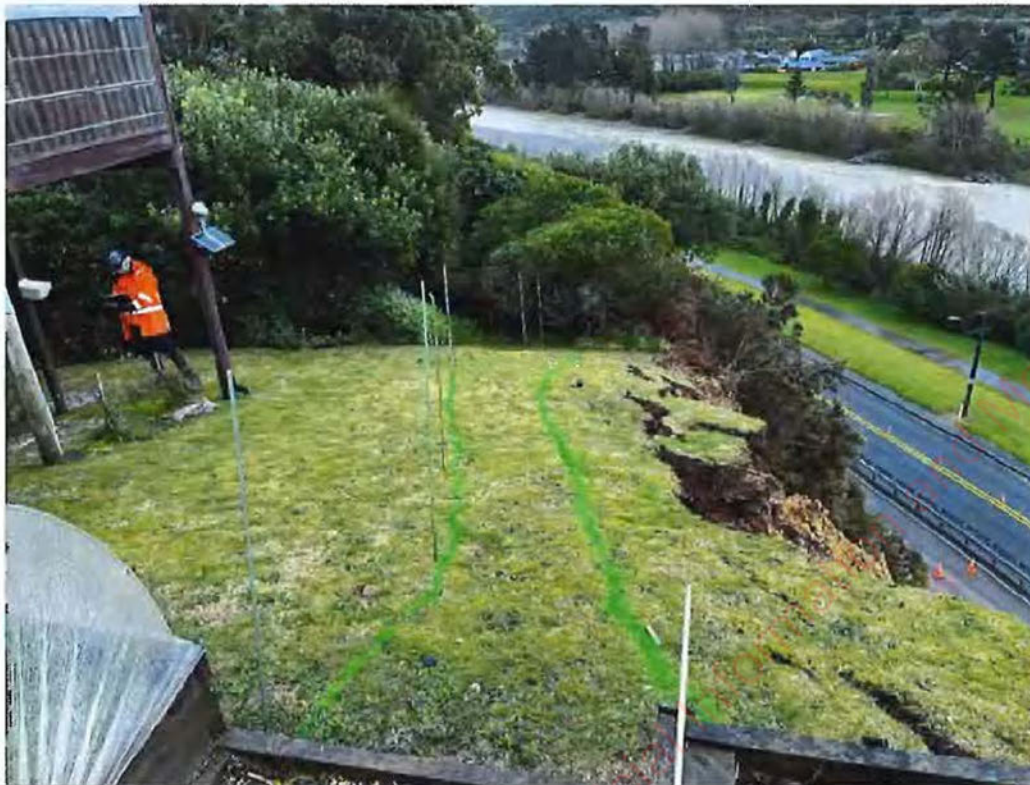
Photograph 3: View looking west along the length of the area behind the observed landslip headscarp. Taken 26 July 2022.

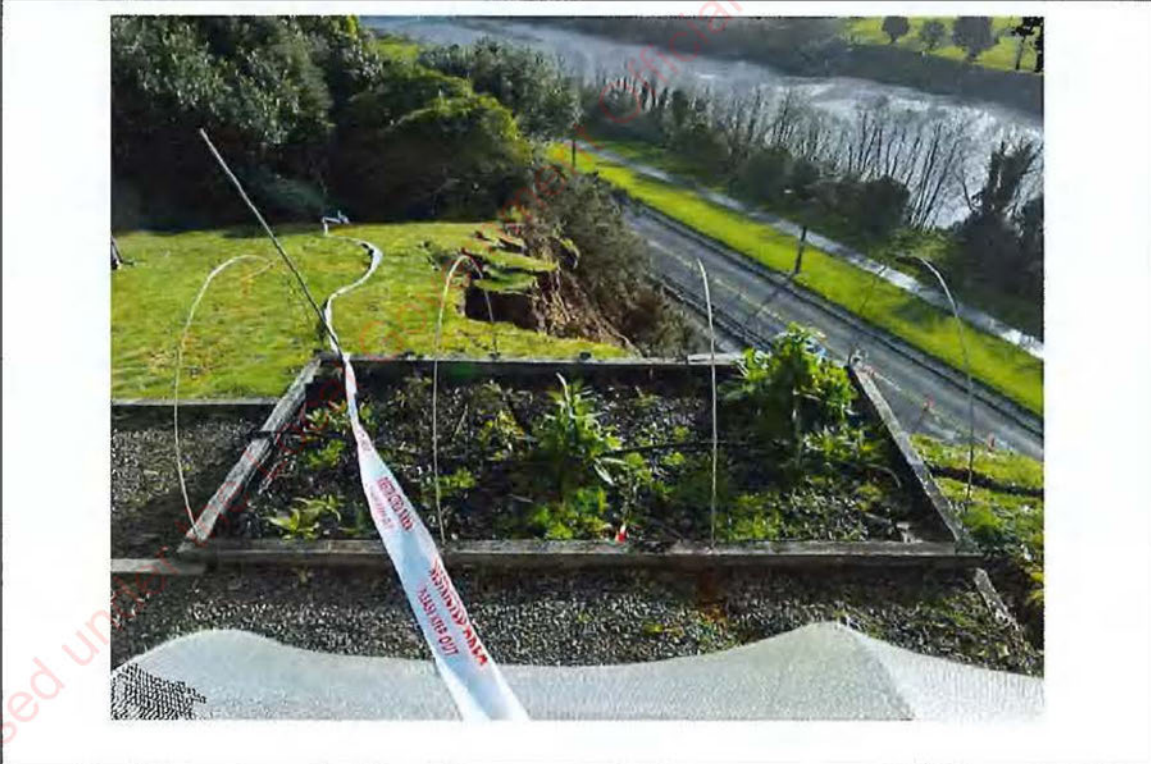
Photograph 8: View looking west along the length of the area behind the observed landslip headscarp. Taken 11 August 2022.
