Request for Information – Local Government Official Information and Meetings Act (LGOIMA) 1987

“...all information relating to slips, slip remediation and internal council correspondence relating to historical 2005 to the recent slips at 46 and 60 Holborn Drive or around that area facing the Eastern Hutt Road”

We have interpreted your request as applying to landslips occurring on or above Eastern Hutt Road, between the Stokes Valley roundabout and the intersection with High Street at Pomare. This covers properties at 46-92 Holborn Drive and 200-204 Eastern Hutt Road.

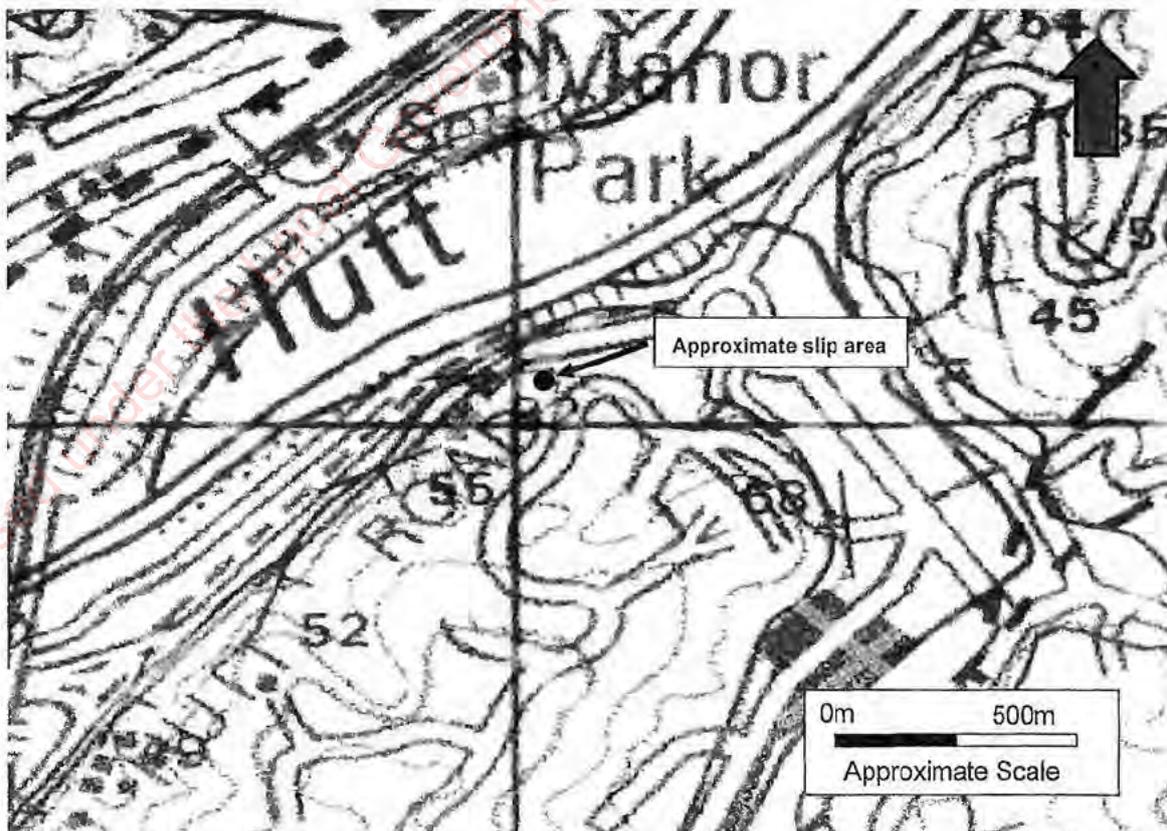
The Wellington geological map (Begg & Mazengarb, 1996) for the area (Figure 1) describes the site to comprise of alternating sandstone/argillite, with conglomerate and minor pillow basalt, chert, diamictite, and limestone (collectively termed greywacke).

Figure 1 Location of failure at 60 Holborn Street (Begg & Mazengarb, 1996)

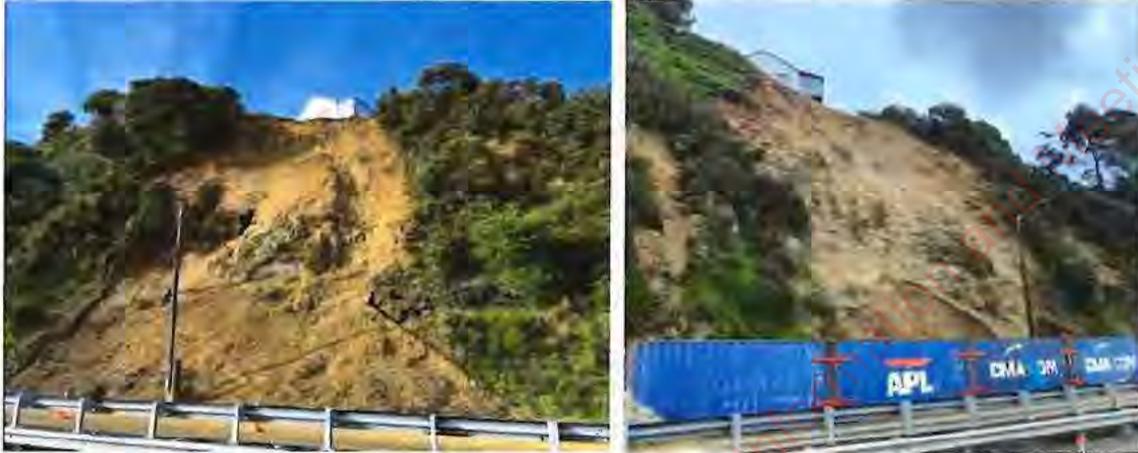
Figure 1 Left: Initial slip (21 July 2022). Right: Current slope condition following temporary works (14 September 2022)

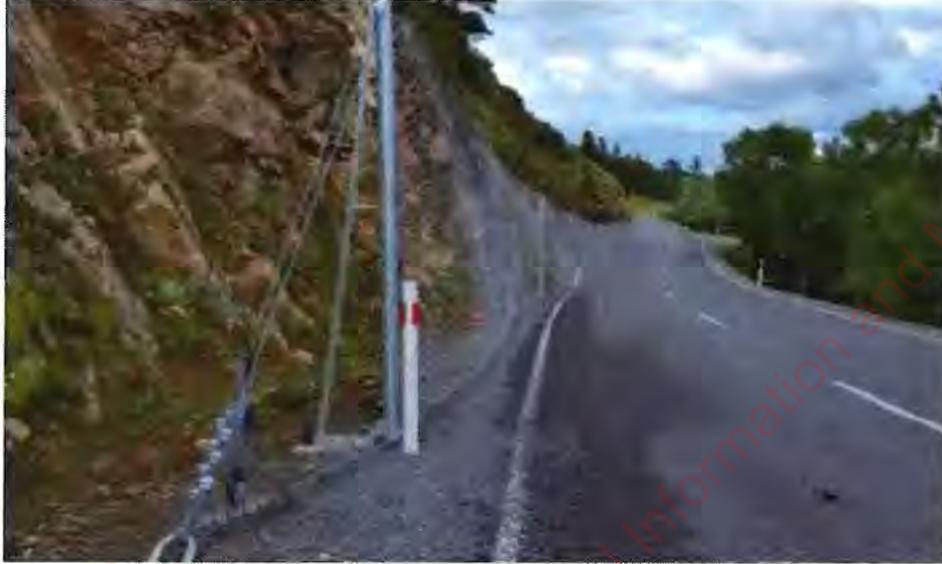
Figure 5 Example of a roadside catch fence

For temporary works to open both lanes, extend and repair the catch fence to the south to encompass the instability. This could comprise of steel/timber posts and chainlink mesh. Look to install proprietary catch fence for permanent works.

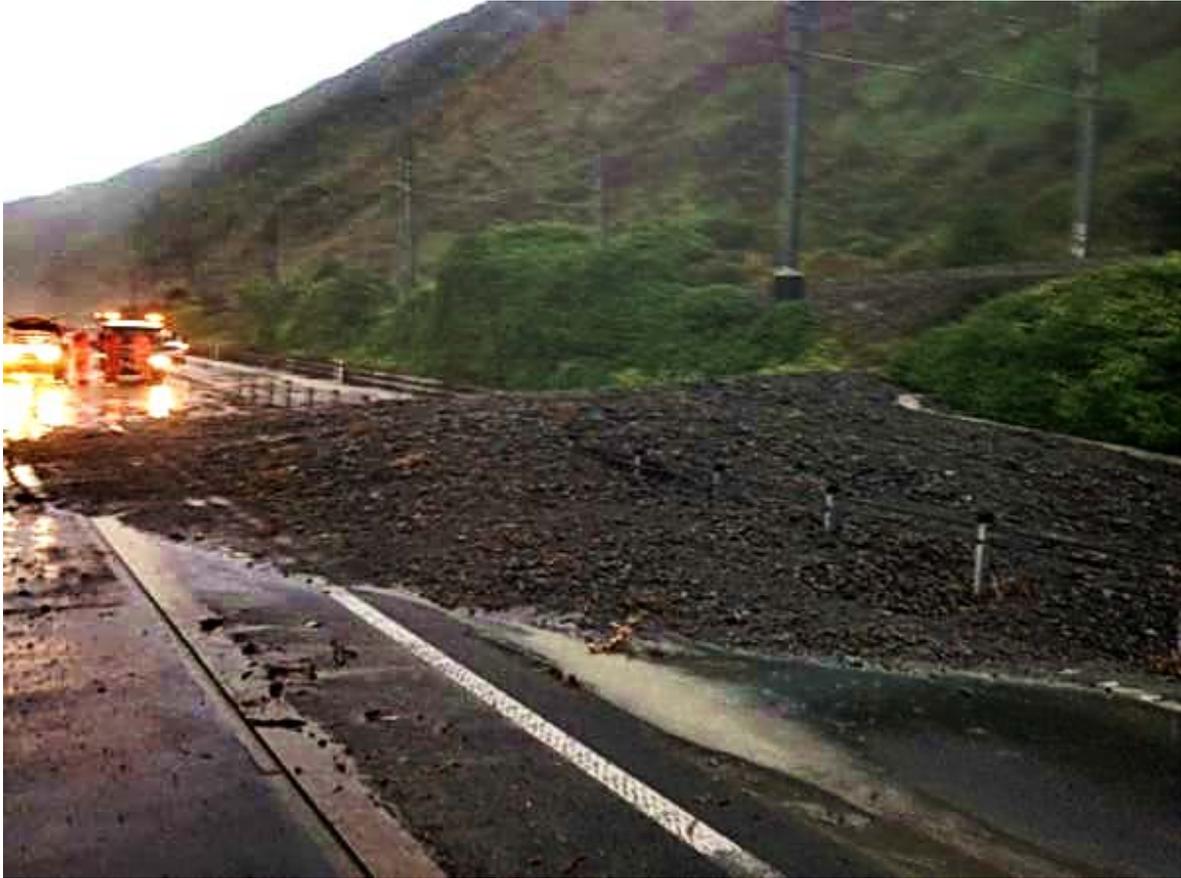
Figure 2.2 Debris flood deposit on SH1, 2.5 km south of Paekakariki, at Bartons Corner (Photo: Dominion Post).

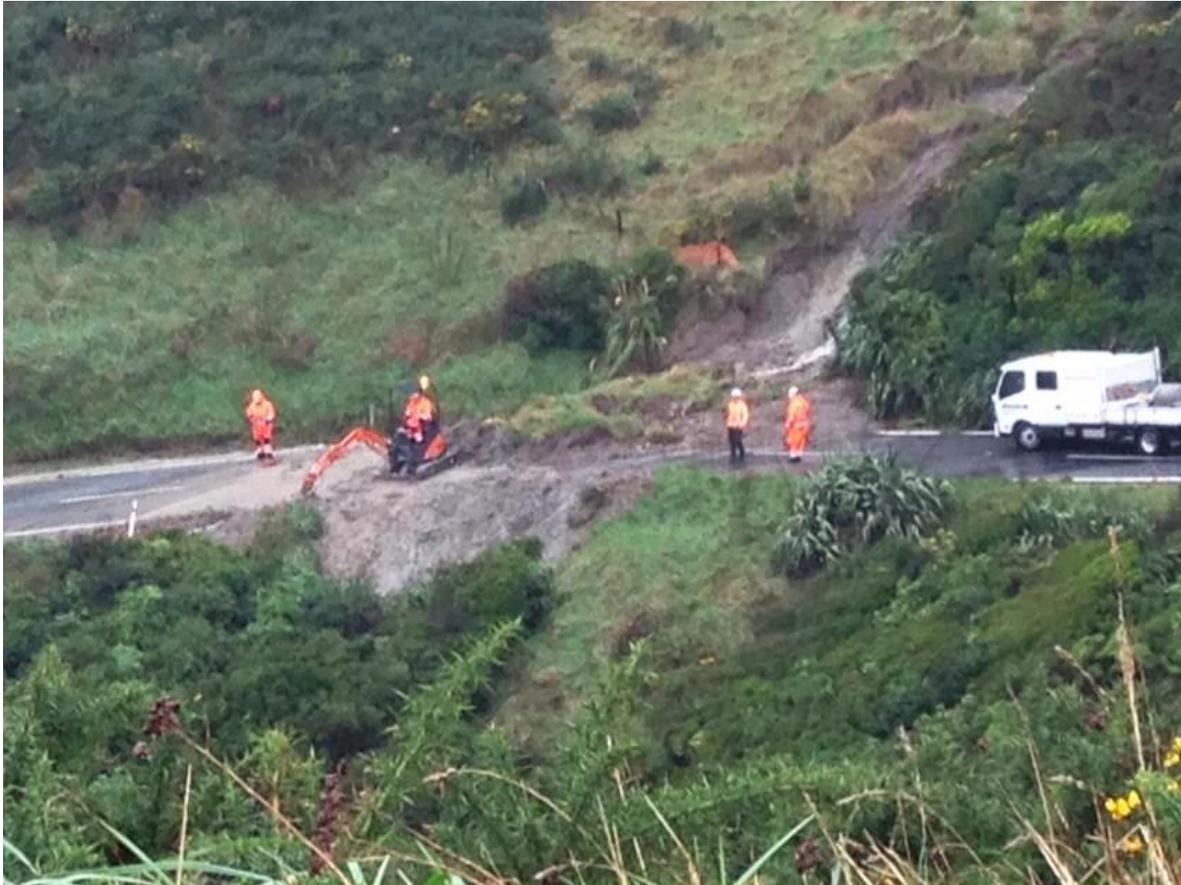
Very few landslides related to road cuts were observed anywhere within the area flown. Figure 4.31 shows one such instance on the Paekakariki Hill Road, just north of the Lookout. Another failure occurred on a steep cut on SH1 ~1 km south of Pukerua Bay. More common were minor rock falls and soil falls too small to block the road.

Figure 4.31 Debris from landslide blocking Paekakariki Hill Road, 250 m north of the Lookout. (Dominion Post Photo).

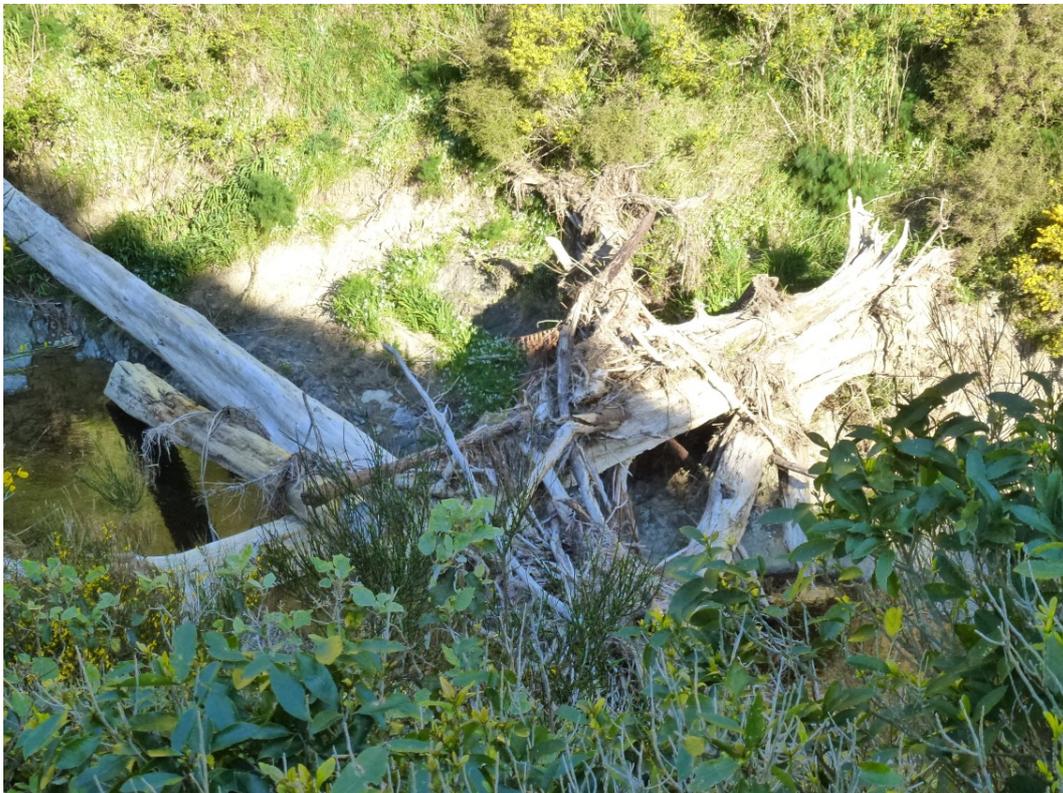
Figure 4.52 Log jam in Korokoro stream, 1.8 km upstream of the fan. The log jam filled the entire width of the channel and may have impeded the flow.

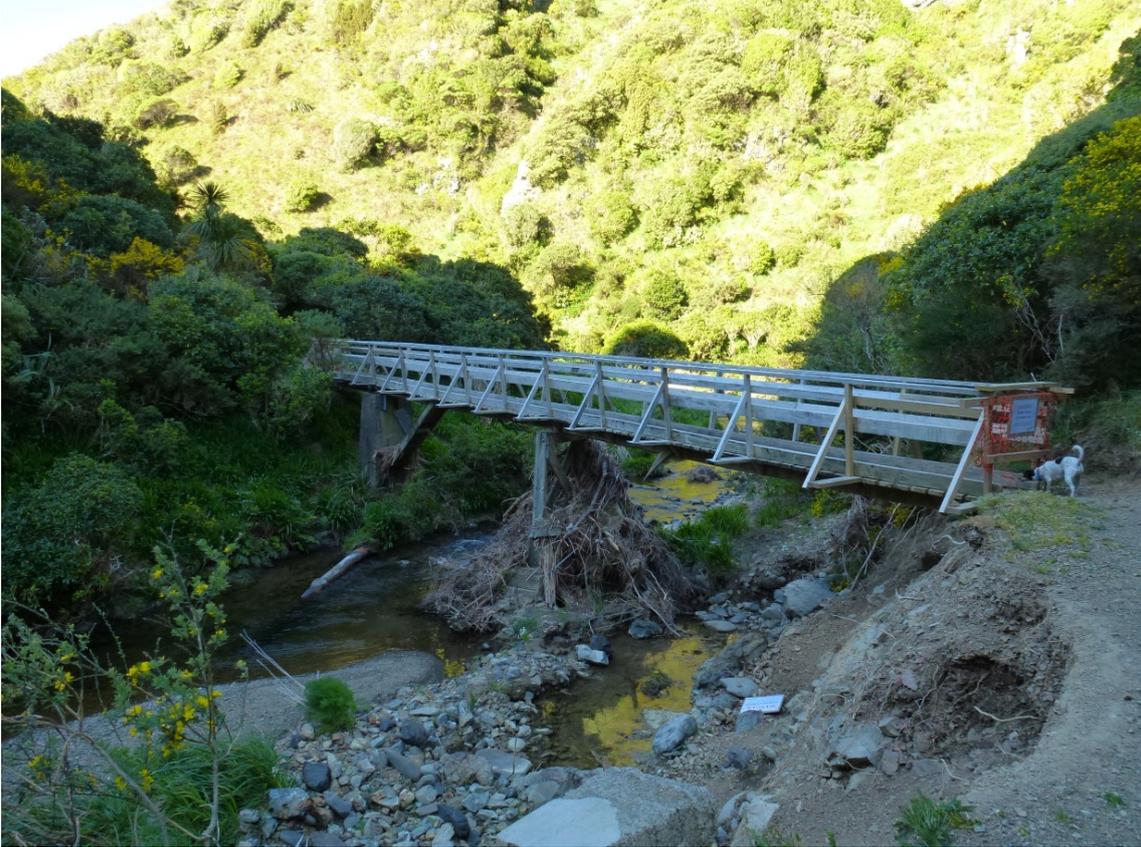
The Korokoro Dam Track from Cornish Street up the Korokoro Stream to the Dam suffered severe damage. Three bridges were damaged (Figure 4.53), others loaded with debris, and sections of the track were washed away (Figure 4.54). Stream bank erosion was infrequent and occurred at isolated places along the stream up to the dam (Figure 4.55) but was more frequent near bridges where scour had occurred, and this was likely the source of most of the sediment that was transported to the fan where the industrial buildings are situated. The small terraces bordering the stream were inundated during the storm and a 2-3 cm layer of fine sediment was deposited on most of the terraces (Figure 4.56).

Figure 4.53 Bridge damage and bank erosion. Note build-up of debris behind bridge support.

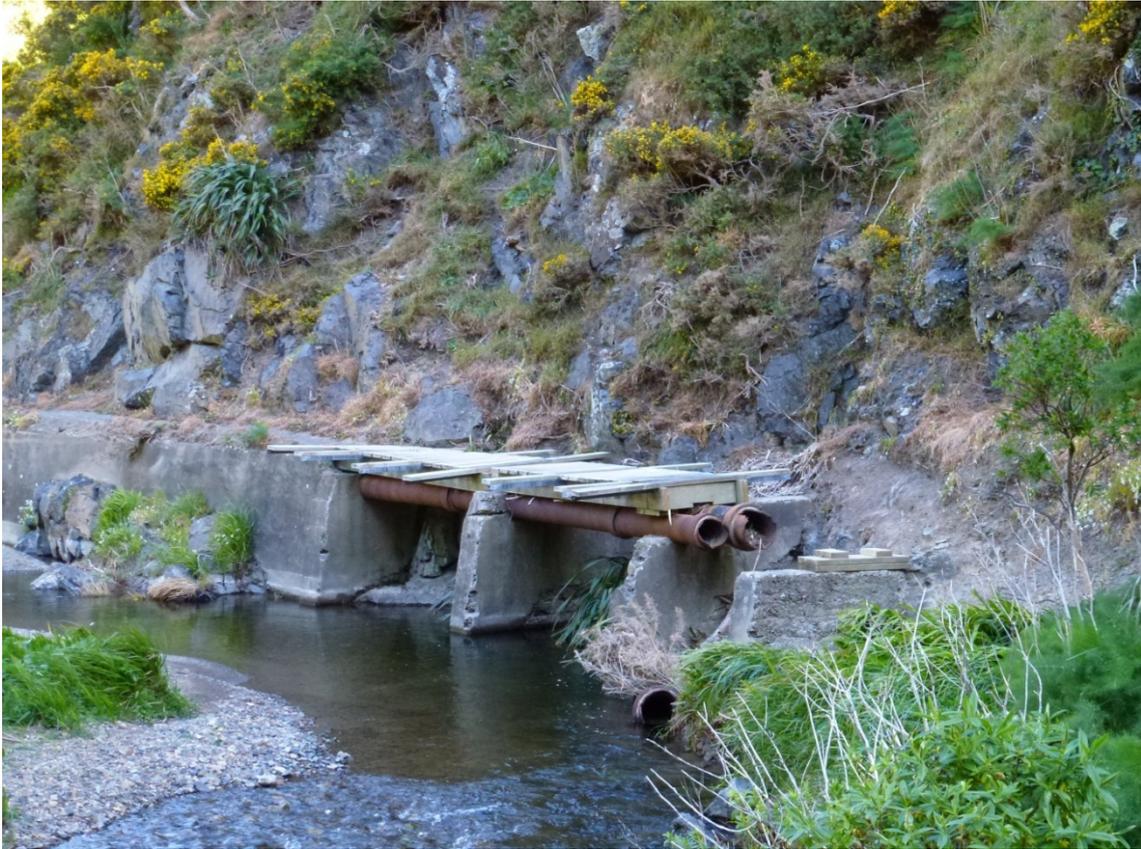
Figure 4.54 Sections of track washed away.

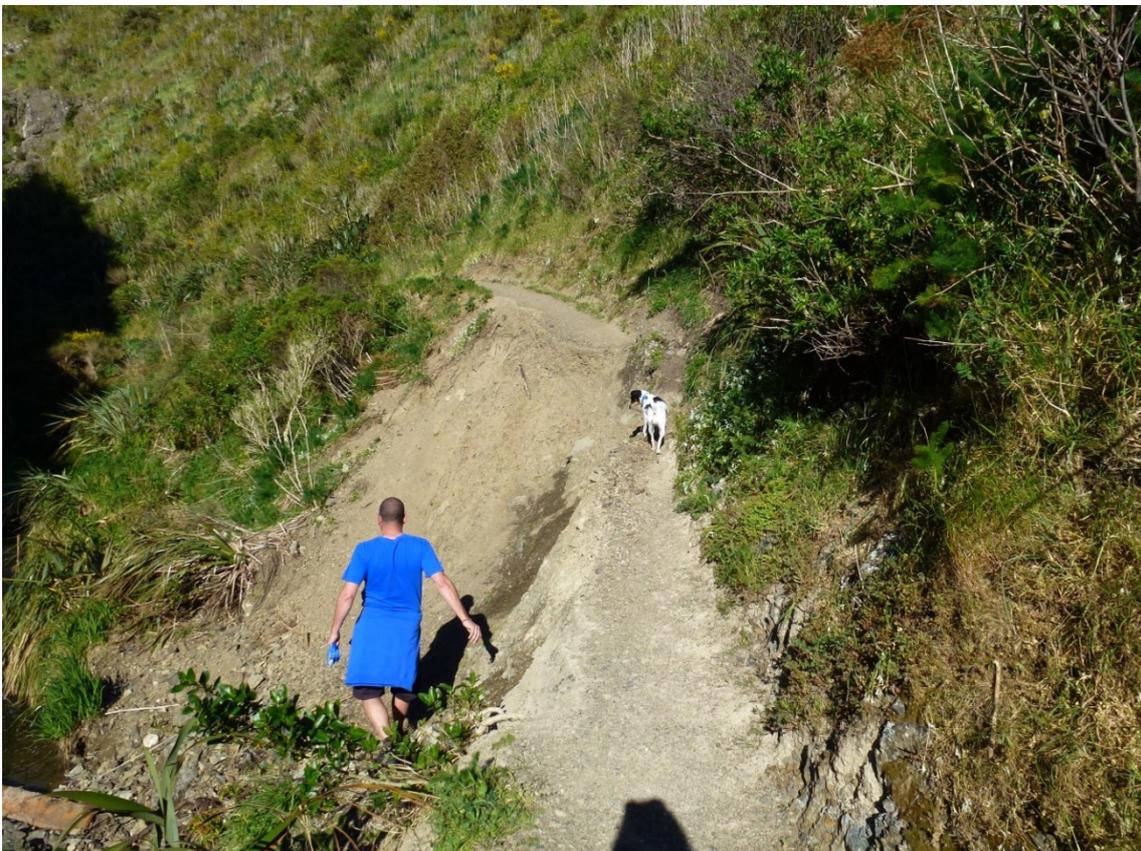
Figure 4.55 Bank erosion or stream-side landslides damaged the walking track in several places (20 October, 2015).

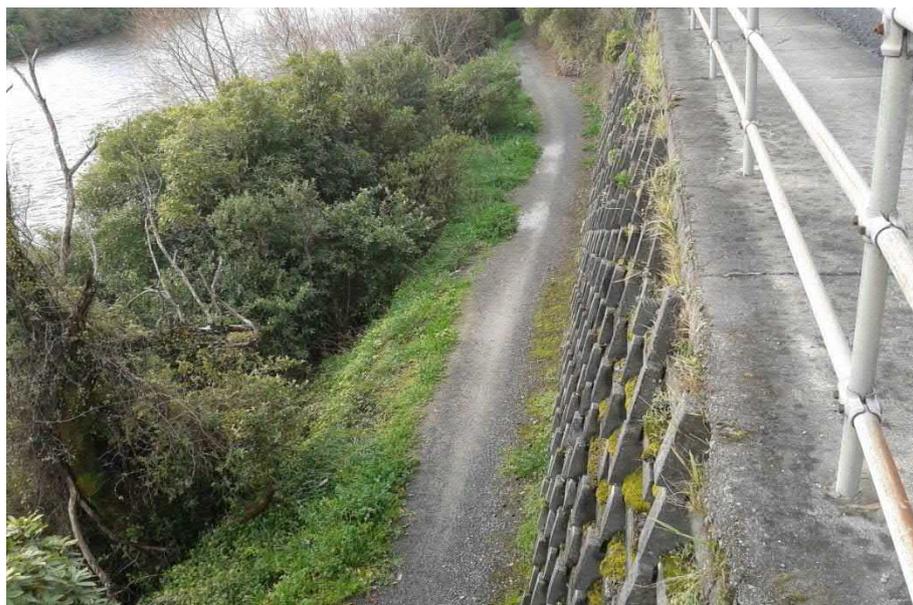
Minor cracks on the crib wall facing units, and deformation and cracking of the pavement adjacent to the southern end of the wall were observed (Photograph 2).

Photograph 1 – Highest crib wall along Eastern Hutt Road

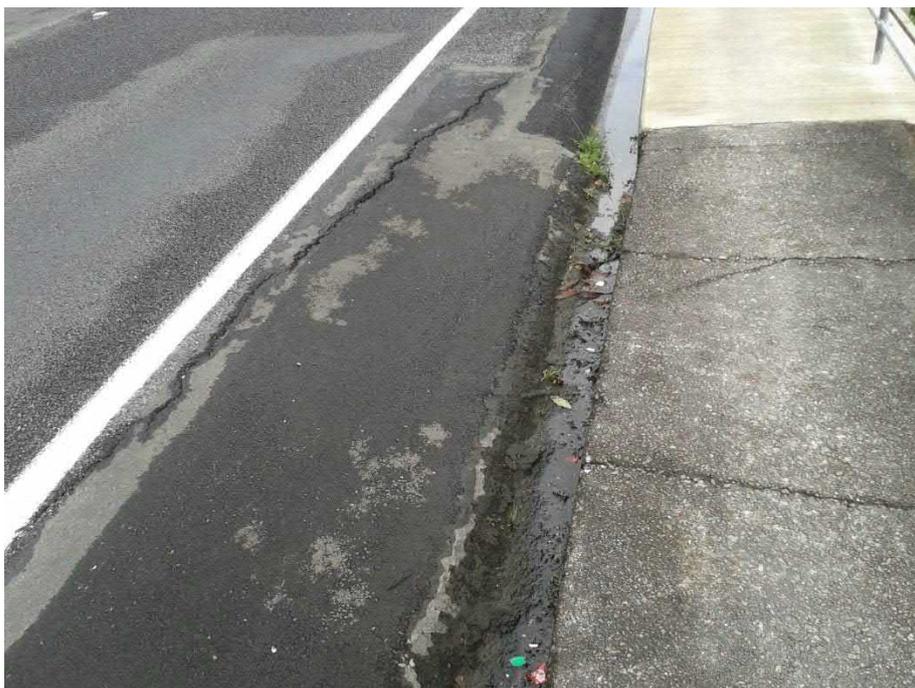
Photograph 2 – Deformation and cracking on the pavement
