Request for Information – Local Government Official Information and Meetings Act (LGOIMA) 1987

Re: Hardwick Smith Lounge – Property Condition Report

Objective:

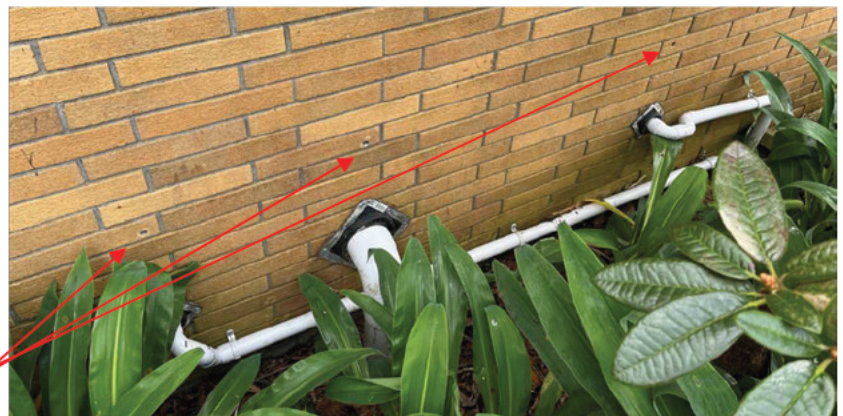
However, worthy of note the modification works have been completed to the exterior wall with a ‘functional’ approach which would have reduced the overall project cost by penetrating the rear wall and providing external surface mounted SWV services using ‘Aquatite’ collars (typically utilised in roofing applications) as an alternative solution to seal the penetration. As can be seen in the below image the drill support wall anchors remain to the brick veneer cladding with no attempt to remove and seal the mounting collars. Over time these will corrode and cause damage to the exterior.

Right:
Drill bore anchors still present in wall. More possibly present.

- 7) Remove (if possible) thread inserts to brick veneer cladding and seal with colour matched silicone / mastic to prevent future damage. If threads are to remain, treat any surface corrosion and seal over with colour appropriate sealant noted above.

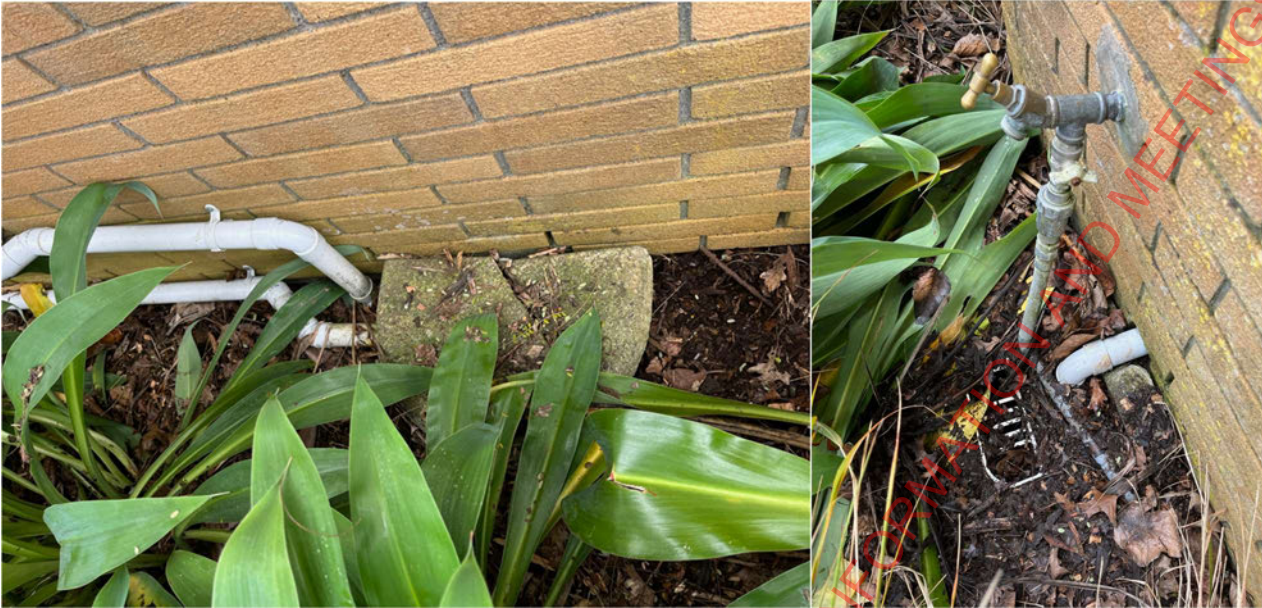
Above Left and Right: High level vegetation and mulch build up surrounding / covering gully trap.

Debris entering gully trap (Right Image). It is assumed this is the main water feed to the premises. It would be advisable to have a 'vacuum break' (brass image directly left) fitting attached to this hose tap to prevent backflow into the facilities.

- 6) Remove perimeter gardens to at least 300mm beyond the perimeter mowing strip and down to ground level – typically allowing for enough room to mow the perimeter and keep vegetation away from the structure. Accommodation may need to be made for Gully Traps to the Eastern elevation or elsewhere as appropriate.

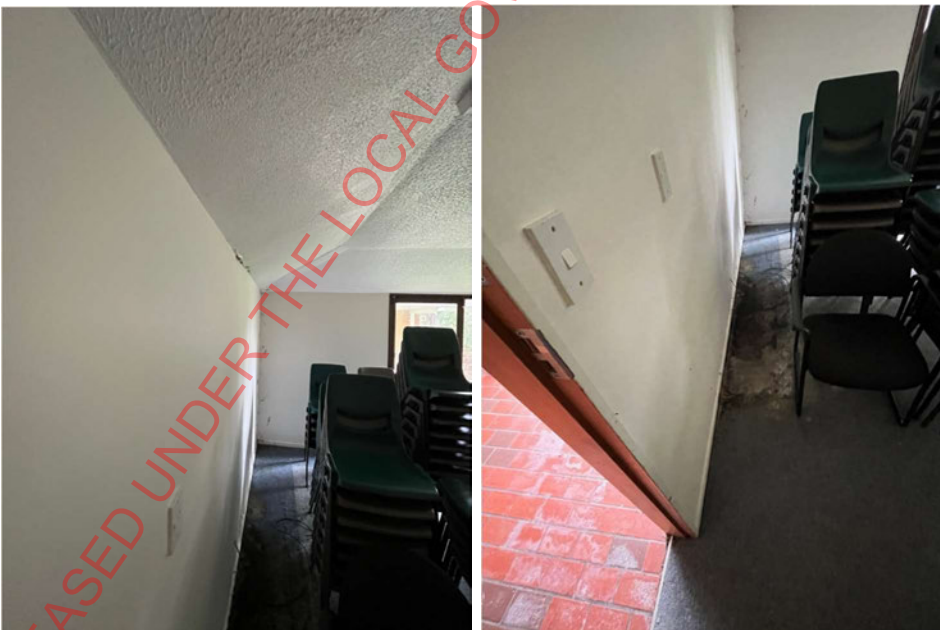
Former Plunket Rooms:

The beginnings of water ingress with mould appearing to the top corner of the room. Repair works have occurred previously in this area as can be seen by the change in texturing on the raking ceiling.

Severe water damage at floor level from water ingress – possibly coming in at brick level

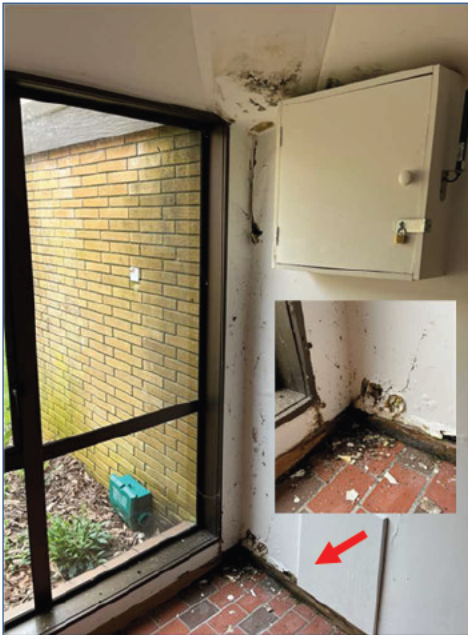
Opposite side of wall in foyer from former Plunket Rooms. High levels of mould to ceiling above (perceived) security system control box cover.

Additionally, high levels of mould and degradation to floor level bottom plate adjacent to aluminium joinery.

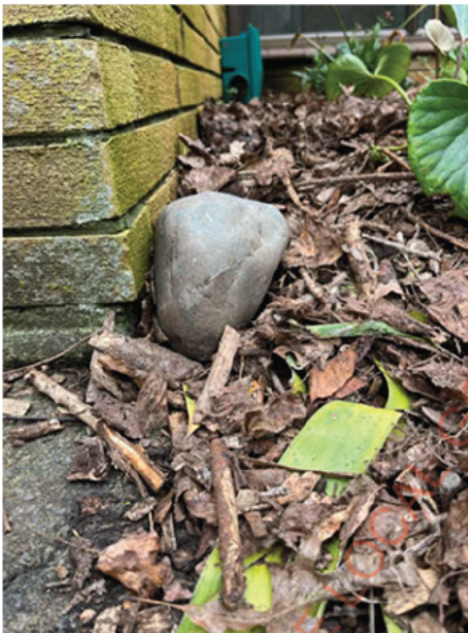
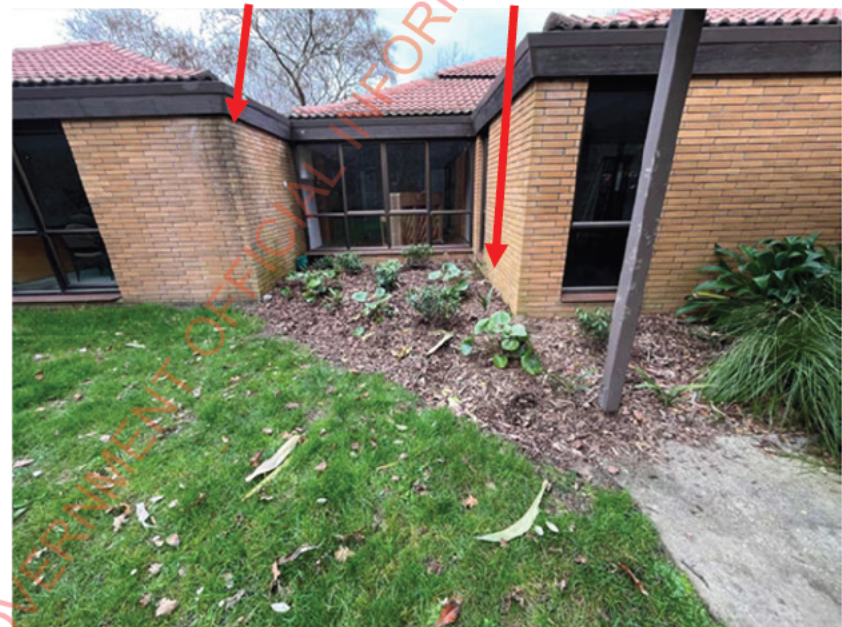
Condition of exterior garden bed with proximity to large windows.

Mould also noted to the base interior of this wall; the former committee room. Note the staining on wall; typical or water ingress locations.

Garden debris and mulch built up against the side of the facilities rising to at least three brick courses above finished ground level and covering the approx 200mm wide mowing strip. This would have been installed as part of the original construction to ensure flora debris / weeds do not encroach on the building and lead to moisture ingress. Although there would have been a rebate in the perimeter footing to accommodate the brickwork, material like this up against the building will be either:

- 1) Blocking up the ventilation / discharge gaps between brick allowing for moisture to ventilate within the cavity and
- 2) Providing a pathway for moisture to enter the building as water moves sideways from the garden bed and in through the now obstructed but purpose built / created discharge holes.

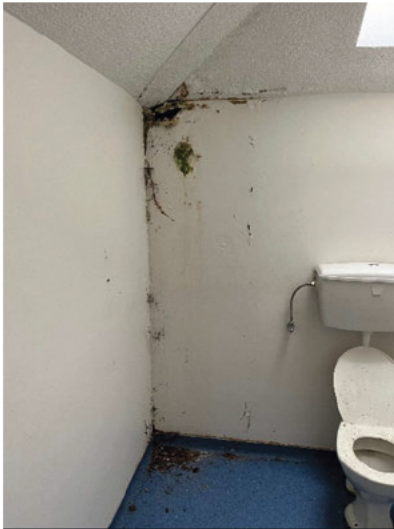
Mould to low level of wall or female WC. High level degradation discussed later.

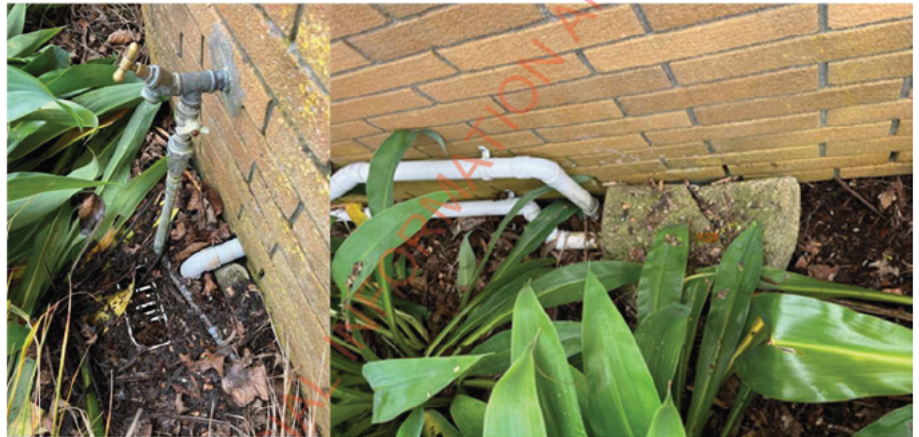
Typical build-up of garden mulch and debris behind toilet wall.

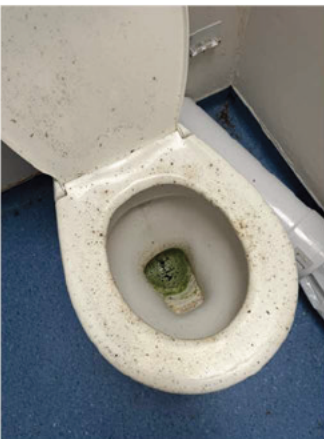
All WC pan traps have dried out (and assumed sink wastes) allowing sewer odours (typically methane) to enter the premises

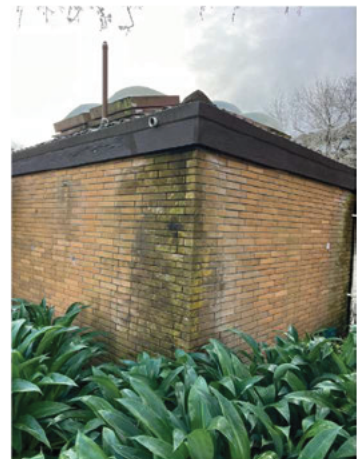
The wall directly behind the female WC heavily covered with staining showing this location has been overflowing for quite some time. Consistent with internal damage.

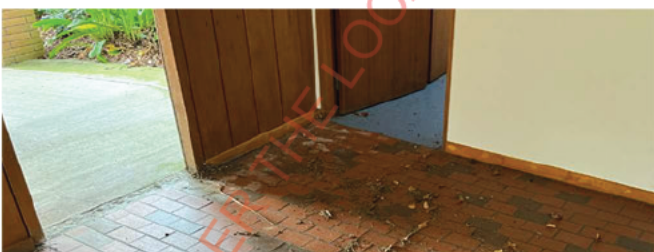
Above: Water ingress to lobby floor.

Right: Entrance lobby exterior. Flooding to outlet location surrounding downpipe outlet. Note moisture to the left of the entrance door.

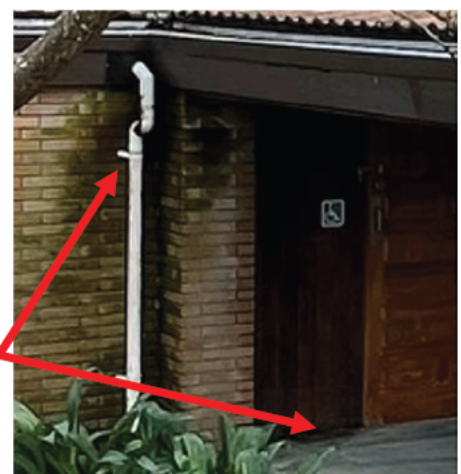
The same entrance door image from directly in front of the location

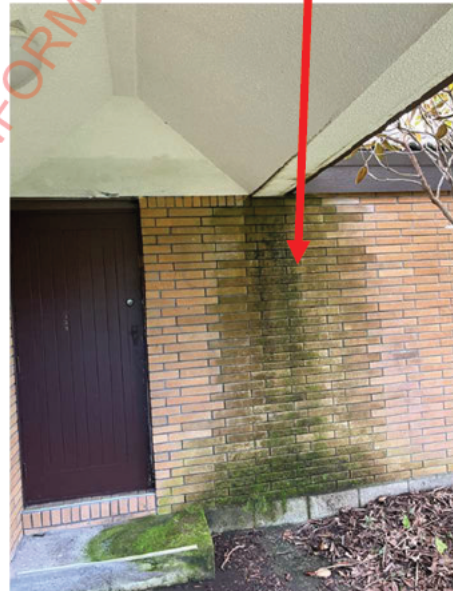
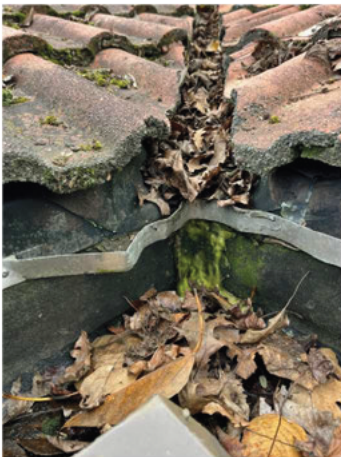
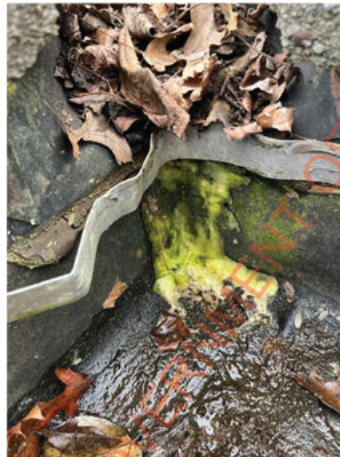
Same image with the debris removed showing the patch. This material is brittle and breaking down. Its' effectiveness is questionable. This should have only been used as a temporary 'Band-Aid' measure until a more permanent solution was found – that being a patch of the same base material as the gutter. It is well past its' usable life, inflexible and is most likely not the solution of the initial fault.

Where water would have been pouring down the wall due to blocked gutters / downpipes.

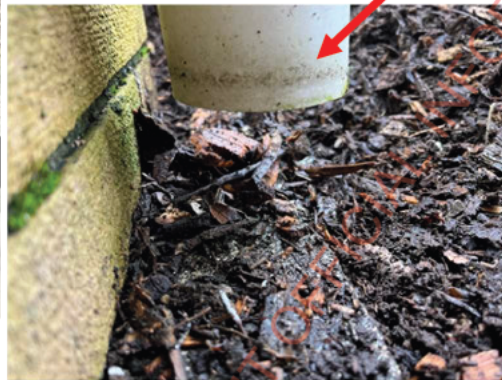
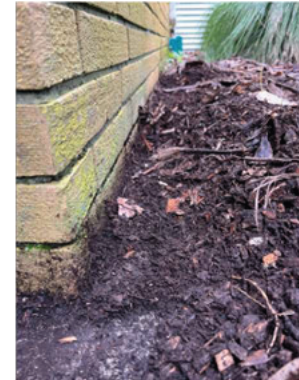
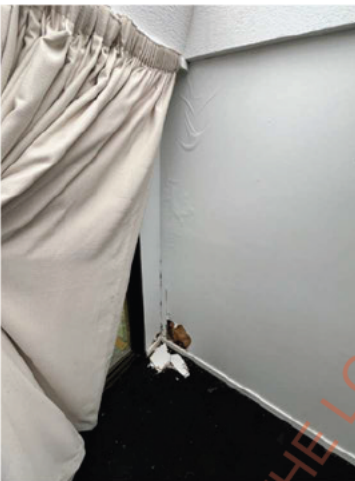
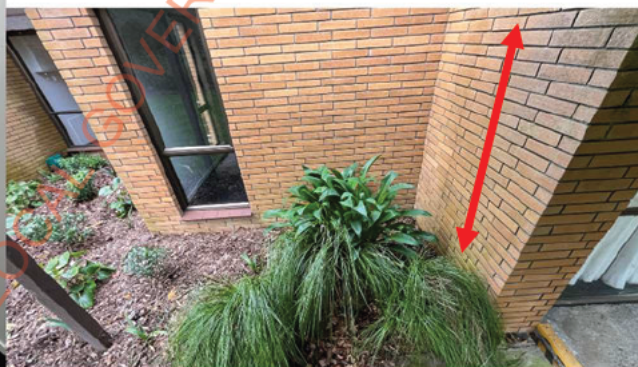
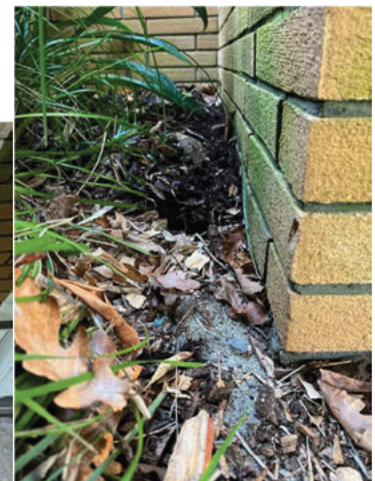
Above Left: Water damage to bottom plate of main lounge wall – northern side

Above Centre: Area directly outside the lounge wall. Note there has been a steady stream of water flowing down this wall as can be seen on the brickwork due to the change in colour; marked with the arrow.

Above right: Note the build-up of mulch and debris against the wall directly outside the internal water damage. Water overflowing from above would have gathered here and remained saturated from the overhead overflow; caused from blocked gutters.

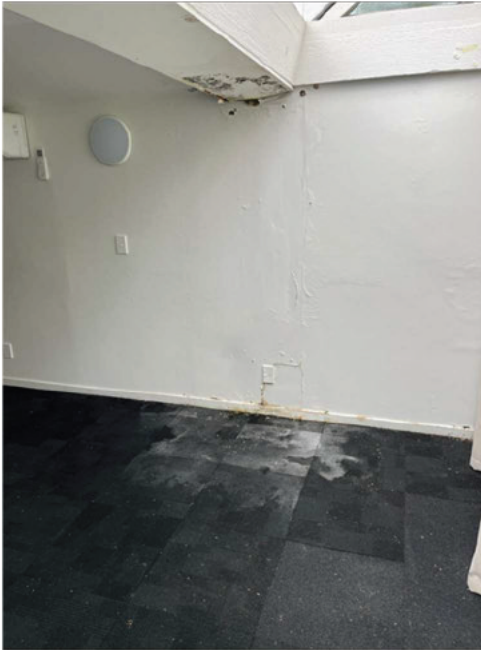
Severed water damage to the wall directly below this supporting beam. We suspect this is a timber element that may have been compromised as there is no evidence of rust coming through at this time. Propping of this location is recommended until the surface cladding can be opened and investigated.

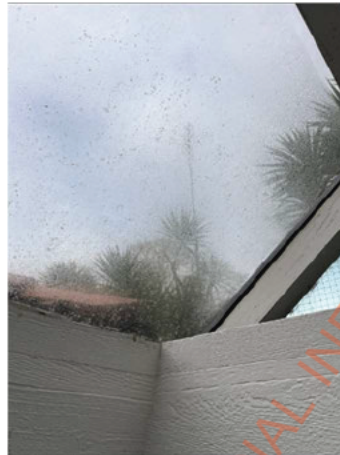
Weed seen growing directly above this location through the angular skylights. This weed is over 600mm long and appears to have died as part of its' natural lifecycle. Given this image was taken on the 12th of August (the last month of winter) and snapped like a twig due to its' dry interior we can only surmise it has been here for quite some time – possibly 6 months or more.

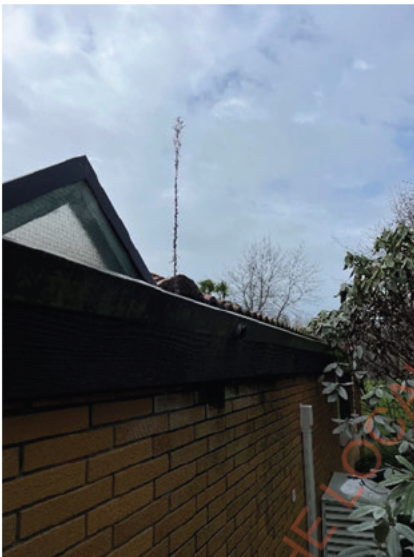
External view of tall weed growing directly above location of severe water ingress.

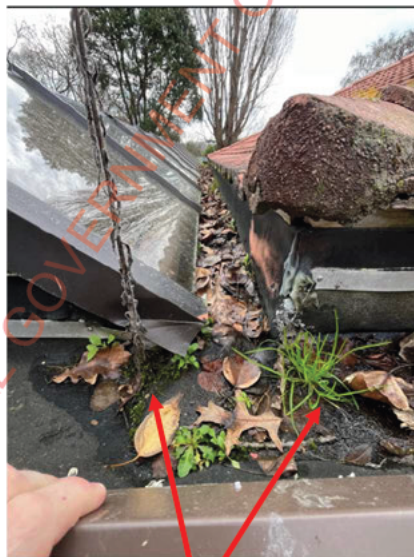
Condition of gutter with debris building up within the longitudinal skylight. As can be seen grasses and weeds are growing within the gutter itself.

The two weeds at the end of this gutter were pulled out separately to see what condition the gutter lining was in; first the tall left-hand weed followed by the smaller 'grass' right hand. Continues next page.

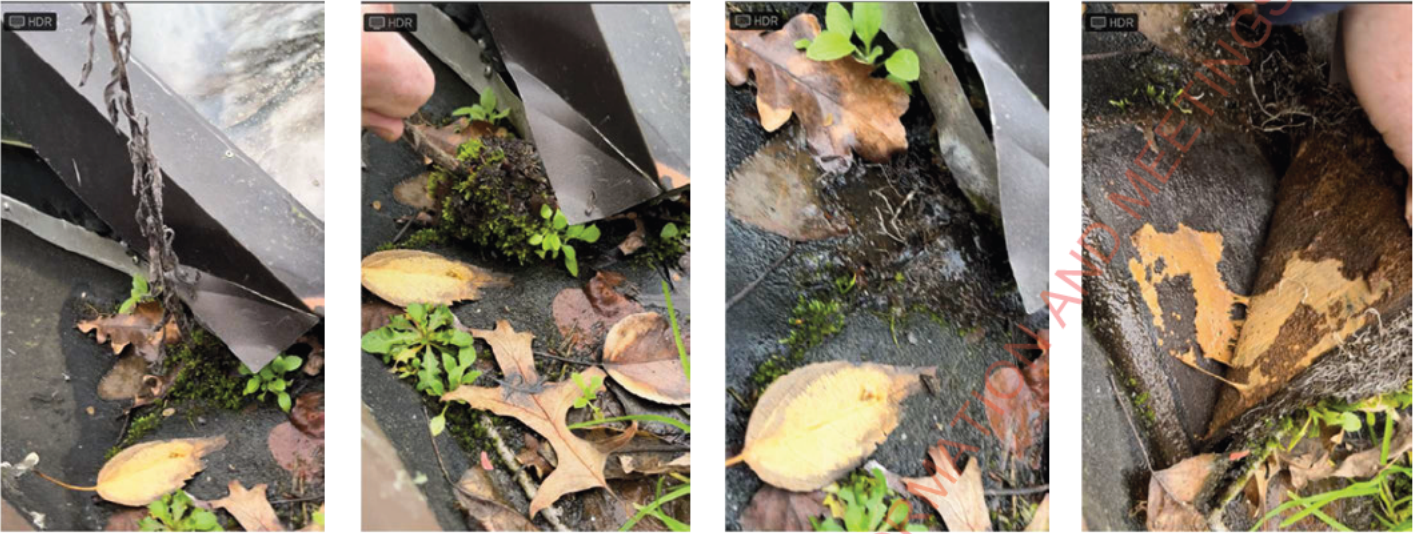
Above images taken from video footage (Left to Right) - Removal of the 600mm + weed

The above images evidence of a weed that has managed to grow withing the gutter and has followed the water course underneath the membrane and back into the building. The root system has come between the membrane layers and had anchored itself firmly into position.

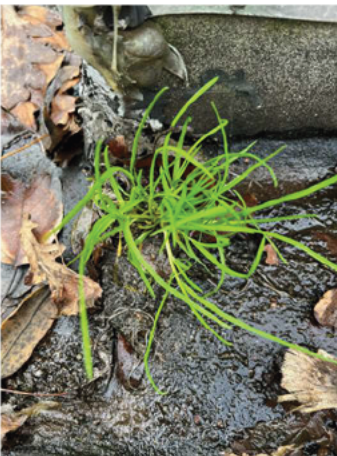
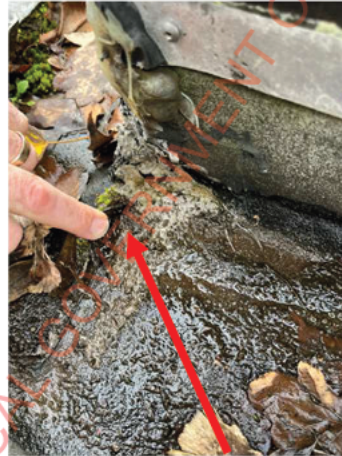
water ingress.

The 'grass' had anchored itself into the gutter membrane and was well established to grow to maturity.

Upon removal of the grass a much clearer indication of the gutter membrane materials condition could be seen in conjunction with the patch repairs that had taken place over time. The membrane layers have separated and allowed

What is evident is these repairs can only be considered as 'patch / Band-Aid' temporary stop gaps as they appear to consist of silicones and mastic materials – not designed to protect the gutter for any extended duration of time given the thickness of the coating and the location; being fully exposed to the elements. This repair (Right) for example should not be considered 'best practice' as a proper waterproofing patch be placed over the entire corner in a compatible material as the system that had been installed.

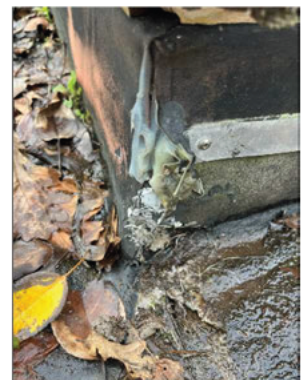
More evidence of overflowing gutters. Although not as bad as other locations – this type of water staining only occurs through prolonged saturation of the brickwork surface allowing the moss and algae time to establish itself on the surface.

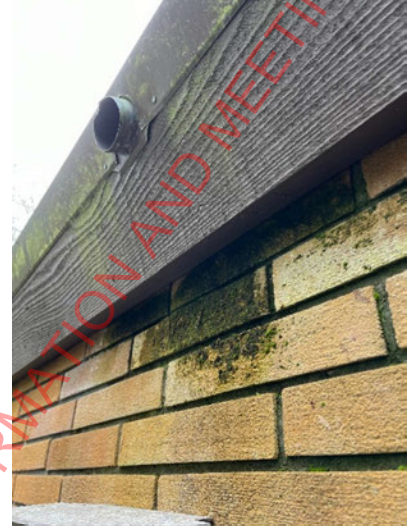
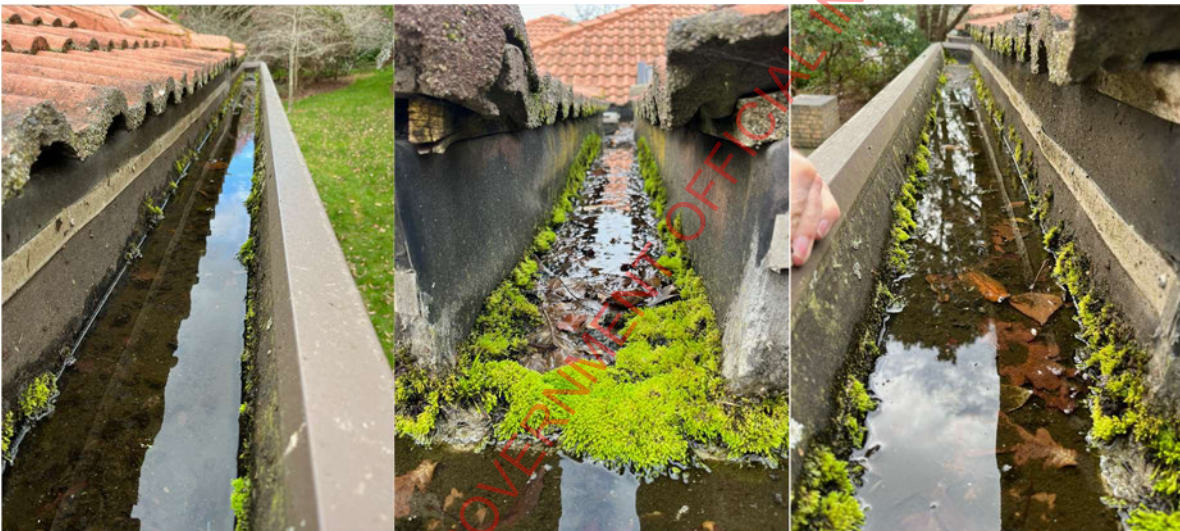
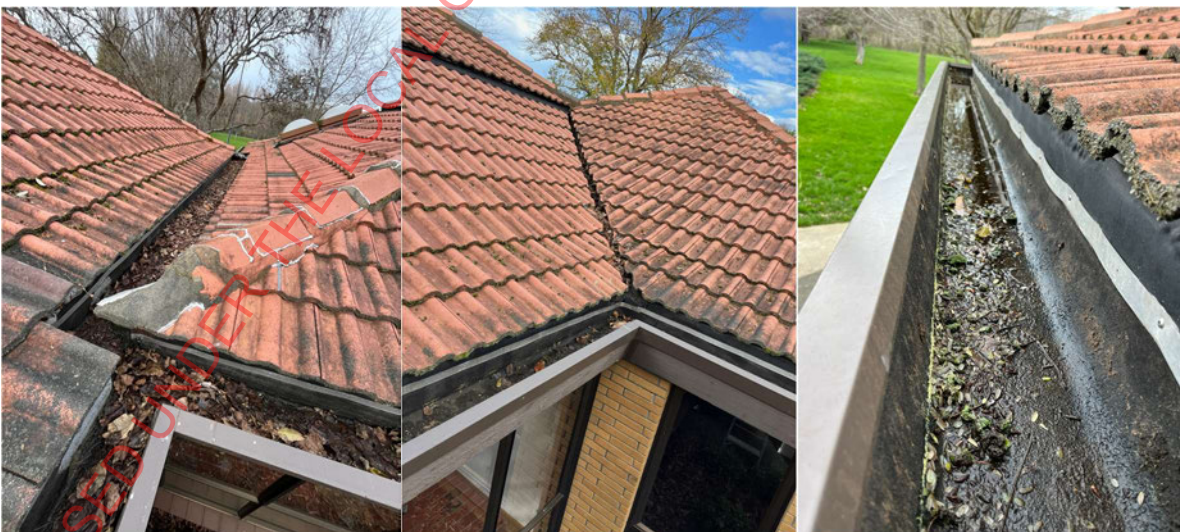
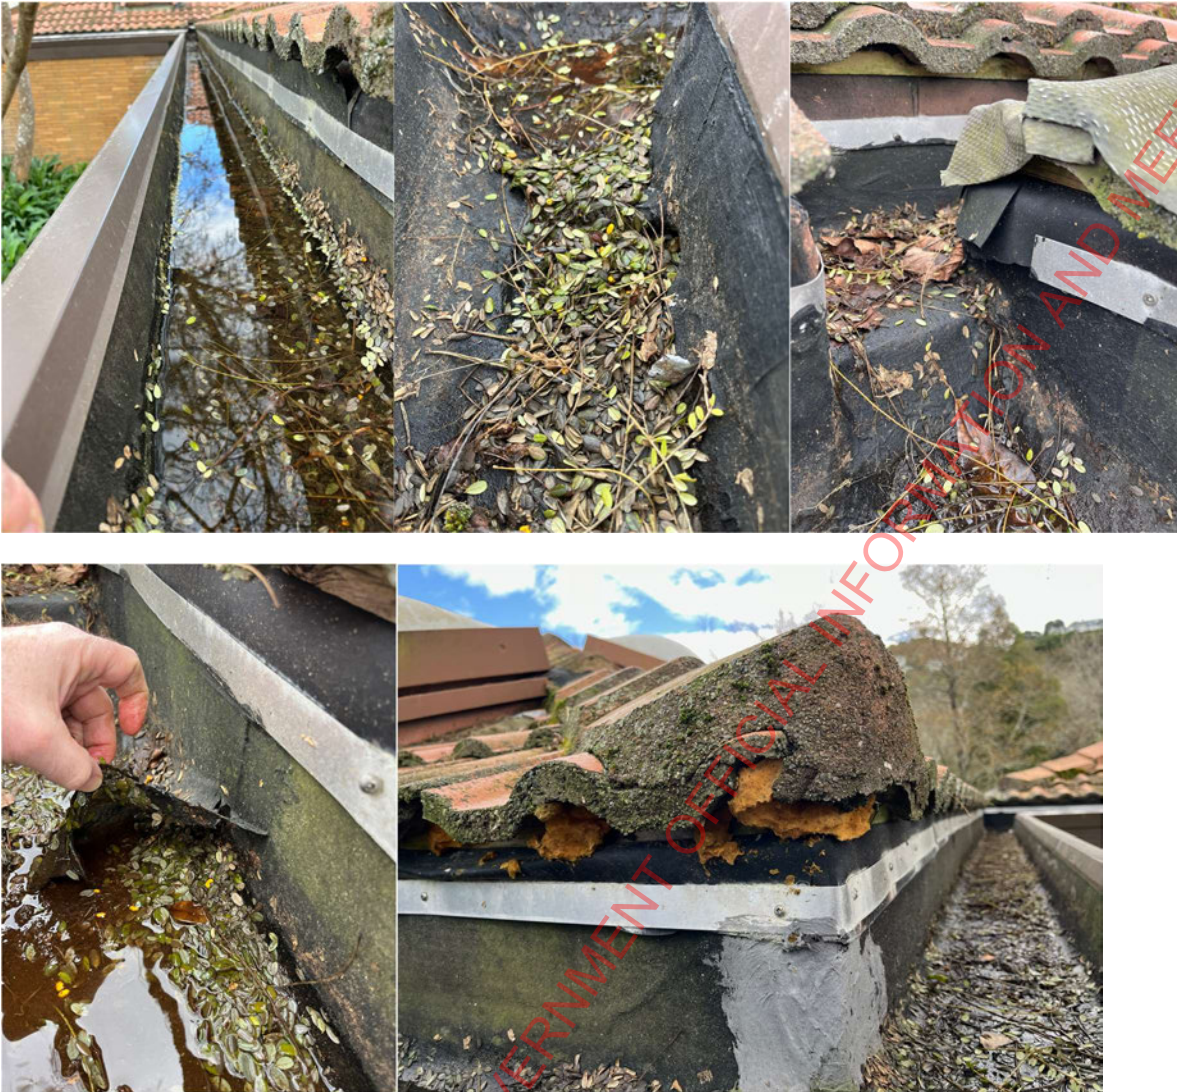
Throughout the facility multiple examples of the gutters filled with leaves, moss and debris. If gutters were cleaned completely, they have not had this level of moss and material present. We suspect no gutter cleaning has been undertaken for months. The deciduous trees surrounding the area were all bare or foliage indicating this has all dropped.

As can be seen in the above images the gutters are in a poor state especially where water ingress is occurring the condition of membrane laps is beyond repair and needs to be replaced. Given its' appearance we suspect it is the original lining and has simply lived out its' natural usable life'. Given the materials suspected age, a test for impregnated Asbestos should be undertaken to eliminate the possibility of contamination before any works is completed. Given the complexities of this gutter system replacing with pressed metal is not advised and will have a shorter lifespan than a membrane system especially when considering thermal expansion.

- 1) Remove the metal pressure strip, cap flashings and gutter linings to the entire perimeter of the building – either in one movement (requiring complete encapsulation of the building) or in stages where tarpaulins are placed up under an upper selected line of concrete tiles and remove the main gutter lining. From our assessment of the exposed edge there is no need to replace the rubber membrane that folds down from under the main roofline leading edge to the entire gutter. This appears to be a form if waterproofing barrier directly underneath the tiles giving one harmonious waterproofing system. As to how extensive and complete this is will require further investigation.

- 2) Remove wet, mouldy or otherwise damaged Gibraltar board linings where affected and review sub-structure. Treat for mould or replace as necessary.
- 3) Assess the gutter lining and replace mouldy / rotten elements with modern treated equivalent; this may be either timber boards or cut to size plywood.

- 4) Reline gutter with conductive primer (such as Truground from Viking Roof Spec) or Controlit GSSP Woven Fibreglass Conductive Sheet (available from Proven Membrane Systems) to allow for futureproofing with undertaking Electronic Leak Detection. Allow for set test points to ensure ELD is possible according to manufacturer's instructions.

- 5) Reline gutter with new non-conductive single ply or double layer torch on material ensuring all laps and connections are in the correct orientation for flow and installed as per the manufacturer's instructions in association with the Waterproofing Membrane Association Incorporated (WMAI of NZ) Best Practice Guidelines

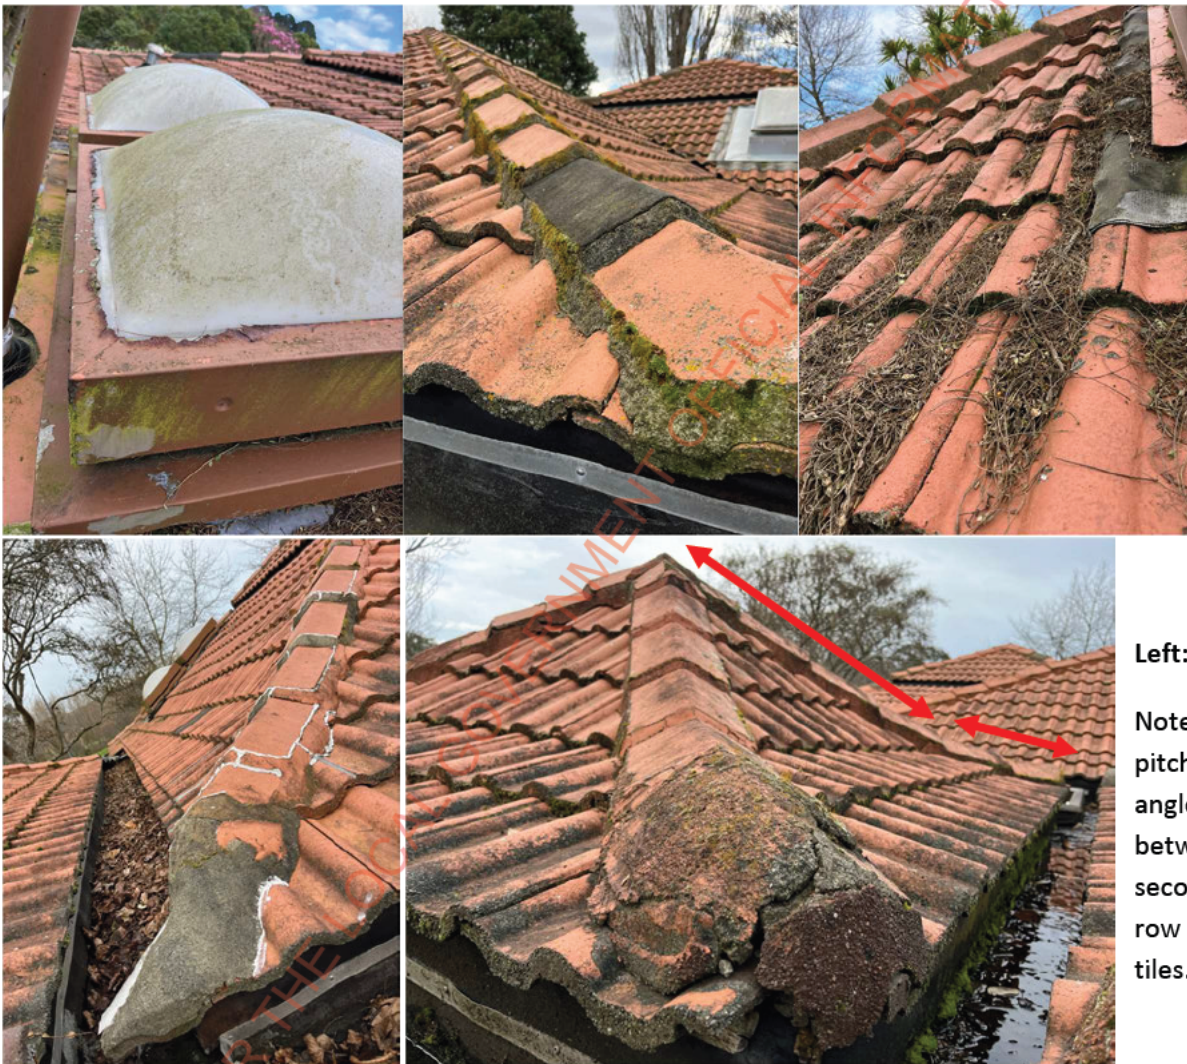
The skylights to the amenities areas are in a very poor condition, moss and severe cracking is occurring to ridge capping, surface glaze (assuming it existed) has virtually gone providing for a roughened surface for debris to build up on the surface, lost capping elements that have virtually broken down and failed over time have been reformed in mortar without sealing. These are patches not permanent.

Note the change in pitch of the roof angle occurring between the second and third row of roofing tiles.

We believe this rooftop with the proper cleaning, repair and coating system applied, is salvageable especially considering the rubberised ponding boards that appears to be in place providing protection when the gutters have overflowed. However, it should be noted this is a heavy concrete tile roof system which the structure would have been designed to accommodate when originally constructed. Consideration may be given to replacement with a lighter alternative option.

Consideration to the concrete tile roof. This element is in a poor state where the surface condition is allowing for growth within the tiles themselves. Any glaze that existed has predominantly gone, allowing a 'key' surface for moss and the likes to establish itself and grow. A rejuvenation of the roof is needed before continuing with the interior spaces. It is recommended a professional tile roofing recoating company be engaged to undertake this task including repointing the approximately 276 ridge tiles that exist.

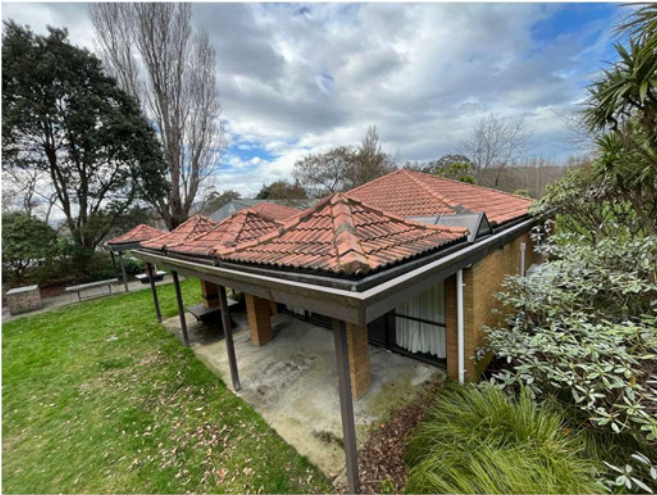
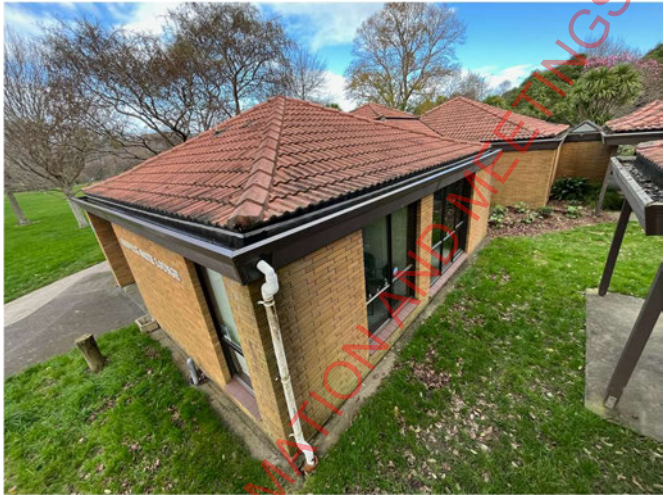
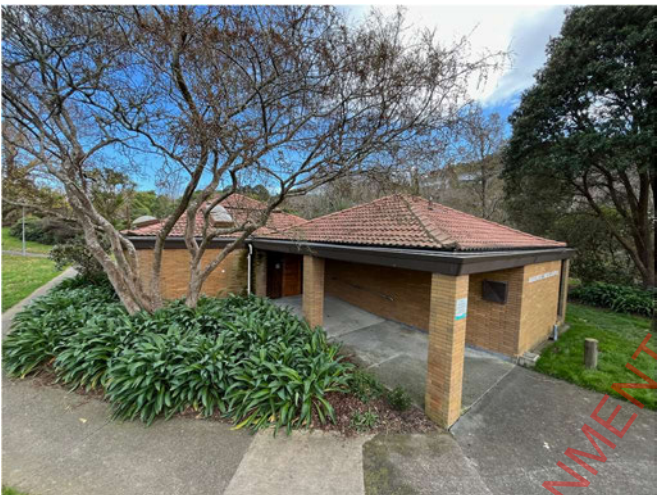
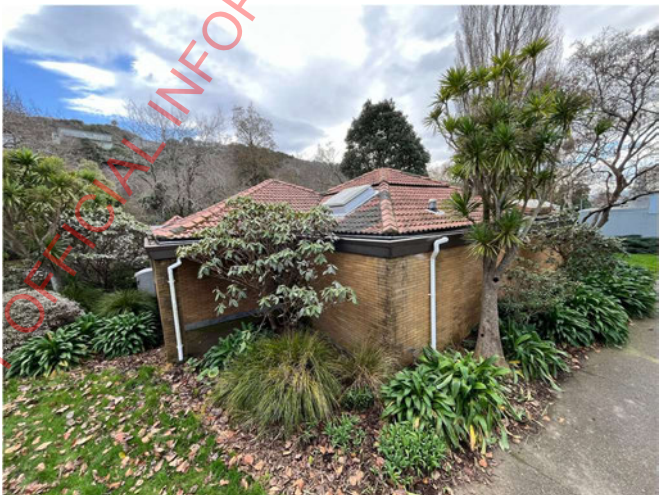
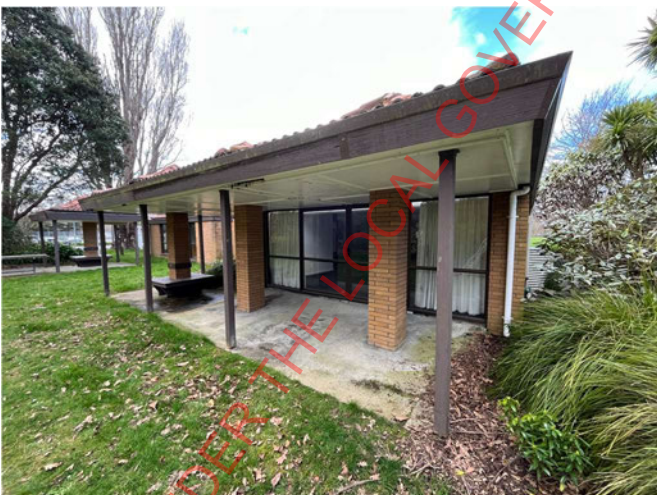
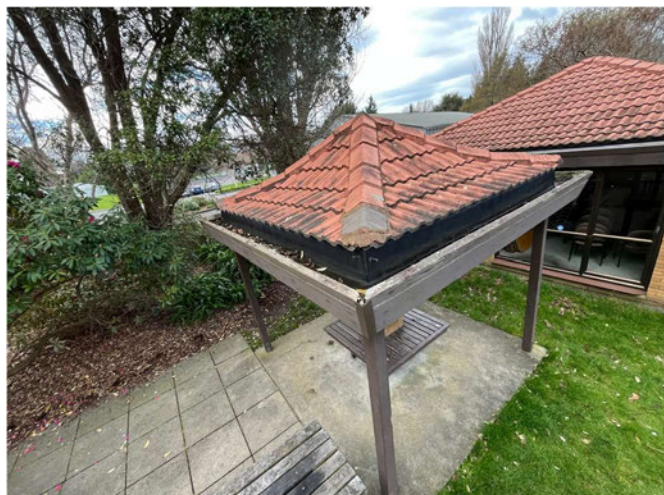
Above: Typical overview of the main building and ancillary structures exterior. Remedial works will be required due to reduced approach on programmed maintenance for this facility.

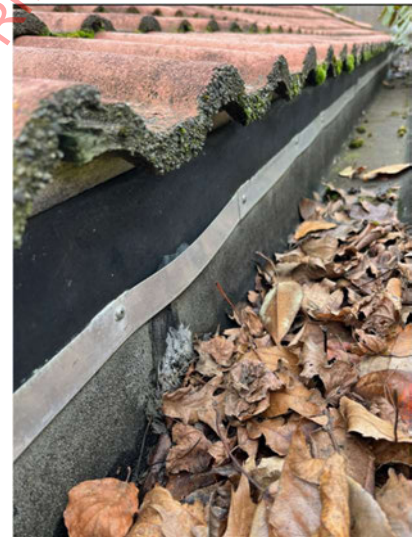
The upper black rubber continues up underneath the concrete roof tiles and folds down into the gutter itself where it meets the gutter lining material – joined by a metal strip.

* Puddle boards are designed to prevent water from flowing back inside the building and are lined with a waterproof material. If the gutters completely block (including the overflows) then the water will find a low point over the top of the gutter perimeter itself and release to the building exterior – thus preventing any internal damage.
