**Request for Information – Local Government Official Information and Meetings Act (LGOIMA) 1987**

**Avalon - Community Connections - Snag List**  
Walkover held on 30.10.25

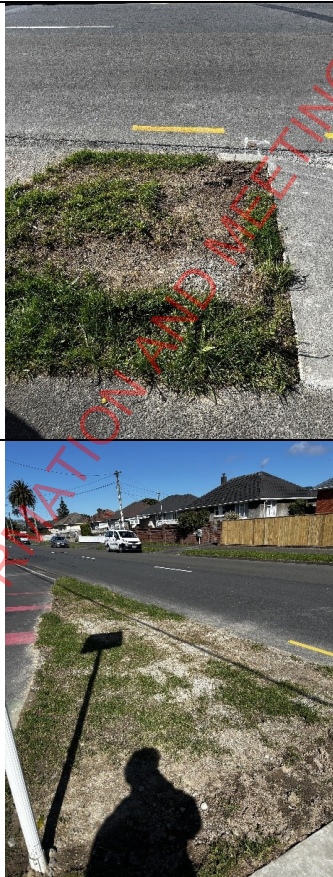
No	Defects / Snags	Description / Remedial Actions	Location/s	Photo
	berm damage	Localised areas of existing berms affected by construction works. Berms to be removed of aggregates, topped up with topsoil and hydroseeded.	1a: 205 Oxford Terrace (level crossing)

1(a-d)	berm damage	Localised areas of existing berms affected by construction works. Berms to be removed of aggregates, reinstated with topsoil and hydroseeded. Grass is to be re-established to achieve good strike, this may areas be fenced off in some situations.	1b: 51 Walters Street (level Crossing)  1c: 13D Walters Street (level crossing) + refer to Photo 2 below  1d: 897 High Street (raised crossing)

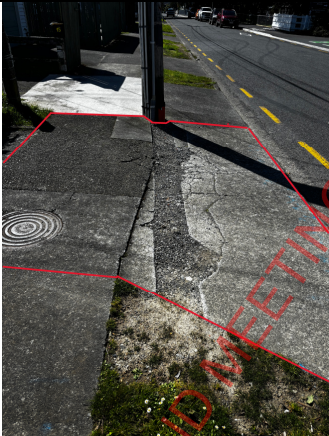
2	Utility trench (across driveway) surface reinstatement not completed	<p>no surfacing over new utility trench to existing power pole. Existing concrete driveway observed with multiple cracks (existing). Agreed on-site to resurface adjacent concrete driveway (from road to existing joint near boundary, Existing channel to remain)</p> <p>Note driveway works outside original scope of works, Contractor to confirm variation cost.</p>	Near 13D Walters Street (level crossing)

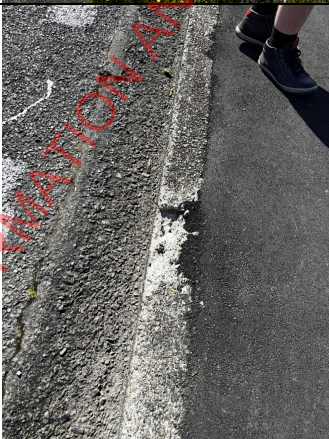
3	Existing kerb block damaged	Remediate broken kerb (same concrete insitu methodology as other sections)	Opposite 1/71 Walters Street

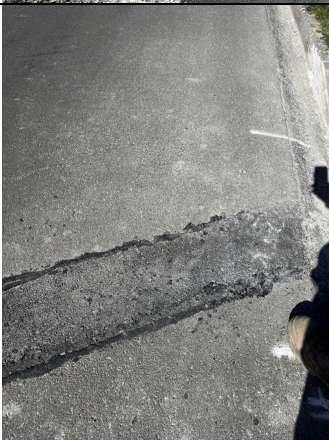
**Answer:** A defect was identified with the quality of the asphalt reinstatement associated with a streetlight trench crossing Oxford Terrace. The current works involve rectifying that defect.

4	Utility road crossing – surfacing texture/mix non-compliant	<p>Asphalt surface is bony. Surfacing mix/compaction appears inconsistent with other new road crossings. Remove and repave to compliant standards. Suggest using RBB at joints</p>	205 Oxford Terrace crossing

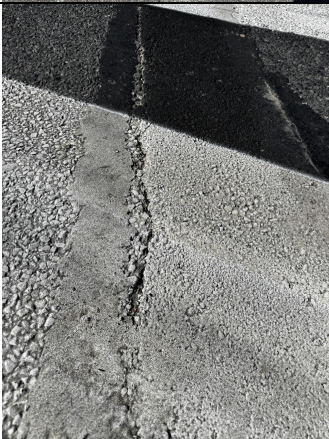
5	Utility Road Crossing - joint seal	<p>inadequate joint seal application. Fill gaps if required and apply crack seal (suggest RBB)</p>	13D Walters Street - Level crossing

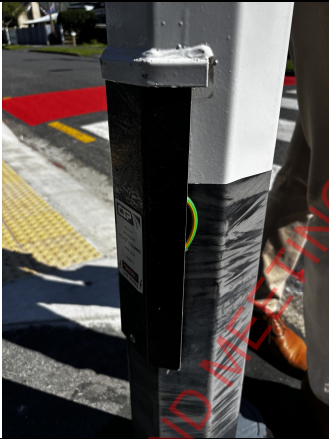
<p>6</p>	<p>New pedestrian light pole - wire exposed</p>	<p>Fit wire within casing / pole.</p>	<p>51 Walters street</p>

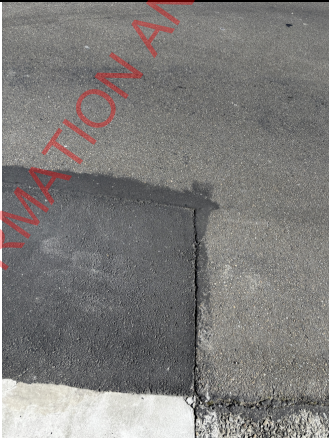
<p>7(a-c)</p>	<p>Dish channel / kerb and channel pavement reinstatement Joint seal</p>	<p>inadequate crack seal at some localised areas Cracks open for water ingress. Suggest filling cracks and applying crack seal (Suggest RBB).</p>	<p>7a: Oxford Terrace new Dish channel at end extents</p>

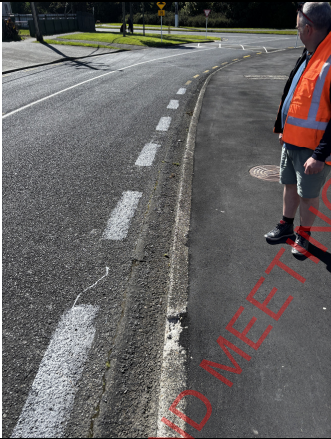
<p>8(a-c)</p> <p>Roadmaking - blackout paint appears grey coloured in some areas.</p>	<p>paint used to blackout broken yellow lines appears grey coloured (not black) in some areas. Contractor to remediate.</p>	<p>8a: 77-66 Walters Street</p>

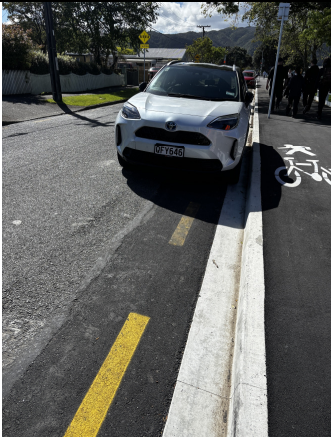
<p>9</p>	<p>road marking - new broken yellow lines appear faint</p>	<p>remark faint yellow lines</p>	<p>5 Walters Street</p>

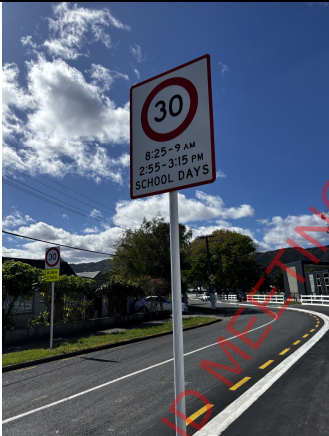
<p>10</p>	<p>Existing Variable Speed School sign – incorrect face direction</p>	<p>reverse sign face direction i.e. sign face positioned towards westbound vehicles on Walters Street (cars approaching intersection from Walters)</p>	<p>Walters Street near High Street Intersection</p>

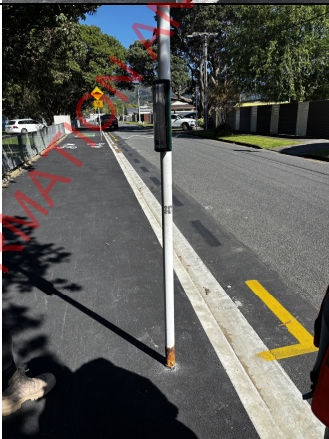
<p>11 (a-c)</p>	<p>Existing sign poles in poor condition</p>	<p>Existing traffic sign posts with rust to be replaced with new. Outside of original scope of works. Contractor to confirm variation with Client</p>	<p>a) 1x bus stop (31a Walters) b) 2x Speed hump (#29 &amp; #9 Walters) c) Street sign (corner High &amp; Walters Street)</p>

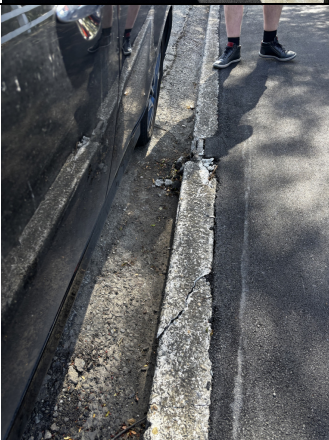
<p>12</p>	<p>Existing kerb damaged &amp; existing channel low point</p>	<p>Existing kerb damaged. Note the existing channel adjacent to kerb appears to contain a low point / ponding spot.  Damaged kerb to be replaced.  Council also agreed to remediate existing channel to remove low spot - consider outside of original scope. Contractor to provide Council variation cost for review.</p>	<p>907 High Street</p>

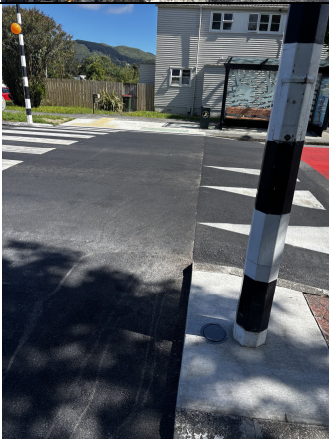
<p>13</p>	<p>High Street Raised Crossings - Paint fading</p>	<p>New paint fading - NCR. Apply second coat. Confirm reflective HPPL paint as per project specifications</p>	<p>897 &amp; 937 High Street Raised crossing</p>

<p>14</p>	<p>Raised crossing - 897 High Street - joint seal</p>	<p>no joint seal applied between ramp and table top. Apply joint seal (suggest RBB)</p>	<p>897 High Street Raised crossing</p>	<p>see picture above</p>
<p>15</p>	<p>Redundant zebra bar marking - raised crossing</p>	<p>Remove new single zebra bar markings behind tactile. Contractor to confirm remedial methodology.</p>	<p>937 High Street Raised Crossing</p>

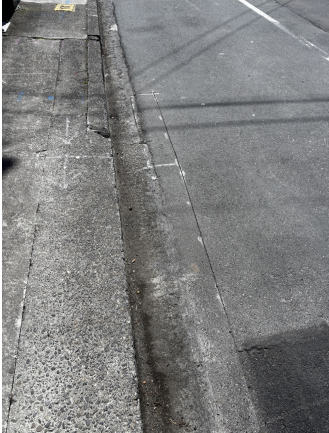
<p>16</p>	<p>Saw cuts</p>	<p>remediate/close up saw cuts. Contractor to confirm remedial methodology.</p>	<p>937 High Street Raised Crossing</p>

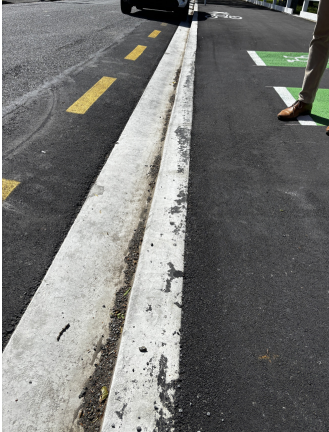
<p>17</p>	<p>Bitumen/asphalt residue on new kerbs</p>	<p>Attempt to remove excess bitumen residue from new kerbs where reasonably able to.</p>	<p>Walters Street</p>

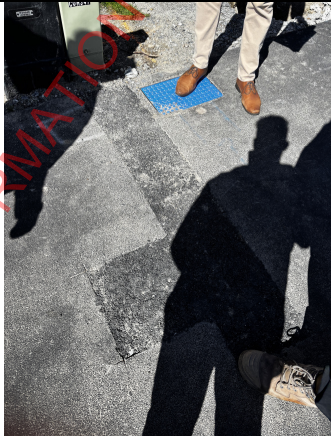
ITEMS FOR COUNCIL'S INFORMATION (OUTSIDE OF SCOPE)				
Utility Trench reinstatement within new shared path	<ol style="list-style-type: none"><li>1. Surfacing for trench reinstatement within new path appears of poor quality (bony surface, inconsistent)</li><li>2. trip hazards from temporary works (corner of driveway/footpath)</li></ol>	Near 58 Walters Street
