| Inspection Type: | General |
| Inspected Date: | 26/03/2025 |

Name  
Estuary Bridge

Road  
Waione Street

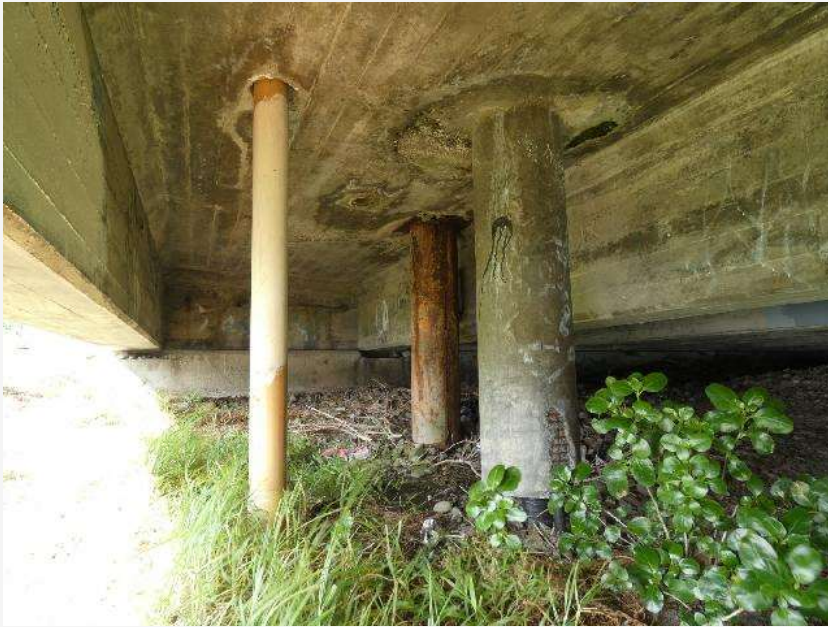
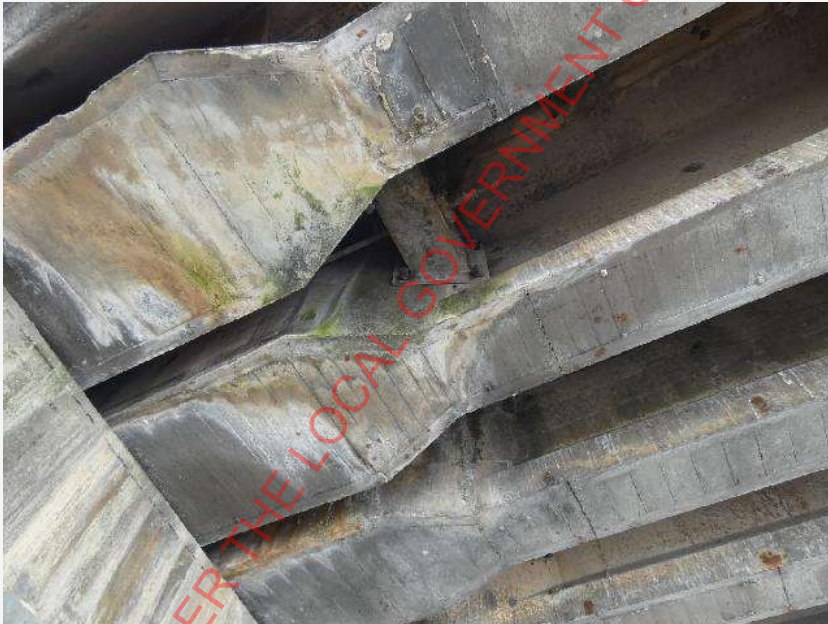
**Element:**  
3 - Secondary element(s) - Other (incl. deck)

| Check List | | | | |
|---|---|---|---|---|
| | 3 | Secondary element(s) - Other (incl. deck) | 3 | 1) Water staining and moss on soffit 2) Spots of corrosion on beams 3) Minor cracking with efflorescence |

**Description:**  
Water staining and moss on soffit

| Ref | Brief description of faults and recommendations for repair. | Priority | W/E | Cost Estimate | Completed |
|---|---|---|---|---|---|
| 3 - Secondary element(s) - Other (incl. deck) | Thoroughly clean and remove all moss buildup from the deck to prevent surface deterioration and slipping hazards | Low | 114A | 2000 | |

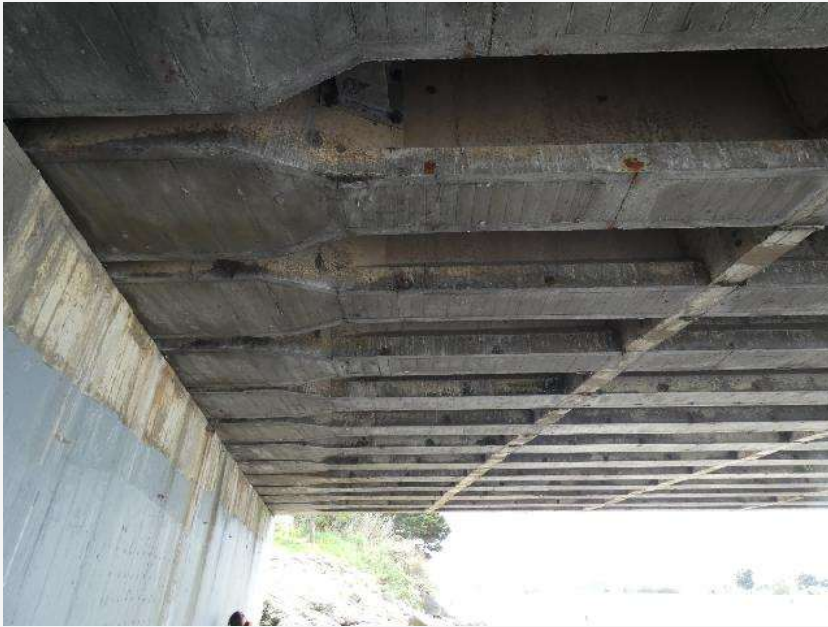
**Element:**  
3 - Secondary element(s) - Other (incl. deck)

**Description:**  
Spots of corrosion on beams

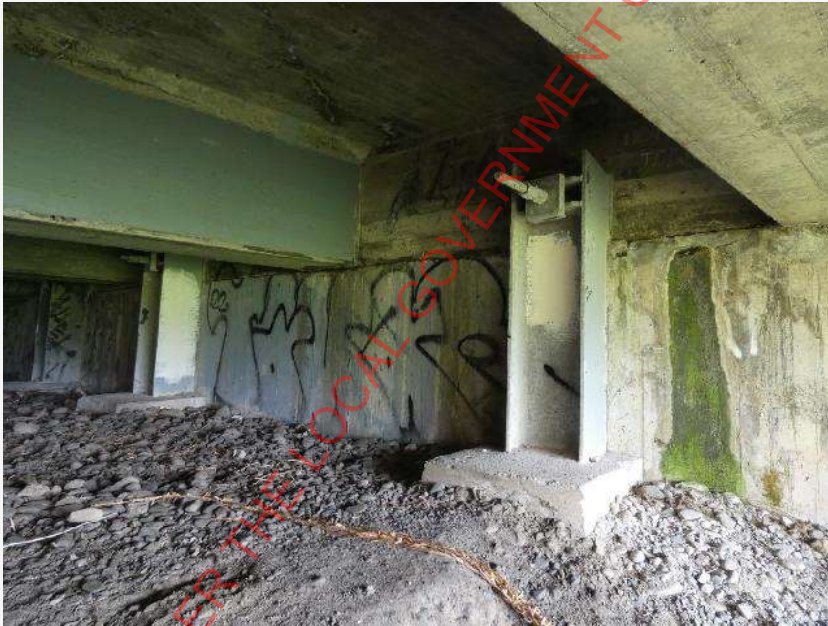
**Element:**  
3 - Secondary element(s) - Other (incl. deck)

**Description:**  
Minor cracking with efflorescence

| Ref | Brief description of faults and recommendations for repair. | Priority | W/E | Cost Estimate | Completed |
|---|---|---|---|---|---|
| 3 - Secondary element(s) - Other (incl. deck) | Inject all visible cracks with suitable sealant to prevent water leakage. | Low | 114B | 5000 | |

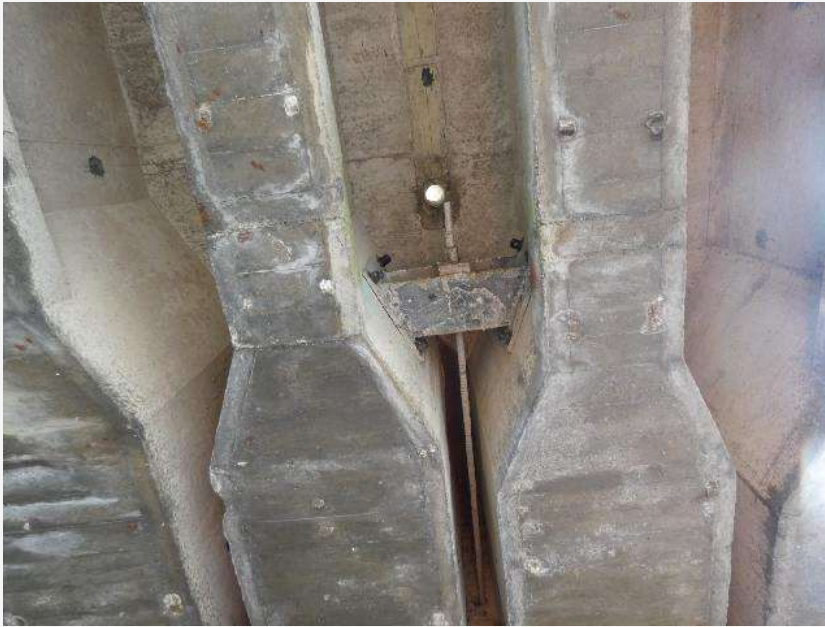
| Check List | | | | |
|---|---|---|---|---|
| | 5 | Seismic linkages/Holding Down bolts | 3 | Seismic linkages directly below where the pigeons are roosting are covered in guano. |

Seismic linkages directly below where the pigeons are roosting are covered in guano.

| Ref | Brief description of faults and recommendations for repair. | Priority | W/E | Cost Estimate | Completed |
|---|---|---|---|---|---|
| 5 - Seismic linkages/Holding Down bolts | Clean off guano from seismic linkages by high pressure water jet | Low | 114A | 4000 | |

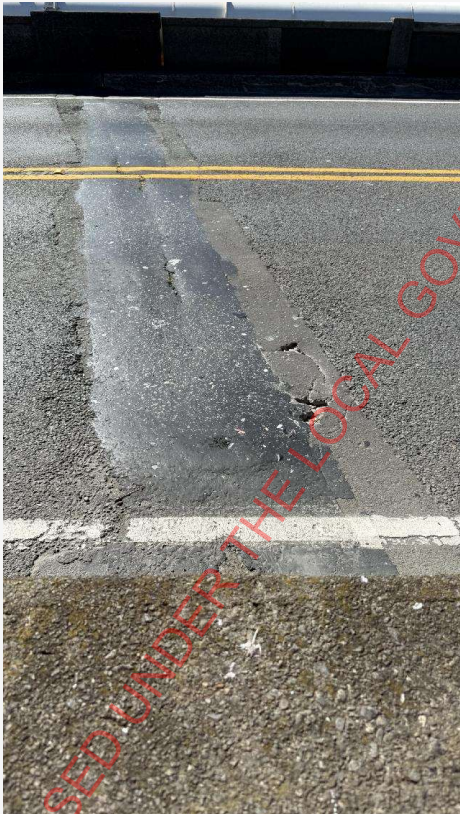
| Check List | | | | |
|---|---|---|---|---|
| | 17 | Movement / expansion joints | 3 | 1) Debris in joints at footpath. 2) Bitumen seal entirely covering joints on carriageway 3) Cracking in seal at eastern joint |
| Waterway Elements | 23 | Carriageway surfacing | 4 | Cracking at deck expansion joint |

1) Debris in joints at footpath. 2) Bitumen seal entirely covering joints on carriageway 3) Cracking in seal at eastern joint

| Ref | Brief description of faults and recommendations for repair. | Priority | W/E | Cost Estimate | Completed |
|---|---|---|---|---|---|
| 17 - Movement / expansion joints | Repair defective expansion joints. Implement appropriate traffic accommodation strategies as needed to ensure safety and minimize disruption. | High | 215A | 30000 | |

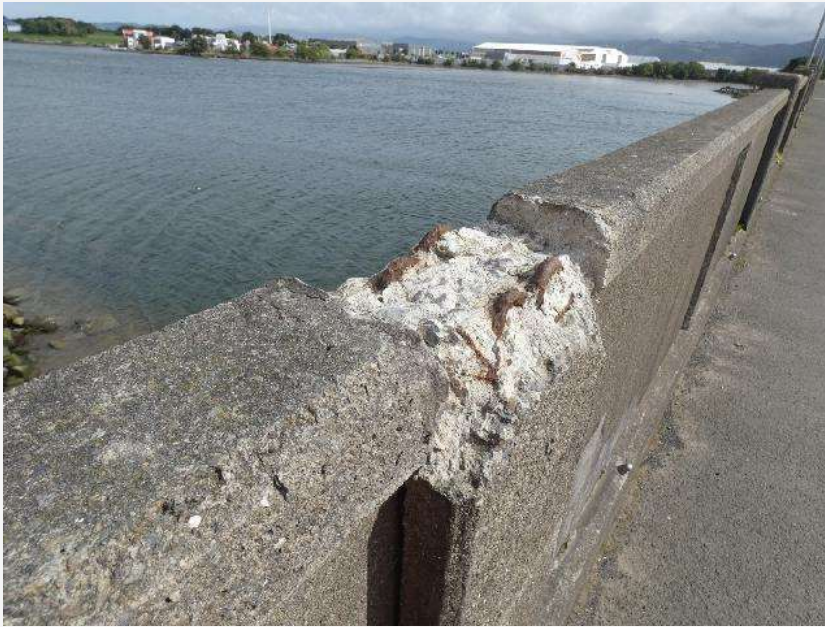
35 - Approach rails / barriers / walls

| Check List | | | | |
|---|---|---|---|---|
| | 22 | Guardrail / handrail / safety fences | 4 | Spalling on concrete barriers with exposed reinforcing |

Spalling on concrete barriers with exposed reinforcing

| Ref | Brief description of faults and recommendations for repair. | Priority | W/E | Cost Estimate | Completed |
|---|---|---|---|---|---|
| 22 - Guardrail / handrail / safety fences | Repair concrete spall on parapets | Medium | 114B | 8000 | |

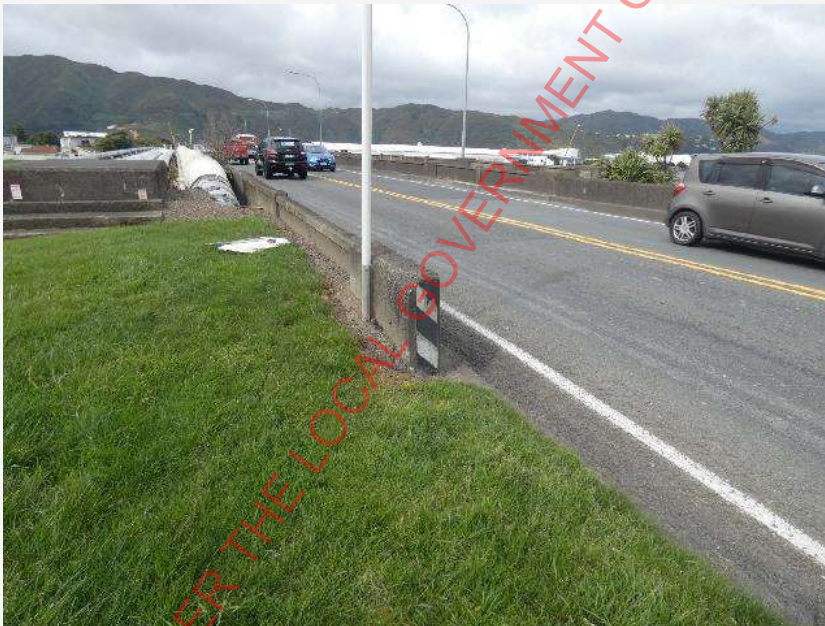
| Check List | | | | |
|---|---|---|---|---|
| | 37 | Signs | 3 | 1) BEMs too short and deteriorating 2) No Bridge ID Sign |

BEMs too short and deteriorating

| Ref | Brief description of faults and recommendations for repair. | Priority | W/E | Cost Estimate | Completed |
|---|---|---|---|---|---|
| 37 - Signs | BEMs are too short and deteriorating - Install 4x BEMs | High | 215A | 3000 | |

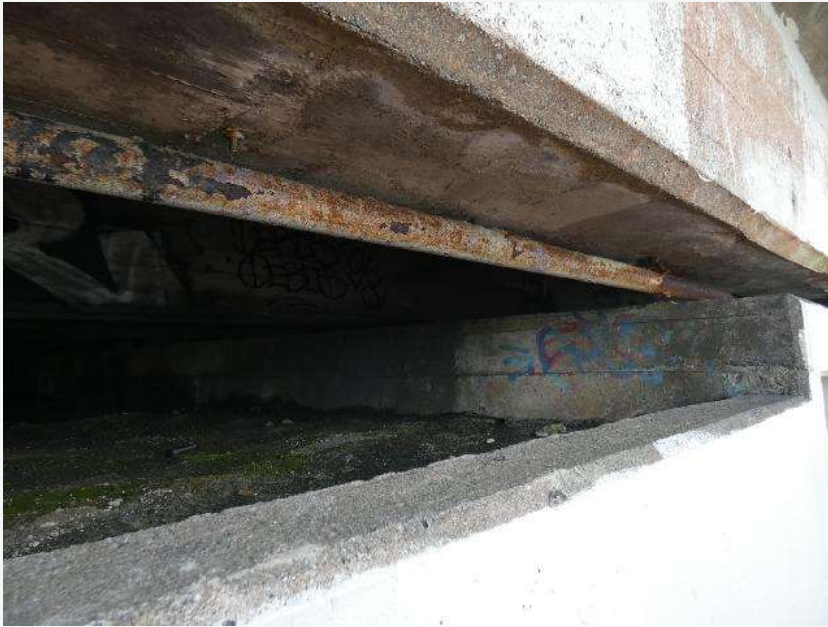
**Element:**  
39 - Services

| Check List | | | | |
|---|---|---|---|---|
| | 39 | Services | 3 | Corrosion on service pipe |

**Description:**  
Corrosion on service pipe

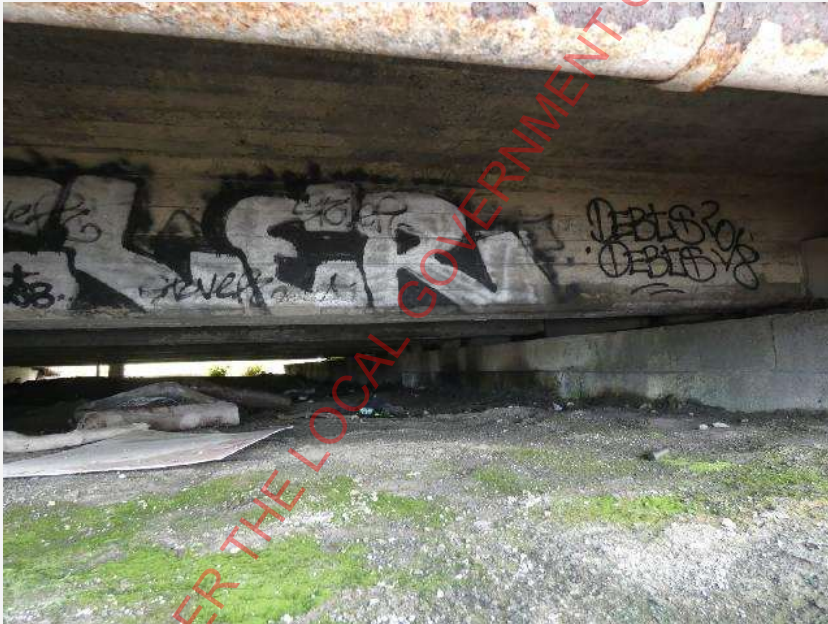
**Element:**  
40 - Appearance

| Check List | | | | |
|---|---|---|---|---|
| | 40 | Appearance | 3 | 1) Graffiti on beams 2) Pigeons on the piers and between beams |

**Description:**  
Graffiti on beams

| Ref | Brief description of faults and recommendations for repair. | Priority | W/E | Cost Estimate | Completed |
|---|---|---|---|---|---|
| 40 - Appearance | Clean off graffiti from the walls | Low | 114A | 4000 | |

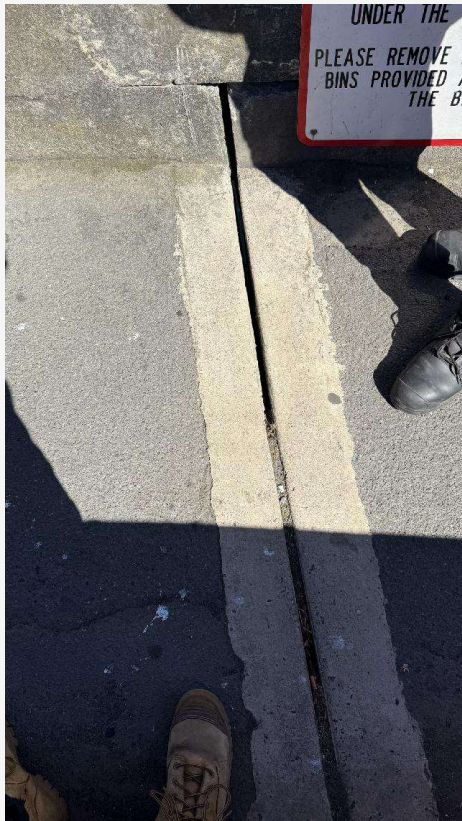
Debris in section of joint on footpath
