## Petone Recreation Ground Grandstand

### Detailed Seismic Assessment

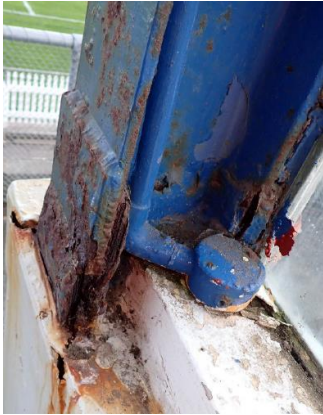
**Figure 16 – Corrosion of Steel Column - Base Connection to Concrete - Column 1 Above Bleachers**

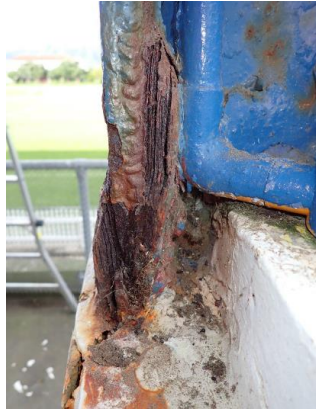
**Figure 17 – Corrosion of Steel Column - Base Connection to Concrete - Column 1 Above Bleachers**

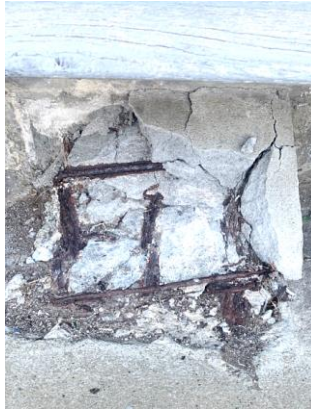
**Figure 18 - Corrosion of Reinforcing Steel - Concrete Bleacher Beam - Column 3 Above Bleachers**

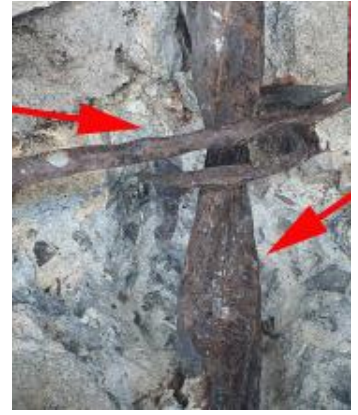
**Figure 19 - Corrosion of Reinforcing Steel - Concrete Bleacher Beam - Column 3 Above Bleachers**

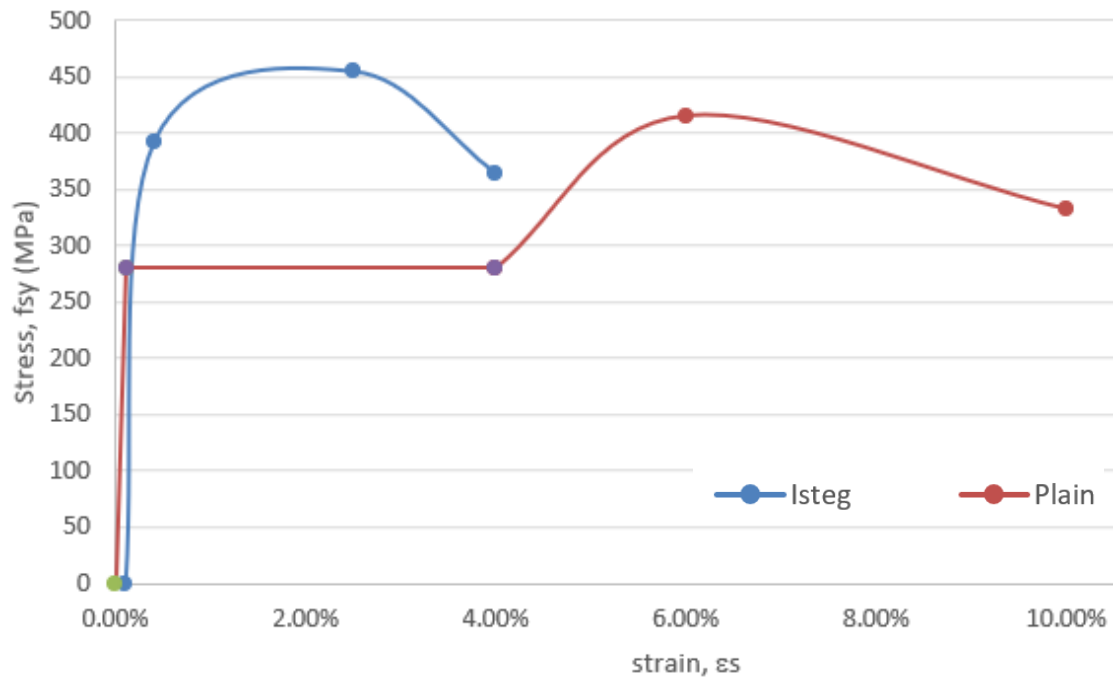
**Figure 31 - Assumptions/model for stress/strain interaction of ISTEg reinforcing steel bars (cf plain round bars)**

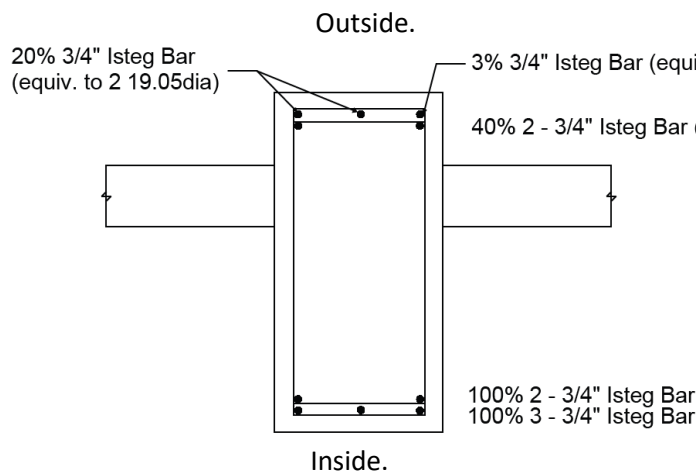
**Figure 32 - Assumptions/model for reduced strength of corroded reinforcing steel: bleacher beam, col 3.**

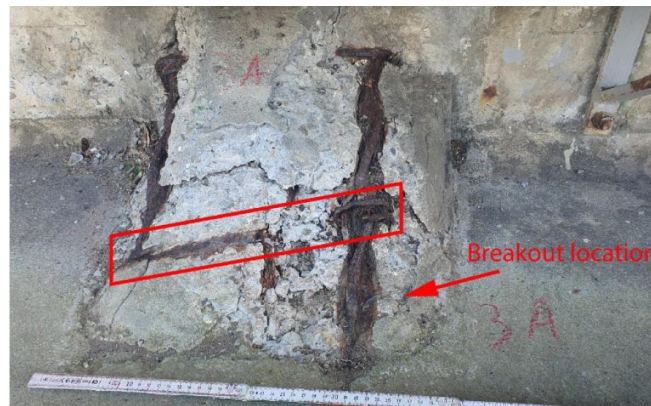
**Figure 33 - Photograph of corroded reinforcing steel: bleacher beam above col 3.**

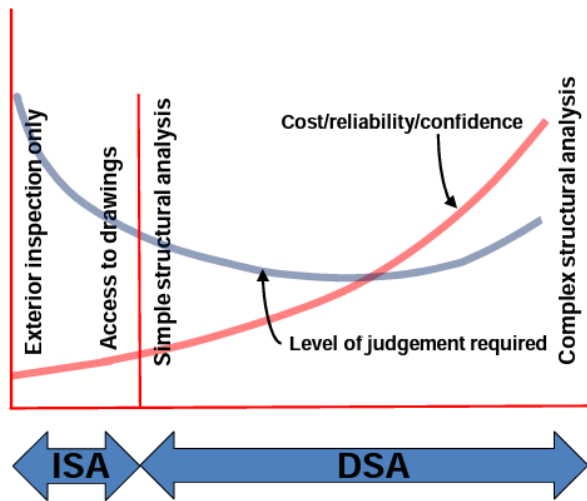
Figure 34 - The continuum of seismic assessment.
