HUTT CITY COUNCIL

Preliminary Geotechnical
Suitability Assessment

60 Eastern Hutt Road

December 2010

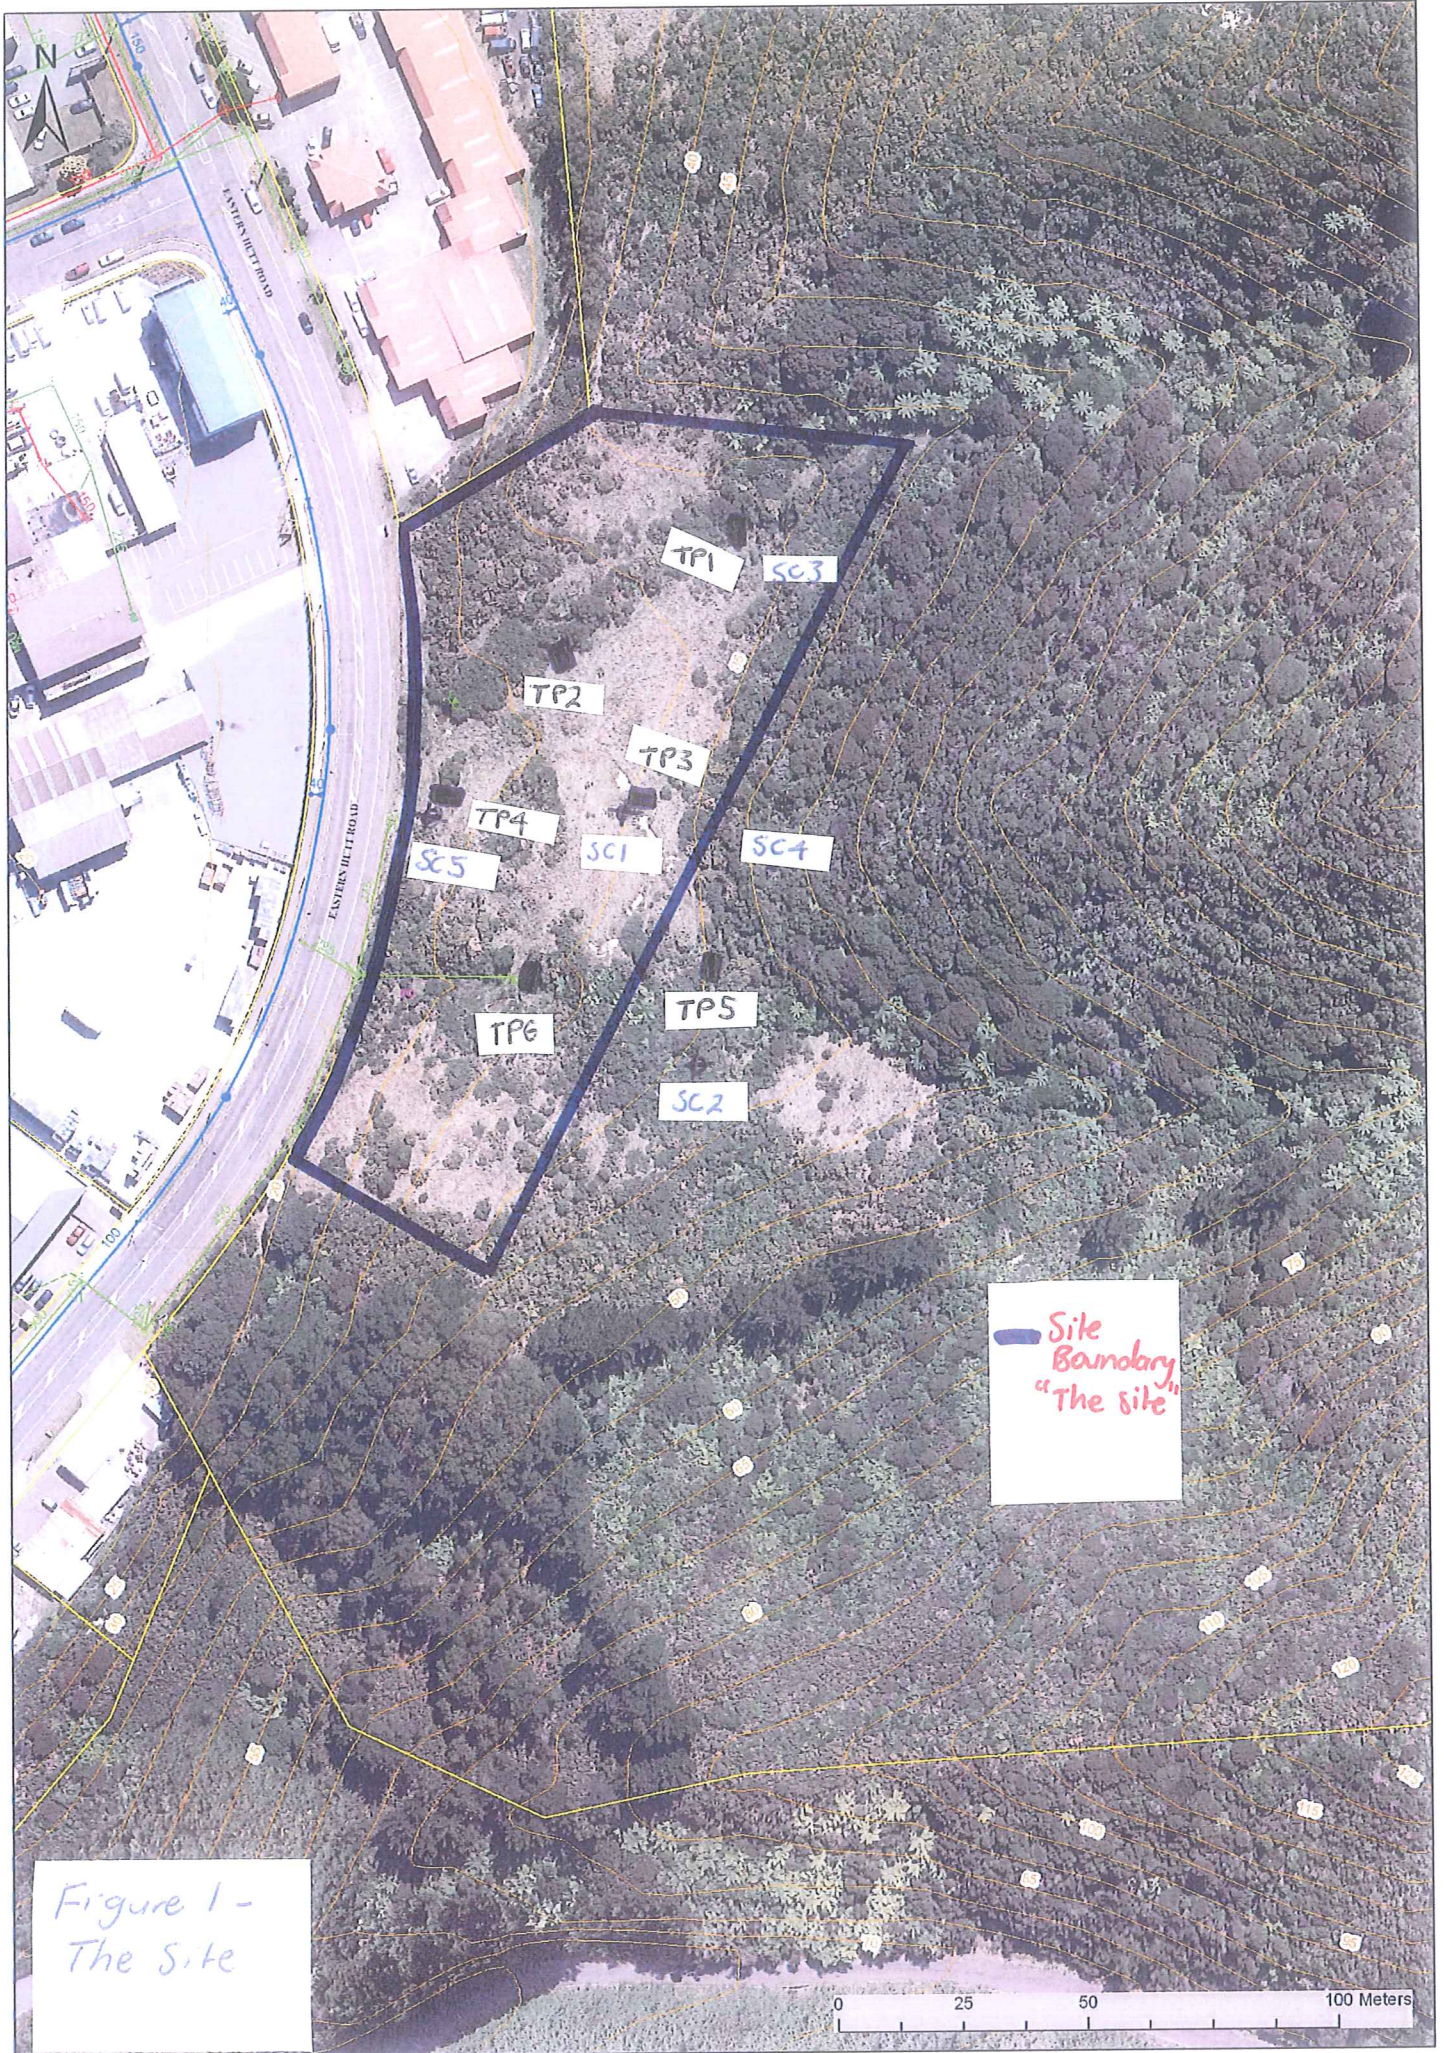
Figure 1 -
The Site

The Site is situated within the Hutt Valley on a west facing, gentle to moderately steep (5 to 20 degree) slope at the toe of the eastern hills. The Site lies at the convergence of two steeply incised gullies. Both gullies hold active watercourses that discharge into existing culverts at the western

edge of the Site, refer Figure 1. The slope gradient steepens significantly at the eastern edge of the Site and beyond (25 to 30 degrees).

The extent of the proposed Site is shown on Figure 1 attached.

Investigation logs for test pits TP1 to TP6 are presented in Appendix A and their locations are shown on Figure 1.

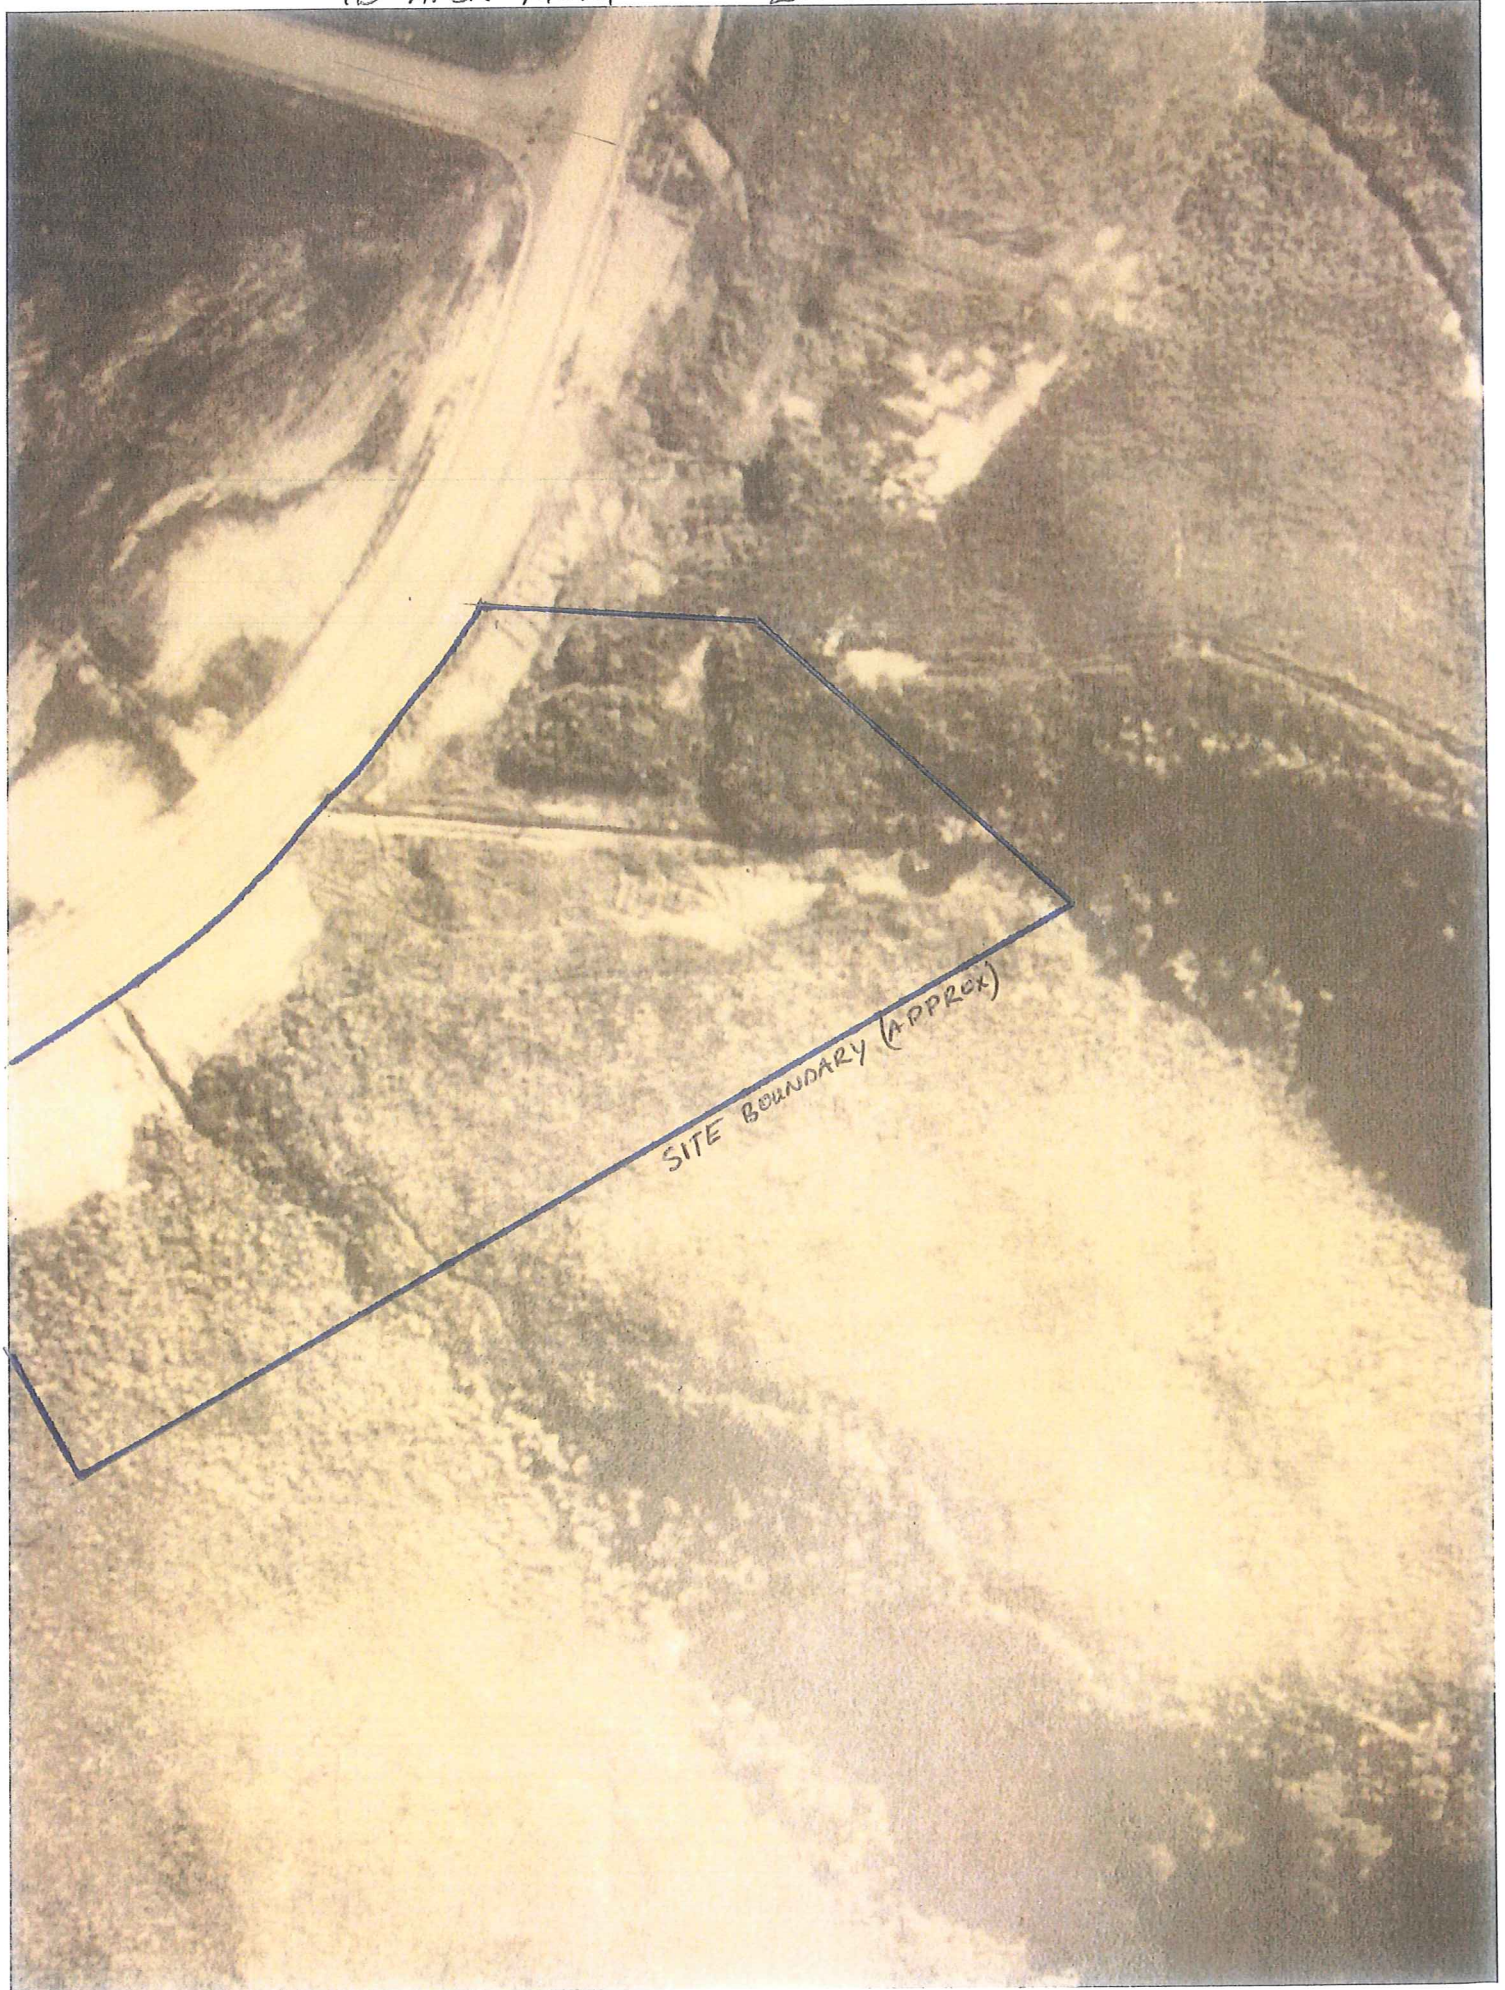
FIGURE 2: 1951 SN 570 HISTORICAL AERIAL PHOTOGRAPH
ID Arch 74074 LOWER HUTT CITY COUNCIL

Historic aerial photographs indicate some ground modification (slope re-profiling and realignment of stream channels) prior to 1951, refer Figure 2. It is likely that some excavation and filling will have been undertaken over the western portion of the Site during construction of the Eastern Hutt Road and the culverts under the road.

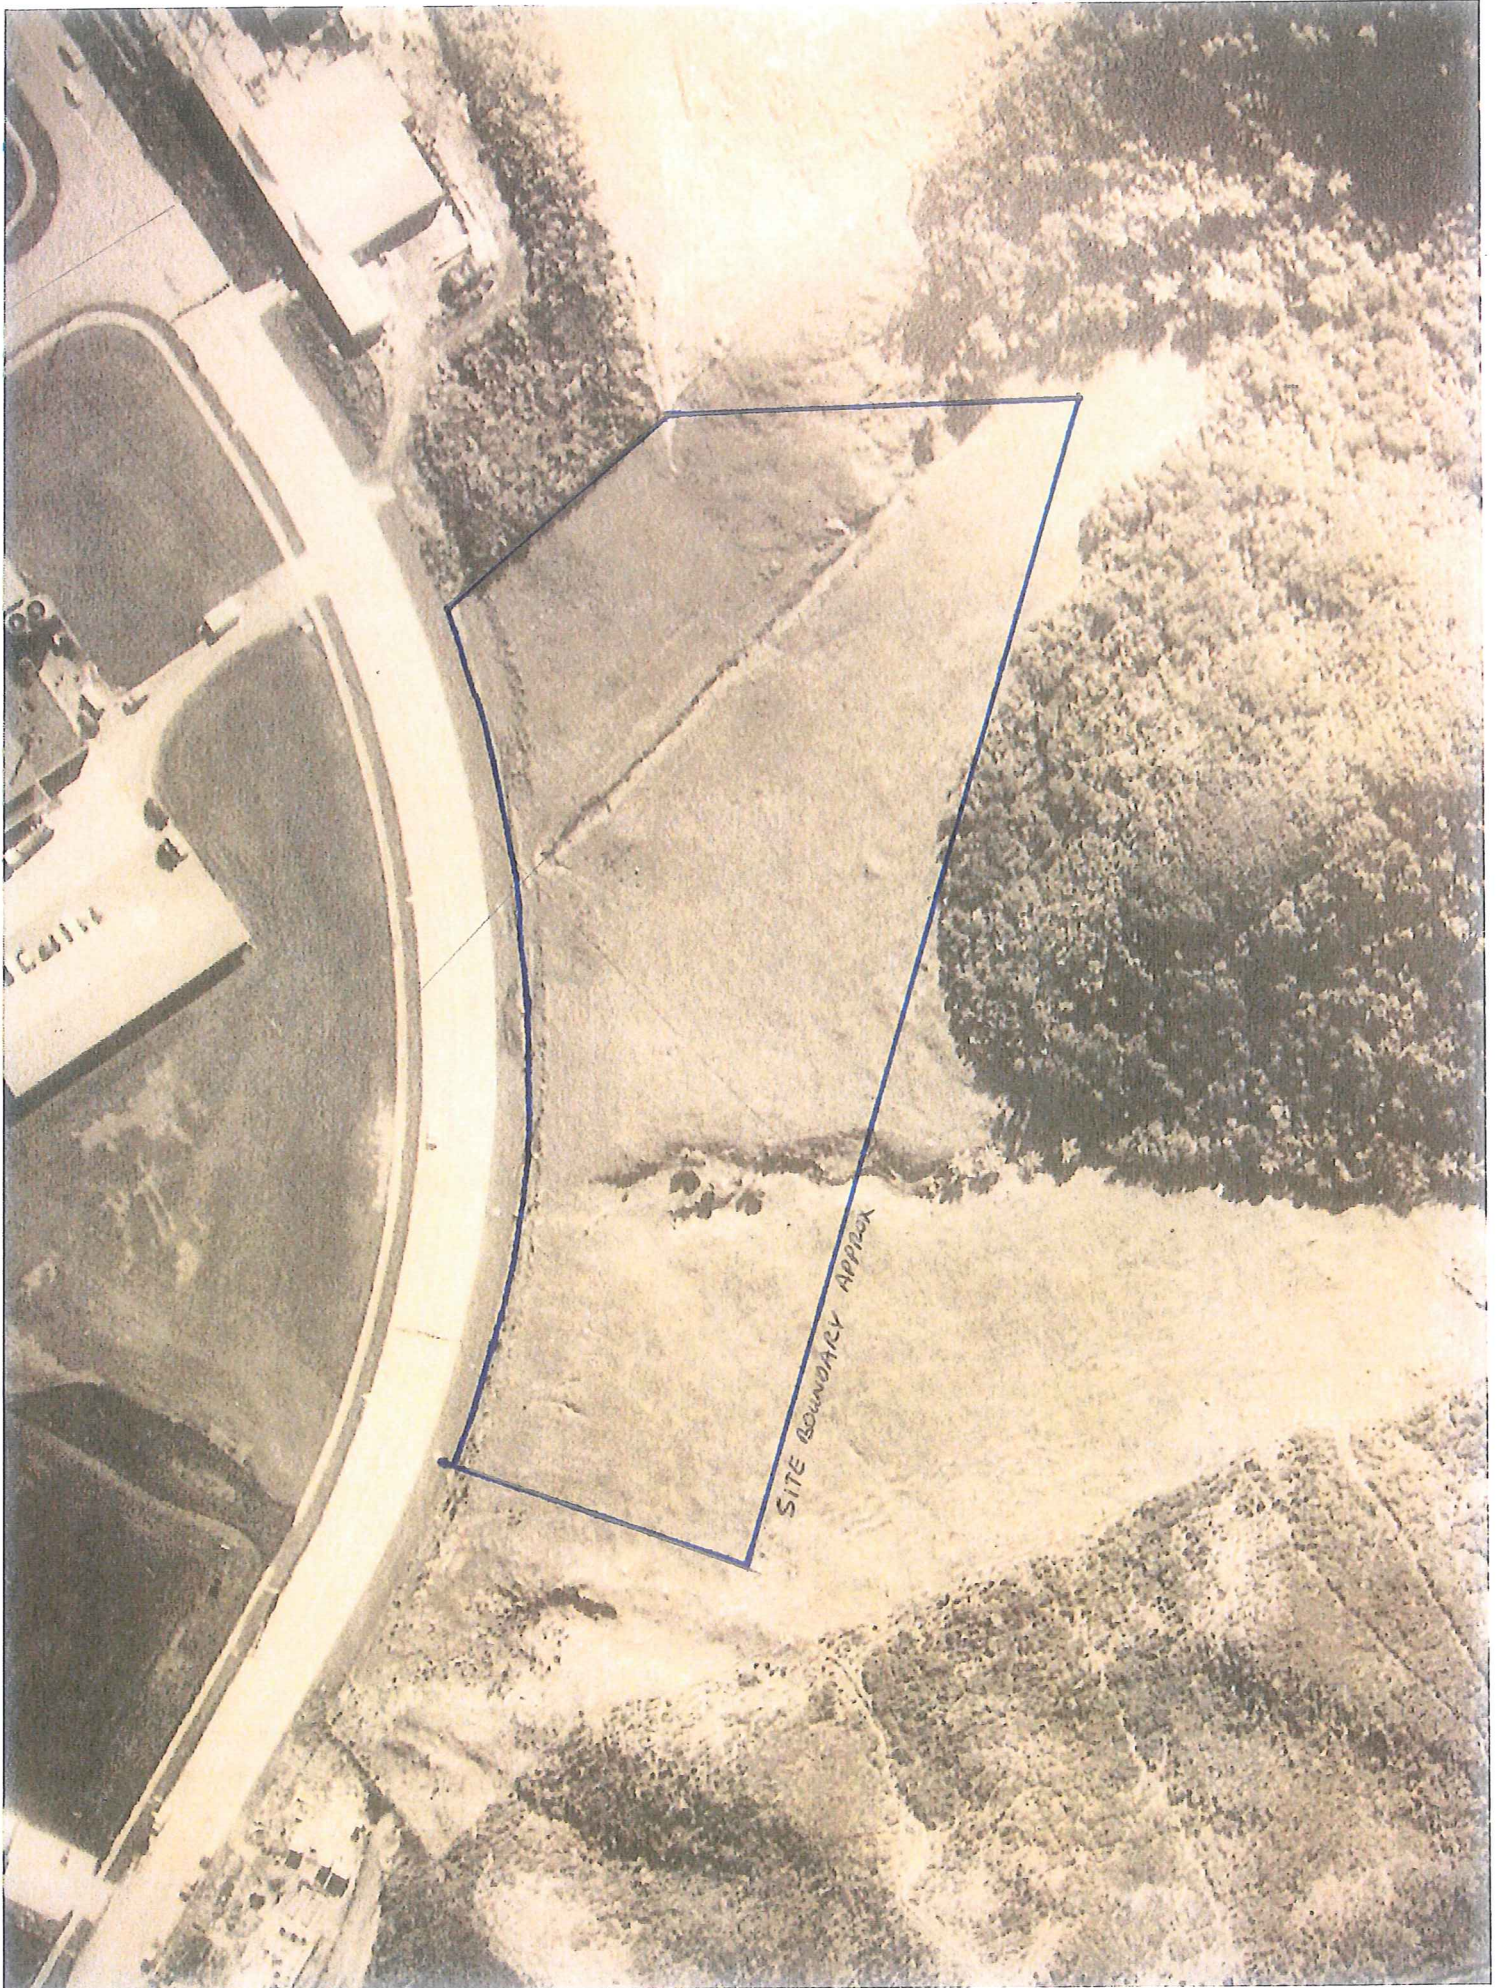
FIGURE 3

The Site is currently vegetated in grass, gorse, scrub and regenerating native bush. An old farm fence was located running alongside the southern stream gully. Historical aerial photographs indicate the Site was cleared of vegetation between 1950 and 1965, refer Figures 3 and 4.

1965 SN 2001
ID ARCH 74080

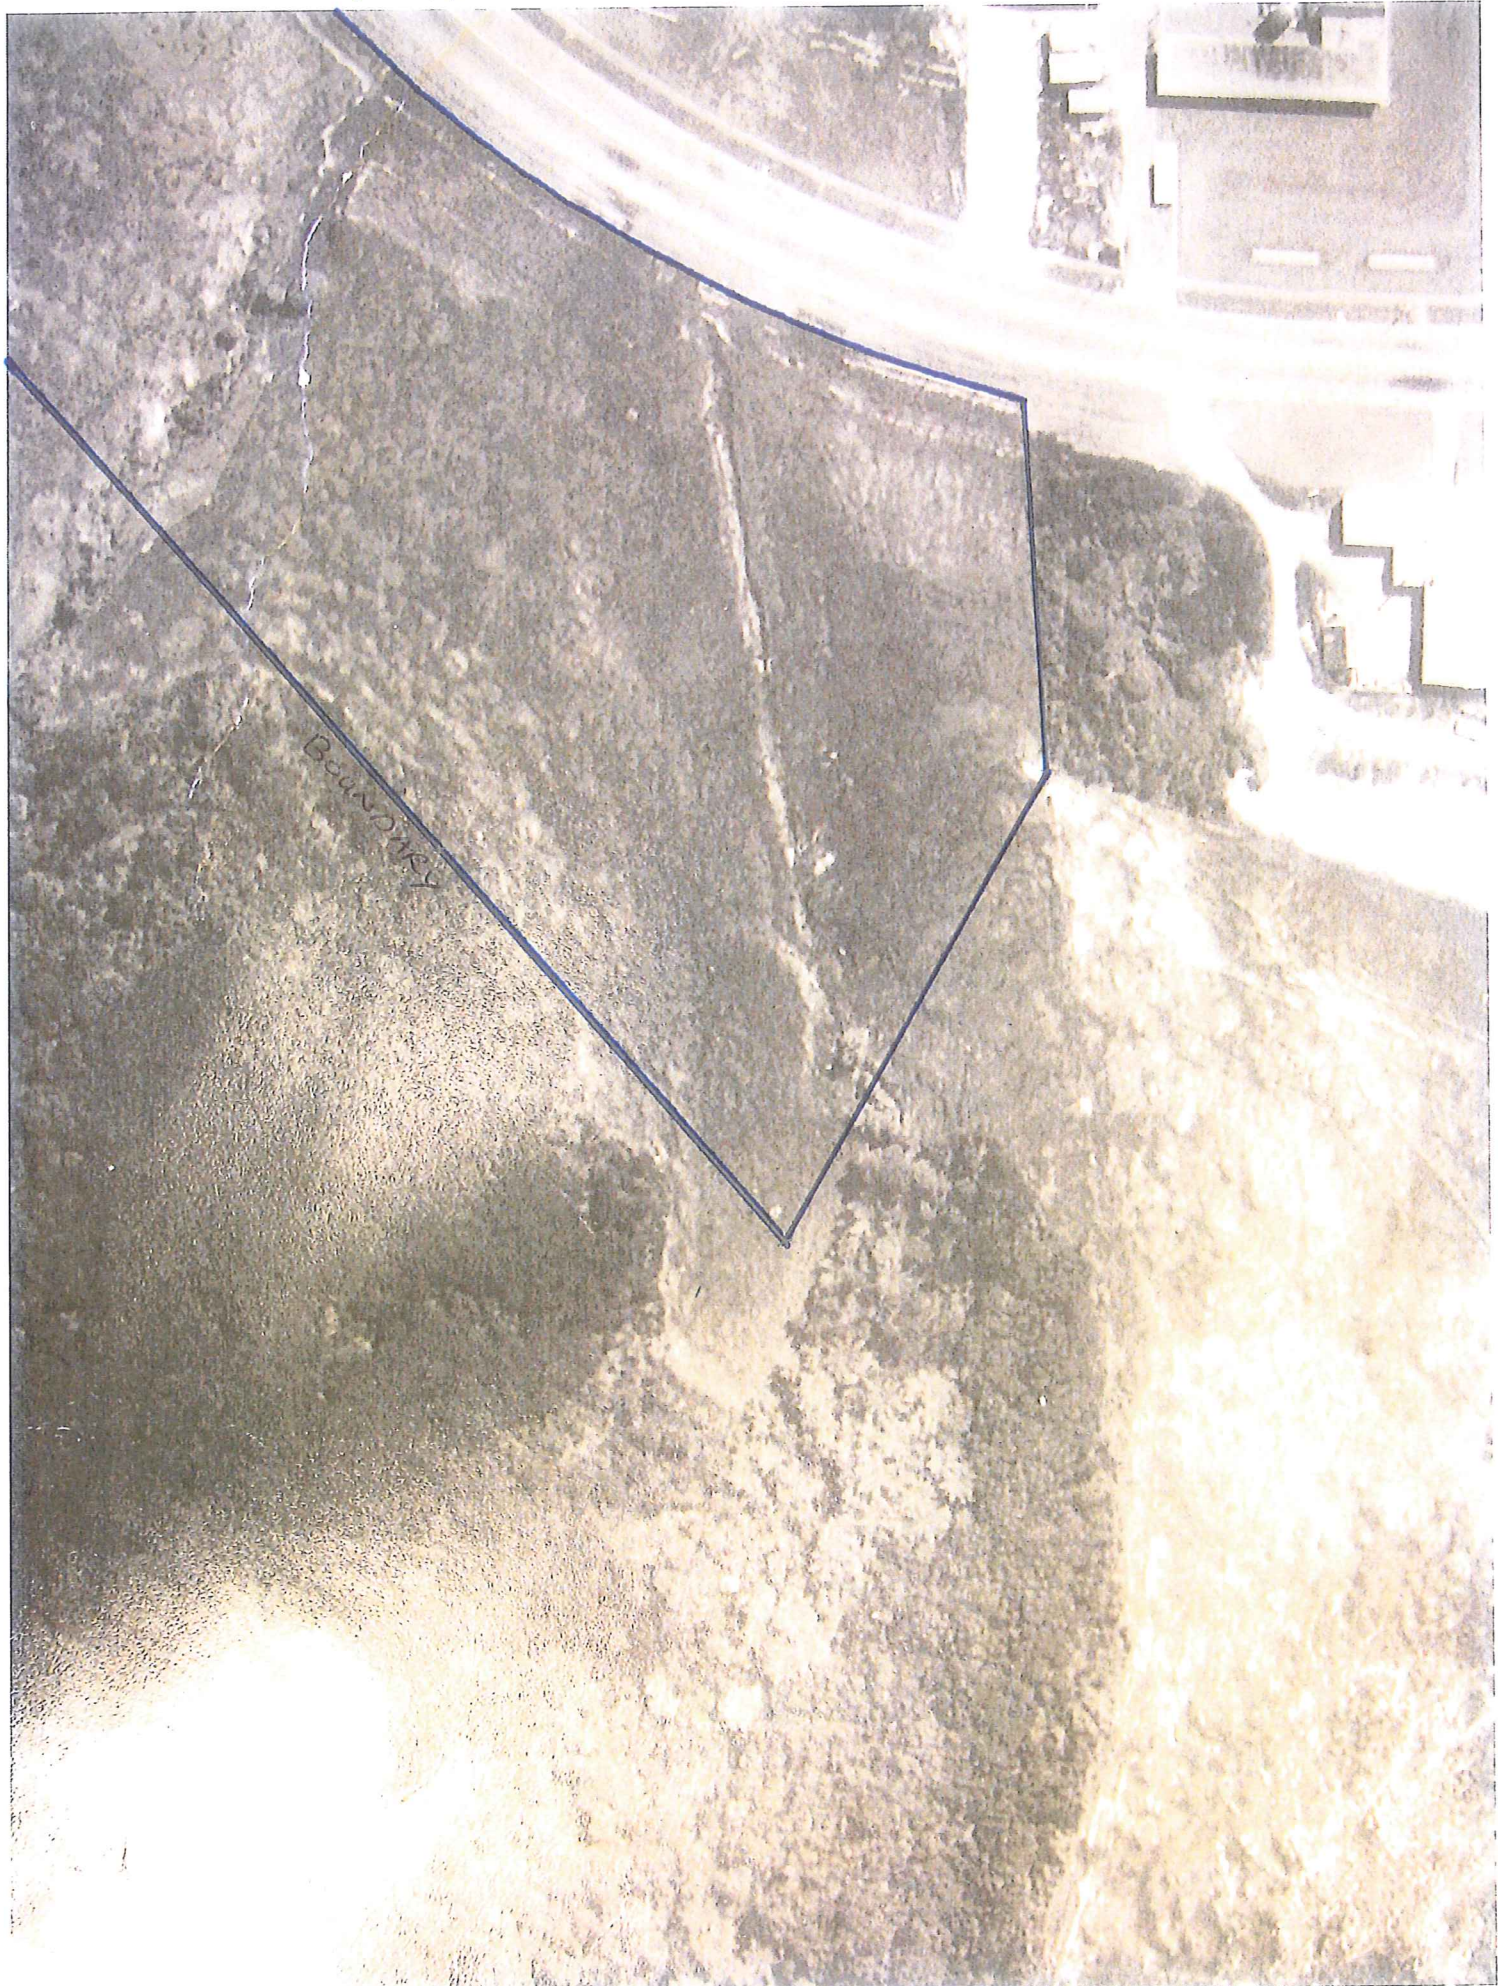
FIGURE 4

1972 SN 4847
ID ARCH 74090

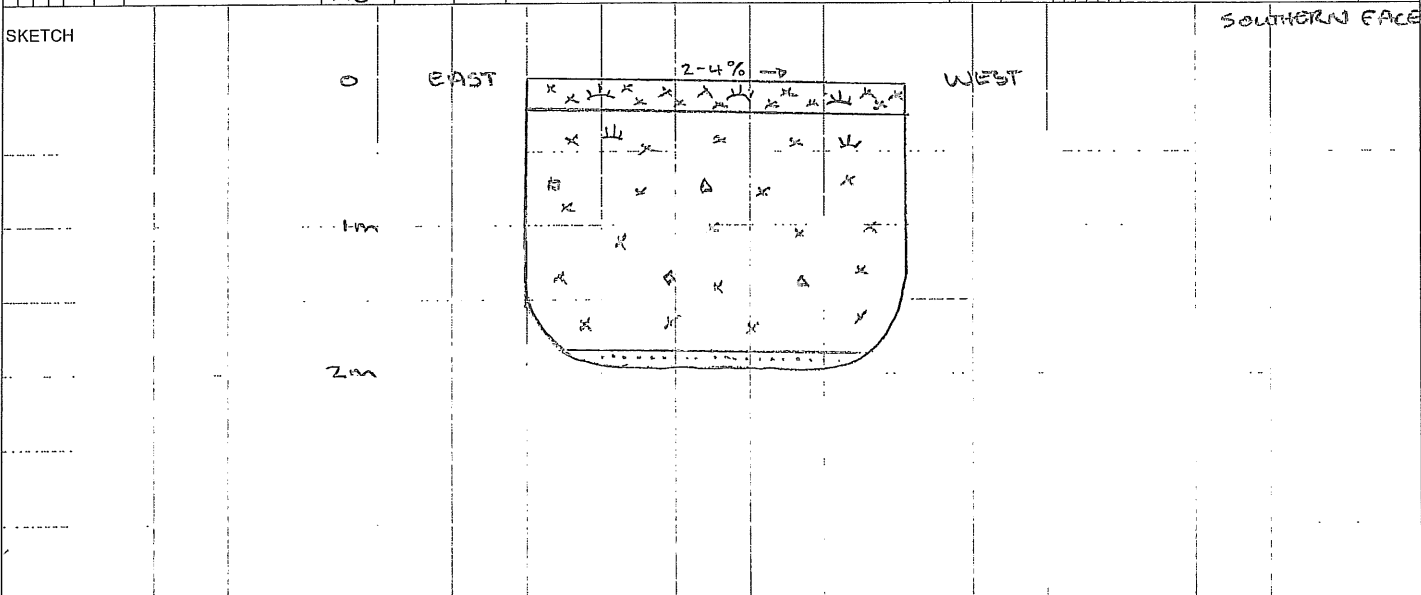
EXCAVATION NO:
TPS
SHEET 1 OF 1

EXCAVATION AND TESTS:			ENGINEERING DESCRIPTION:					GEOLOGICAL:				
PENETRATION	SUPPORT	WATER	SAMPLES, TESTS	RL (m) DEPTH (m)	GRAPHIC LOG	CLASSIFICATION SYMBOL	SOIL NAME, PLASTICITY OR PARTICLE SIZE CHARACTERISTICS, COLOUR, SECONDARY AND MINOR COMPONENTS	MOISTURE CONDITION	SHEAR STRENGTH OR RELATIVE DENSITY	ESTIMATED SHEAR STRENGTH, kPa	ORIGIN TYPE, MINERAL COMPOSITION, DEFECTS, STRUCTURE	UNIT
1 2 3							Topsoil SILT with high organic content, dark brown	D	fb		Topsoil	A
			158 kPa (P) 64 kPa (R) 152 kPa (P) 70 kPa (R)	0.5	X X X	ML	SILT with minor gravel and trace organics (fibrous) stiff, low plasticity mottled orange/grey				CW Greywacke Rock/ Residual Soil	C1
			158 kPa (P) 67 kPa (R) 149 kPa (P) 30 kPa (R)	1.0	X X X			M	VSE			
			139 kPa (P) 45 kPa (R)	1.5	X X X

2.0	X X		SAUNDSTONE blue grey, highly weathered, stony	m	Str		HW Greywacke Rock	C2
				2.5								
				3.0

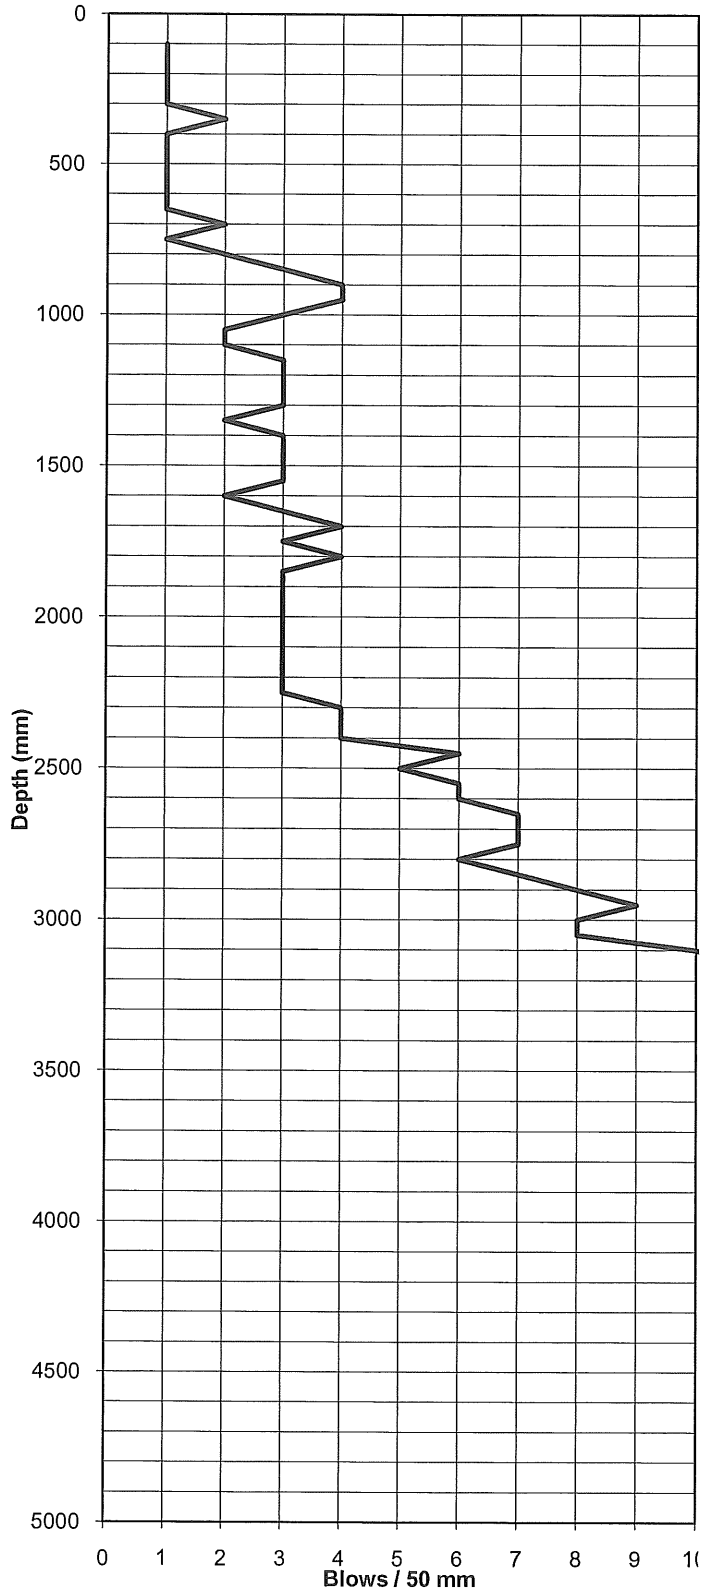
Test No.	SC-1
Sheet of	1 / 1

mm Driven	No. of Blows	mm Driven	No. of Blows
50		2550	6
100	1	2600	6
150	1	2650	7
200	1	2700	7
250	1	2750	7
300	1	2800	6
350	2	2850	7
400	1	2900	8
450	1	2950	9
500	1	3000	8
550	1	3050	8
600	1	3100	10
650	1	3150	11
700	2	3200	11
750	1	3250	
800	2	3300	Refusal
850	3	3350	
900	4	3400	
950	4	3450	
1000	3	3500	
1050	2	3550	
1100	2	3600	
1150	3	3650	
1200	3	3700	
1250	3	3750	
1300	3	3800	
1350	2	3850	
1400	3	3900	
1450	3	3950	
1500	3	4000	
1550	3	4050	
1600	2	4100	
1650	3	4150	
1700	4	4200	
1750	3	4250	
1800	4	4300	
1850	3	4350	
1900	3	4400	
1950	3	4450	
2000	3	4500	
2050	3	4550	
2100	3	4600	
2150	3	4650	
2200	3	4700	
2250	3	4750	
2300	4	4800	
2350	4	4850	
2400	4	4900	
2450	6	4950	
2500	5	5000

Test Method Used: NZS 4402:1988 Test 6.5.2 Dynamic Cone Penetrometer

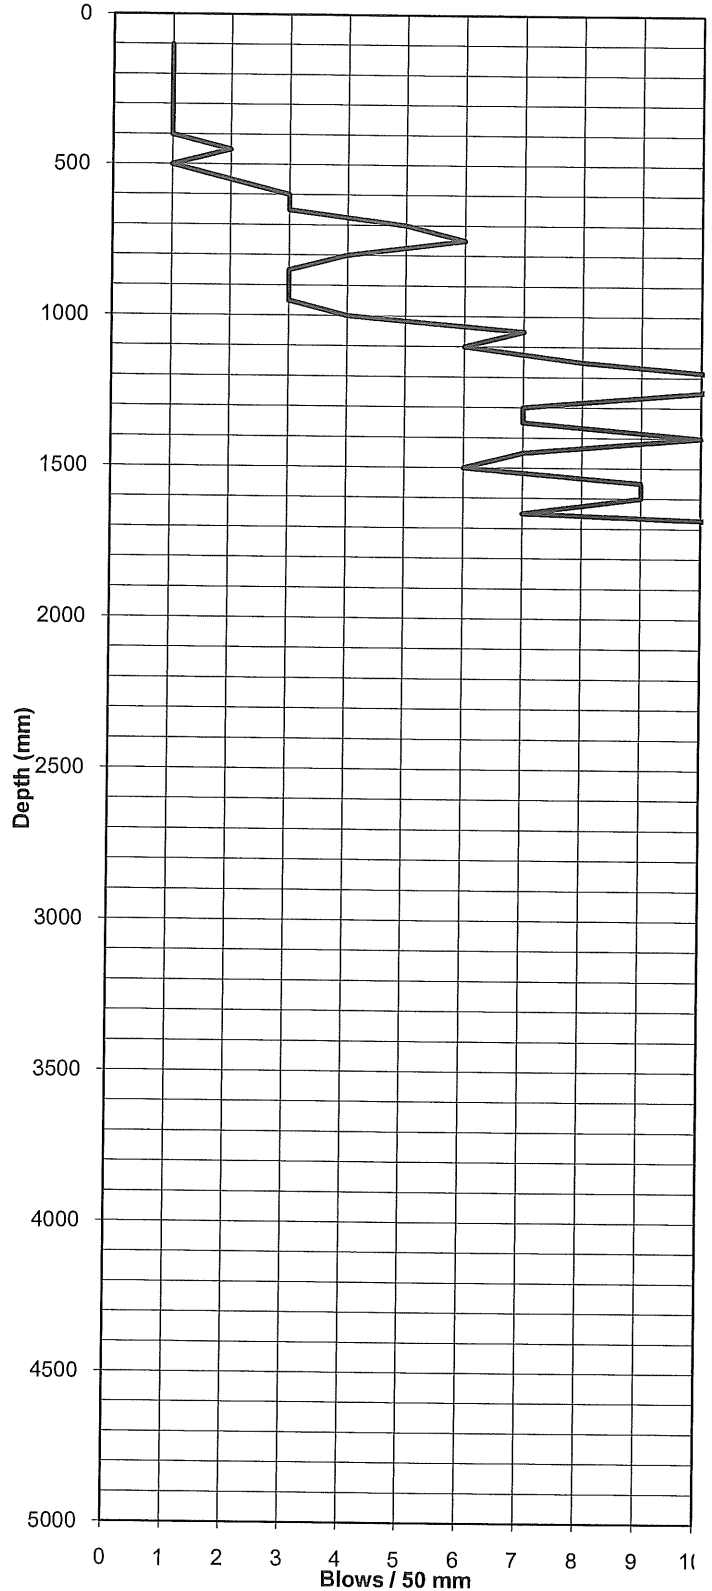
Test No.	SC-3
Sheet of	1 / 1

mm Driven	No. of Blows	mm Driven	No. of Blows
50		2550	
100	1	2600	
150	1	2650	
200	1	2700	
250	1	2750	
300	1	2800	
350	1	2850	
400	1	2900	
450	2	2950	
500	1	3000	
550	2	3050	
600	3	3100	
650	3	3150	
700	5	3200	
750	6	3250	
800	4	3300	
850	3	3350	
900	3	3400	
950	3	3450	
1000	4	3500	
1050	7	3550	
1100	6	3600	
1150	8	3650	
1200	11	3700	
1250	10	3750	
1300	7	3800	
1350	7	3850	
1400	10	3900	
1450	7	3950	
1500	6	4000	
1550	9	4050	
1600	9	4100	
1650	7	4150	
1700	14	4200	
1750		4250	
1800	Bouncing	4300	
1850		4350	
1900		4400	
1950		4450	
2000		4500	
2050		4550	
2100		4600	
2150		4650	
2200		4700	
2250		4750	
2300		4800	
2350		4850	
2400		4900	
2450		4950	
2500		5000

Test Method Used: NZS 4402:1988 Test 6.5.2 Dynamic Cone Penetrometer

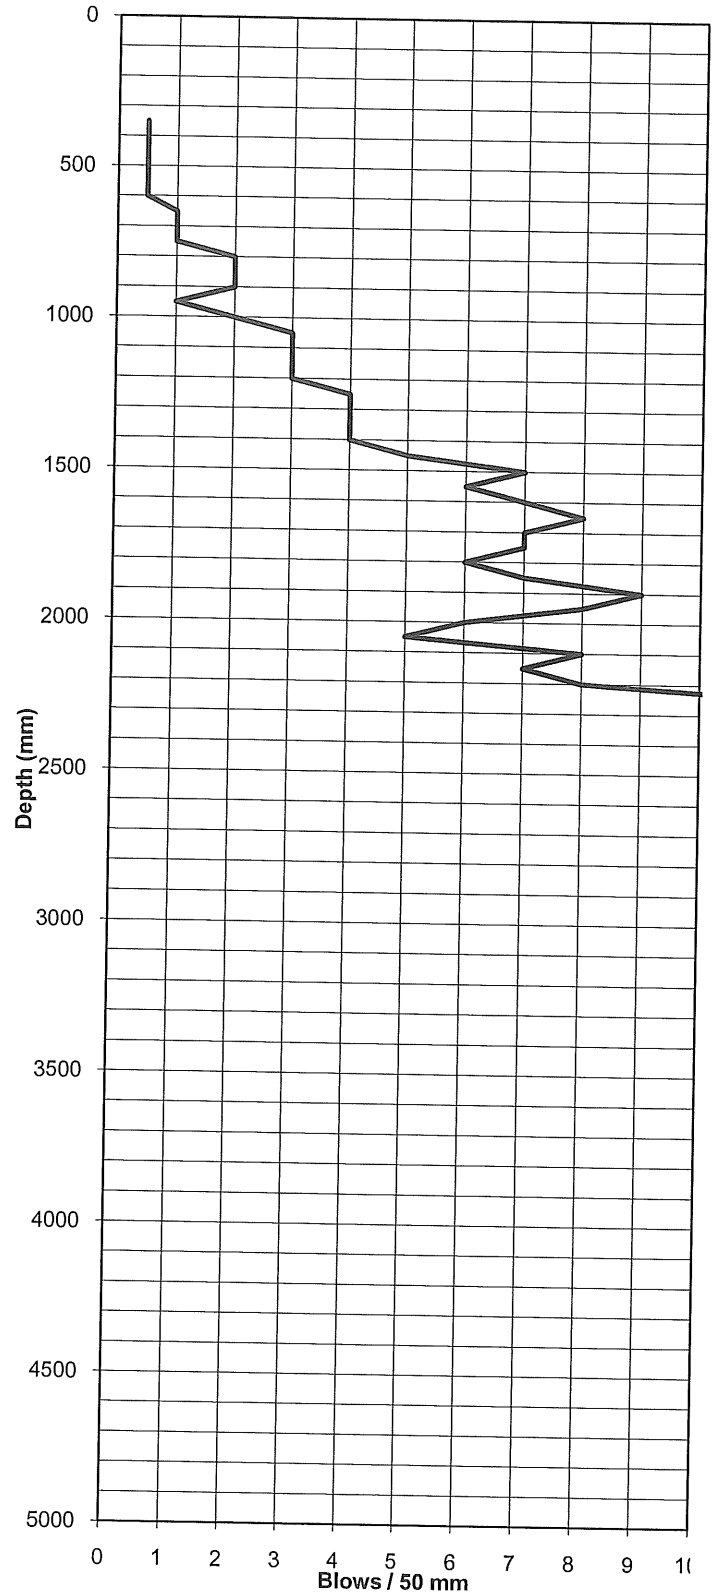
Test No.	SC-5
Sheet of	1 / 1

mm Driven	No. of Blows	mm Driven	No. of Blows
50		2550	
100		2600	
150		2650	
200		2700	
250		2750	
300	↓	2800	
350	0.5	2850	
400	0.5	2900	
450	0.5	2950	
500	0.5	3000	
550	0.5	3050	
600	0.5	3100	
650	1	3150	
700	1	3200	
750	1	3250	
800	2	3300	
850	2	3350	
900	2	3400	
950	1	3450	
1000	2	3500	
1050	3	3550	
1100	3	3600	
1150	3	3650	
1200	3	3700	
1250	4	3750	
1300	4	3800	
1350	4	3850	
1400	4	3900	
1450	5	3950	
1500	7	4000	
1550	6	4050	
1600	7	4100	
1650	8	4150	
1700	7	4200	
1750	7	4250	
1800	6	4300	
1850	7	4350	
1900	9	4400	
1950	8	4450	
2000	6	4500	
2050	5	4550	
2100	8	4600	
2150	7	4650	
2200	8	4700	
2250	12	4750	
2300	12	4800	
2350	Refusal	4850	
2400		4900	
2450		4950	
2500		5000

Test Method Used: NZS 4402:1988 Test 6.5.2 Dynamic Cone Penetrometer
