**Petone Memorial Park Changing Rooms and Offices
28 Bracken Street, Petone**

Initial Seismic Assessment

**for
Hutt City Council**

**Initial Seismic Assessment Report
Petone Memorial Park Changing Rooms and Offices, 28 Bracken Street, Petone**

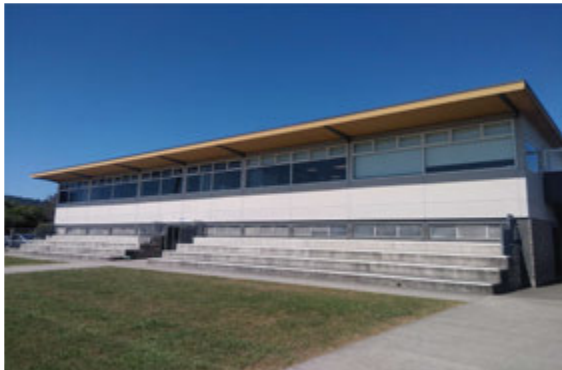
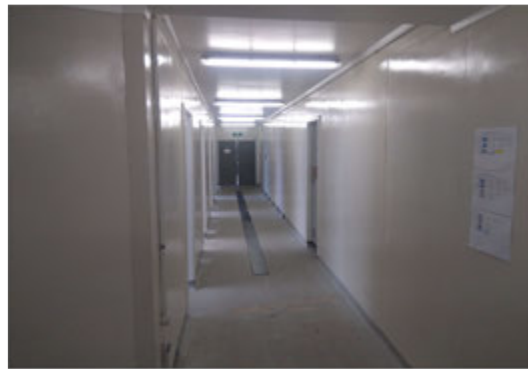
1.1 Photos (attach sufficient to describe building)

The building was originally constructed in 1961 as a pavilion with grandstand on top of changing rooms and toilets.

Major alterations and strengthening were carried out in 2005. This involved removing the grandstand seating (and replacing with precast concrete bleachers in front of the building from ground level), building offices above the changing rooms and toilets, and strengthening the existing lower level.

The building is two storeys with a light roof. The lower floor of the building is constructed with reinforced masonry walls external walls and timber framed internal walls. It has a series of structural steel braces in the longitudinal direction, and plywood and shotcrete shear walls in the transverse direction. The top level is made up of timber framing with universal steel beams supporting the roof structure.
