13 June 2018

Hutt City Council
Private Bag 31912
Lower Hutt

**Initial Seismic Assessment Report
Wainuiomata Summer Pool - 99 Main Road, Wainuiomata**

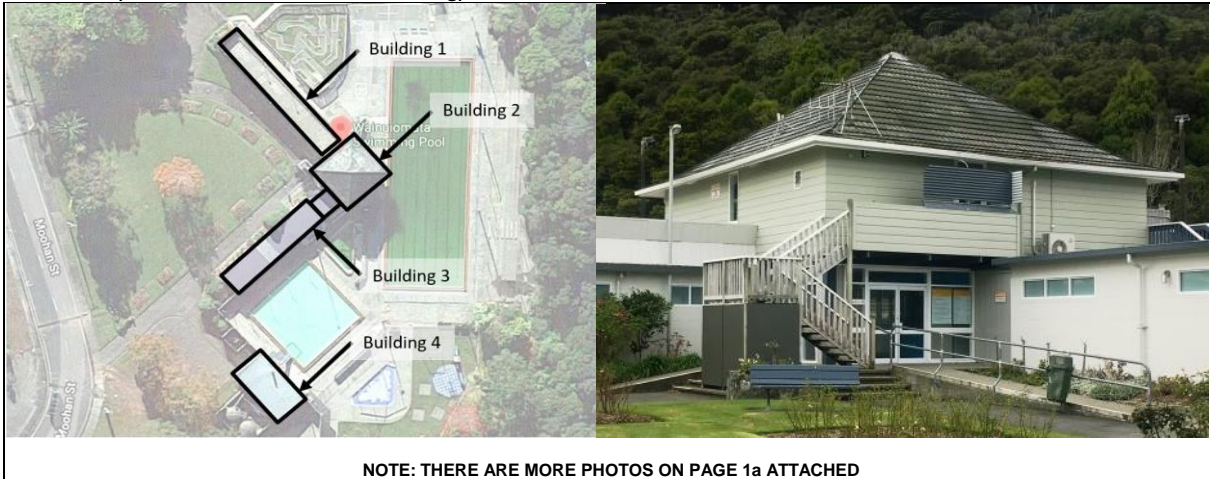
1.1 Photos (attach sufficient to describe building)

Built in 1970. The upstairs is an open plan meeting room with a balcony along two sides. The downstairs is a foyer, ticketing booth and toilet. 9.7m square floor plan upstairs with a 1 m wide cantilever balcony along two sides, and 8.4m square floor plan downstairs. The balcony provides access to the balcony on building 1. Two steel portal frames crossing in the centre. Upstairs floor level is 3m, eaves height is 5.3m and the apex is at 8.8m. Shallow reinforced concrete perimeter foundation wall with strip footings for the ground floor slab, and 1.4m by 1.4m by 0.3m square pads for the portal legs. Foundations are shown to be 1.4m deep but noted as 'excavate to solid'. Portal legs are 10"x10"x1/2" RHS and the Rafters are 10"x5 3/4"x 25lb UB. The Eaves tie is 5" x 3" x 1/4" RHS. The upstairs flooring is particle board with hard wood fillets on 250x50 joists at 450 crs. Joists are supported on 16"x7"x36lb UB bearers at 3.3m crs each way. Bearers are supported on 18"x6"x45lb beams around the perimeter forming a steel frame. Balusters are 3 1/2" by 3 1/2" RHS.
