Initial Seismic Assessment Report: The Pavilion - 25 Laings Rd Lower Hutt

Initial Evaluation Procedure (IEP) Assessment - Completed for Urban Plus

THE PAVILION, Laings Rd
Initial Seismic Assessment

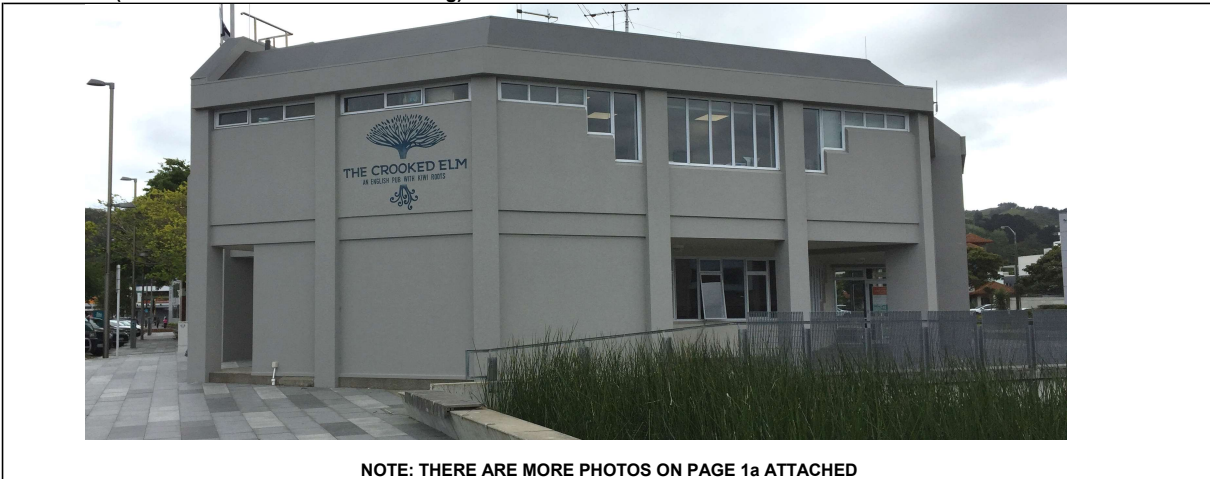
1.1 Photos (attach sufficient to describe building)

The building is two storey with four bracing lines that pass through the centre of the building. These radial bracing lines are at 45 degrees to one another. Lateral support to the Level1 Floor is provided by two steel portal frames on each radial bracing line, and seven additional steel portal frames around the perimeter . Lateral support to the Level2 Roof is provided by concrete encased cantilever steel columns. These are 530UB92 or 310UB46. Concentric bracing line portals consist of 530UB92 legs and 460UB82 composite steel and concrete beams. Perimeter portals consist of 310UB46 portal legs and beams.

The main roof is butynol and 12mm ply on steel framing in the middle and on timber framing around the perimeter. The main roof is 2° in the middle and 45° around the perimeter. There is a poptop roof in the centre. The trusses are comprised of rolled steel angles and there are eight primary trusses and fifteen secondary trusses.
