Initial Evaluation Procedure (IEP) Assessment - Completed for Hutt City Council

Street Number & Name:	9-11 Myrtle Street	Job No.:	5-C3957.00
AKA:		By:	GSF
Name of building:	Hutt Art Society	Date:	10/12/2019
City:	Hutt City Central	Revision No.:	0

Table IEP-1 Initial Evaluation Procedure Step 1

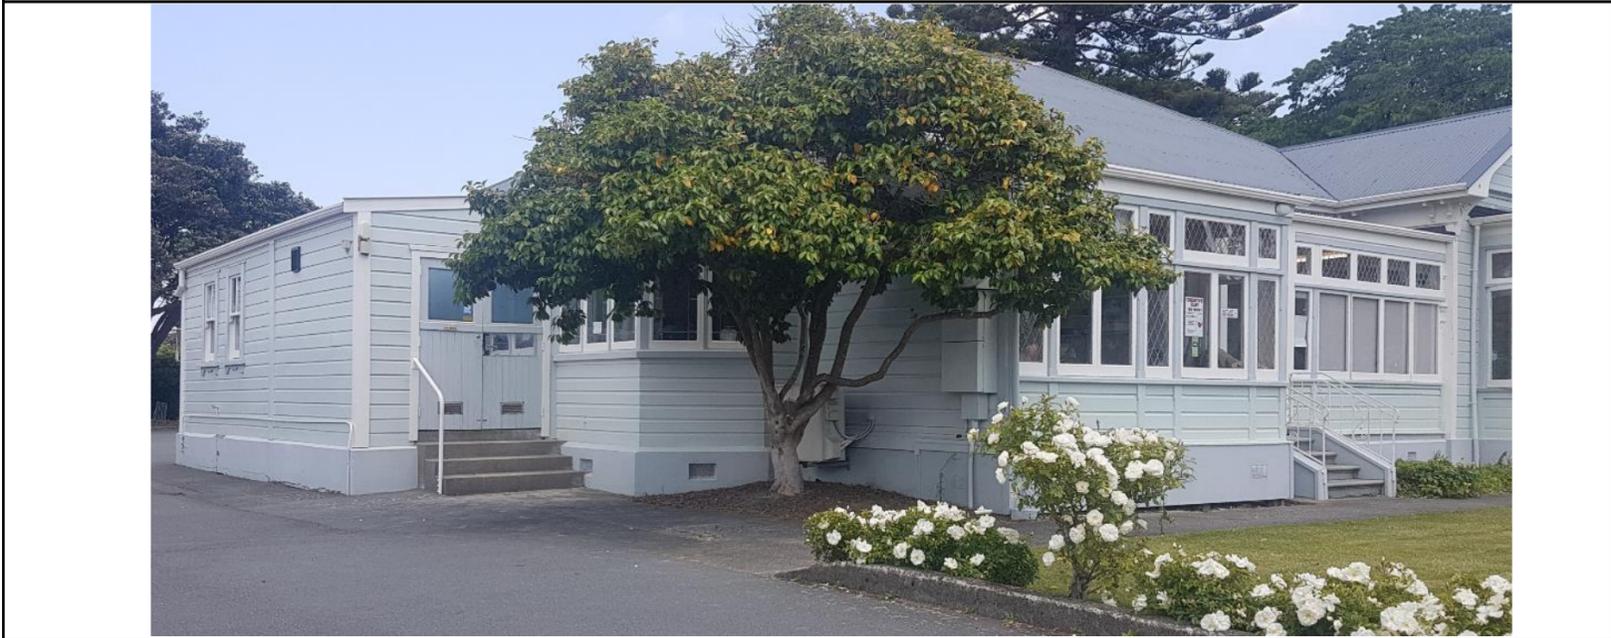
1.1 Photos (attach sufficient to describe building)

Structure: Timber framed with lined walls and weatherboard cladding
 Foundations: Concrete foundation walls and concrete piles - re-plied
 Roof: Timber truss with lightweight cladding
 Subsoil: D soft or deep soils - NZS1170.5:2004 Site Subsoil Classification of Lower Hutt
 Construction Date: 1920s

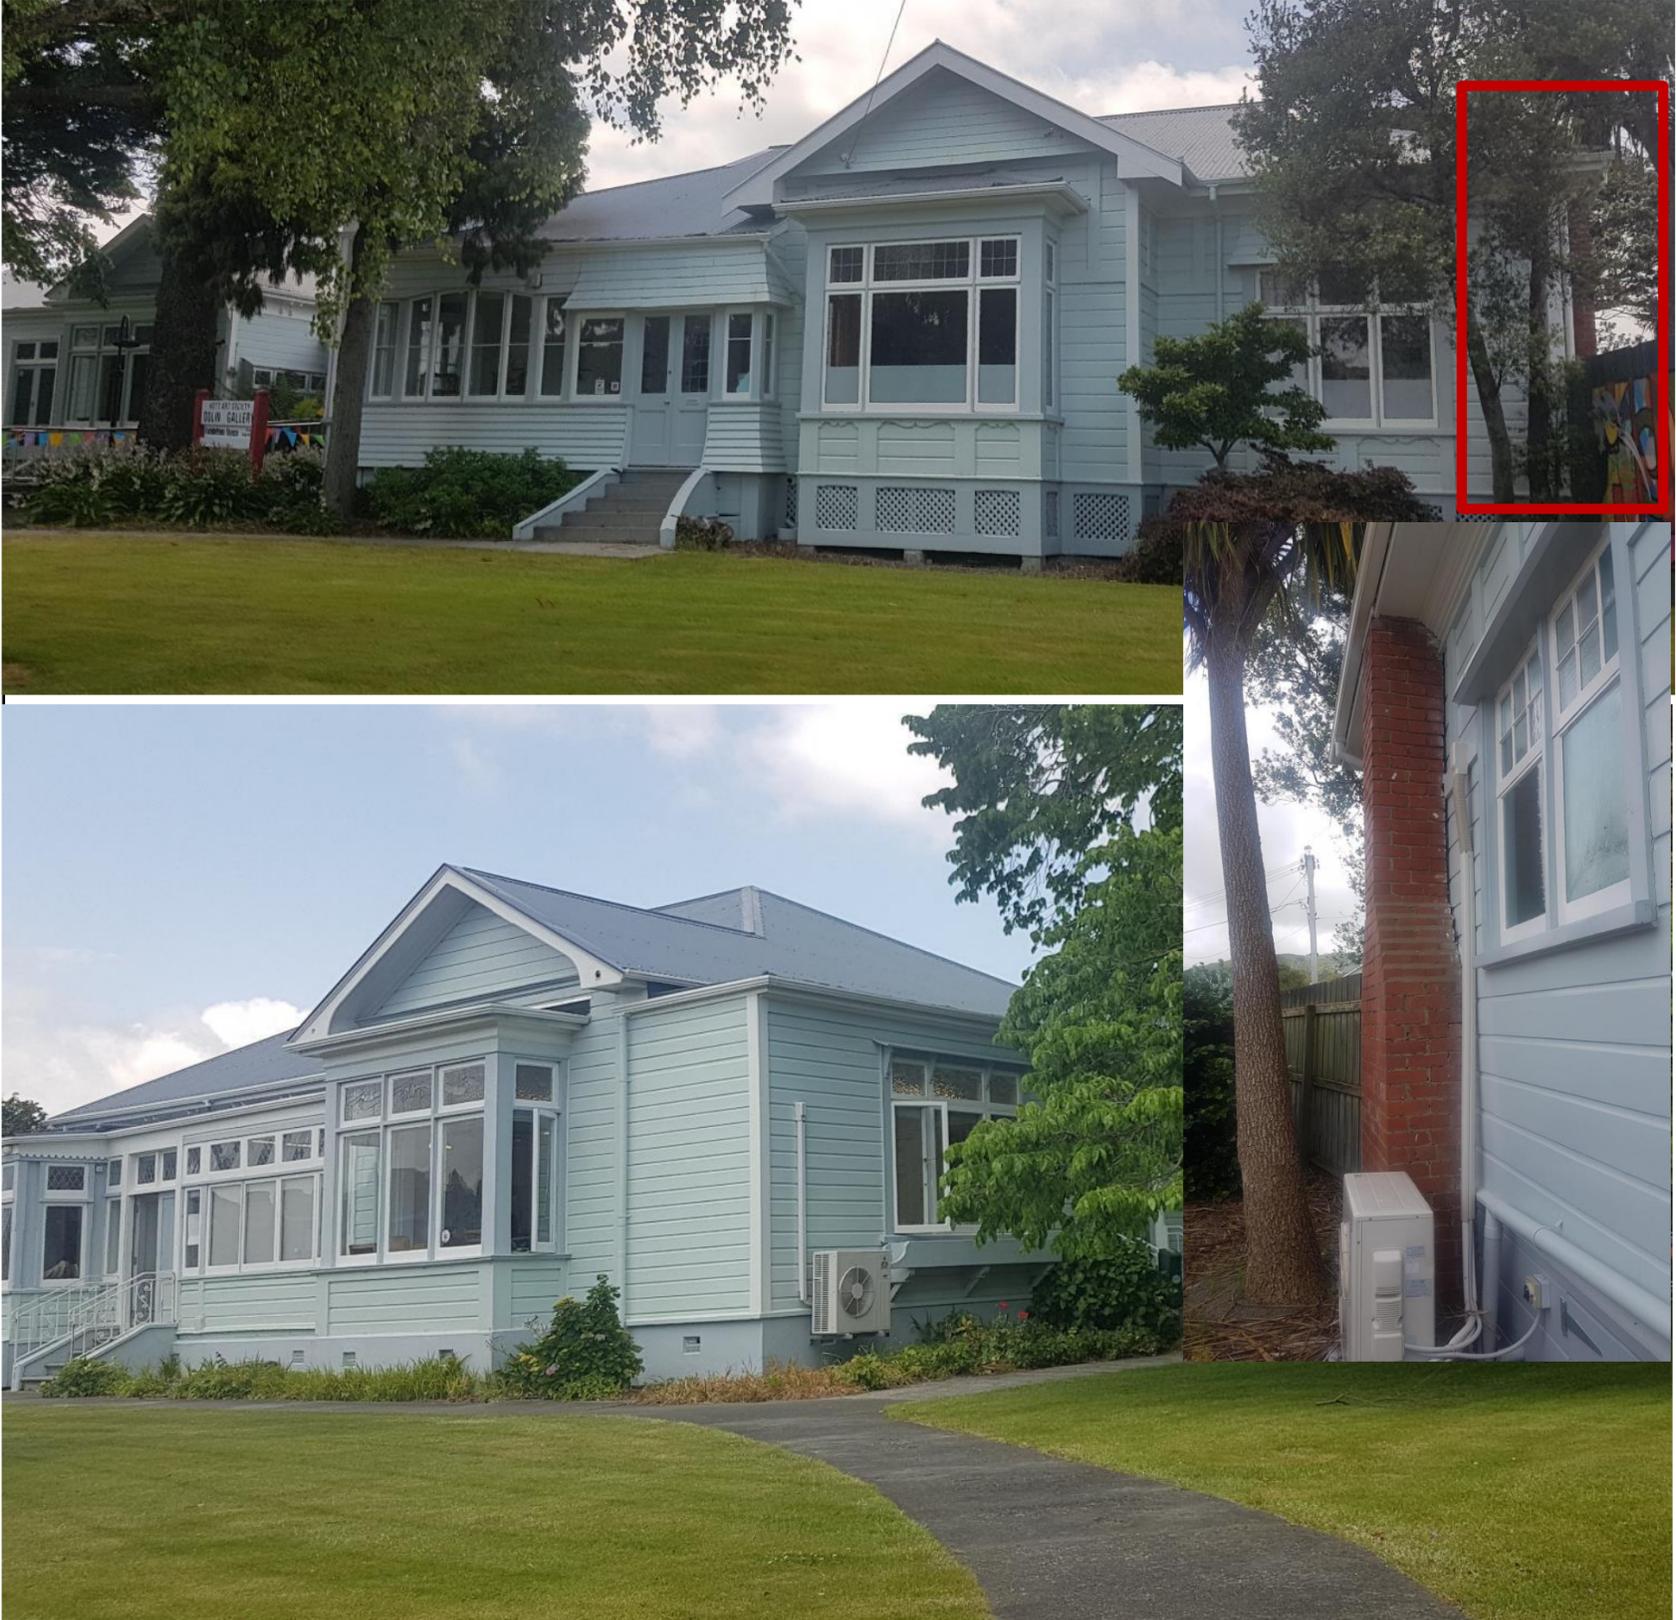
Table IEP-1a Additional Photos and Sketches

Comment: Potentially EQ Prone - recommend removal of the chimney as marked
The area potentially impacted by the chimney is outside of the building and a generally unoccupied zone
Building overall rated 55%IL2

Comment on the nature of Secondary Structural and Non-structural elements/ parts identified and assessed		
Describe the Governing Critical Structural Weakness		
If the results of this DSA are being used for earthquake prone decision purposes, <u>and</u> elements rating <34%NBS have been identified (including Parts) ³ :	Engineering Statement of Structural Weaknesses and Location	Mode of Failure and Physical Consequence Statement(s)
Recommendations (optional for EPB purposes)	Overall building rated 55%IL2 – recommend removal of the chimney
