Noise monitoring results July 2020

This letter report presents the results of the recent noise monitoring at Wainuiomata Cleanfill site. Monitoring is undertaken on a 3-monthly basis to fulfil Condition 16 of resource consent RM190050. Noise limits for the cleanfill are contained in Condition 12 and reproduced below for reference:

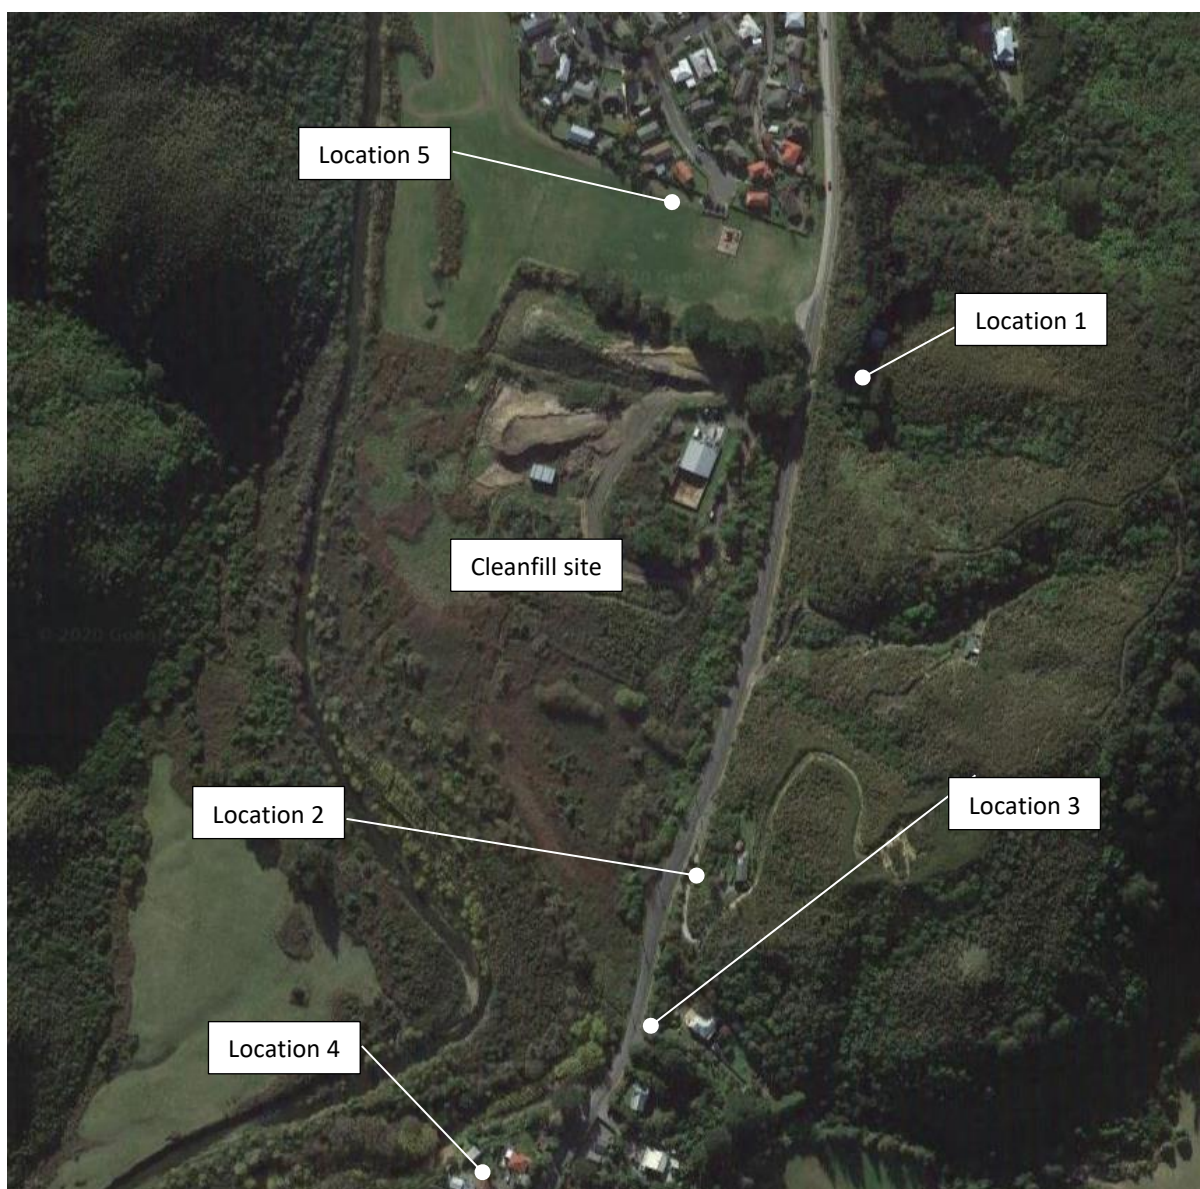
Figure 2.1: Noise monitoring locations

Noise monitoring locations are shown in **Figure 2.1** and listed in **Table 2.2**. Photos from the locations of monitoring are attached in **Appendix A**. Condition 12 states that the noise limit applies at the notional boundary. For ease of access noise levels were measured slightly closer to the cleanfill site at locations 2 and 5. This would result in marginally higher sound levels from cleanfill activities.

Monitoring location	Description	Comment
Location 1	Within property of 119 Coast Road	At the notional boundary
Location 2	Entrance to 199 Coast Road	c6 m closer to the site than the notional boundary location
Location 3	Within property of 200 Coast Road	At the notional boundary
Location 4	Within property of 204 Coast Road	At the notional boundary
Location 5	Ngaturi Park	c5 m closer to the site than the notional boundary location

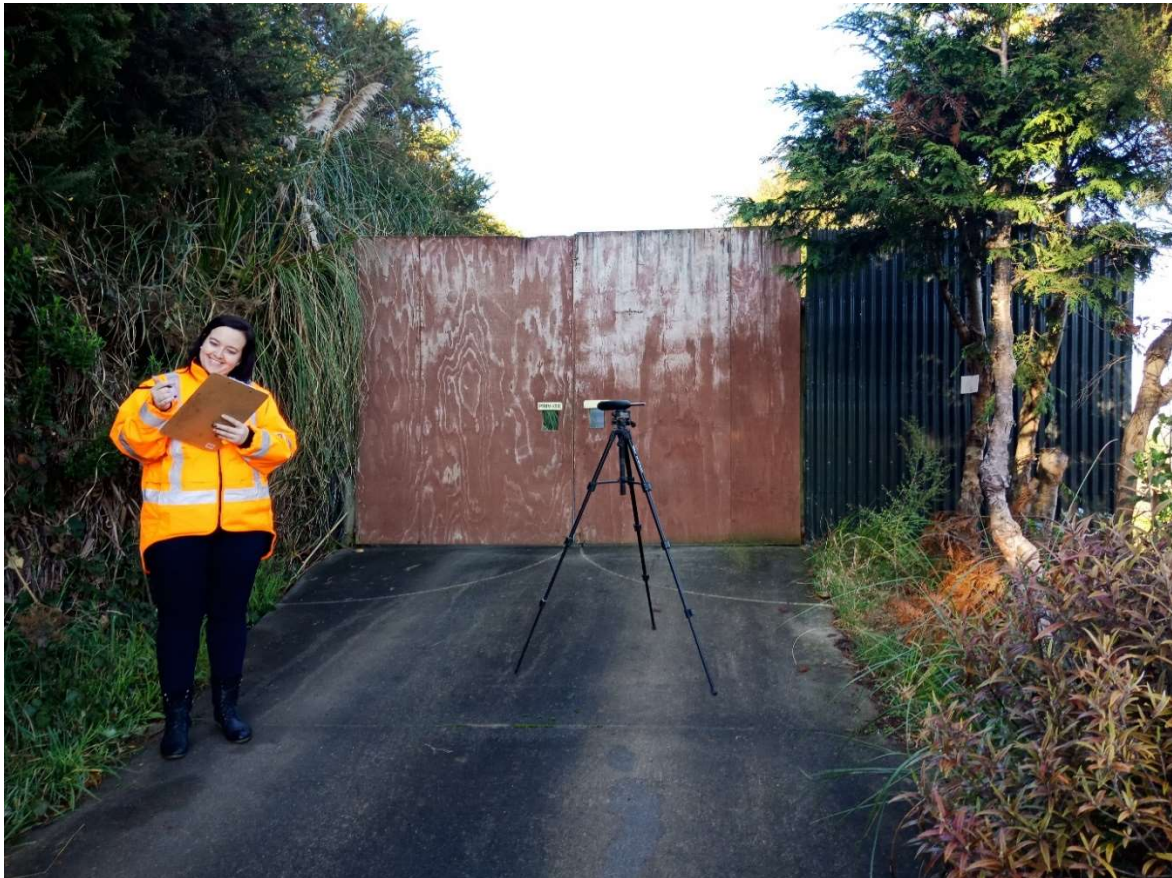
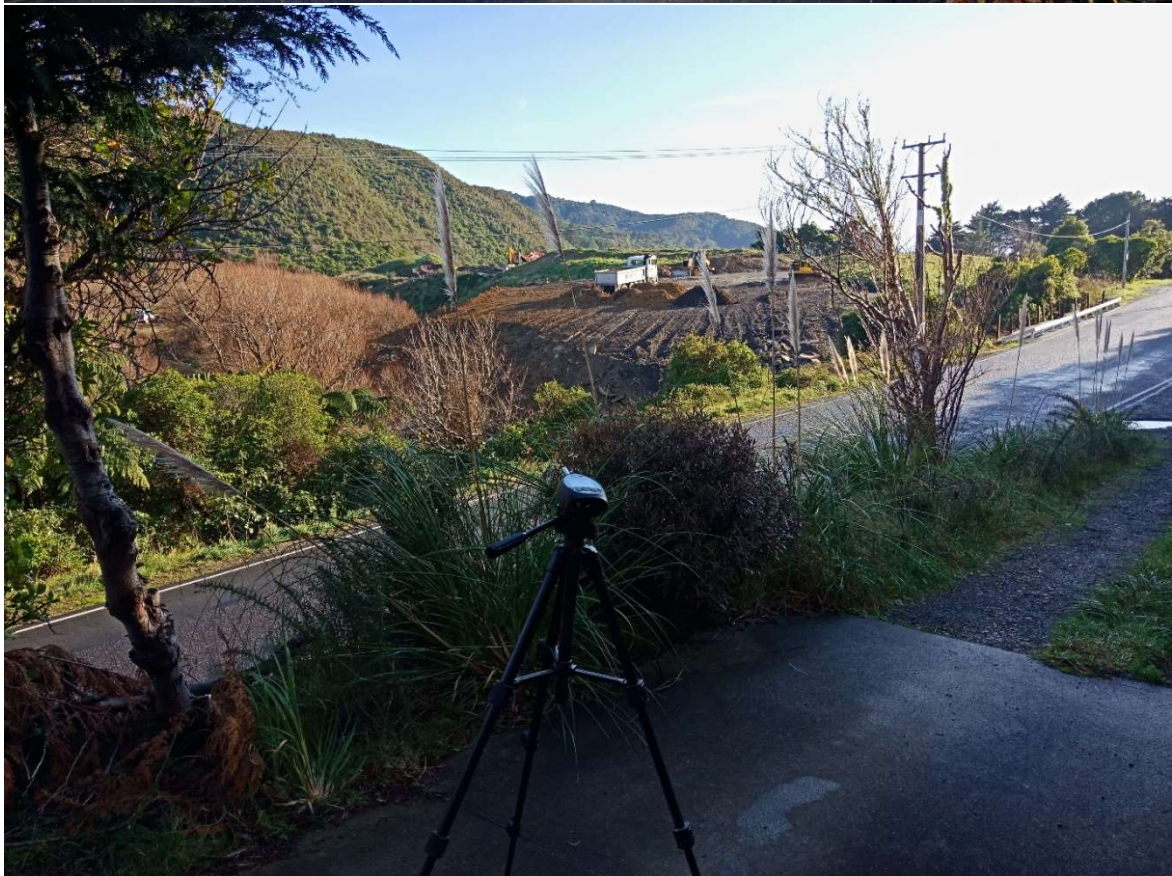
Location 2
Recording 2:

At location 2 vehicle pass-bys could easily be removed from the first measurement, giving a residual LAeq of 50 dB. This is compliant with the consent conditions. Vehicle pass-bys could not easily be removed from the second measurement.

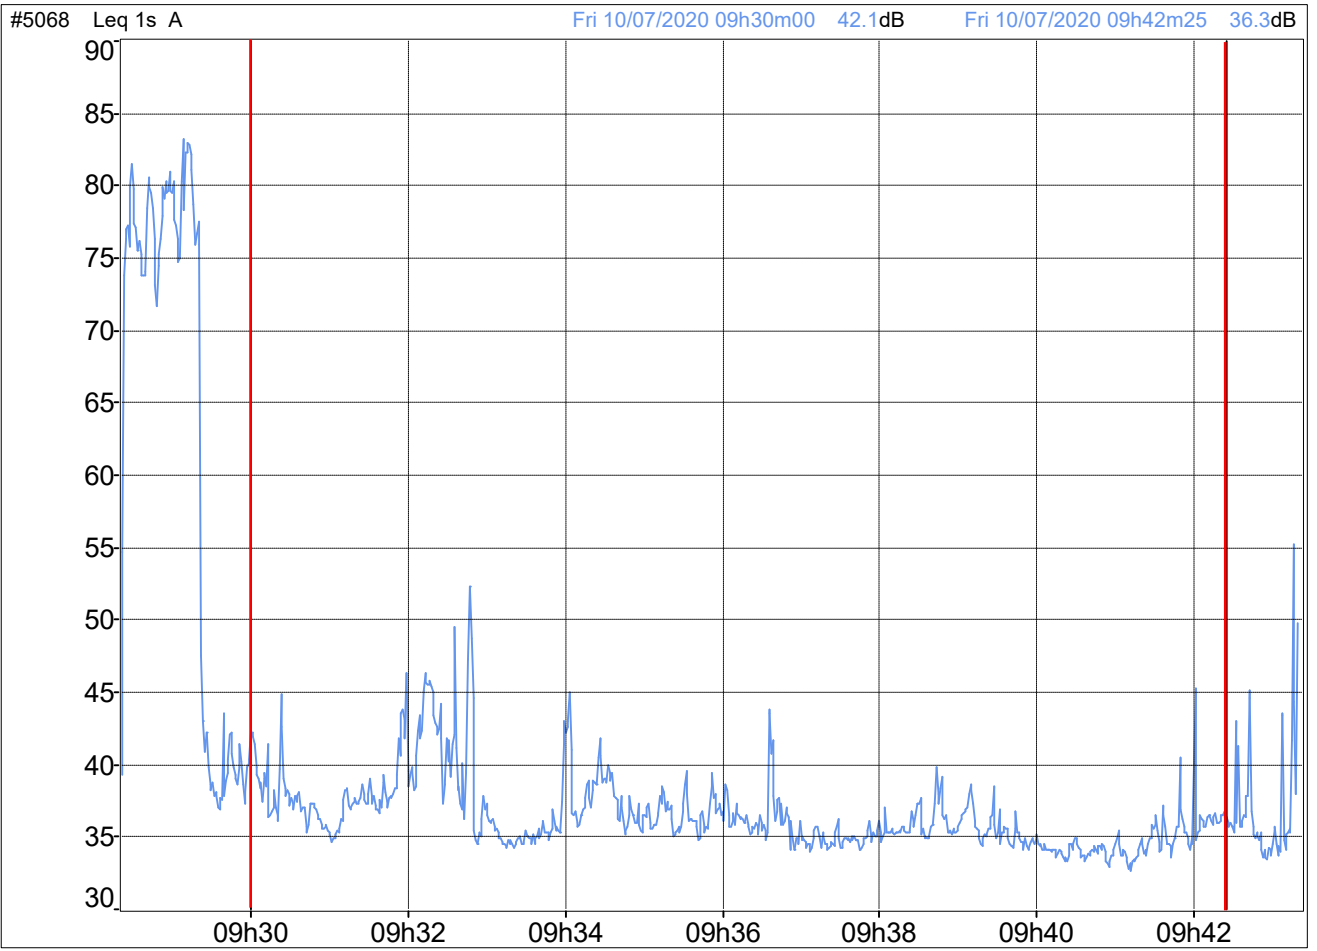
Location 1,
Recording 1

Location	Time	LAeq(t)	LAmaz	LA90	LA10	Construction equipment operating & other sources of sound heard at measurement
Location 1	9:30-9:45	38	52	34	39	Cleanfill excavator with a break in activity at some point during recording. Sporadic bird noise and some constant light construction noise.
Location 1	11:42-11:57	43	56	36	46	Excavator operational, dump truck tipping, sounds of dozer truck. Motorcycle noises in the park and an airplane.
Location 2	9:58-10:13	61	80	42	63	Dump truck operational, excavator and front-end loader running. Vehicles passing and some bird noise.
Location 2	11:59-12:14	66	87	46	66	Dozer running, truck dumping. Passing vehicles, scaffolding unpacking next to the road, construction rubble tipped, motorcycle in park/road.
Location 3	10:58-11:13	58	75	42	62	Excavator operational, activity stopped periodically. Active flowing river, vehicles passing, airplane passing, some birds, trucks passing.

The measured LAeq levels at locations 1 and 5 were below the limit of 50 dB LAeq specified in the consent during both recording periods. However, the LAeq noise levels at locations 2, 3, and 4 were above the limit during both recording periods at each location.

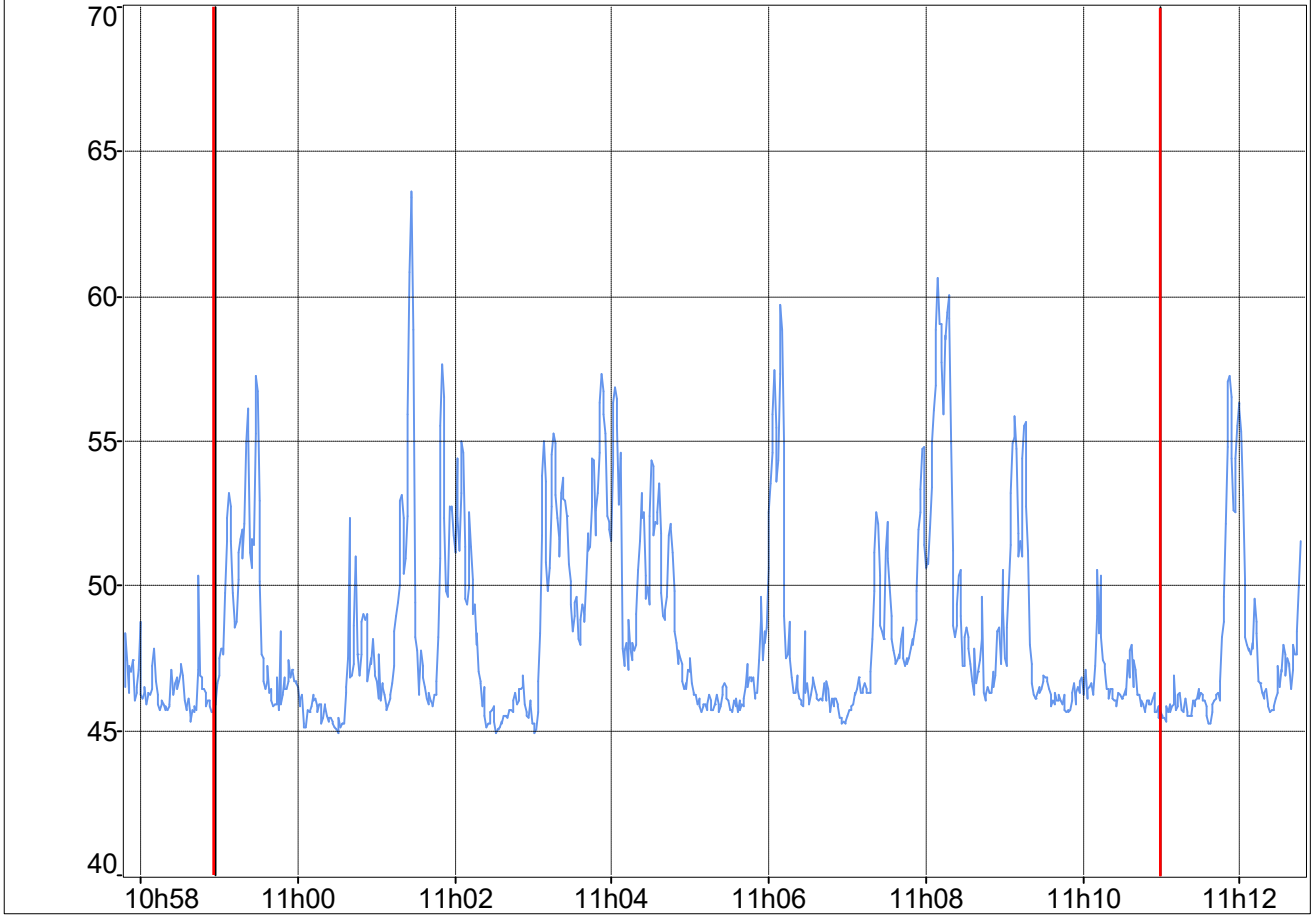
Location 4,
Recording 4

Location 3	12:39-12:54	54	72	41	57	No activity at clean fill. Road noise, flowing river, airplane, some cutting noise.
Location 4	10:33-10:58	51	64	46	54	Excavator and dump truck operational. Dump truck makes 3-4 loud bangs to remove fill. River flowing, some construction noise, vehicles passing.
Location 4	12:20-12:35	54	72	47	56	Dump truck tipping. River, birds, road noise, motorcycle, construction noise.
Location 5	11:17-11:32	48	60	36	51	Visuals obstructed to site, dump trucks entering and leaving site, no other ops noise observed. Motorcycles, birds, truck on road, kids playing golf in the park, dog barking, construction noise, vehicles passing.
Location 5	12:59-13:14	49	65	38	52	Playing of drums, kids in the park playing, vehicles on the road, motorcycle, airplane, music playing.

At location 4 vehicle pass-bys could be removed from the first measurement, giving a residual LAeq of 47 dB which is compliant. It was more difficult to distinguish pass-bys from the time trace of the second measurement.
