# Site Suitability for Onsite Stormwater Disposal Report

Ref: 29909

Revision A – October 2021

## **PRELIMINARY INVESTIGATIONS RELATING TO POSSIBLE DEVELOPMENT OF LAND AT BOULCOTT FARM HERITAGE GOLF CLUB**

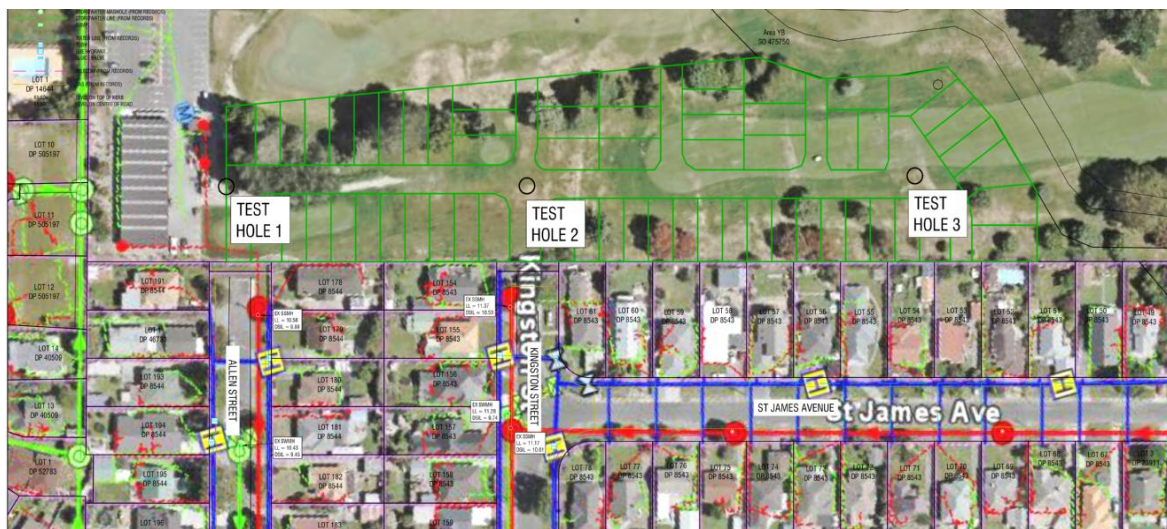
Image 1 – Approximate test pit locations

The additional investigations comprised three new percolation tests being undertaken, in the areas indicated in Image 1 below and in Appendix A. These tests were taken to have a further understanding of suitability for the possible future development to utilise on-site soakage as its primary method of stormwater control.

The test pits were dug by the golf club groundskeepers at various sizes. The test pits were to depths between 1.4m to 2.0m deep depending at what depth free draining material was observed.

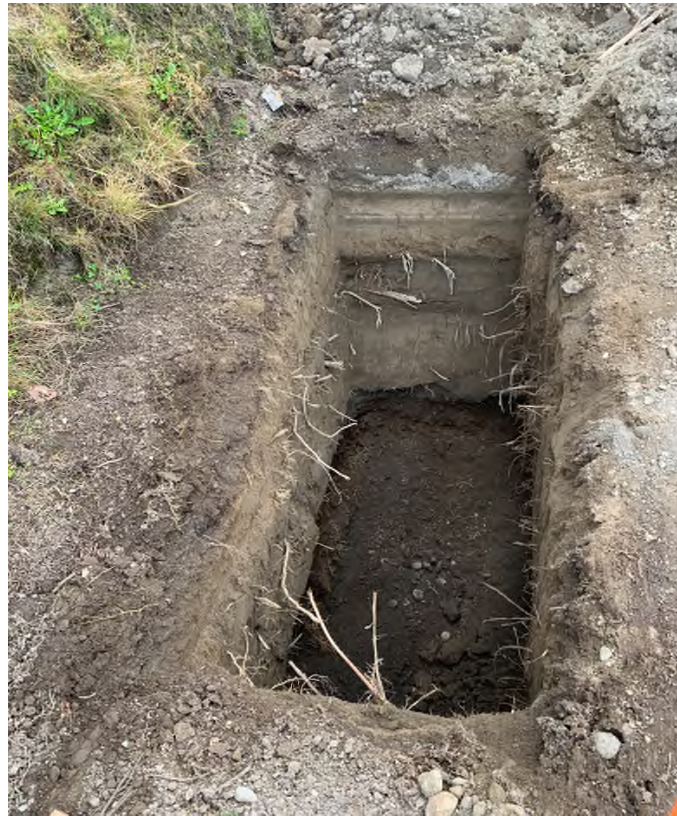
Above: View of excavated pit at test location 1

Width	1.0 m
Length	2.3 m
Depth	1.9 m
Volume	4.37 m <sup>3</sup>

Test hole with topsoil & fine gravels

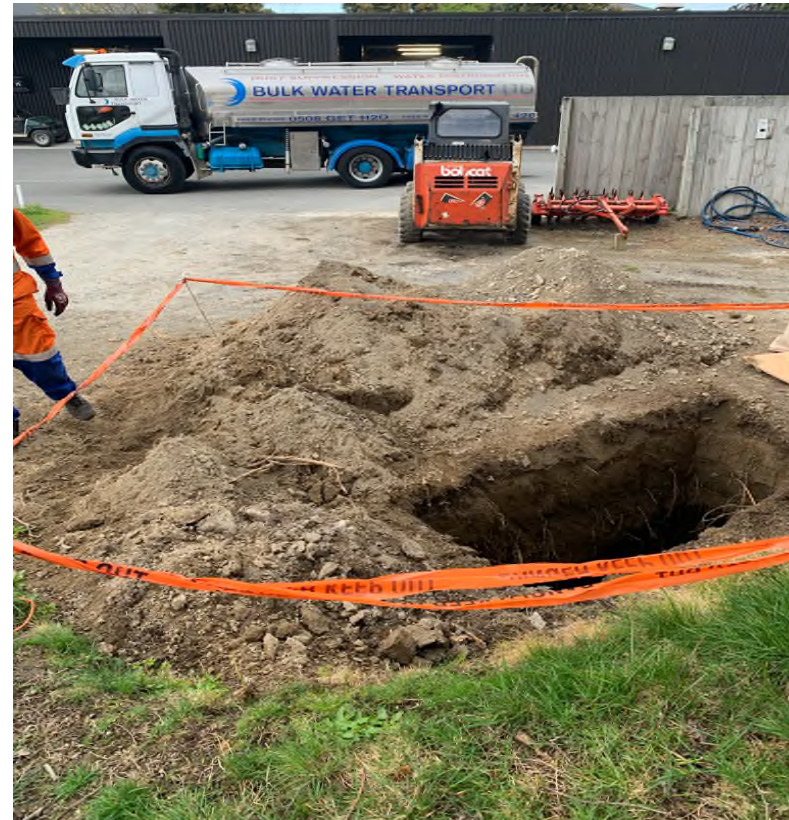
Above: View of excavated pit at test location 1 with material removed from ground shown

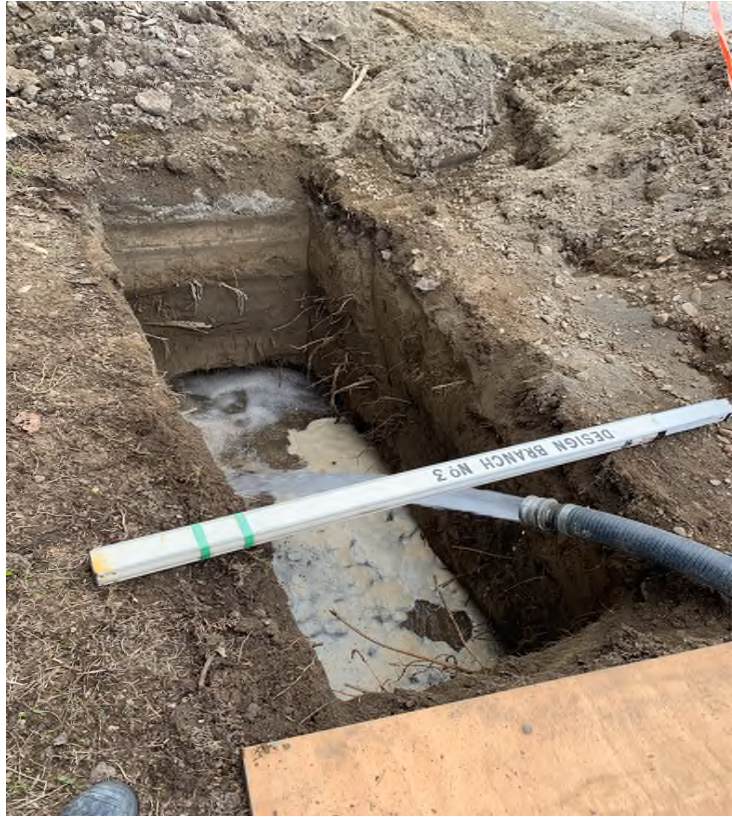
Above: View of soakage testing at test location 1

Tank Size & Water	10,000 l
Filling rate supplied by tanker being pumped into hole	1111.1 l/min

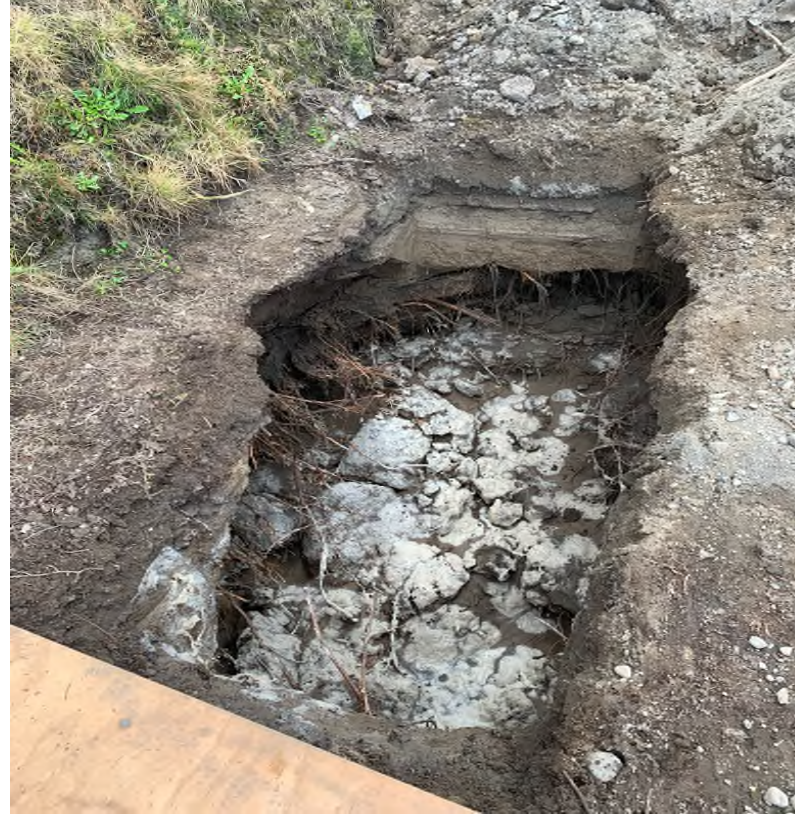
Above: View of excavated pit at test location 1 at completion

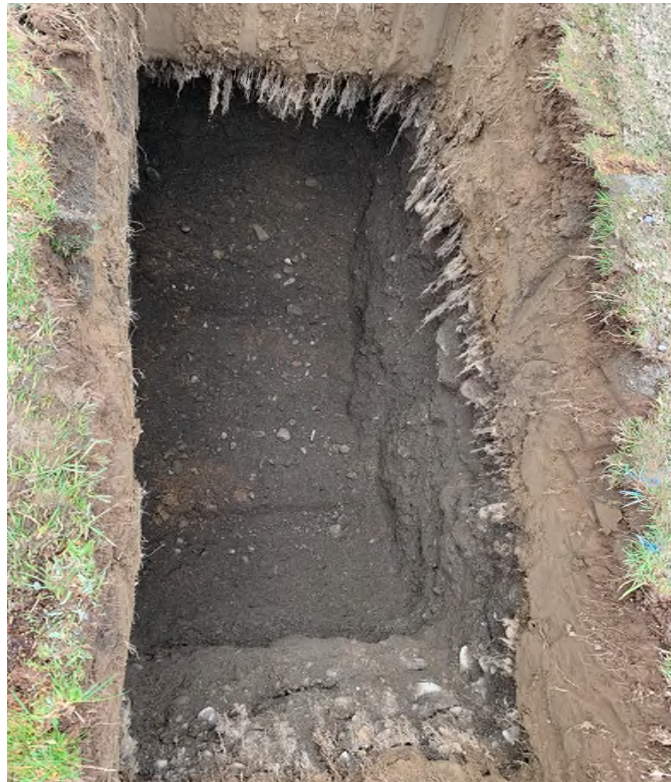
Above: View of excavated pit at test location 2

Width	1.0 m
Length	2.2 m
Depth	1.57 m
Volume	3.45 m <sup>3</sup>

Test hole with topsoil, rocks & fine gravels

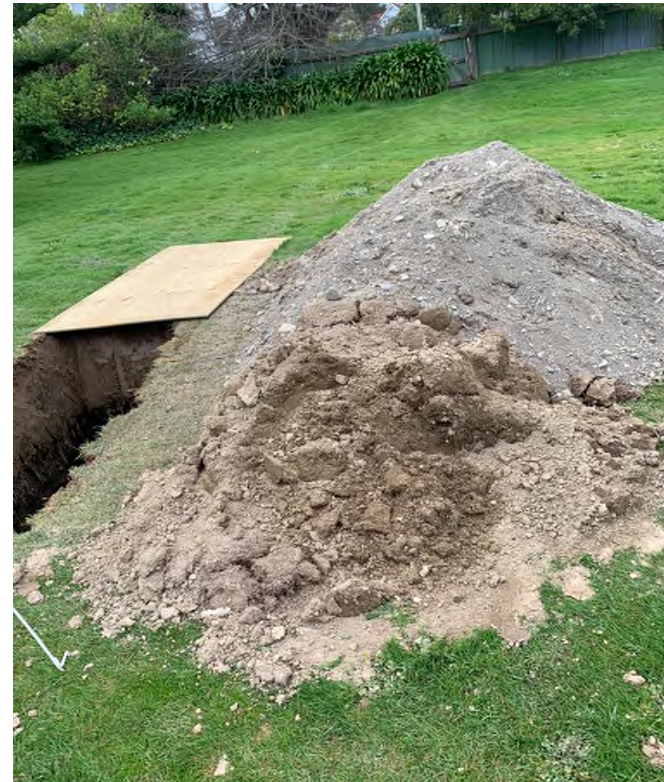
Above: View of excavated pit at test location 2 with material removed from ground shown

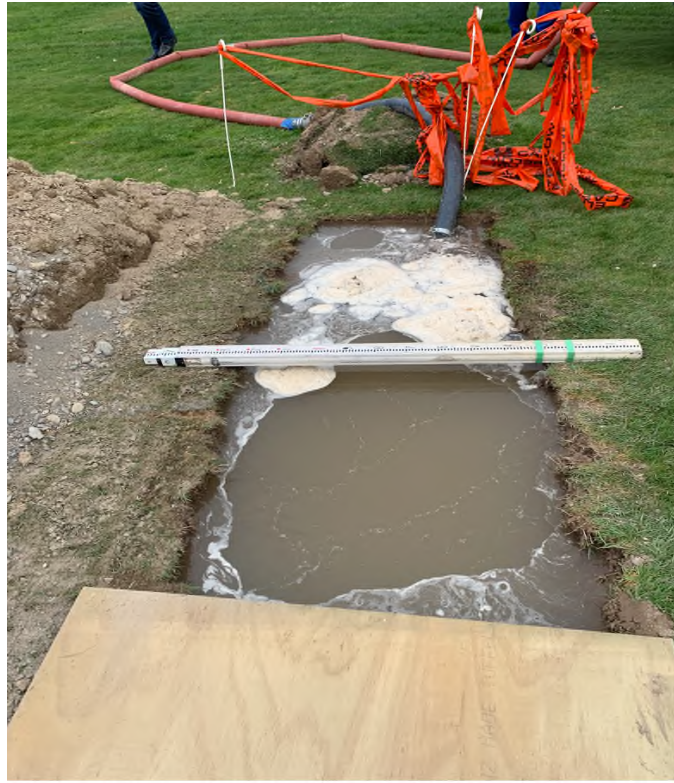
Above: View of soakage testing at test location 2

Tank Size & Water	10,000 l
Filling rate supplied by tanker being pumped into hole	1428.6 l/min

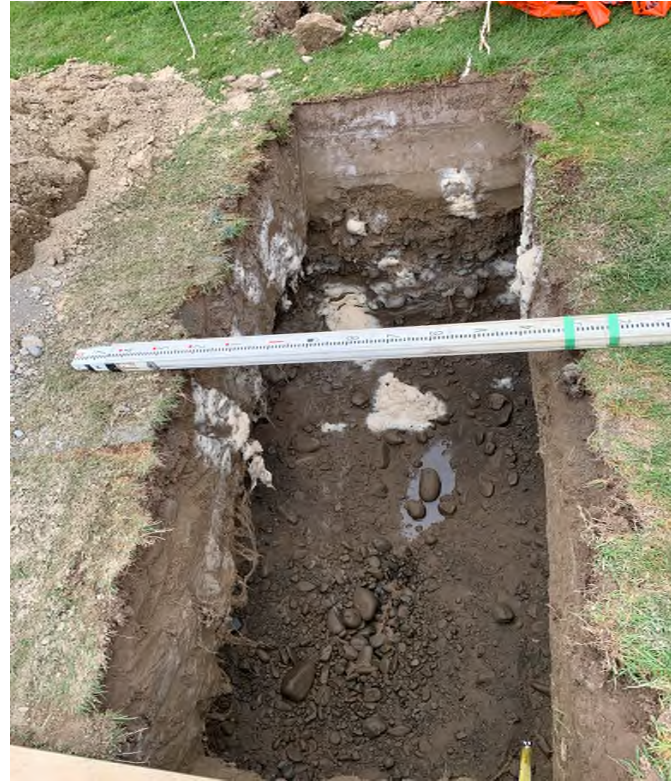
Above: View of excavated pit at test location 2 at completion

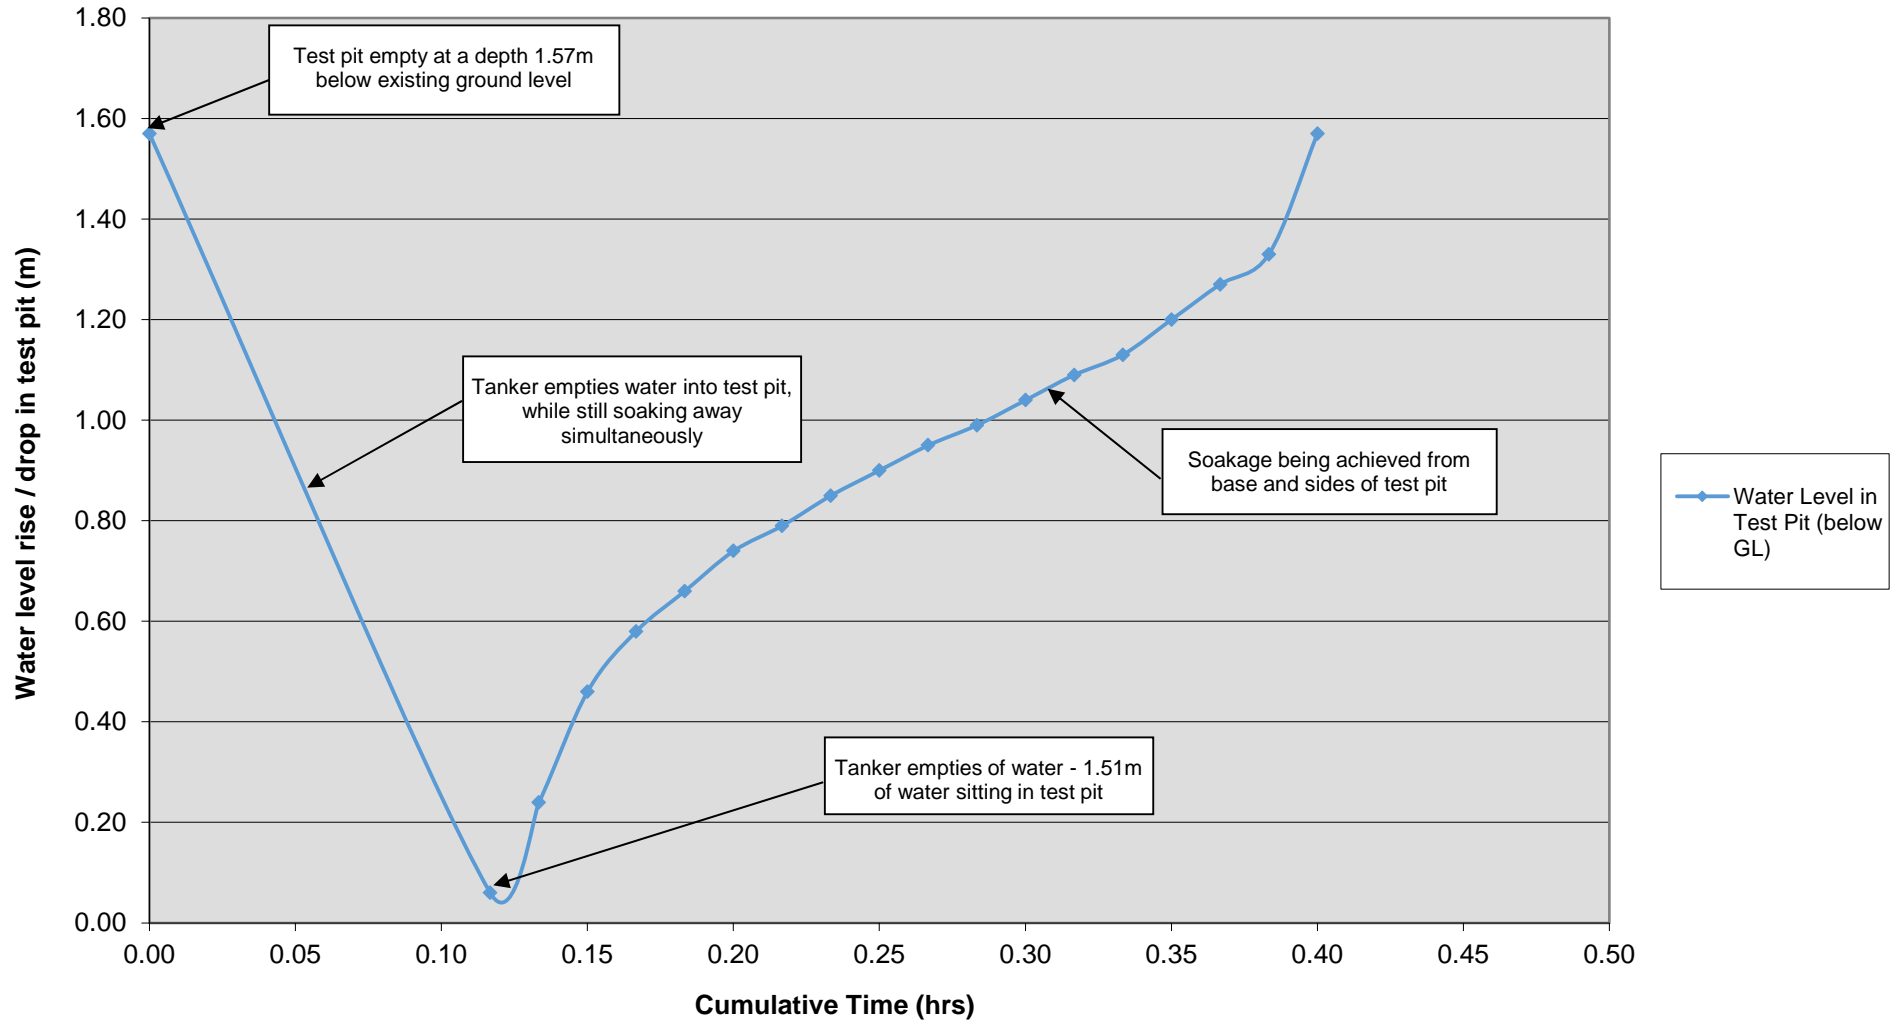
## Plot of water level (m) vs time (hrs) - Location 2 - 30 September 2021

(0.0m = existing ground level)

Time	Time Difference	Cumulative Time	Water Level in Test Pit (below GL)	Cumulative Fall in Test Pit	Time	Time Difference	Cumulative Time	Water Level in Test Pit (below GL)	Cumulative Fall in Test Pit
[hh:mm:ss]	[min]	[hrs]	[m]	[m]	[hh:mm:ss]	[min]	[hrs]	[mm]	[mm]
10:25:00	0	0.00	1.57						
10:32:00	7	0.12	0.06						
10:33:00	1	0.13	0.24						
10:34:00	1	0.15	0.46						
10:35:00	1	0.17	0.58						
10:36:00	1	0.18	0.66						
10:37:00	1	0.20	0.74						
10:38:00	1	0.22	0.79						
10:39:00	1	0.23	0.85						
10:40:00	1	0.25	0.90						
10:41:00	1	0.27	0.95						
10:42:00	1	0.28	0.99						
10:43:00	1	0.30	1.04						
10:44:00	1	0.32	1.09						
10:45:00	1	0.33	1.13						
10:46:00	1	0.35	1.20						
10:47:00	1	0.37	1.27						
10:48:00	1	0.38	1.33						
10:49:00	1	0.40	1.57

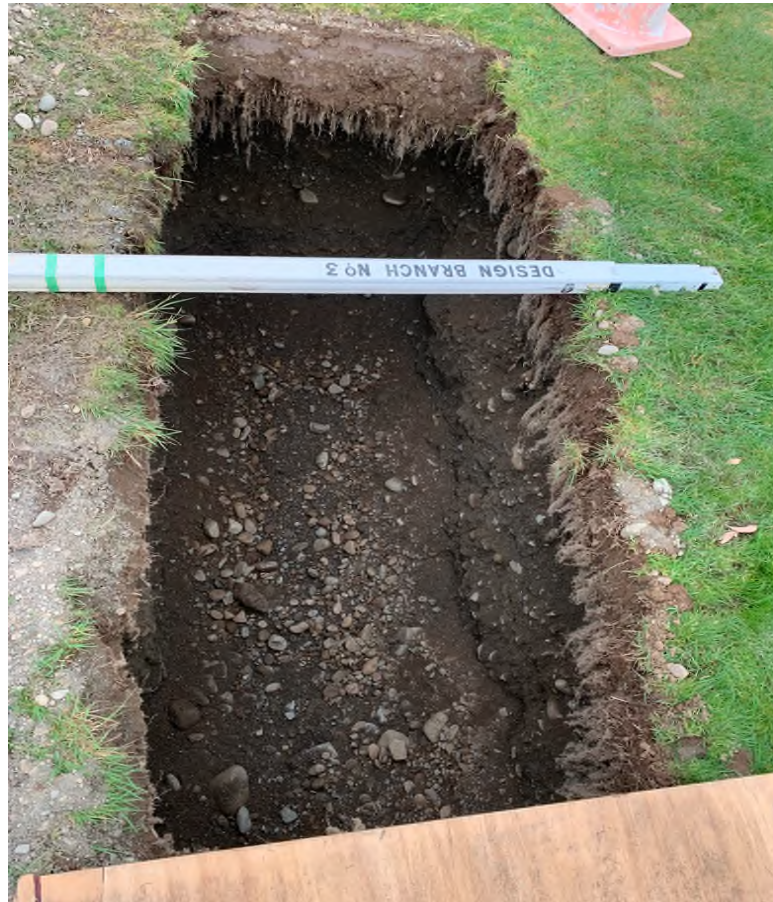
Above: View of excavated pit at test location 3

Width	1.0 m
Length	2.2 m
Depth	1.4 m
Volume	<b>3.08 m<sup>3</sup></b>

Test hole with topsoil, rocks & fine gravels

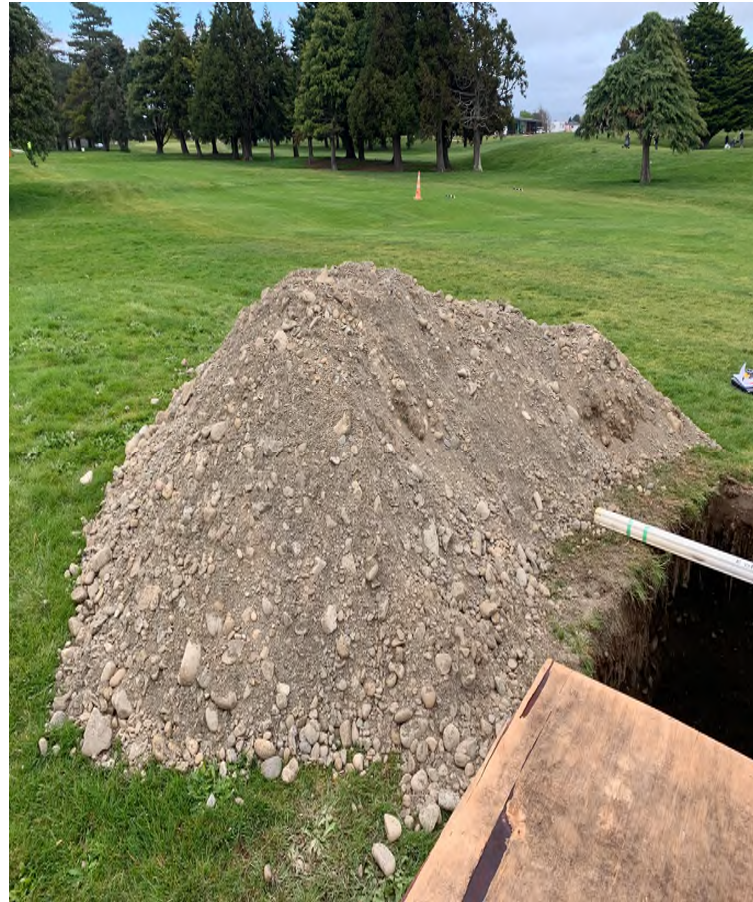
Above: View of excavated pit at test location 3 with material removed from ground shown

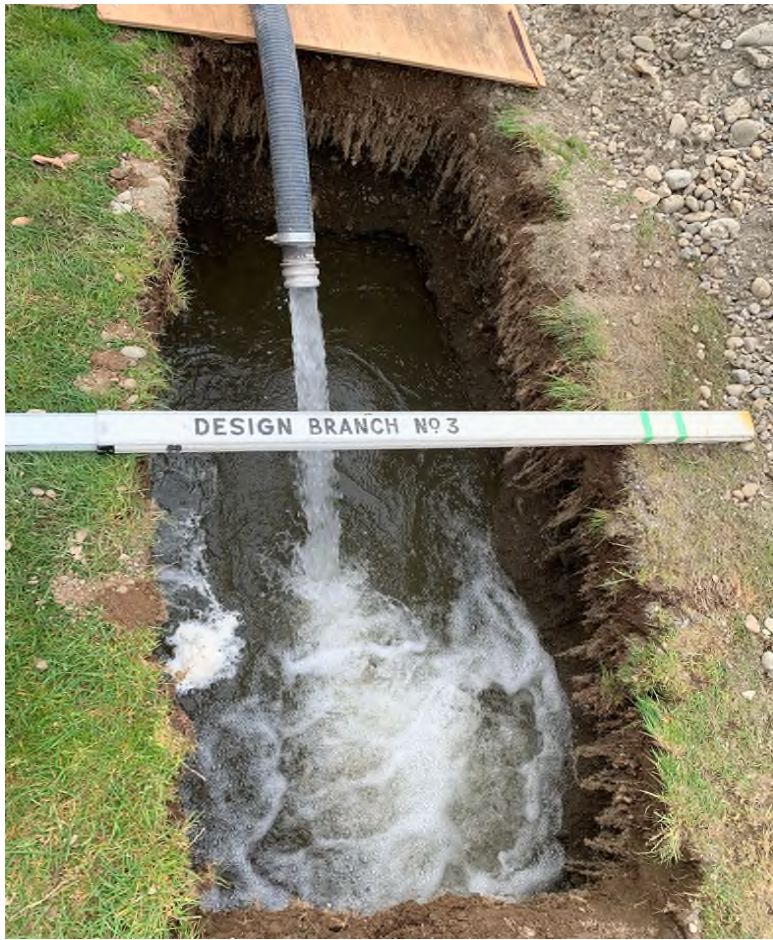
Above: View of soakage testing at test location 3

Tank Size & Water	10,000 l
Filling rate supplied by tanker being pumped into hole	1000.0 l/min

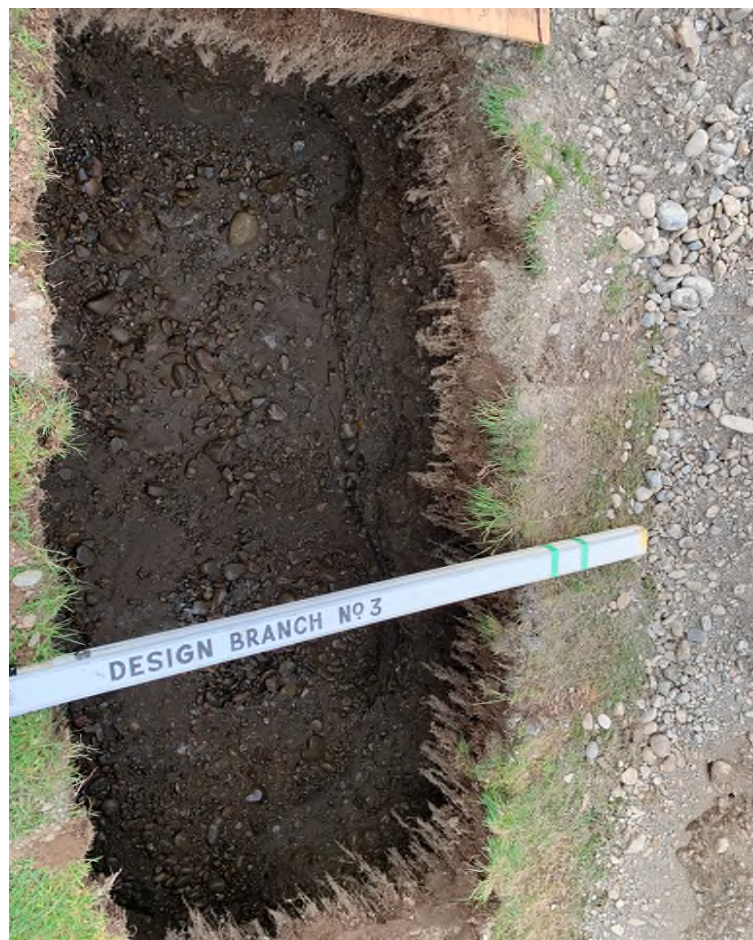
Above: View of excavated pit at test location 3 at completion

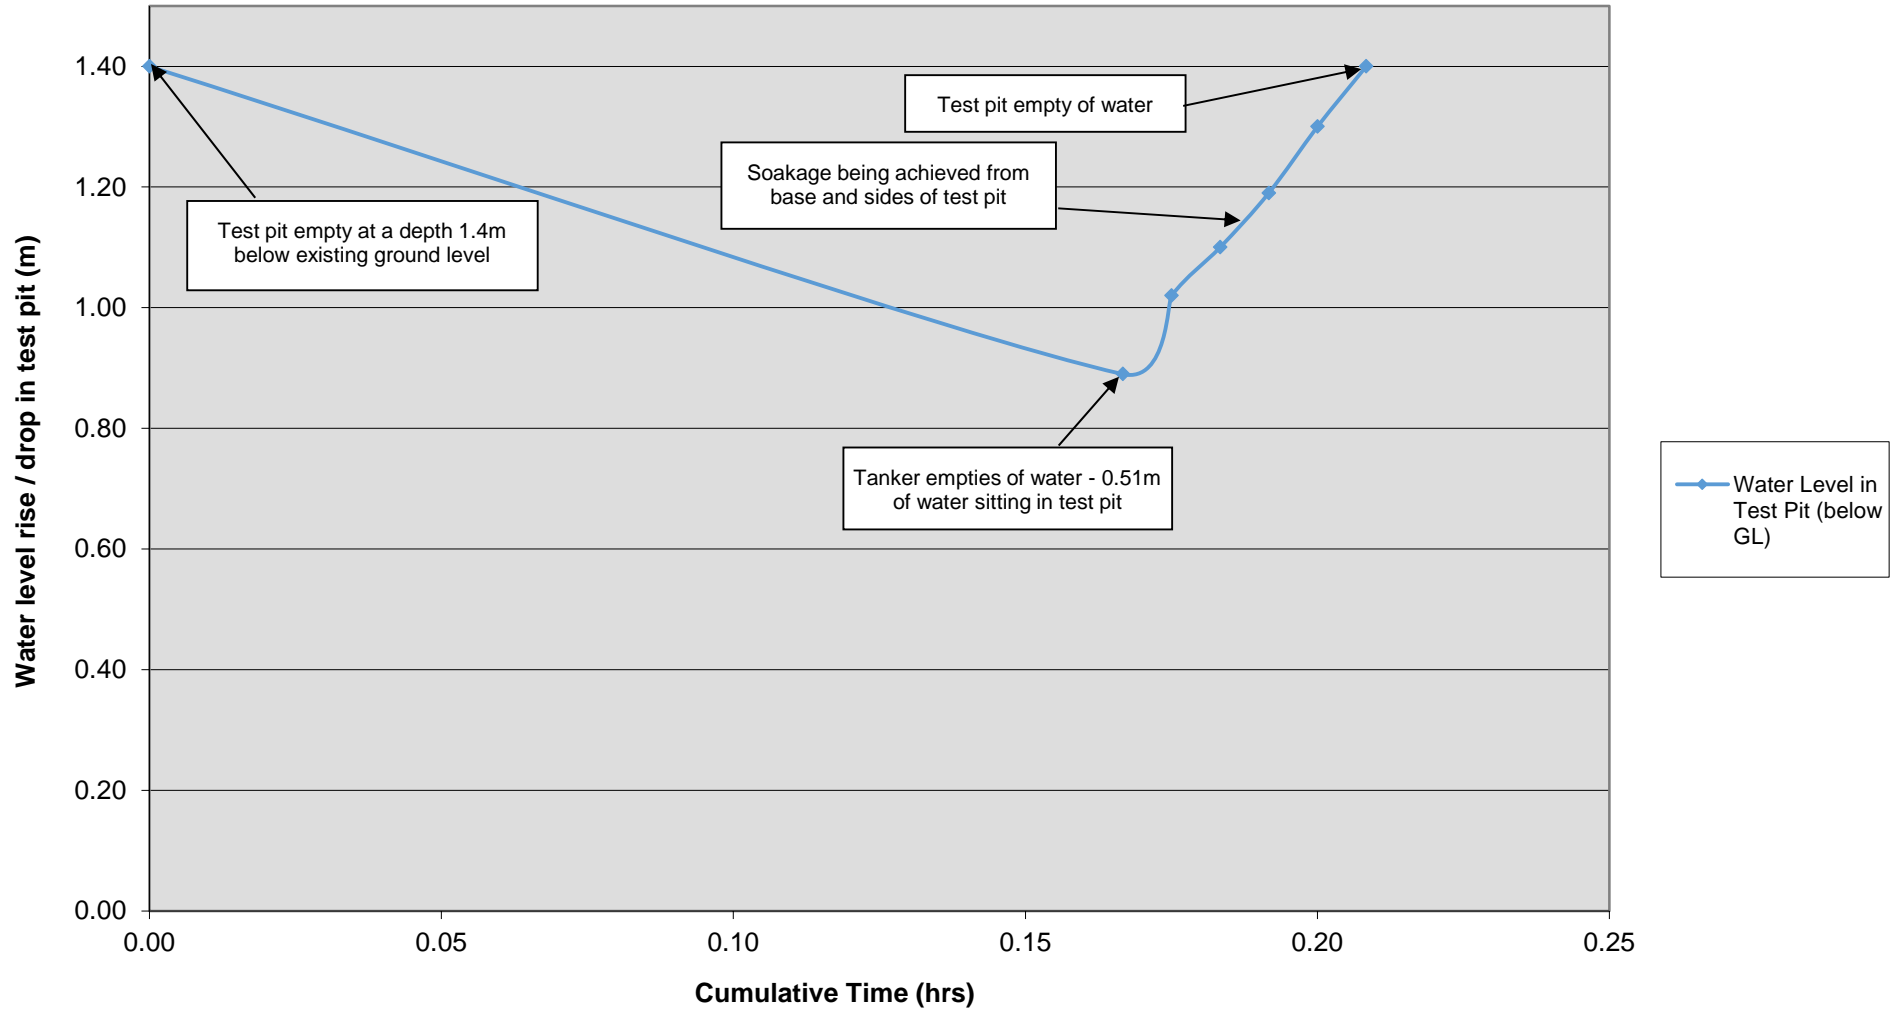
# Plot of water level (m) vs time (hrs) - Location 3 - 30 September 2021

(0.0m = existing ground level)

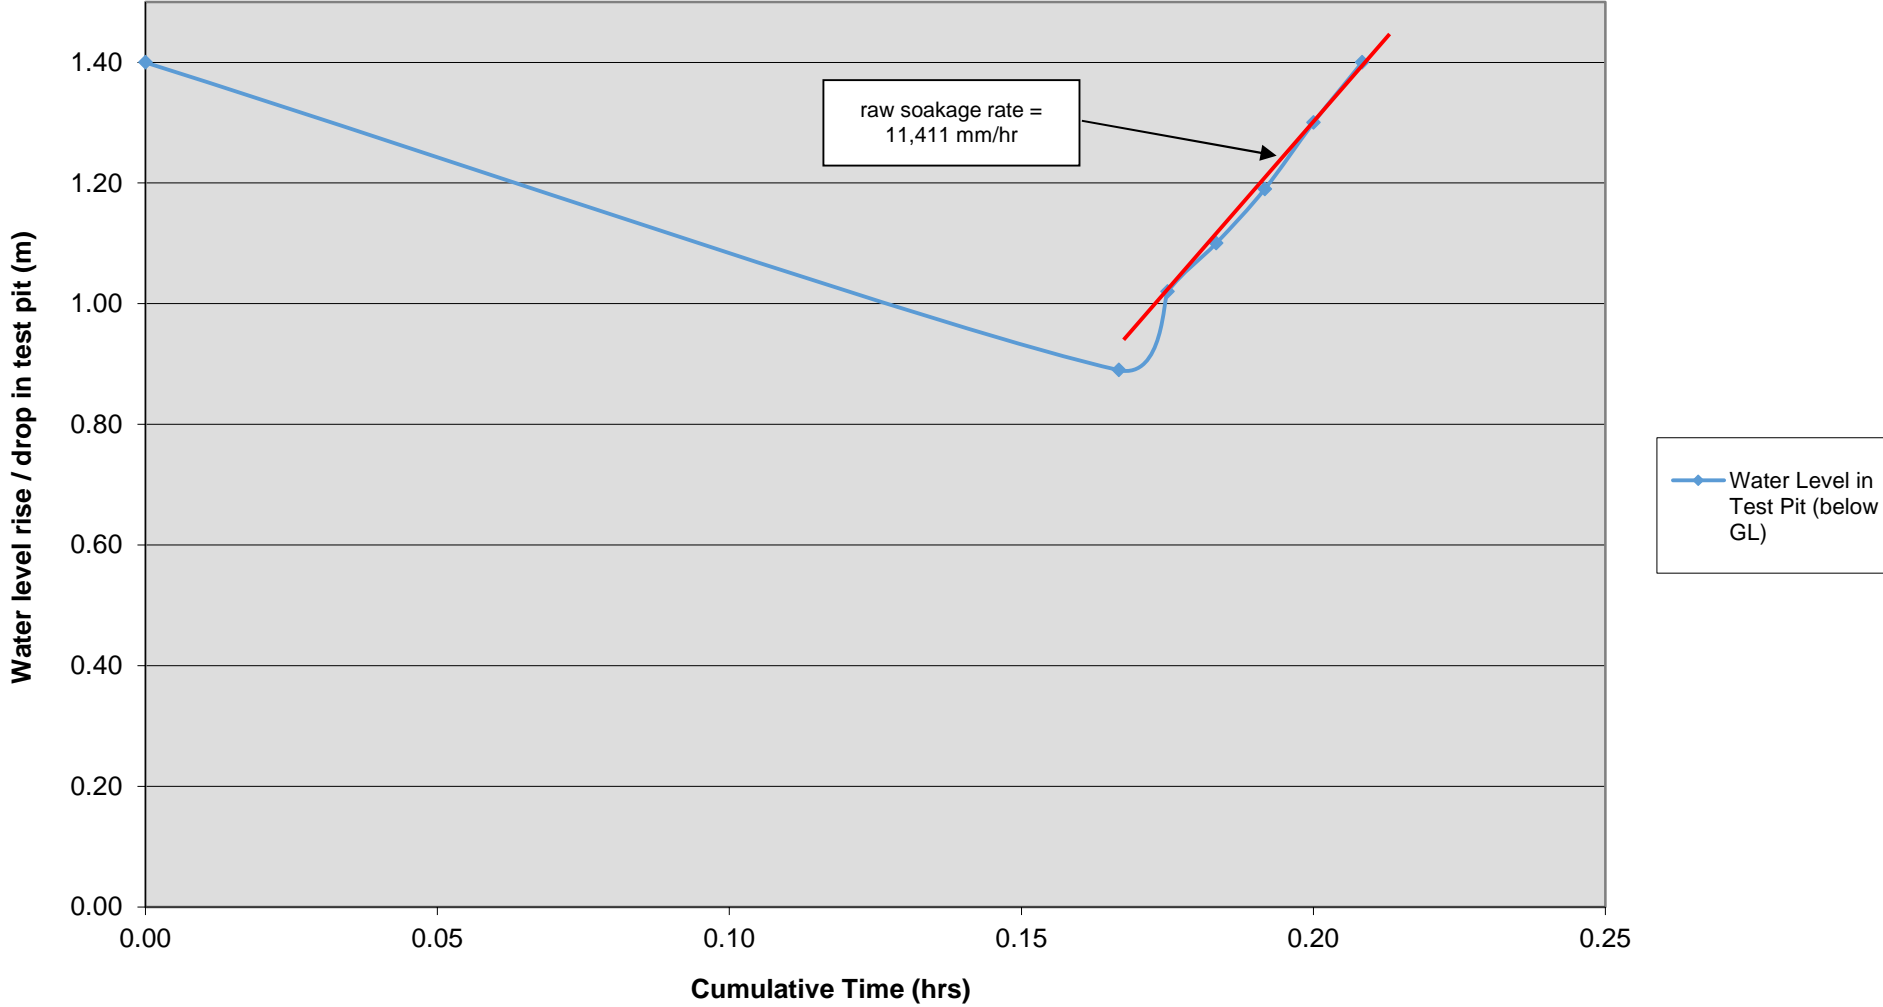
# Plot of water level (m) vs time (hrs) - Location 3 - 30 September 2021

(0.0m = existing ground level)
