6, 7 & 8 Johnston Grove

Geotechnical Assessment

Palmer and Cook Developments

Reference: 773-WLGGE287885

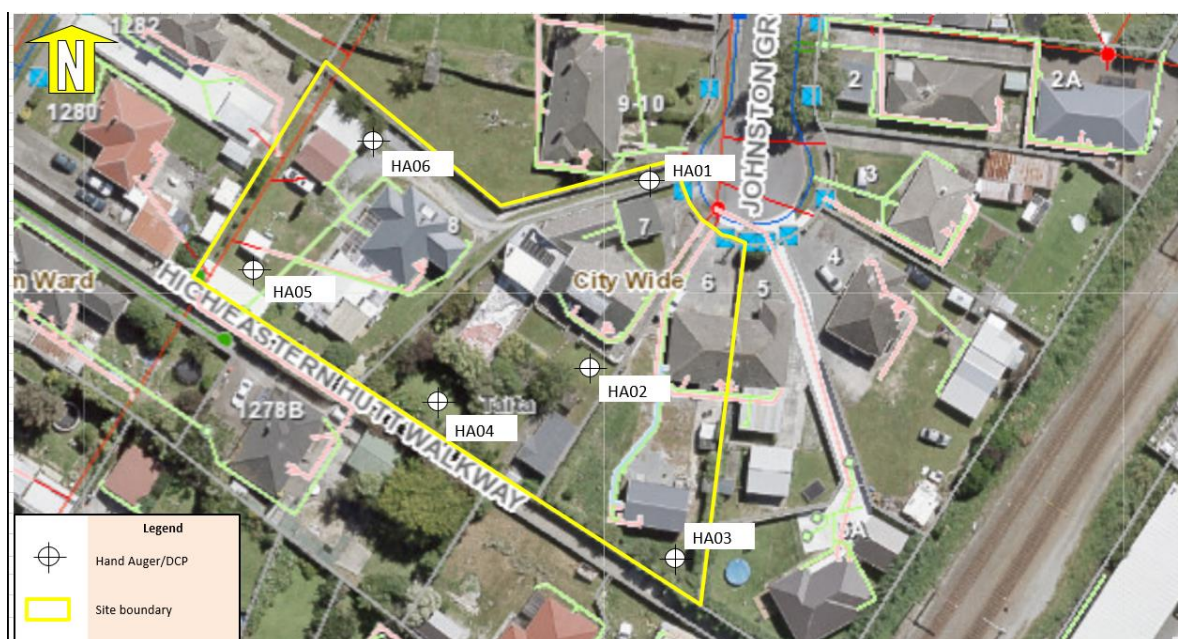
Figure 1: Site investigation Plan

Refer to Figure 1 for Site Investigation Plan. Engineering logs are provided in Appendix B.

The site investigation was undertaken on the 9th of November 2021 and included six hand augers with in-situ shear vane testing, and six dynamic cone penetrometers (DCPs). Hand augers refused on gravel at 0.7m and 1.6m depth.

We have developed a ground model for the site largely based on the site-specific geotechnical investigation and supplemented with the NZGD data. Generally, the subsoil profile comprises ~100mm of topsoil underlain by alluvial soils consisting of silt and sand. The top of the gravel unit is inferred from the testing refusal on gravel. Gravel fill 0.15m thick was encountered in HA06 in the north-west of the site

As is typical in alluvial soils, the thickness and depth of material units varies across the site. In particular, the gravel layer (Alluvium 3) was typically encountered at a depth of 0.65m to 0.8m except for HA01 which this was noted at 1.6m depth.

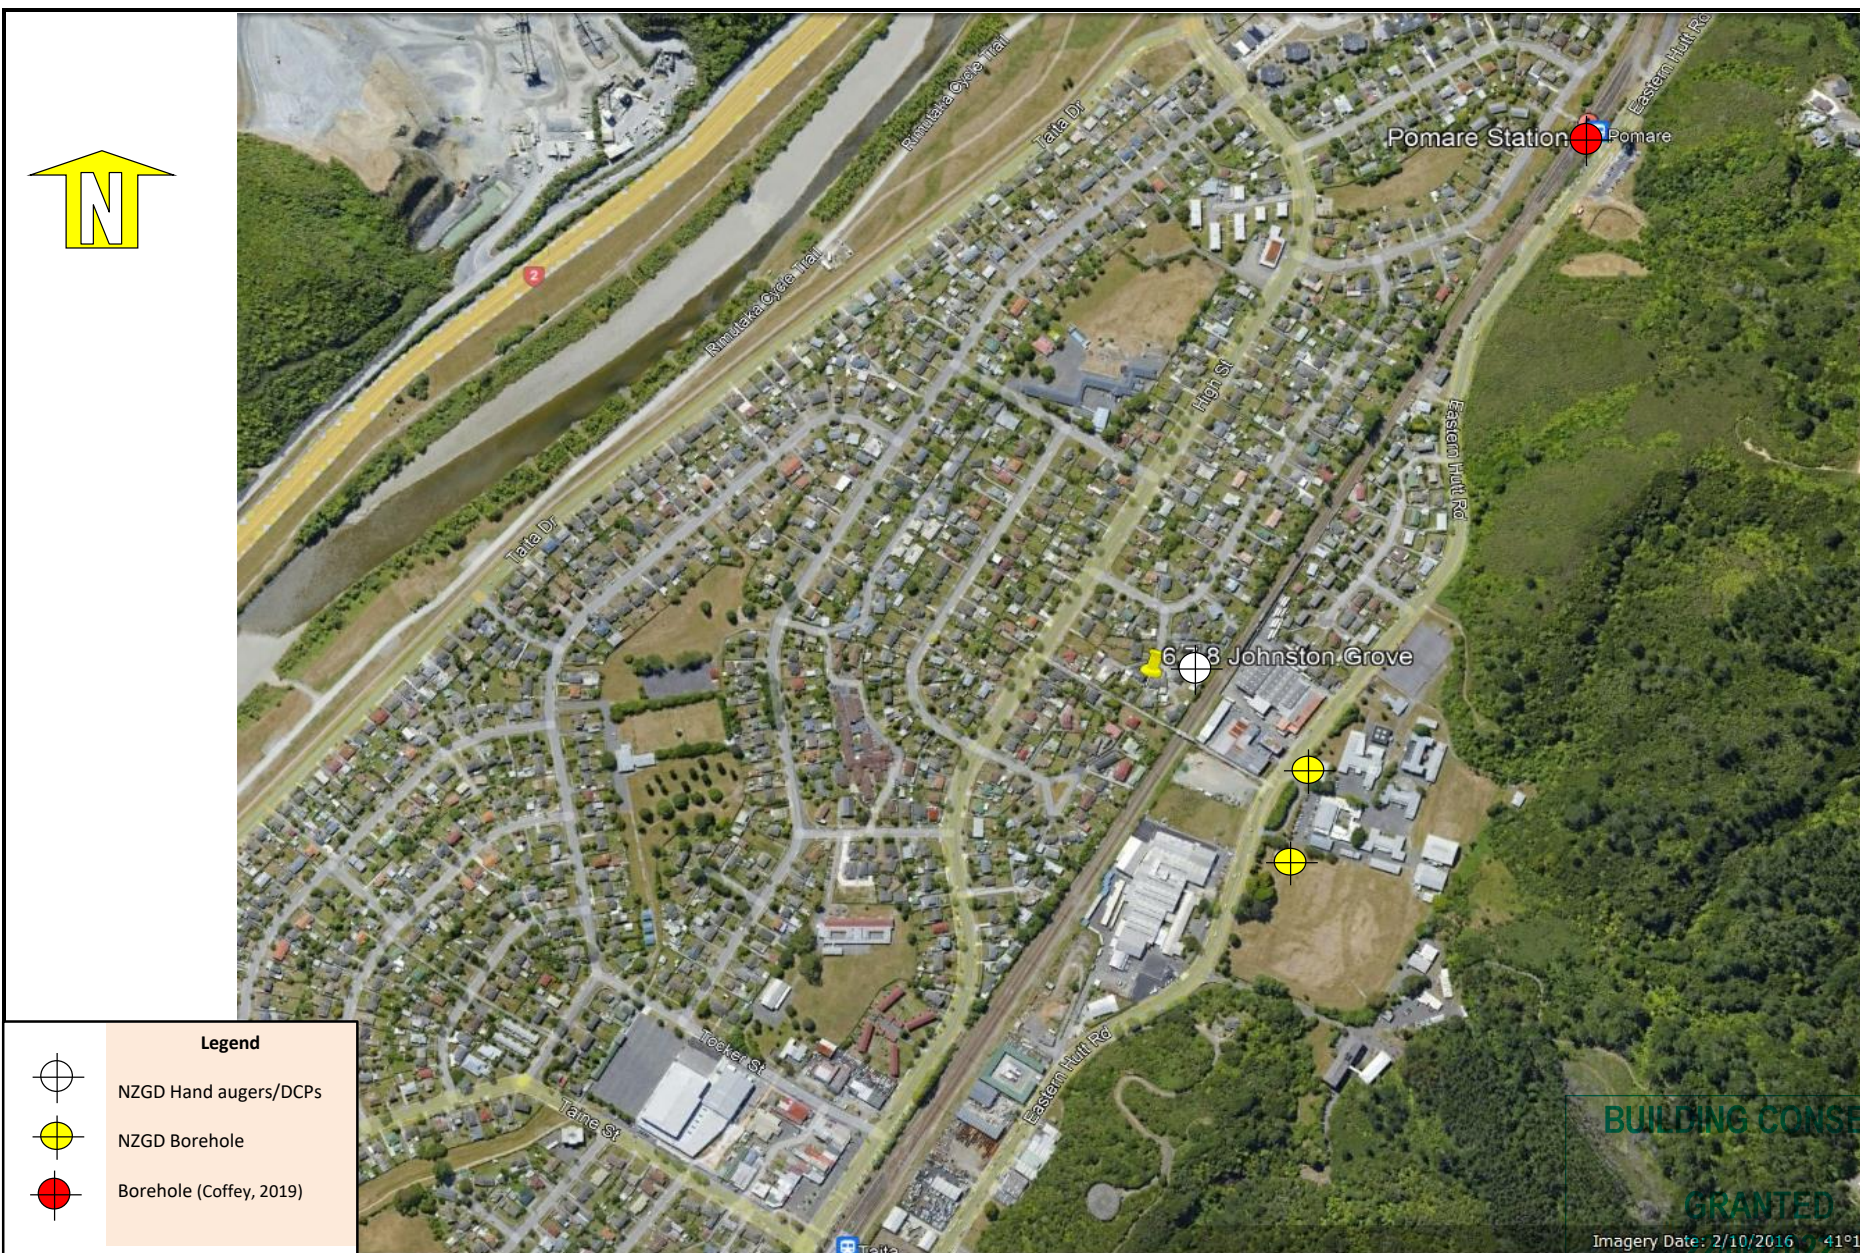
A map showing the location of these investigations is in Appendix A.

NZGD Hand augers/DCPs

A review of the New Zealand Geotechnical Database (NZGD)⁶ show there has been previous shallow geotechnical investigations at 3 & 4 Johnston Grove. This comprised six Hand Augers and Dynamic Cone Penetrometers (DCPs) 40m to 80m east and north-east of the site.

The hand augers achieved depths of 0.7-2.1m depth terminating due to gravel obstruction. DCPs achieved 1.0-2.5m depth. These logs indicate a ground model consisting of ~200mm of topsoil overlying alluvium. Alluvial soils were typically 500 to 900mm thick firm to hard silt overlying sandy gravel/gravelly sand at 1.1 to 1.9m depth.
