Project Number: 5-C4307.00

Slope Failure Susceptibility Assessment

Hutt City Council District Plan Review

Report No: GER 2021 / 36
Date: September 2021

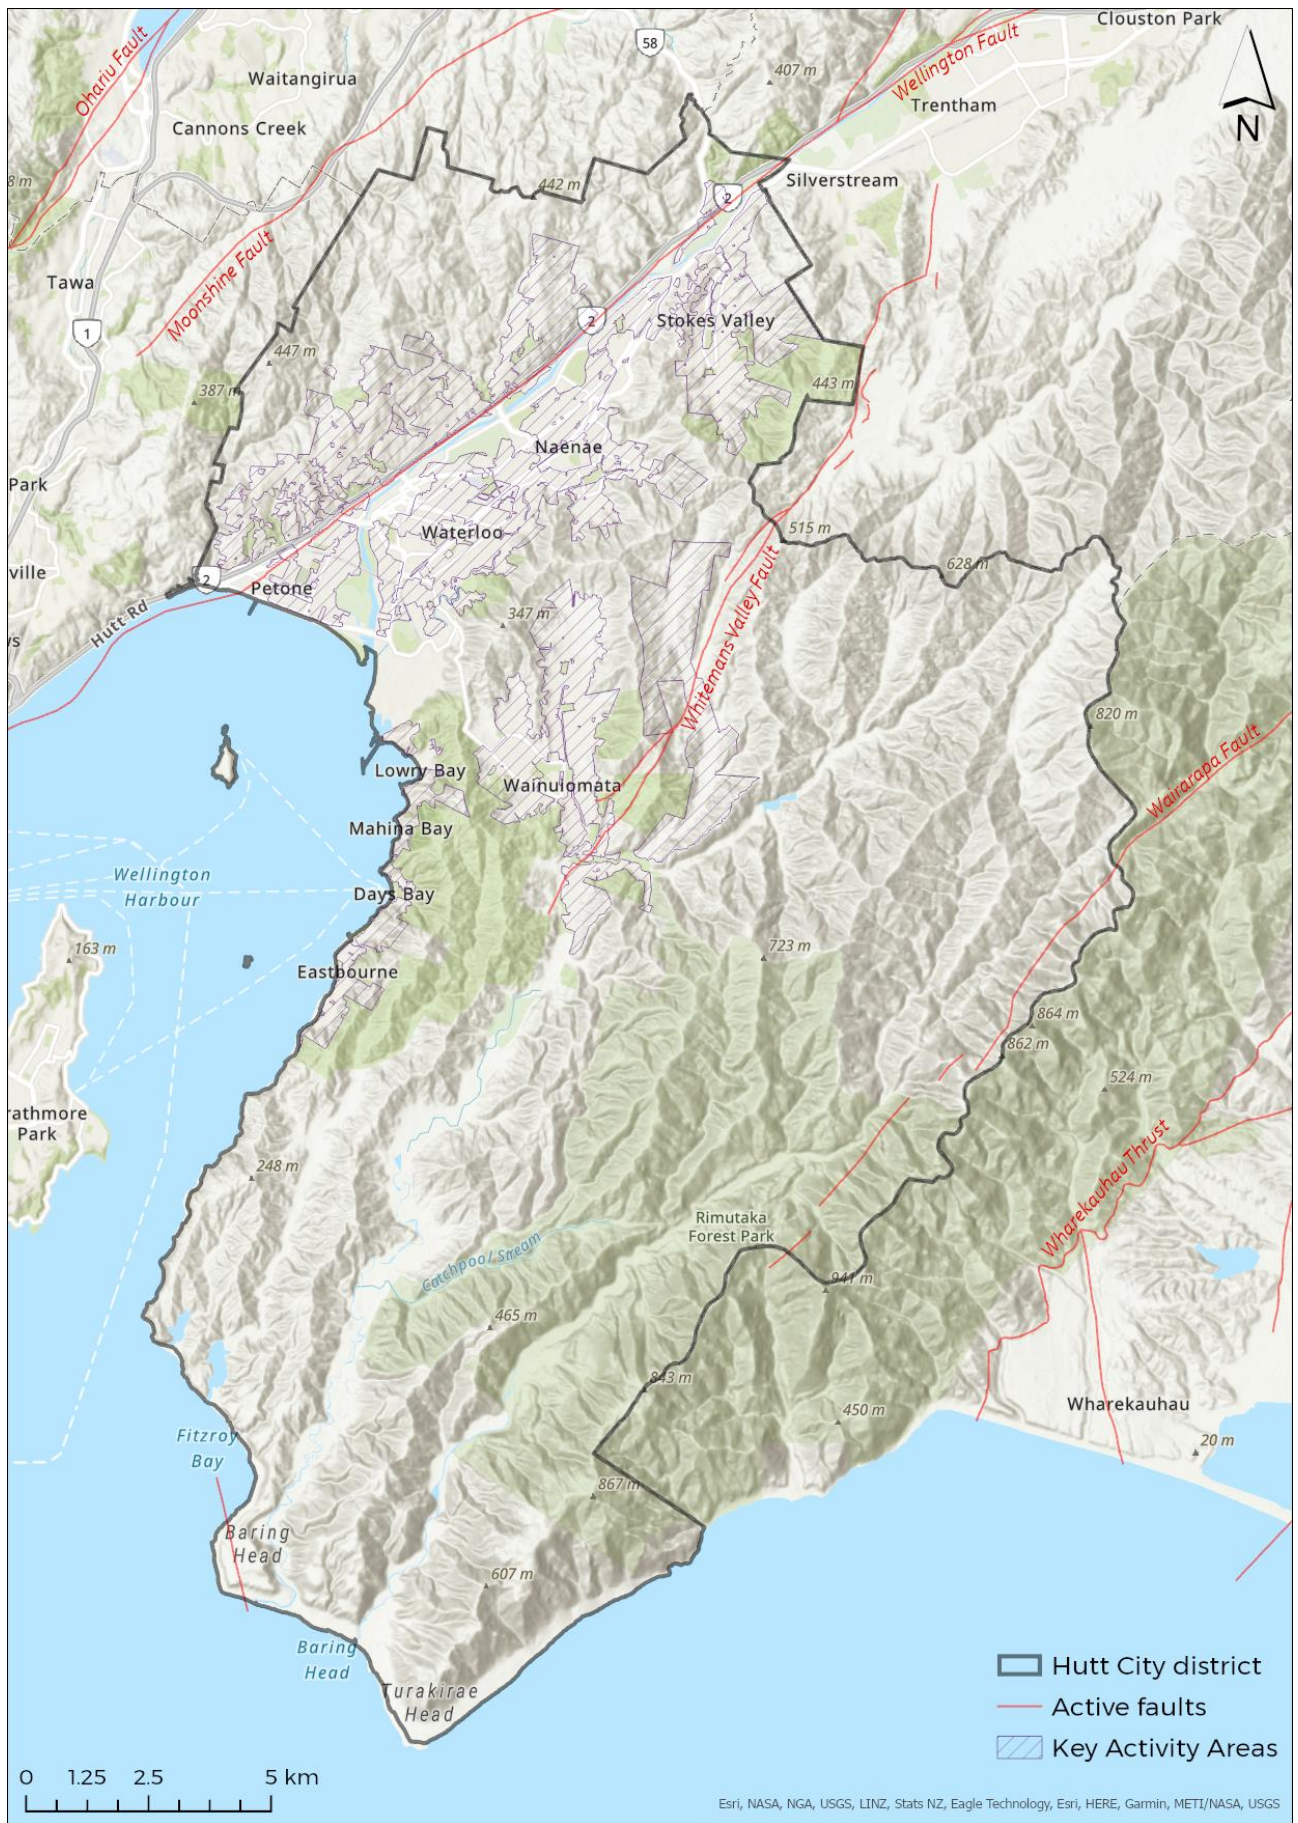
Figure 1: The Hutt City district.

The main valley in the Hutt City district is Hutt Valley, which extends southwest to northeast from the harbourfront at Petone to the northern extent of the district at Taitā Gorge. Secondary valleys include Stokes Valley, which connects to Hutt Valley at Taitā Gorge, and Wainuiomata Valley, which meets Cook Strait at the south coast.

Coastal geomorphology is highly varied in the Hutt City district. Steep bedrock cliffs, sometimes in excess of 200 m high, are present in places, particularly on the south coast. Gently sloping beach and dune environments can be found in the Petone and Eastern Bays harbourfront areas, as well as to the south of Pencarrow Head and Wainuiomata Coast.

The Council have requested an assessment of slope failure susceptibility for the Hutt City district, see Figure 1. This report details our methodology, which included a desk study and landslide susceptibility mapping. It provides an appraisal of the stability issues in the Hutt City district, and recommendations for measures to manage the effects of land instability hazards.

The Hutt City district is an area of significant seismicity. The New Zealand Active Faults Database from GNS (<https://data.gns.cri.nz/af/>, 1:250,000 scale) shows that four active faults fall within the Hutt City district, including the Wellington Fault that runs through the urban areas of the district, see Figure 1. These faults are summarised in Table 1.

Greater refinement of mapped slope failure susceptibility zones has been applied in key areas of existing and potential future development (see outlined areas in Figure 1). These areas were selected by the Council from activity areas within the operative District Plan. The key activity areas are:

LiDAR data from 2013 and 2016 were used in the susceptibility mapping. The slope angle, slope aspect and slope curvature factor datasets have been processed from a DEM derived from a combination of 2013 and 2016 LiDAR data. The 2016 LiDAR data covers only the urban areas of the district, but is of higher quality than the 2013 LiDAR data which covers the full district. Therefore, there is a difference in quality of the mapped susceptibility zones in the urban areas compared to the rural areas. The higher-quality data covers the majority of the key activity areas selected by the Council (see Figure 1).

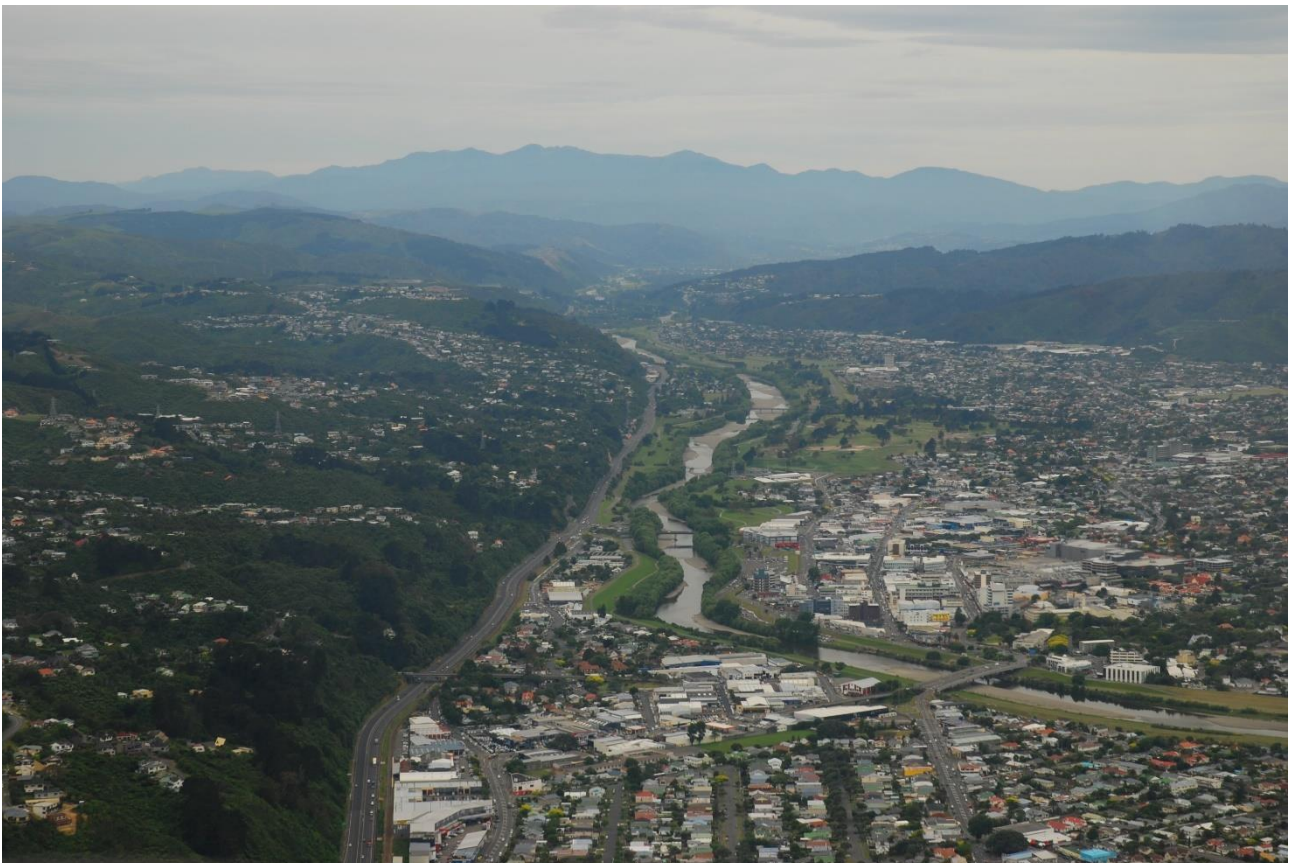
Figure 2: The steep eroded scarp of the Wellington Fault running parallel to State Highway 2.

These greywacke slopes bounding the western side of the Hutt Valley are generally very steep, and have been steepened in places by formation of road cuttings (Figure 2). The slopes are underlain by fault-disturbed or highly fractured rock due to their close proximity to the Wellington Fault, resulting in high susceptibility to failure. The proximity of the fault would also expose them to strong ground shaking and topographic amplification effects in the event of a localised fault rupture.

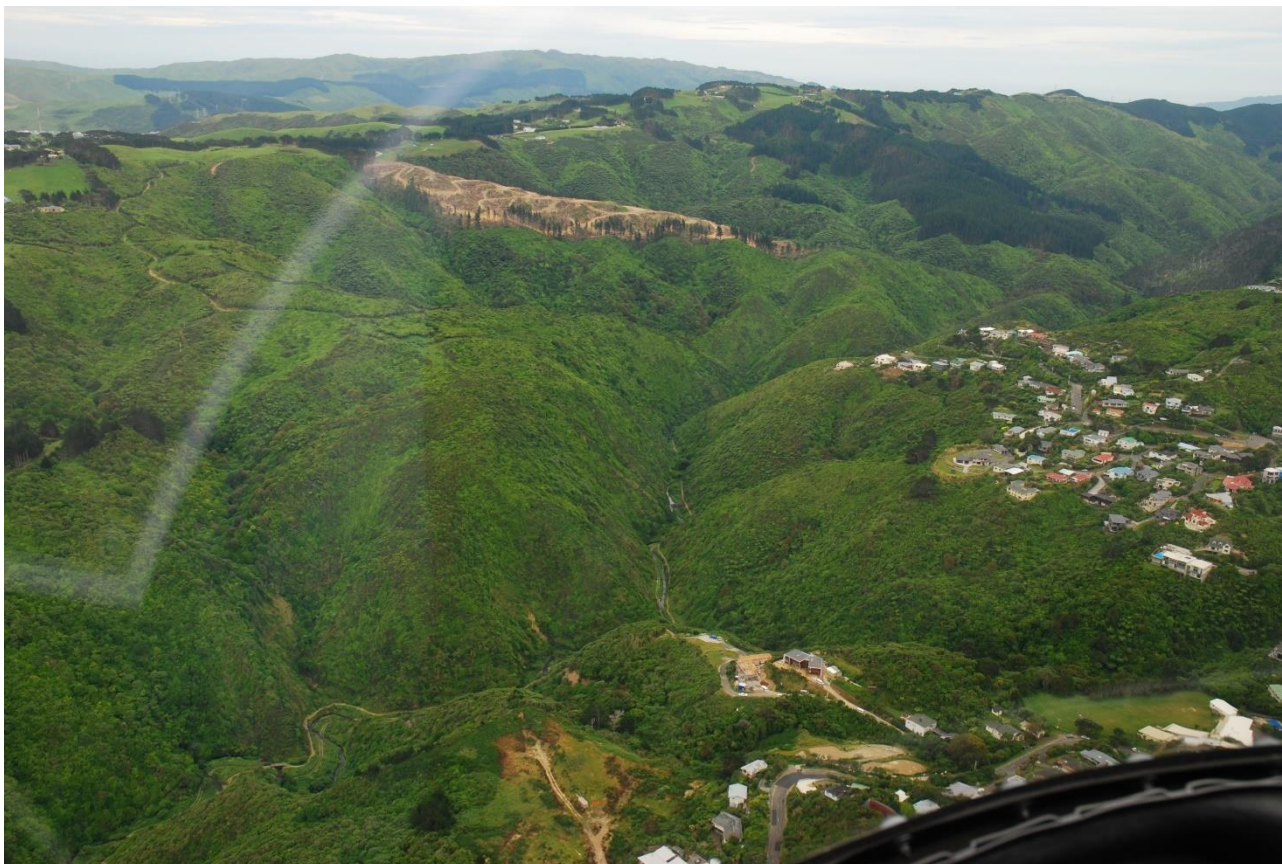
Figure 3: Korokoro Stream gully, with very steep greywacke slopes.

slopes such as these are considered to be very highly susceptible to failure due to significant earthquakes or storms. See Figure 3.

It should be noted that the stable angle of individual greywacke slopes is highly dependent on the degree of weathering and the extent and intensity of fracturing in the bedrock, as well as the presence, persistence and orientation of dominant defects with respect to the overall slope.

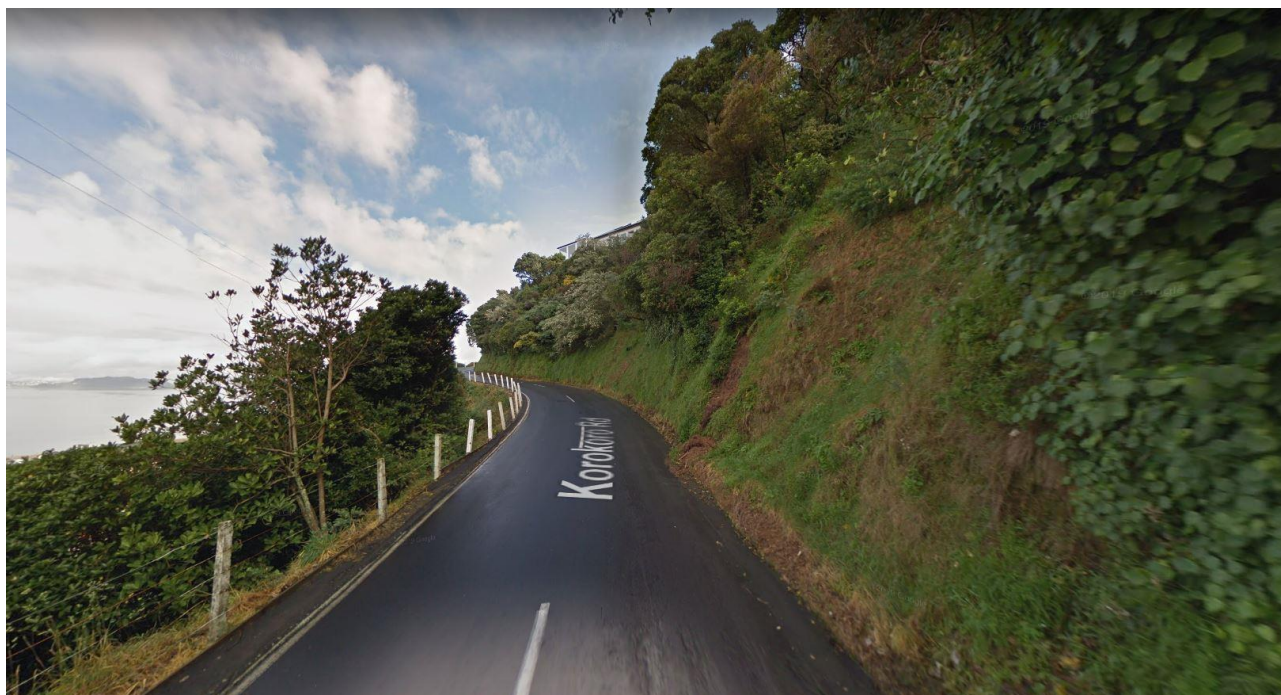
Figure 4: Korokoro Road, with steep cut slopes to the right of the road, and houses positioned behind the crest of these slopes. (Image from Google Maps Street View).

Many smaller residential streets in the hill terrain areas of Hutt City district also feature steep road cuttings that are susceptible to slope failure, as indicated by the landslide inventory compiled for this study.

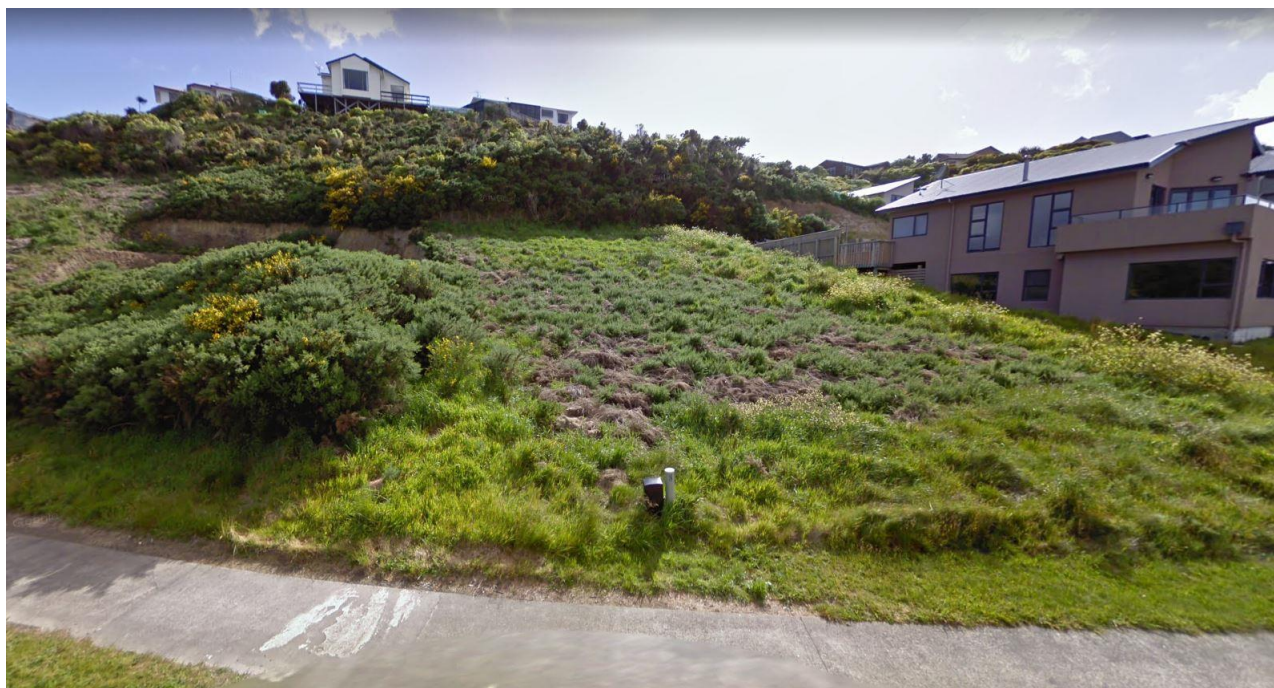
Figure 5: Cedar Street, Maungaraki, showing different stages of slope modification for residential development. Note cut slopes behind the house on the right, and in the plot to the left. (Image from Google Maps Street View).

In the hill suburbs of the Hutt City district, slopes are often modified to form flat building platforms (Figure 5). This process has typically involved the formation of cuts in bedrock slopes, and the downslope placement of fill material to create level ground with steepened edges. Cuttings are generally steeper than natural greywacke slope angles and are susceptible to rock falls and slides if left unsupported. The placement of fill materials can overload natural slopes and increase the failure susceptibility of the underlying bedrock. Where fill slopes are poorly constructed, there is potential for significant failures within the fill material, like that which occurred in Kelson in 2006.

The slope failure susceptibility of residential cuts and fills may be reduced by the implementation of retaining measures including retaining walls, soil nails, rock anchors, and shotcrete, and by good stormwater drainage design and infrastructure. These measures generally exist on a property-specific basis and have not been mapped in this study. It should be noted that engineered measures remain susceptible to being overwhelmed in significant trigger events, particularly under strong seismic shaking such as that from a large Wellington Fault earthquake.

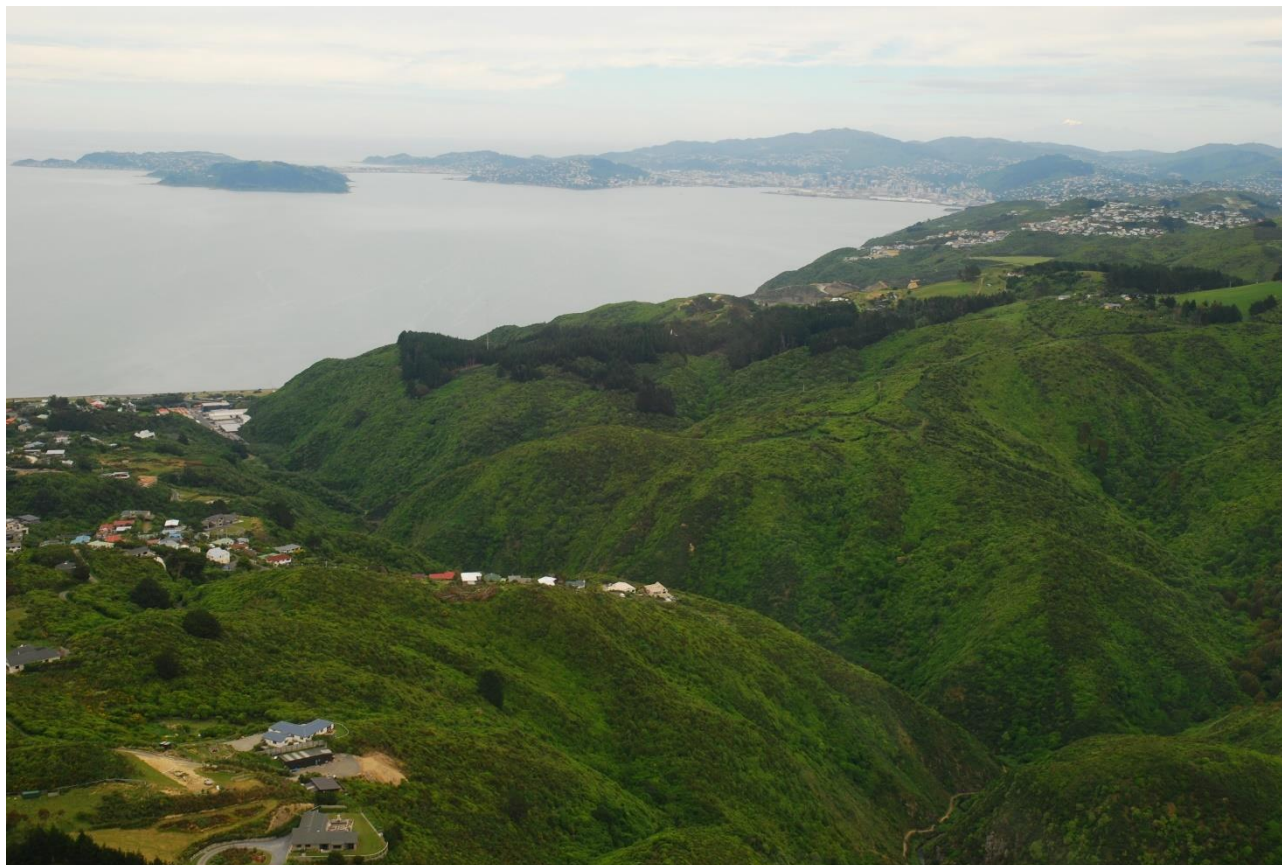
Figure 6: View over Korokoro Stream gully, with residential development on the rounded hillslopes adjacent to the steeper gully slopes.

While steep to very steep greywacke slopes are often present in large gullies in the Hutt City district, slopes at the upper and outer margins of these gullies are generally more rounded and shallower (Figure 6), so have a lower failure susceptibility. These areas are also not subject to significant stream undercutting like the slopes deeper in gullies. Vegetation coverage is also likely to be denser due to the shallower slope angles, with the roots of trees and scrub often providing a stabilising effect.

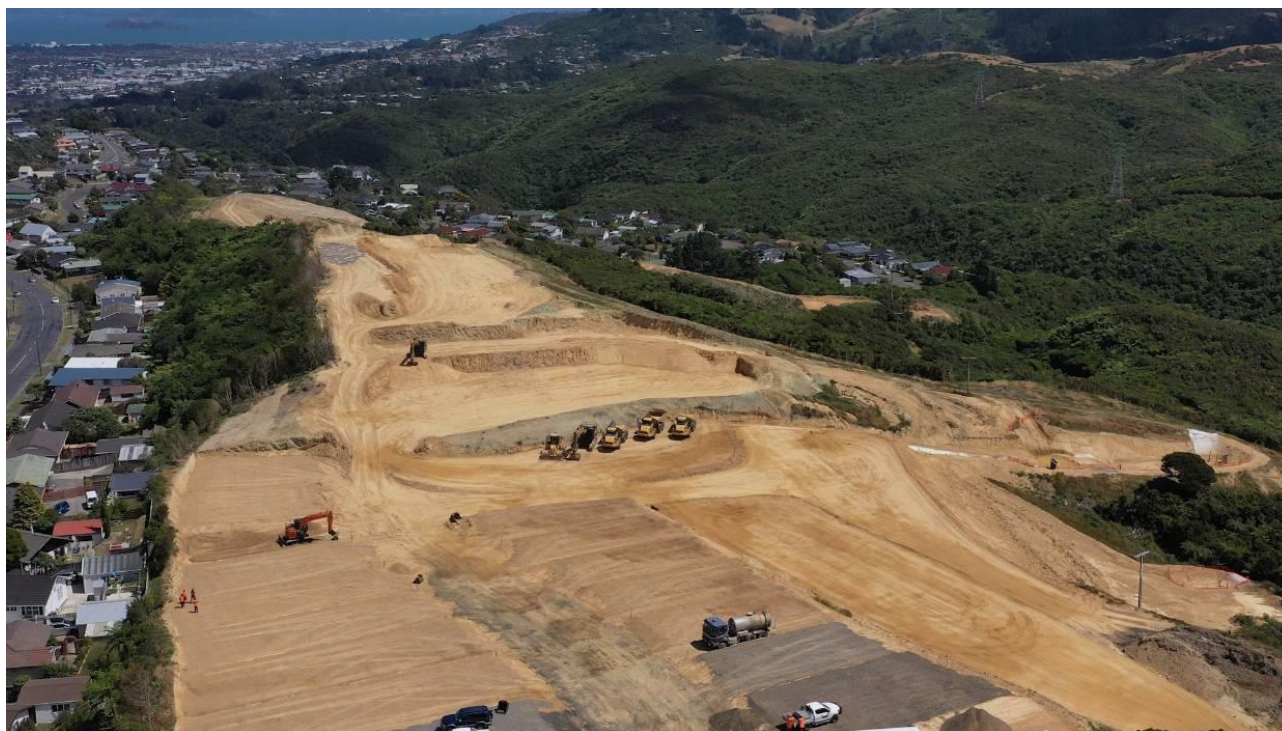
Figure 7: Slope modification, including some small residential cuts and fills, at a recent subdivision in Kelson. (Photo from Stuff).

In areas of residential development on gently dipping land, or where there is a lower density of development, some slopes have only been subject to minor modification in order to construct level building platforms. See examples within the Kelson subdivision shown in Figure 7. Cut and fill slopes that are shallower in angle and smaller in height have a lower slope failure susceptibility than those which are steeper and/or higher. Given that there is still a potential for slope failure however, slope stability should be addressed if additional development is considered on or close to these slopes.

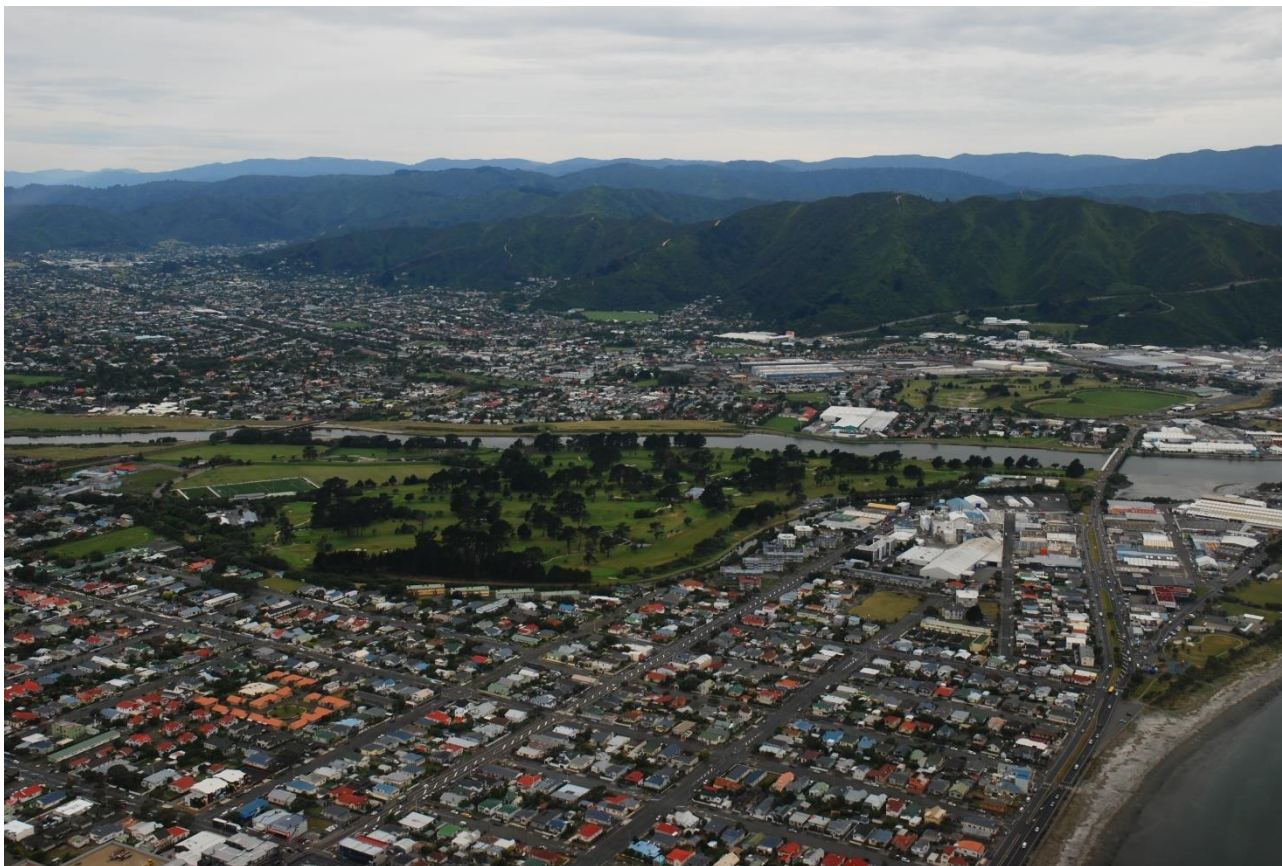
Figure 8: The flat floor of Hutt Valley, looking towards the Eastern Hills.

The valley floors in the Hutt City district, such as the Hutt Valley (Figure 8), Wainuiomata and Stokes Valley, are generally flat or gently dipping at less than 20° , as are beach areas in Petone, the Eastern Bays, and the south coast. Valley floors and beaches have a very low potential for slope failure, although the formation of cuttings in these areas (e.g. for residential development) would increase the slope failure susceptibility. Beach areas will often be exposed to coastal erosion, but this process is not considered in this study.

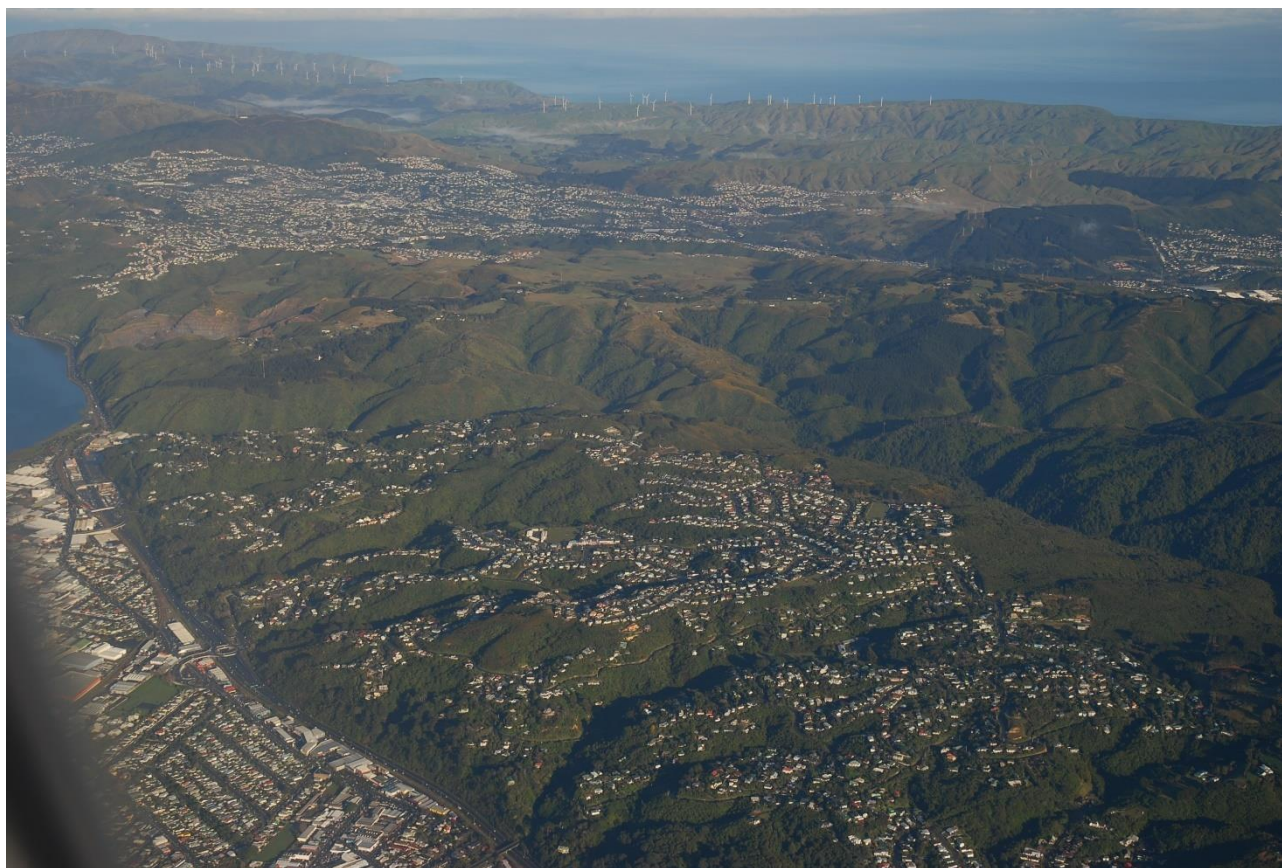
Figure 9: Broad hilltops in the Western Hutt Hills, characteristic of the K-surface. Several suburbs are located across these hilltop areas.

Gently sloping elevated areas, which are particularly common within the Western Hutt Hills (Figure 9), are generally considered to have very low and low slope failure susceptibilities, based primarily on their shallow slope angles. These areas are typically underlain old, uplifted alluvial deposits or loess and topsoil in the highly weathered K-surface areas. Where these materials are eroded and steepened, particularly at the fringes of these raised, flattened areas, the potential for slope failure tends to increase.

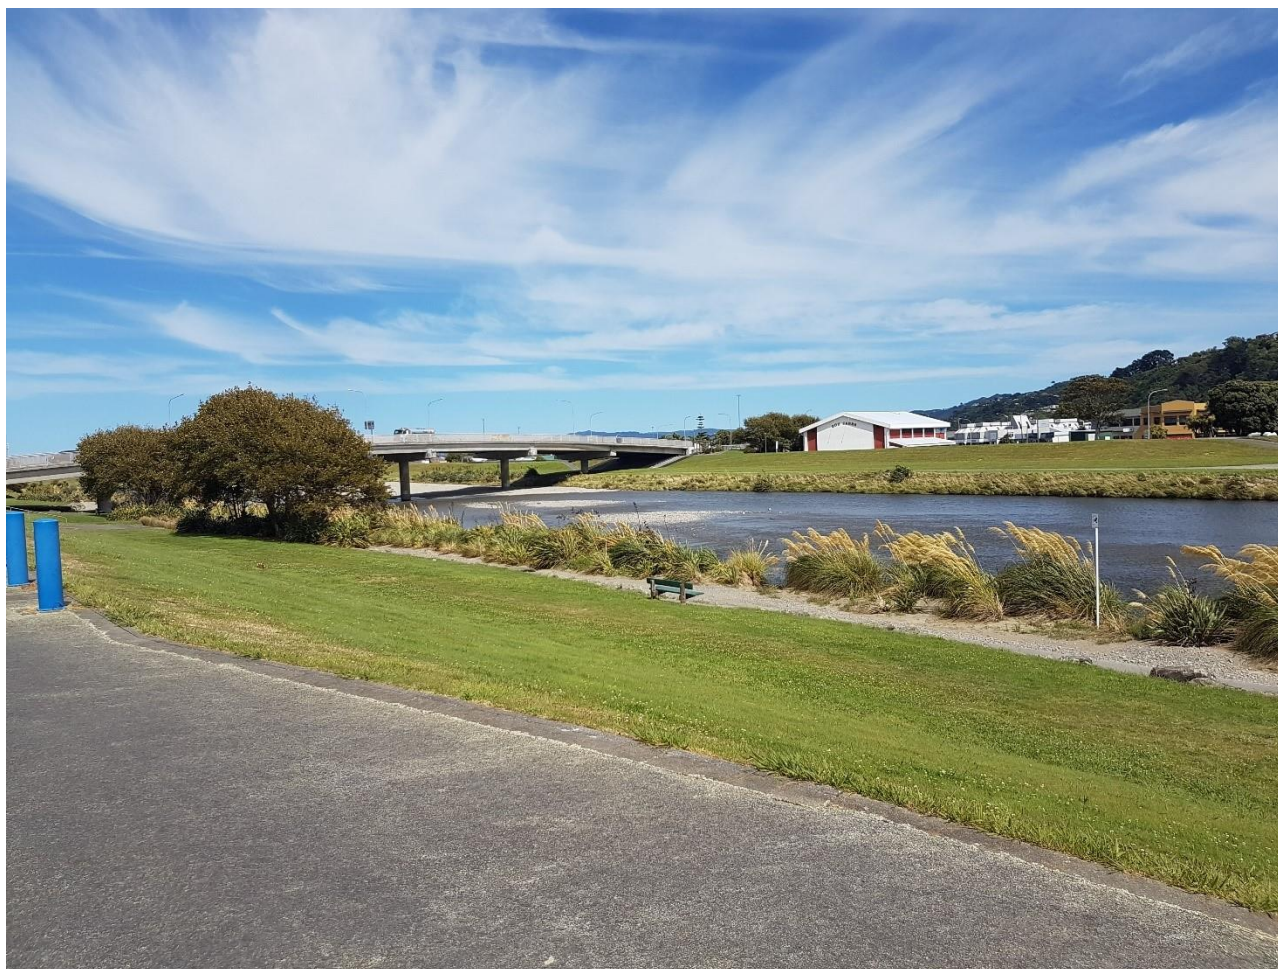
Figure 10: Stopbanks to either side of the Hutt River.

Some man-made slopes are present in the valley floor areas of the Hutt City district, with the majority of these located in the Hutt Valley and Wainuiomata. Stopbanks alongside the Hutt and Wainuiomata Rivers and bridge abutments on the Hutt Valley floor are moderately steep to steeply sloping in places (Figure 10). However, these slopes are generally engineered and unlikely to fail in the same manner as undisturbed and modified slopes in the hill terrain around the district. Therefore, these slopes have been classed as areas of very low slope failure susceptibility.

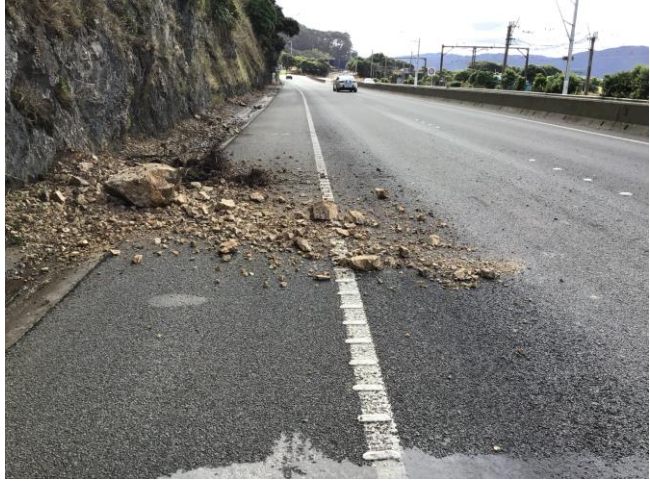
Failure Type	Slope Details	Slope Modifications contributing to failure / failure triggers	Consequences	Example	Example Photo
Rock falls	Typically occurs from closely jointed, steep greywacke slopes, either unvegetated or with low vegetation.	Cut slopes, cut too steeply, with adversely oriented defects. Rock falls often occurs during and following heavy rainfall events.	Usually small volume (20 m^3) rockfalls and overslips, which fall close to the source. Larger boulders can roll or bounce further downslope if the slope below the source allows (up to several hundred metres)	SH2, Petone, 29 June 2020: Rock fall from a 13 m high, 70° to 80° cut slope onto SH2. Failure surface was a steep, planar joint set dipping subparallel to the cut slope.

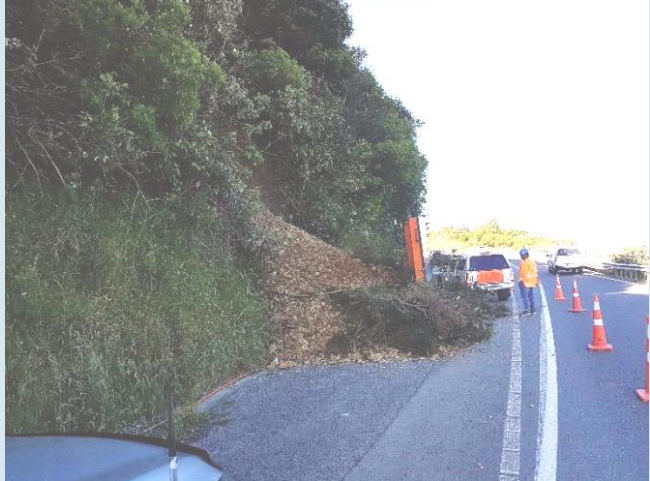
Rock slides / wedge failure	Development of planar or wedge-shaped failures along adversely oriented defects within the greywacke bedrock. Defects are typically persistent joints or crushed/sheared zones which are often bedding parallel.	Can occur in rock cut slopes, which may be oversteepened. Often triggered by heavy rainfall events.	Rock slides result in debris onto roads and property, and can undermine properties at the headscarp of the failure. Typical failure volumes are 10 m^3 up to $500 \text{ m}^3</math> or greater$	SH58, Haywards, 11 December 2020: Shattered bedrock in the upper section of a 65° rock cut slope failed along sheared zones or bedding visible in headscarp. Debris from the slide filled the road shoulder.

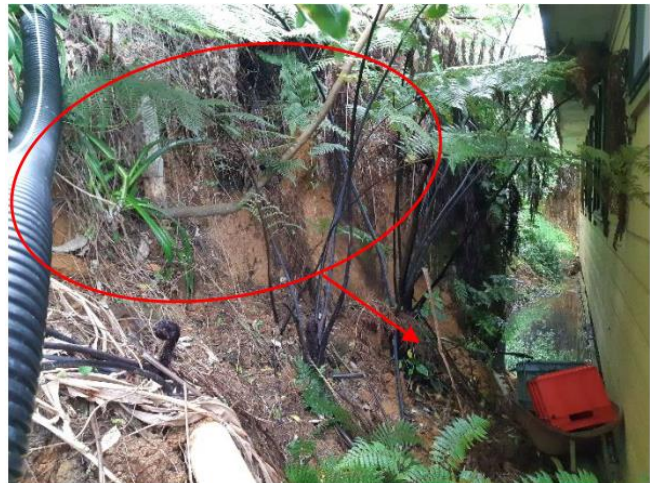
Soil failure	Surficial failures of topsoil, loess, alluvium, colluvium or fill, typically as a result of heavy or intense rainfall. Failures often develop as retrogressive failures in catchments of small drainage channels, or soil failures following vegetation loss on steep slopes.	Poor drainage conditions within the slope, removal of vegetation or excavation of the toe can increase the likelihood of failure. Often triggered by heavy rainfall events. Can also occur as a result of earthquakes, with failure along the soil/rock interface.	Soil failures result in debris onto roads and property and can undermine properties at the headscarp of the failure. Typical failure volumes are 10 m^3 up to $200 \text{ m}^3</math> or greater$	Residential failure in Naenae, 27 September 2020: Failure of residual soil (silty clay with gravels) from a 2 m to 3 m high, $\sim 70^\circ$ cut slope behind a dwelling, causing inundation behind the house, damage to services and a loss of 1 m^2 of land at the headscarp.

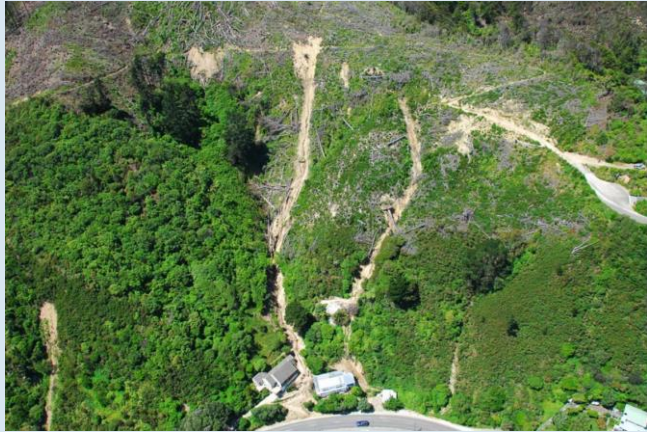
Failure Type	Slope Details	Slope Modifications contributing to failure / failure triggers	Consequences	Example	Example Photo
Debris flow	Loose, dry or saturated debris mobilised downslope, typically down a pre-existing channel. Slope angles typically 20° to 40°.	Debris flows have occurred in areas where there has been vegetation removal upslope of developed areas. They are triggered by earthquake shaking, or later by heavy rainfall following an earthquake, or by heavy rainfall events mobilising poorly vegetated soils.	A debris flow forms a fan when the channelised flow meets a plain or gentler slope (< -4°). The fan can inundate houses, roads and other infrastructure at the bottom of the channel. Debris volumes were analysed by Massey et al. (2019) and found to be between 15 m ³ and 11,000 m ³ . but smaller volumes (<100 m ³) are more prevalent.	Sunshine Bay, Eastbourne, 24 October 2006: Two large debris flows, initiated as shallow soil slides in an area of recent pine felling, were triggered by intense rainfall. Two houses were damaged and eventually abandoned. Photo from Hancox et al. (2006).

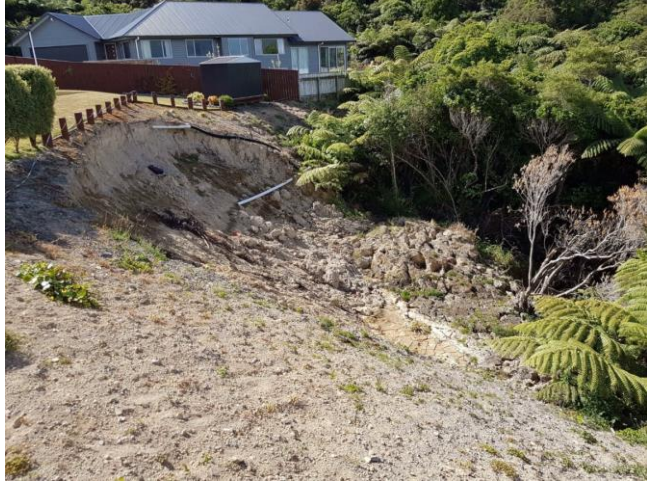
Fill embankment failure	Gullies are often filled with granular material to provide a larger platform for residential development, roads and other infrastructure.	Failure of fill slopes is often triggered by heavy or prolonged rainfall events, particularly when fill slopes are steep or poorly compacted during construction and have high natural groundwater levels. Uncontrolled stormwater discharge or removal of vegetation cover may also trigger failure.	Inundation of property or infrastructure at the toe of the failure, with loss of land and possible damage to buildings at the headscarp. Damage to services buried within the fill embankment. Typical failure volumes are 100 m ³ to 10,000 m ³ .	Residential failure in Kelson, 8 December 2019: Failure of fill slope following a prolonged heavy rainfall event, causing inundation of land below failure and loss of approx. 30 m ² of property at the headscarp.
